**REPORT
OF THE
AMERICAN PUBLIC TRANSPORTATION ASSOCIATION
PEER REVIEW PANEL
FOR
MEMPHIS AREA TRANSIT AUTHORITY
Memphis, TN**

REPORT
OF THE
AMERICAN PUBLIC TRANSPORTATION ASSOCIATION
PEER REVIEW PANEL
ON
TROLLEY FIRES
AT THE
MEMPHIS AREA TRANSIT AUTHORITY

Executive Summary

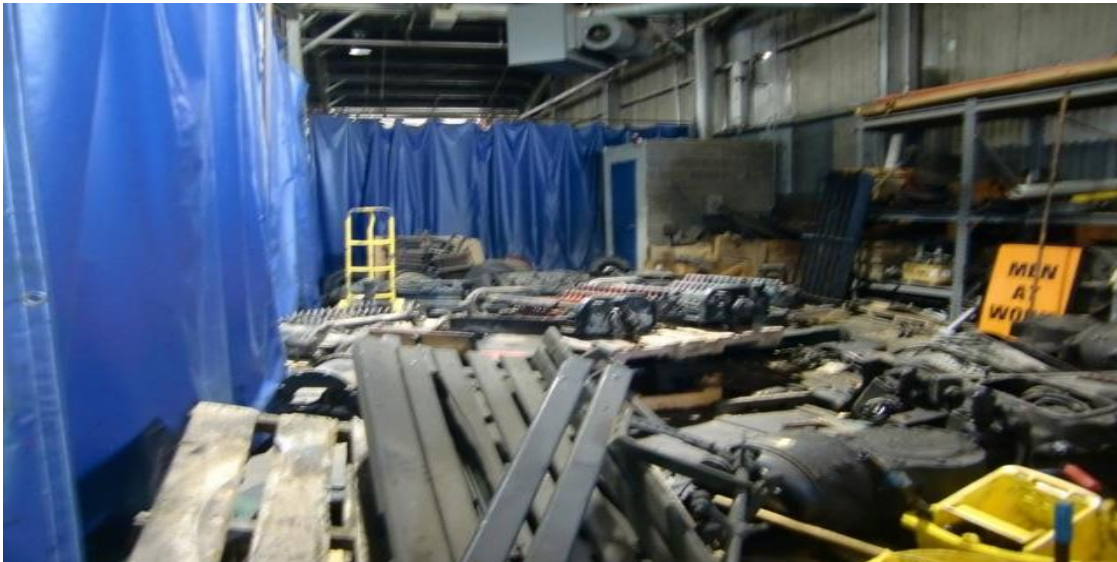
Figure 1 – Heavy parts storage area

- c) A large quantity of worn out parts, such as motors, compressors, trucks and controllers, were found in various state of disrepair. See Figure 1.
- d) Defect Cards for Car #553 were reviewed for the period January 3, 2014 to April 6, 2014. Forty three defects were recorded during this three month period. Fire on this car was on April 7, 2014.

- l) Arrange for worn out parts, such as motors, compressors, trucks, controllers, etc.), be serviced or rebuilt.
- m) Develop an oversight procedure for checking on work done on defects reported on defect cards.

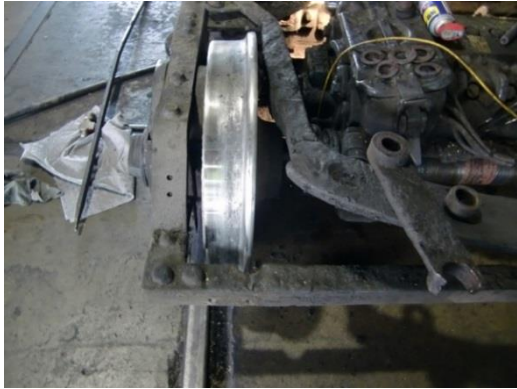
Figure 2 - Wheel with normal wear

- i) Some MATA staff indicated that there is a lack of available maintenance manuals, etc.
- j) On some cars inspected, we found the brake systems to be worn out. (See Figures 2 -6)

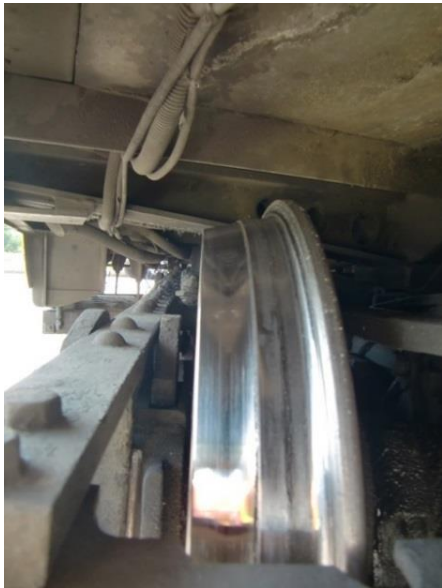
Figure 3 - Trolley #453 Abnormal wear on left side tread. The narrow flange and uneven tread surface requires the wheel to be trued.

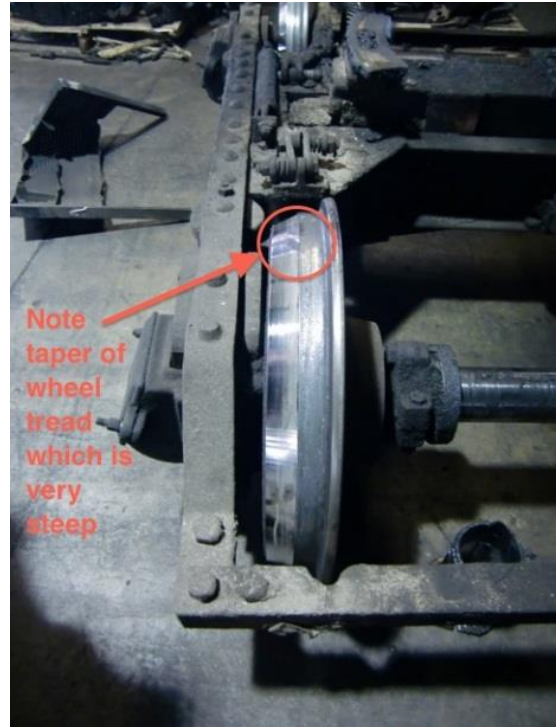
Figure 5 - Steep tapered wheels

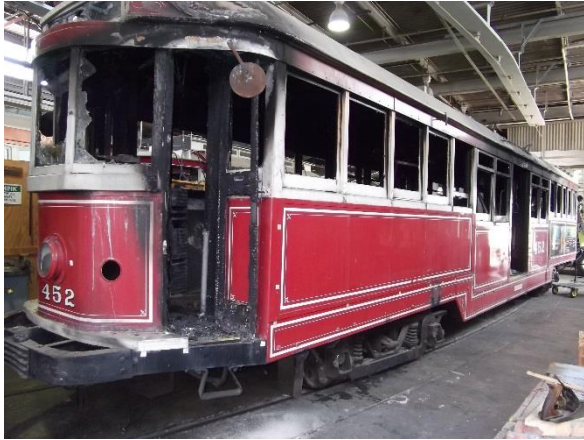
Figure 7 – Trolley #452 after the fire

As trolley #452 is proceeding along on Madison Street, the operator has the control handle in full power or “full parallel” point 8 position. (See Figure 14 for a Typical Cab Controller/Key Switch Position). At a moment in time, there was a flash in the controller (See Figure 15) and a subsequent fire begins. The operator backed off the controller initially to point 1 and moments later to the OFF position. The operator applied the brakes, and attempted to stop the fire by means of turning off the line breaker main switch behind the operator on a panel. (See Figure 13). The car slows down, and as it does, the fire becomes more intense. This would be due to the motors straining against the braking system and the motors drawing more current. The controller at this point is acting as the circuit breaker and is the weak link in the chain.

It is clear that had the line breaker and control apparatus functioned as designed, the line breaker would have opened (dropped out) and no power would be flowing through to the controller and motors. Looking at the arch it would appear the safety equipment did not function as designed and the motors continued to receive power. The flames from the arch appeared to be severe enough that the operator may have run the risk of getting their clothing on fire had they attempted to stay longer and move the controller all the way to the OFF position.

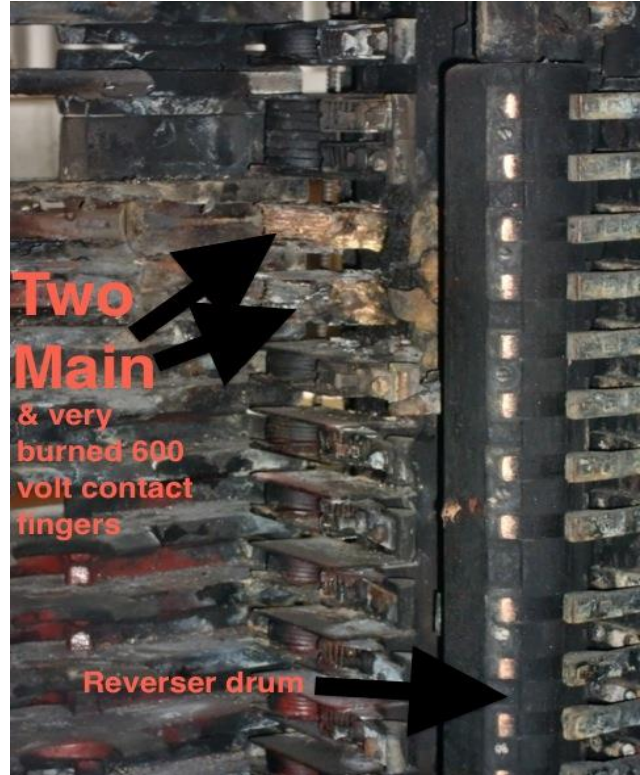
According to the shop staff, motor # 3 was shorted. Typically this would have happened at the same time as the controller was moved from notch 5 to 6. The line breaker overload, which should have protected the car wiring and motors failed to do so.

With the line breaker tips closed it allowed more current into the controller due to the heavy current draw from the motors caused by the brakes being applied and trying to slow the car down. This caused the fire to become intense and severely burn the car.

Figure 10 – Reverser drum on trolley #452 after the fire,

showing burned 600 volts dc fingers on the controller

In an emergency, had there been a way to lower the pantograph, and then keep it lowered and latched down, would have been a way to keep the car from

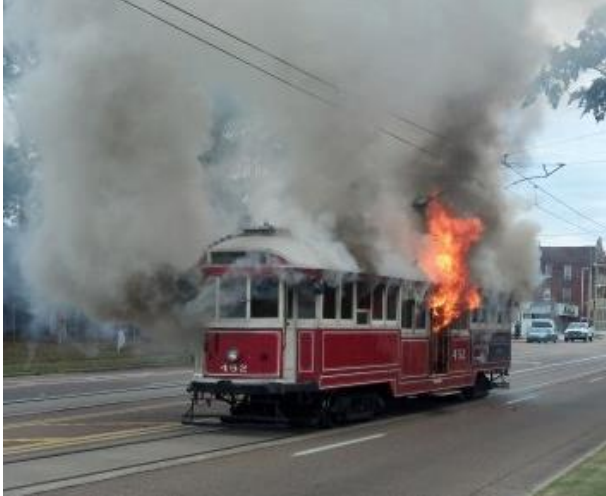
This photo in the FTA report shows the pantograph still raised on the overhead wire system. If the overhead were still energized, this would have greatly contributed to the fire.

This car was partially stripped when the review team saw it. The line breaker we were told was moved to car 453.

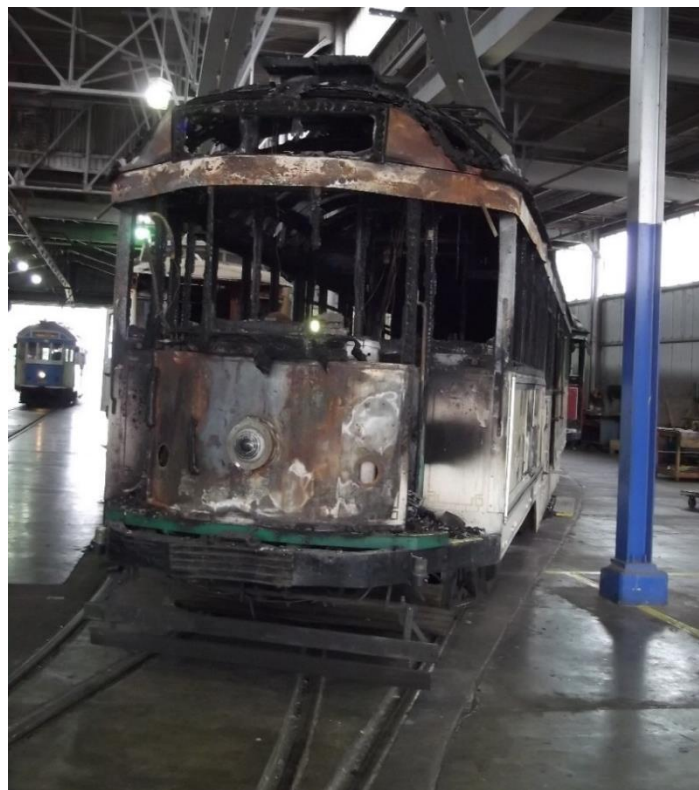
The photo in the FTA report June 2, 2014, shows the pantograph is still raised onto the overhead contact wire system. Had there been a way to lower the pantograph and keep in down and latched in an emergency it could have reduced the amount of damage to the car. Had the pantograph been lowered in of sufficient time there is no doubt it would have substantially reduced the damage to

Figure 13 – Trolley #553 showing the burnt out shell at one end of the car.

It also shows the lack of safeguards with the pantograph as it should have a means to hold it down in emergencies and be recognized by the fire department of a hazardous situation. The shop staff should also have a 'hot stick' capable of pulling the pantograph down in an emergency on their road call truck.

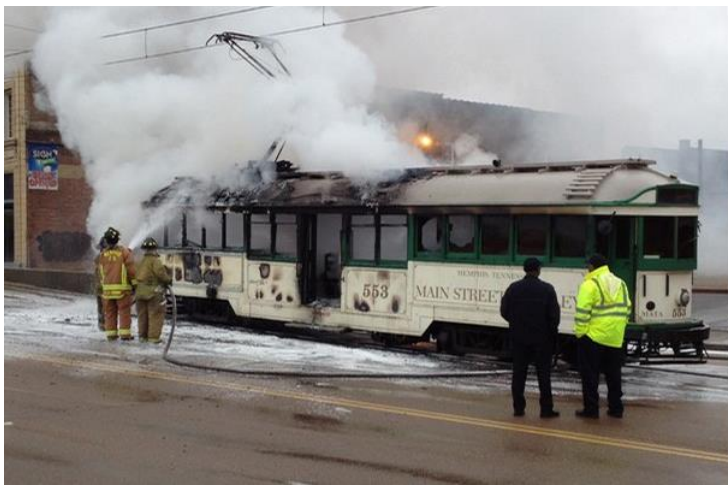
Figure 14 – Trolley #553 fire being extinguished by the Memphis City fire department.

Note: Pantograph is still raised and in contact with the overhead wire.

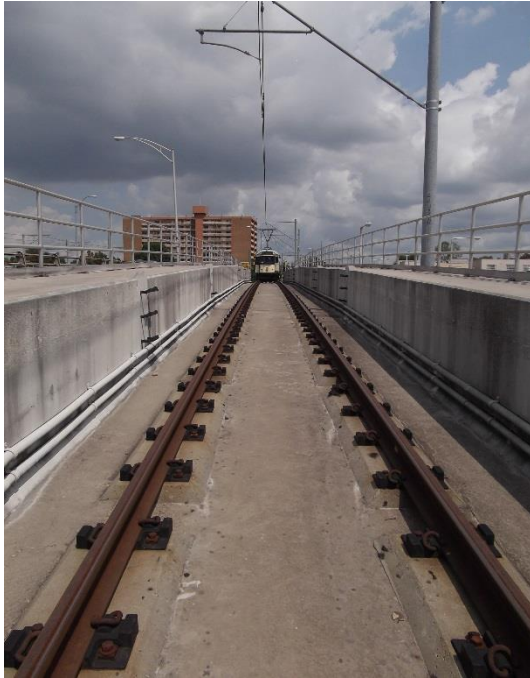
Figure 16 – Showing the limited clearance and the 6% grade over the Danny Thomas Blvd. Bridge on the Madison Avenue Line

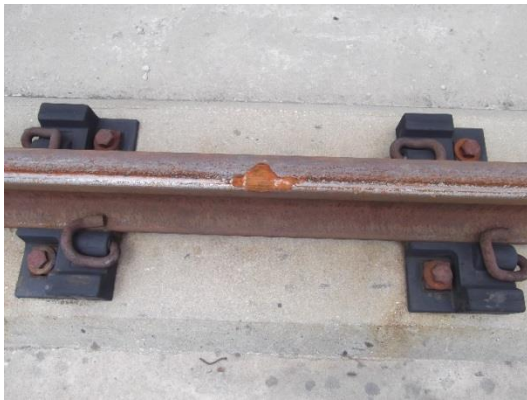
The following photos show rail burn marks at the location where trolley #553 caught fire on the Danny Thomas Blvd. Bridge on the Madison Avenue Line. These marks occur when the motors cause the wheels to spin in the same place.

Figure 17 – Rail burn marks on the Danny Thomas Blvd. Bridge on the Madison Avenue

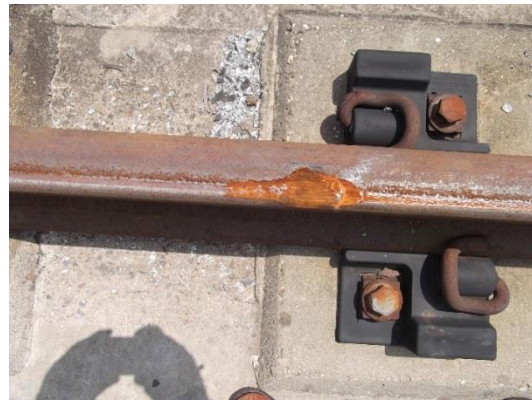
Figure 18 – Rail burn marks on the Danny Thomas Blvd. Bridge on the Madison Avenue Line
