Structural

Environmental

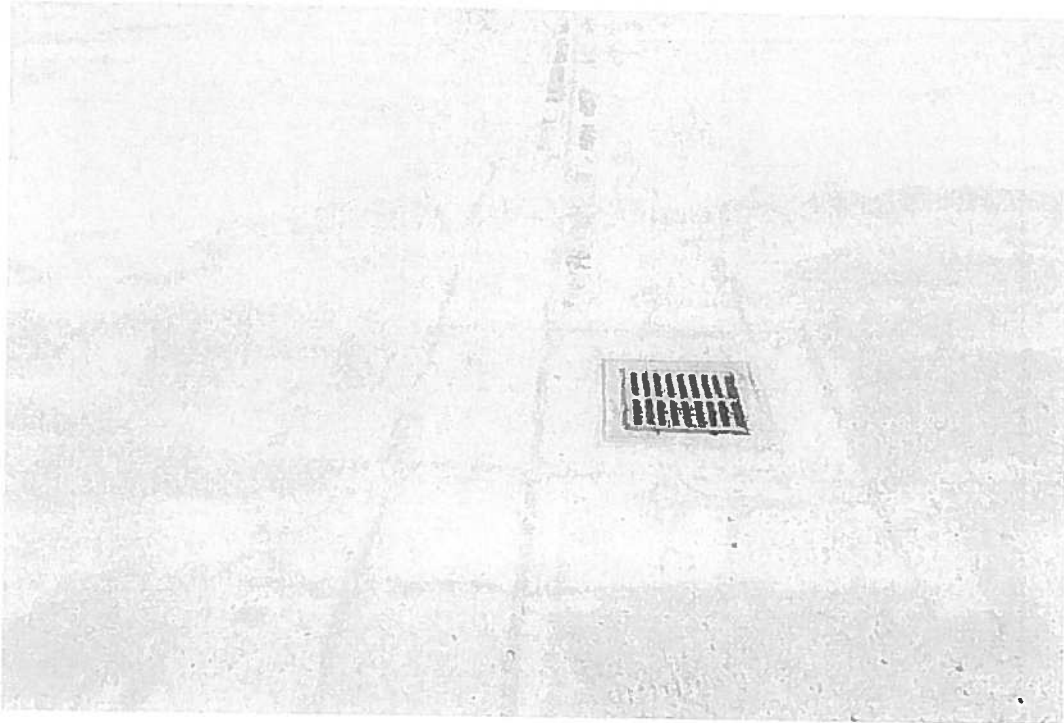
Picture 3: Parking deck sealant in joints and deck drain above area leaks below in Zellers.

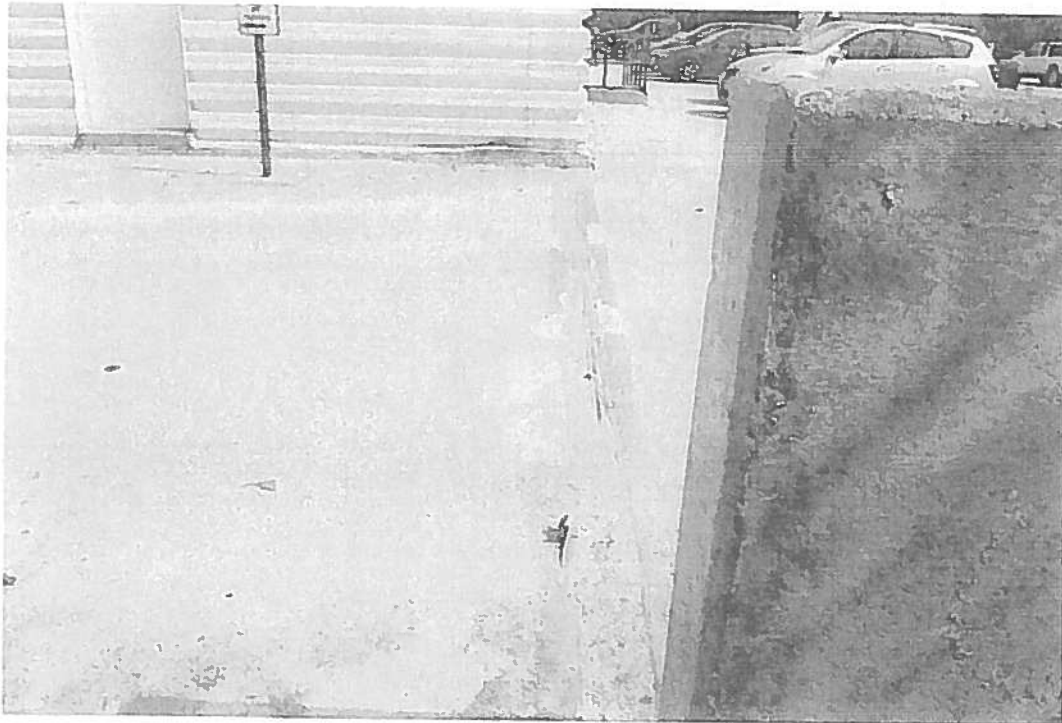
Picture 4: Major expansion joint at SW corner of Algo Inn. Leakage in Library below.

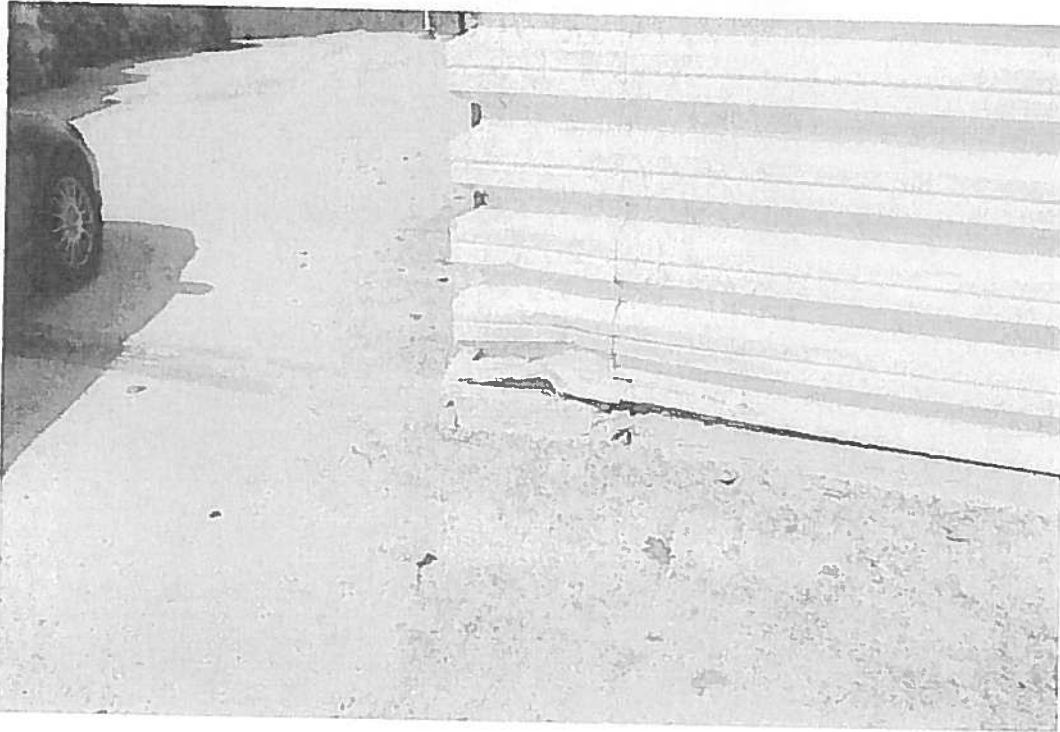
Picture 5: Impact at SW corner of Algo Inn at expansion joint.

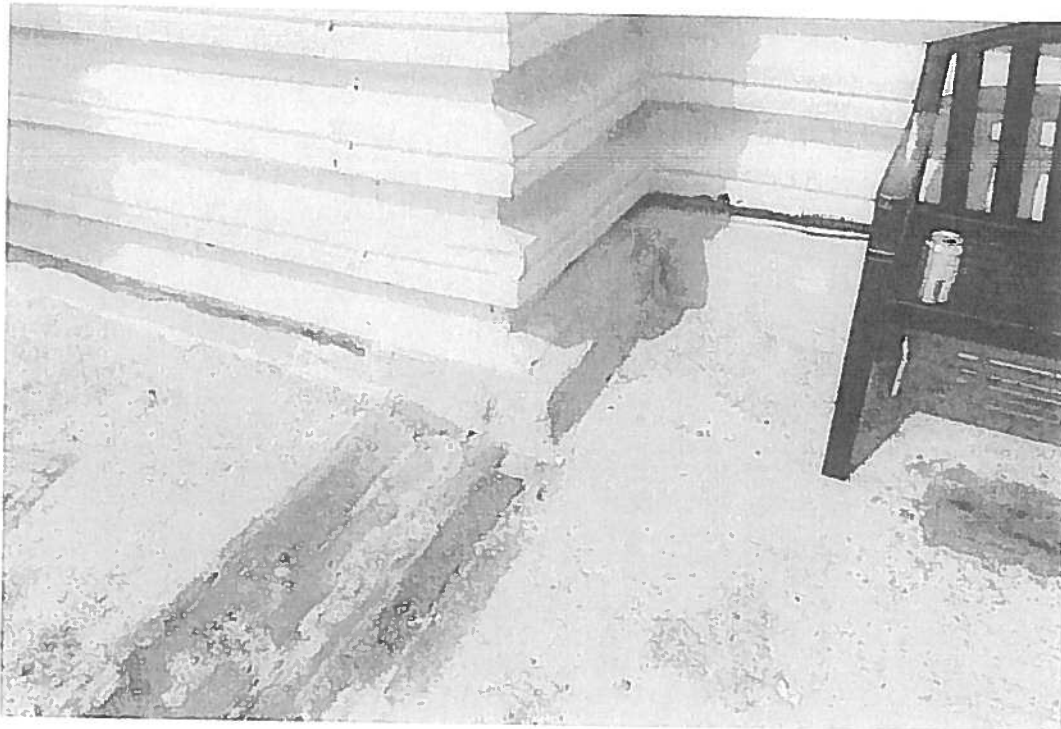
Picture 6: Expansion joint at SE corner of Algo Inn leaks in lottery ticket booth mall below.

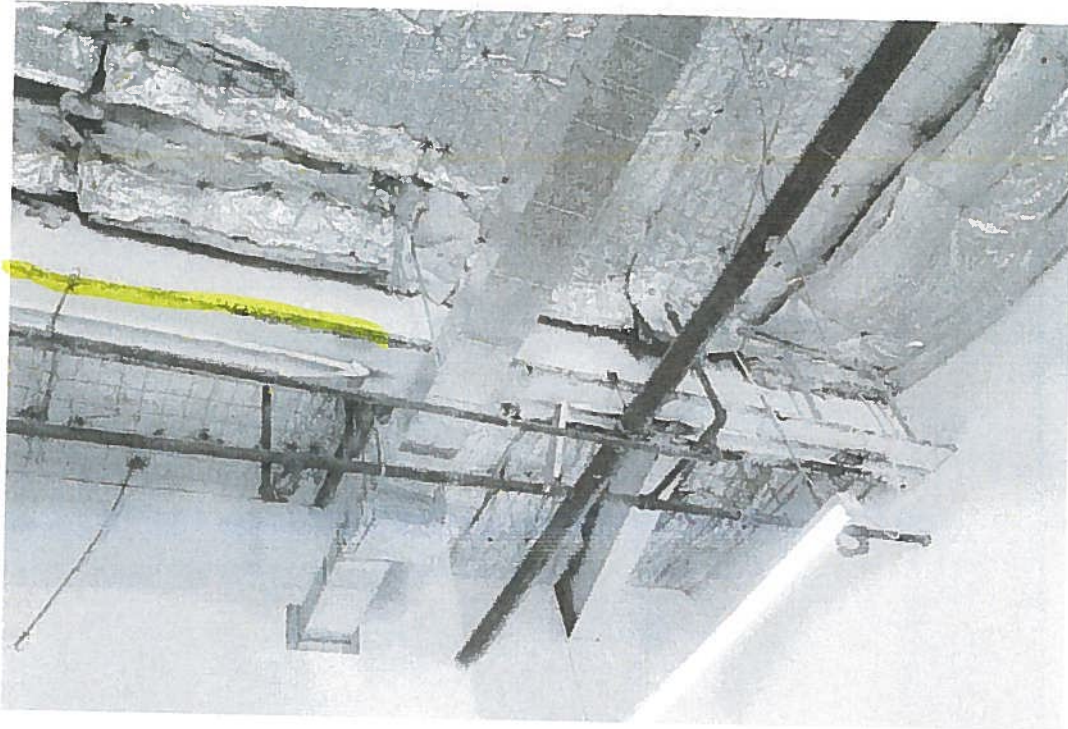
Picture 7: Rusting on steel beams in receiving of Zellers.

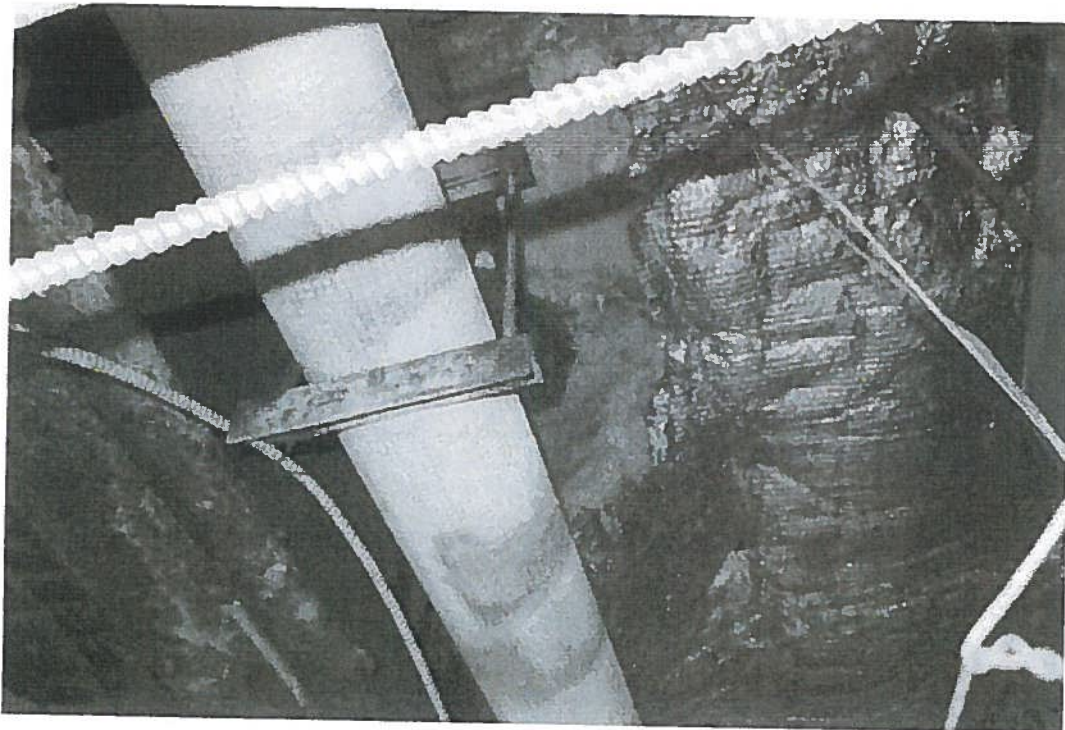
Picture 8: Rusting steel beams and drain pipe below parking deck above Zellers ceiling below Picture 2.

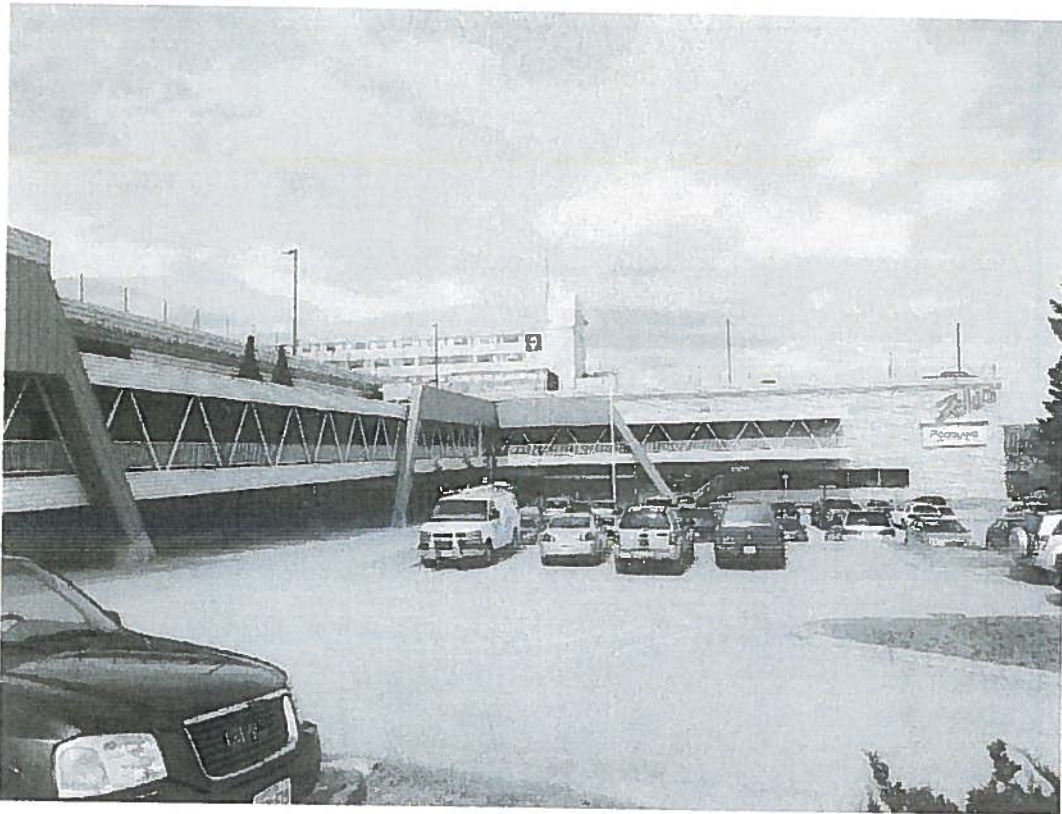
Picture 9: East side open walkways of Algo Mall.

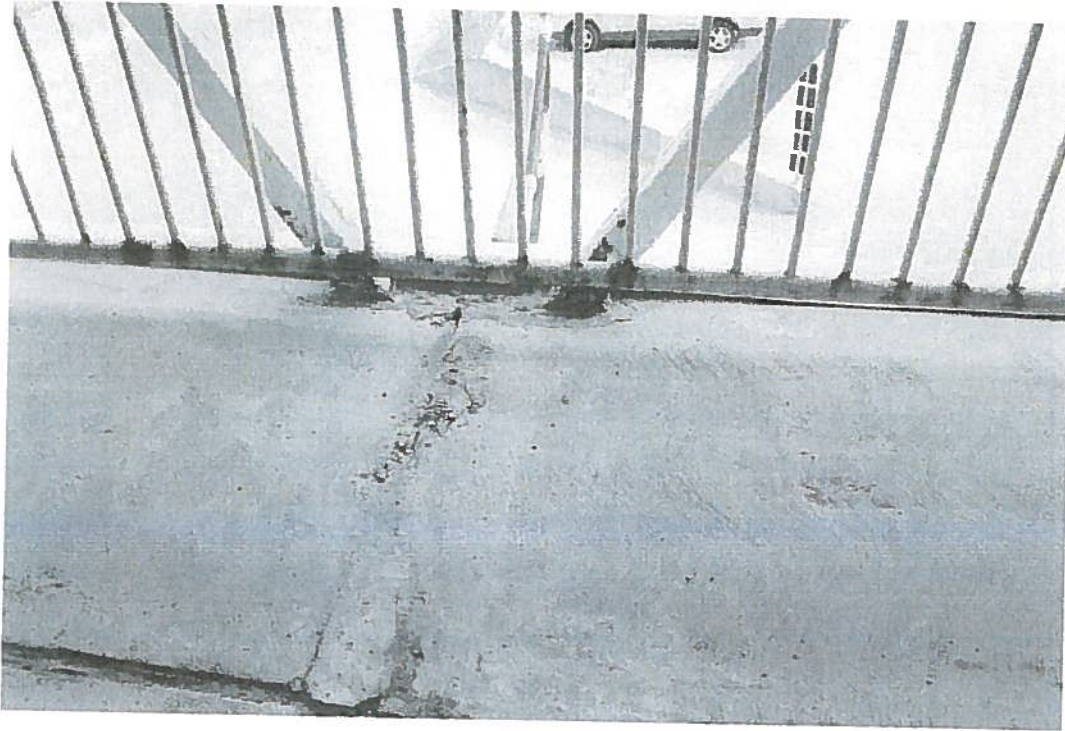
Picture 11: Rusting steel at base of diagonal HSS members of open walkway.

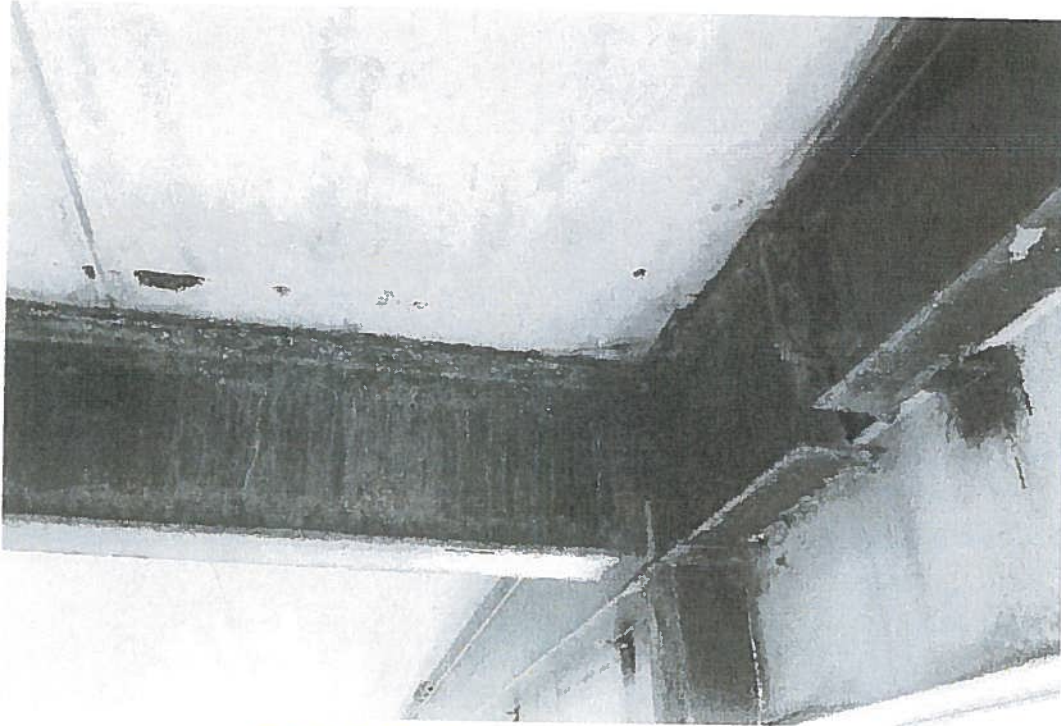
Picture 12: Rusting steel U/S of deck of open walkway.

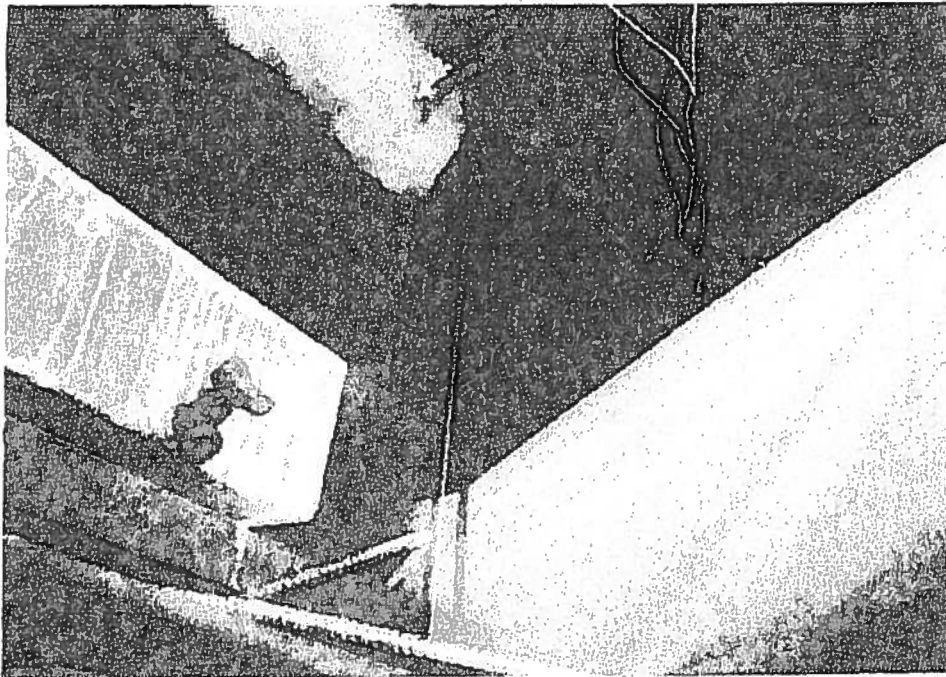
Picture 4: Yellow tarp and galvanized eavestrough with faucet to collect water penetration through slab steel not fire-rated in Zellers. Only surface rusting on beams.

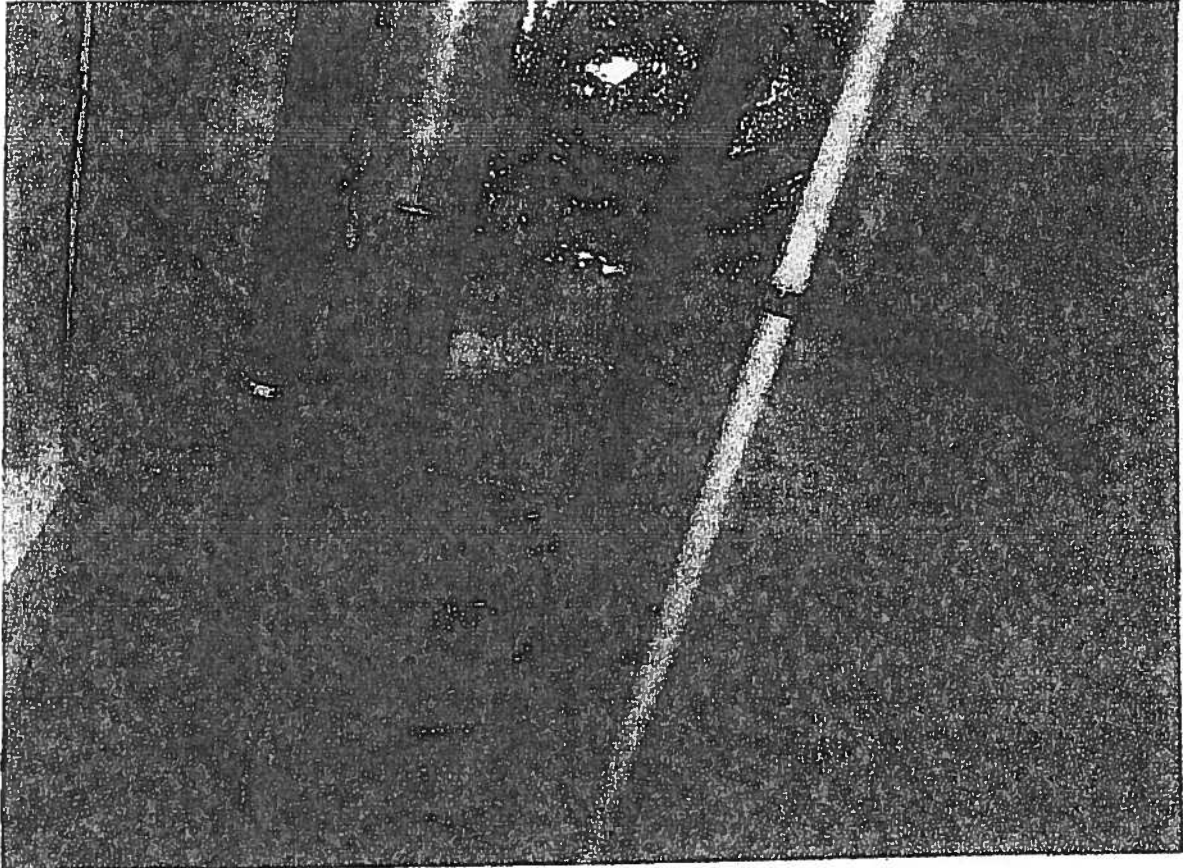
Picture 5: Corridor west of hotel. Past leakage has resulted in removal of fire proofing. BTM flange still has primer paint. Minimal rusting on top of bottom flange.

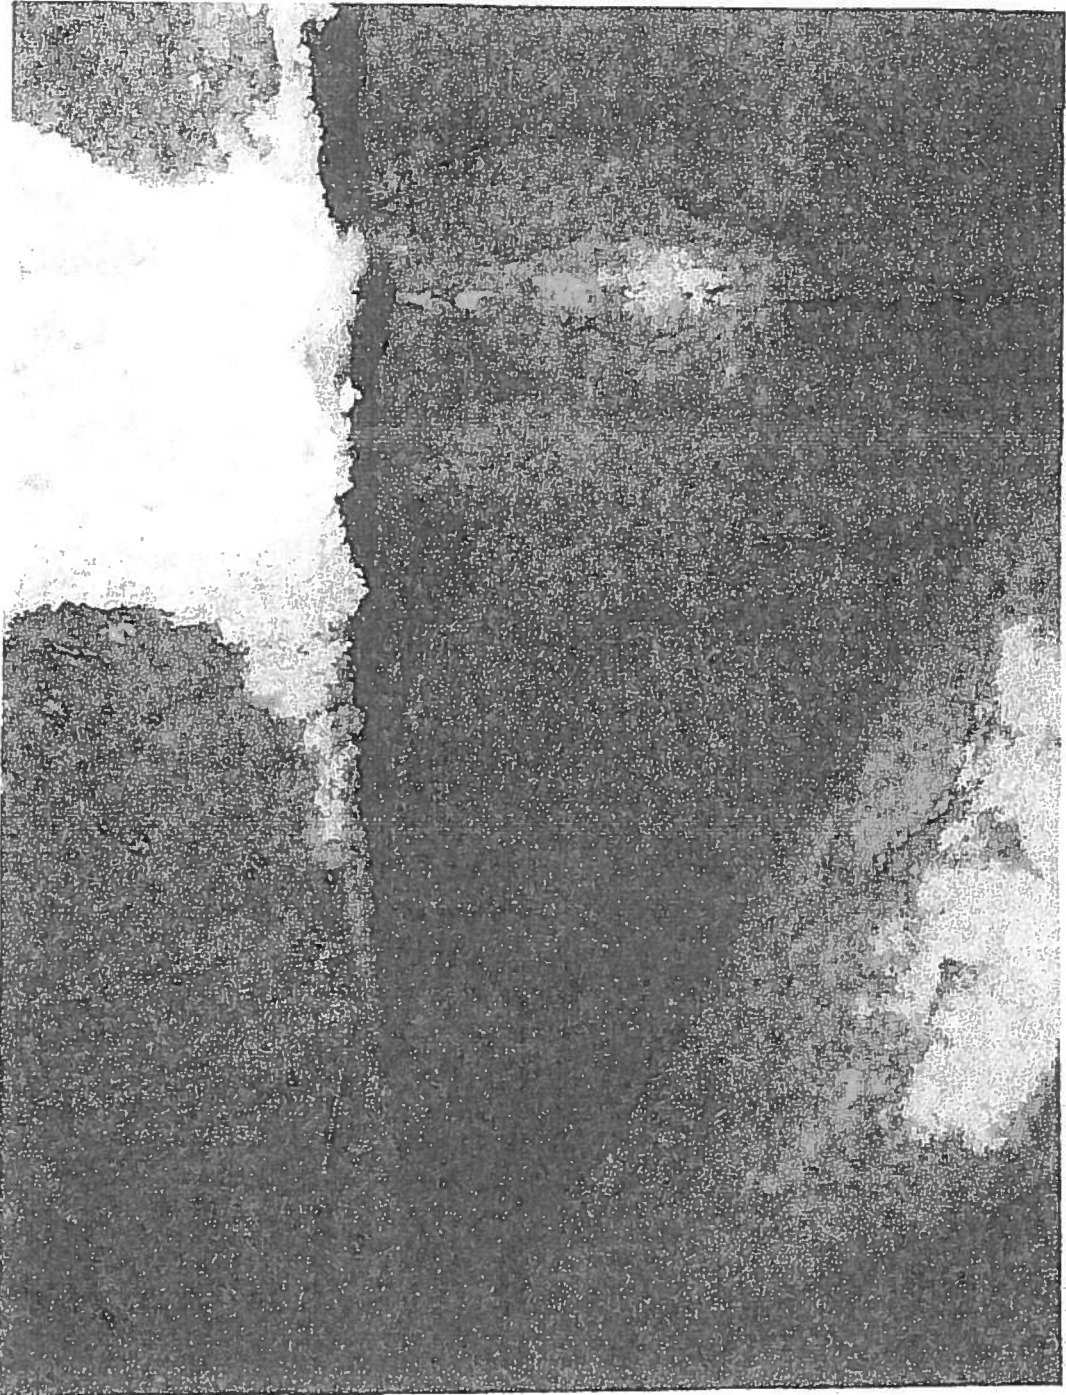
Picture 6: Exposed underside of right parking area. Precast slabs right of beam leakage location at ticket kiosk in Mall, Grid Line 16 efforescence stain at precast slab joints and fire proofing has fallen off bottom flange of steel support beam.

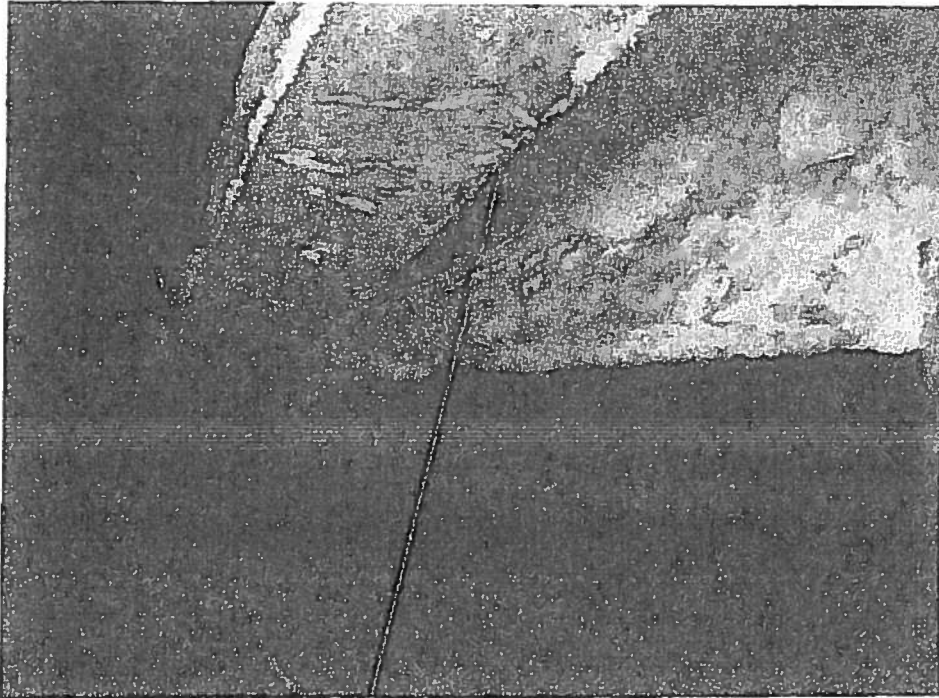
Picture 7: Missing fireproofing bottom flange of beam at Ticket Kiosk in mall. Insulation fallen off precast slabs.

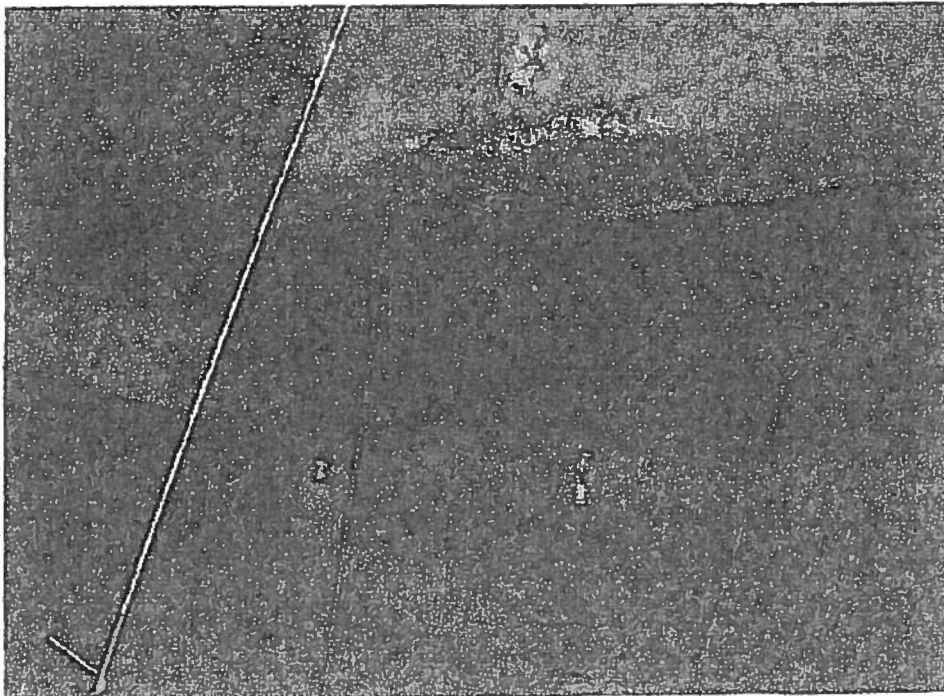
Picture 8: Fireproof missing bottom flange steel beams in Bargain Shop.
