Expert Evaluation of the D.A. Hughes Collier-Hogan 20-3H

Well Drilling and Workover

Prepared for
Florida Department of Environmental Protection
3900 Commonwealth Blvd. M.S. 35
Tallahassee, FL 32399

December 2014

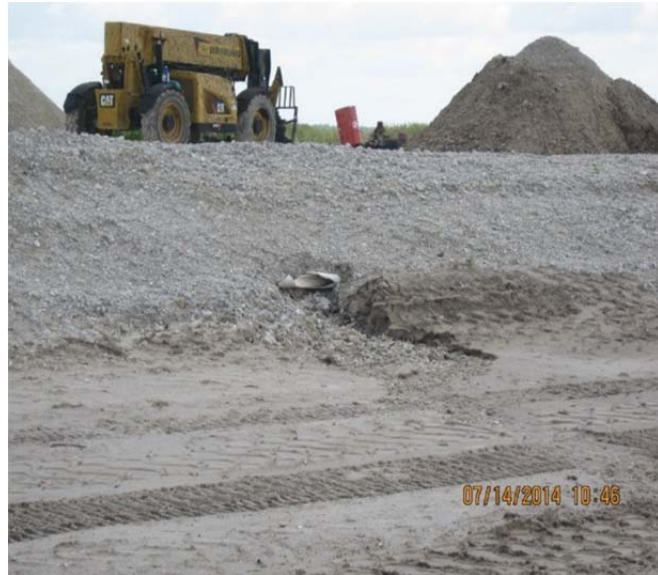
Figure 2: Apparent Berm Fluid Discharge Pipe with Erosional Gully

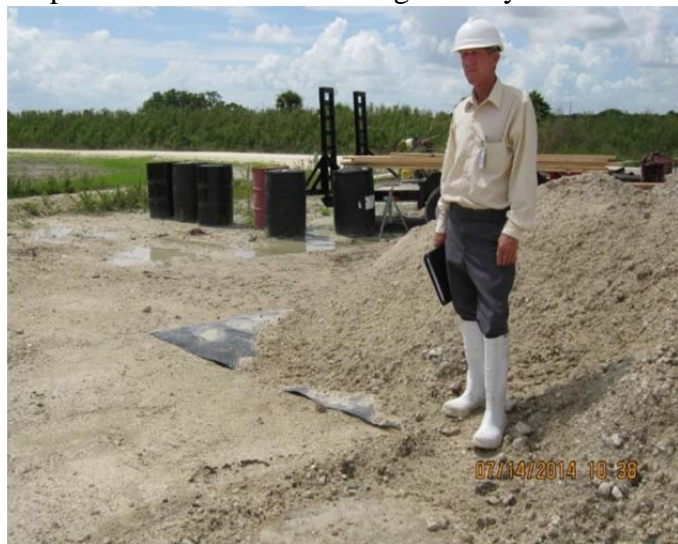
Figure 4: Foreground- What Appears To Be Contaminated Rubble with Improper Containment and Coverage; Background- Barrels of Chemical with No Obvious Secondary Containment

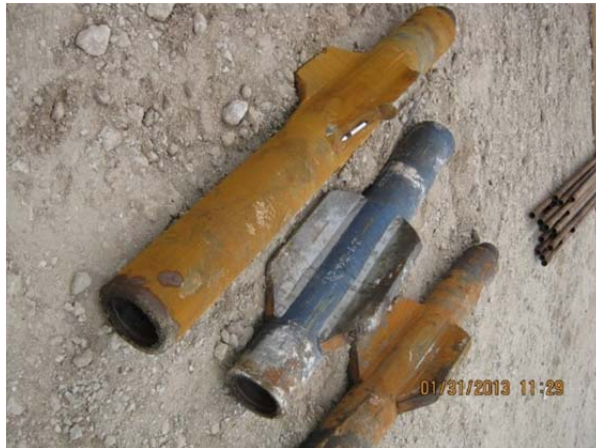
Figure 5: FDEP Photo Indicating Damage to Stabilizer

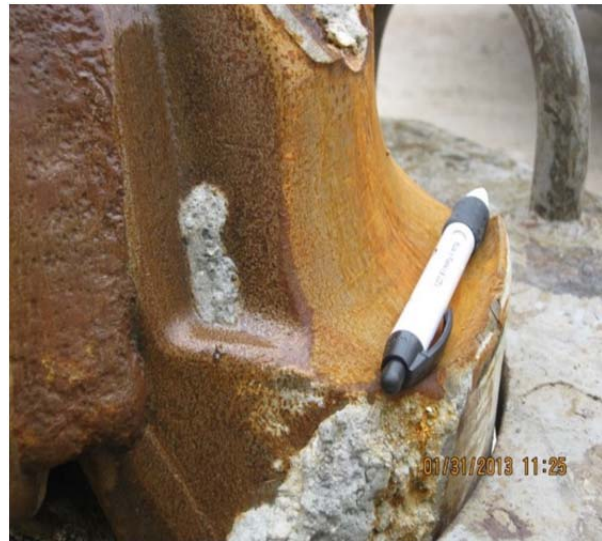
Figure 6: FDEP Photo Indicating Damage to Drill Bit

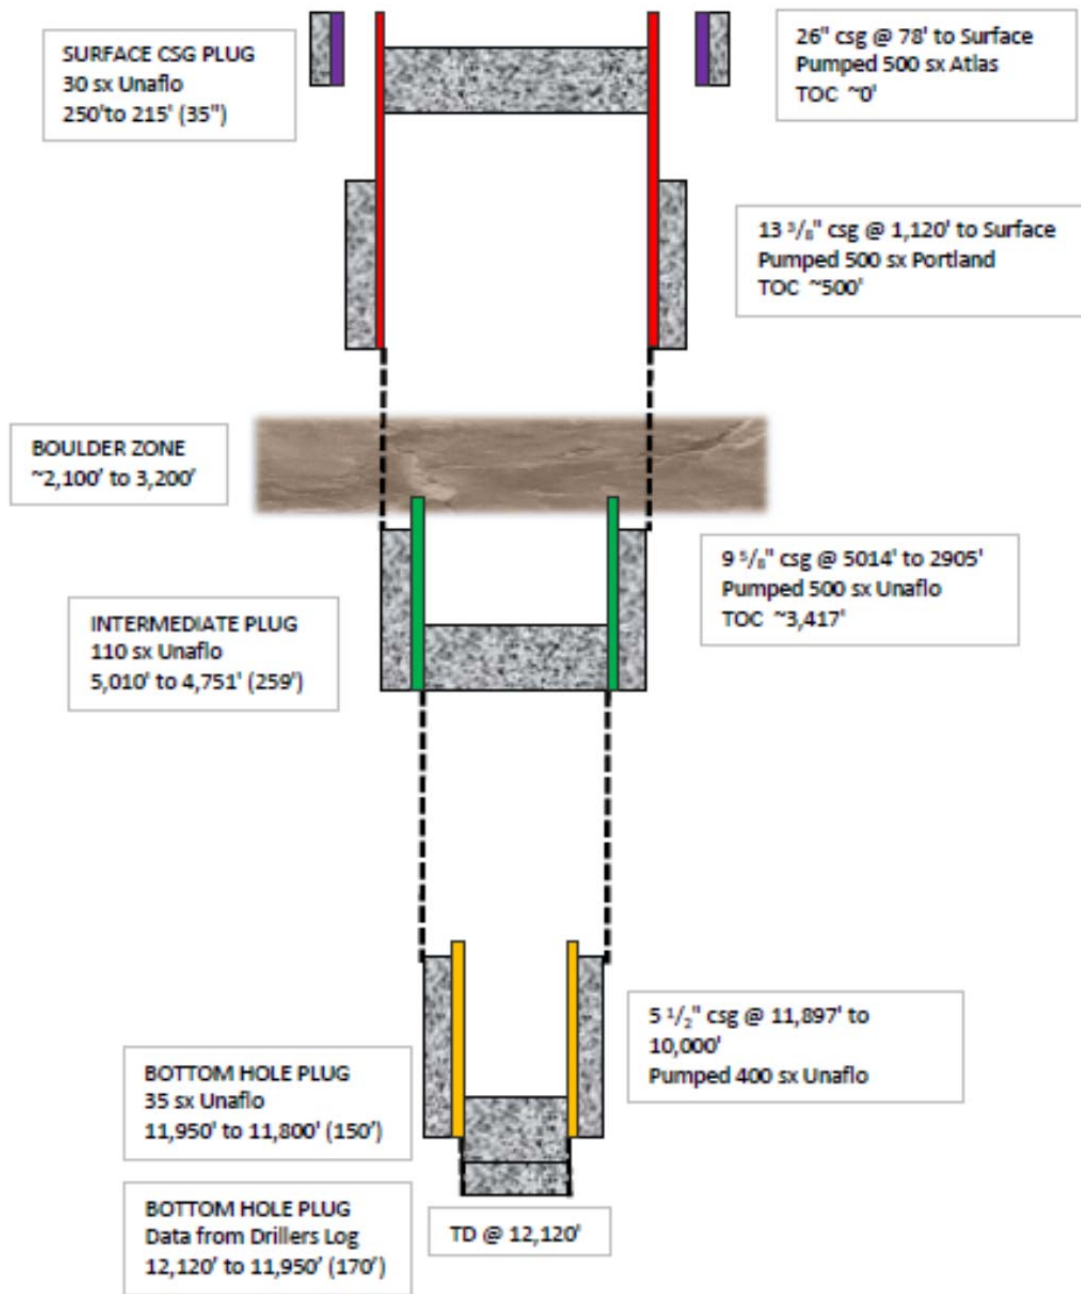
Figure 14: Permit 86 Wellbore Schematic

The “Boulder Zone” and the lower portion of the USDW were not cemented and the records do not indicate there was a cement plug placed between the two zones. This uncemented interval could have provided a pathway for potential communication of the saline waters from the “Boulder Zone” to the lowermost USDW.

Re-entering the well to drill out the cement plugs to investigate for potential cross-flow conditions is not recommended. The risk of damaging the casings and plugs, thus creating a conduit for potential cross-flow of larger magnitudes, is greater than the benefit of isolating the USDW.

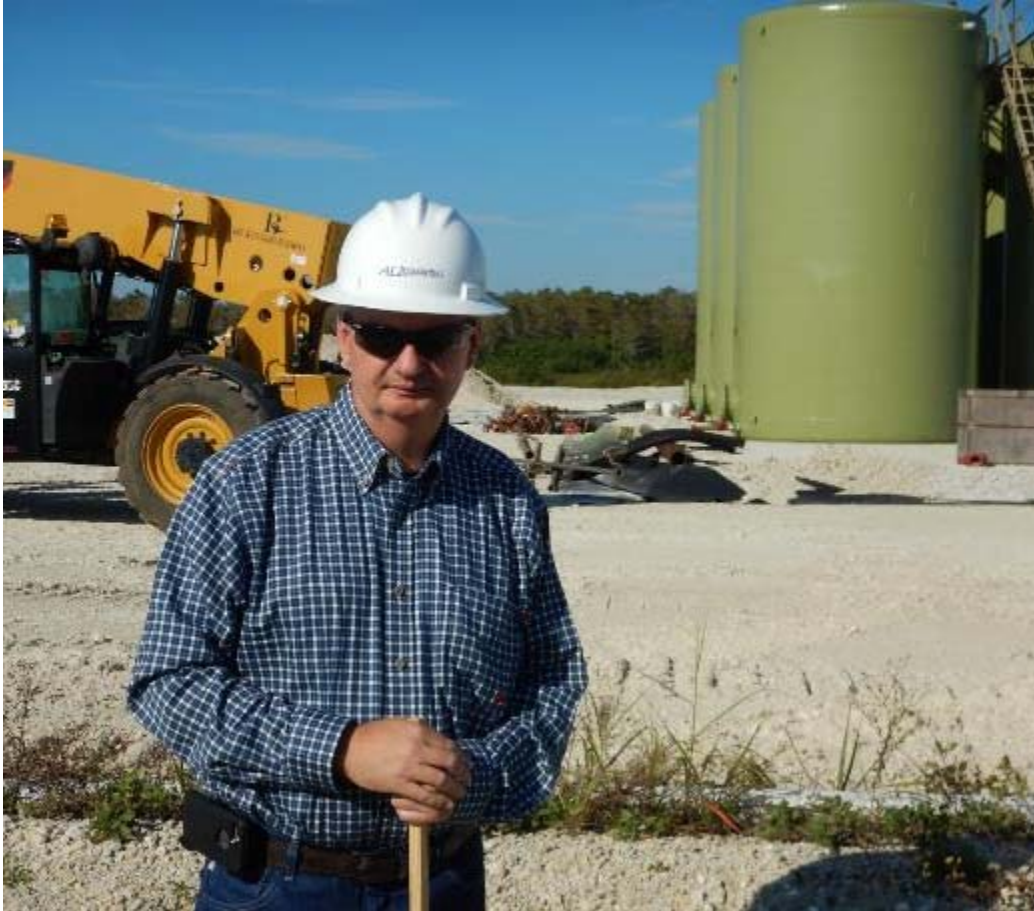
Photograph 14

Pipe laying on liner and possible damage to same

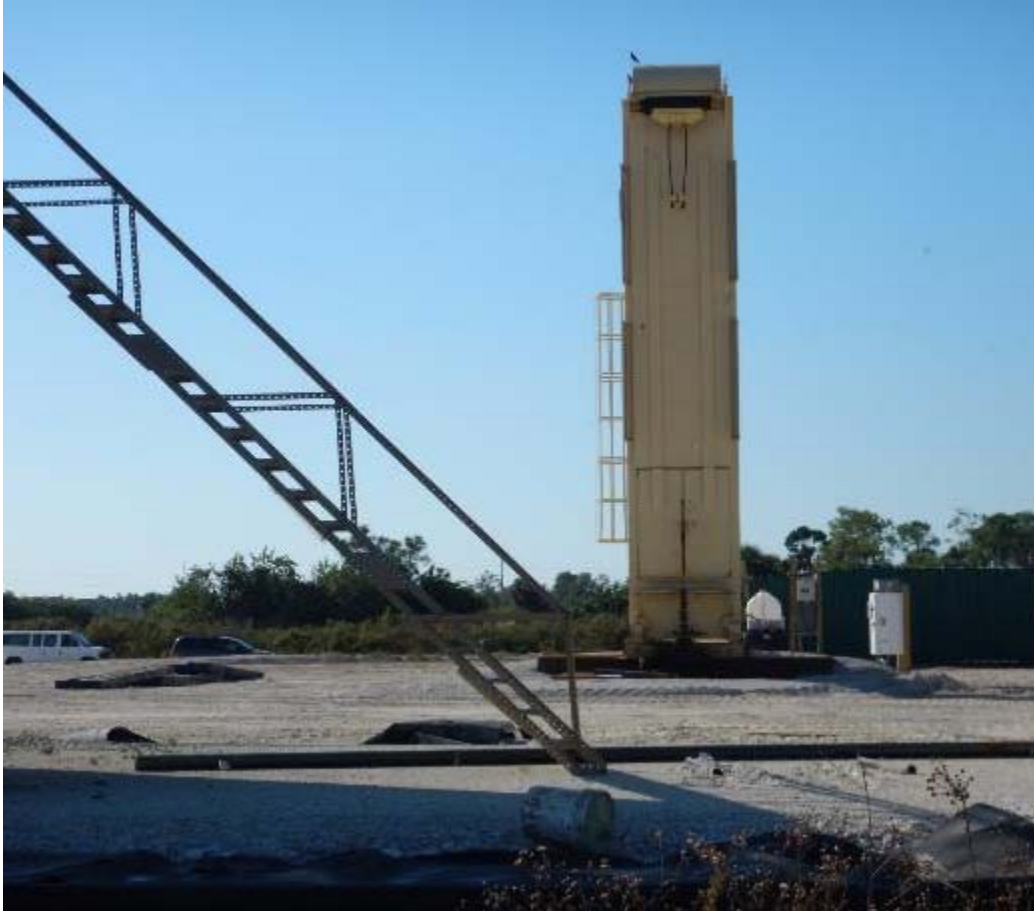
Photograph 31

Harness not connected to rod assembly (not capable of activating till reconnected – indication of long term shut-in)

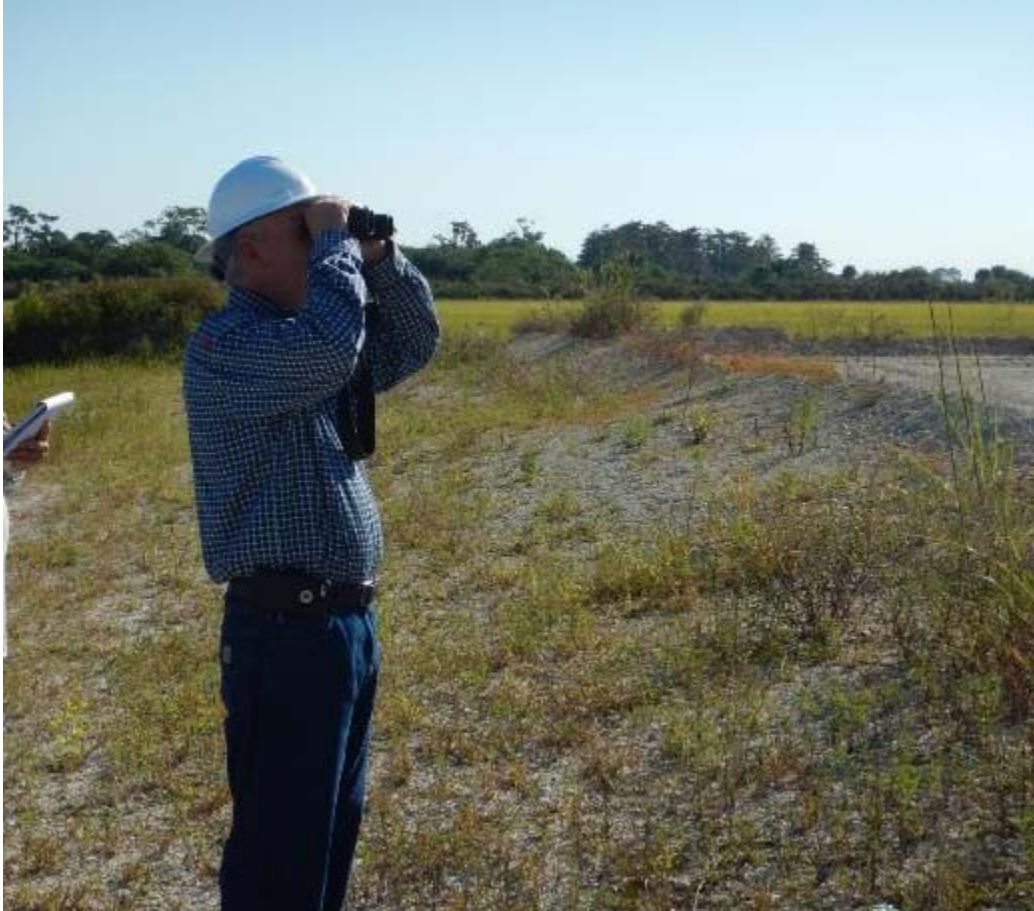
Photograph 32

Notes: Dan Arthur with binoculars noting presence of pressure gauges with open valves and zero pressure on tubing and annular

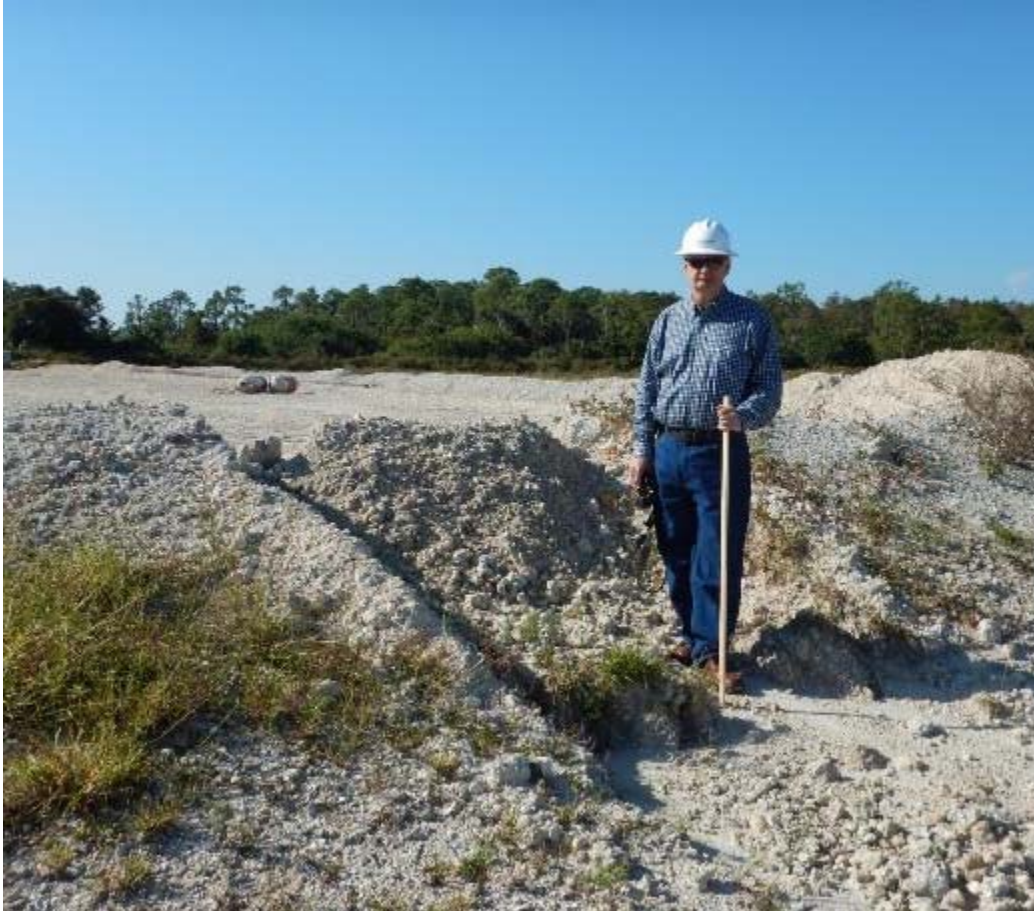
Photograph 39

Notes: Breached berm with subsequent fill

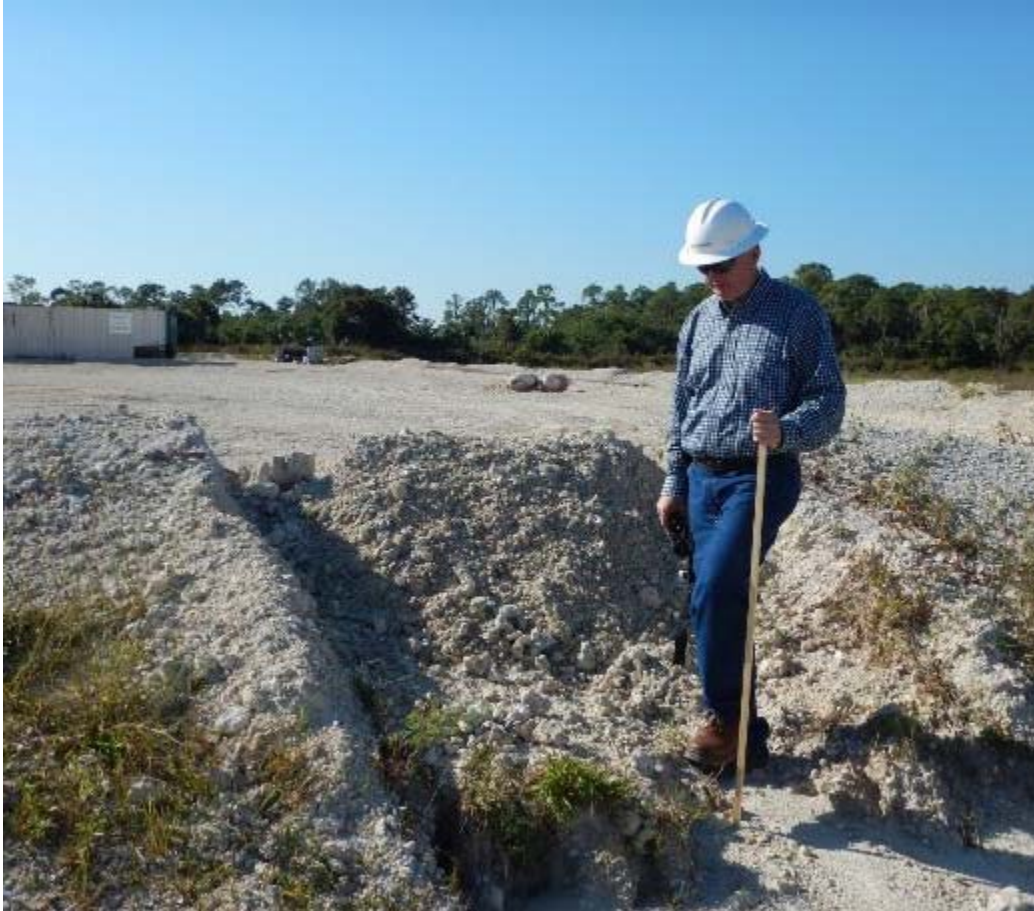
Photograph 40

Notes: Breached berm with subsequent fill

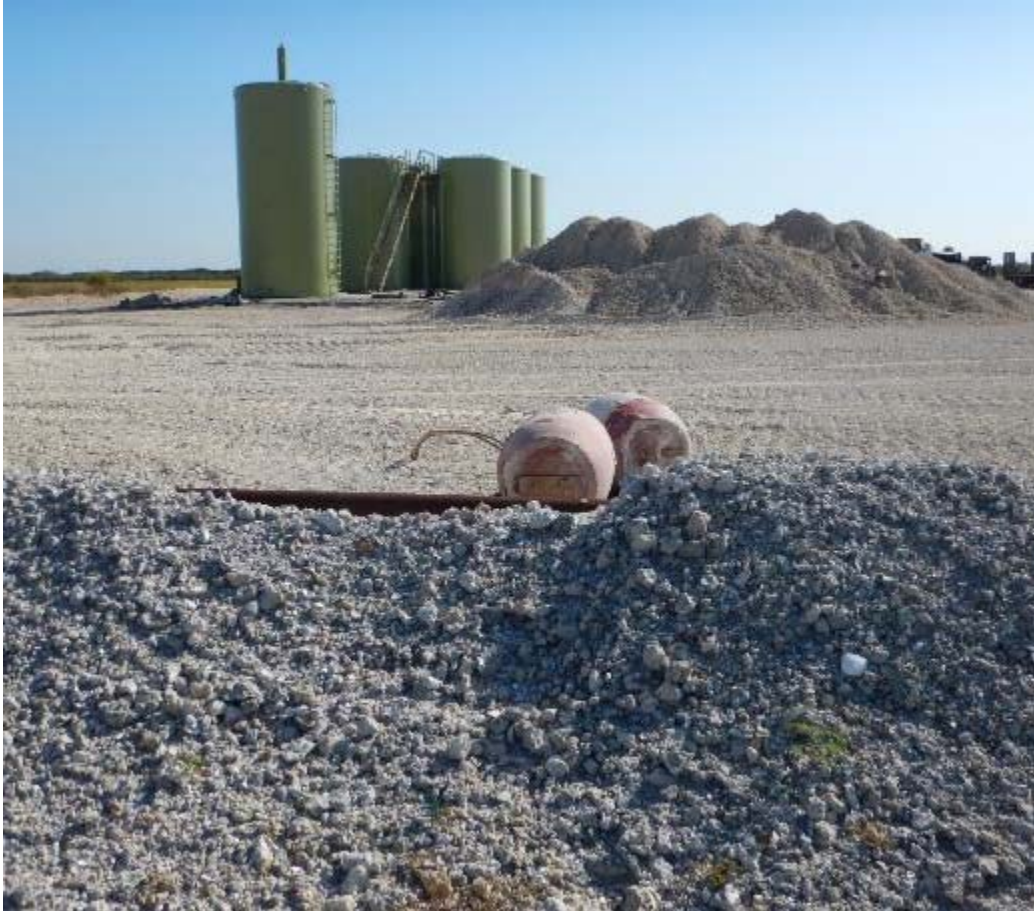
Photograph 58

Notes: Notation of freshly painted tanks (buckets noted, and reference to prior photos and site visit by Danielle Irwin reference notation of PE seal and fiberglass by Levi Sciara. (Holes and tears in plastic on battery from this vantage)

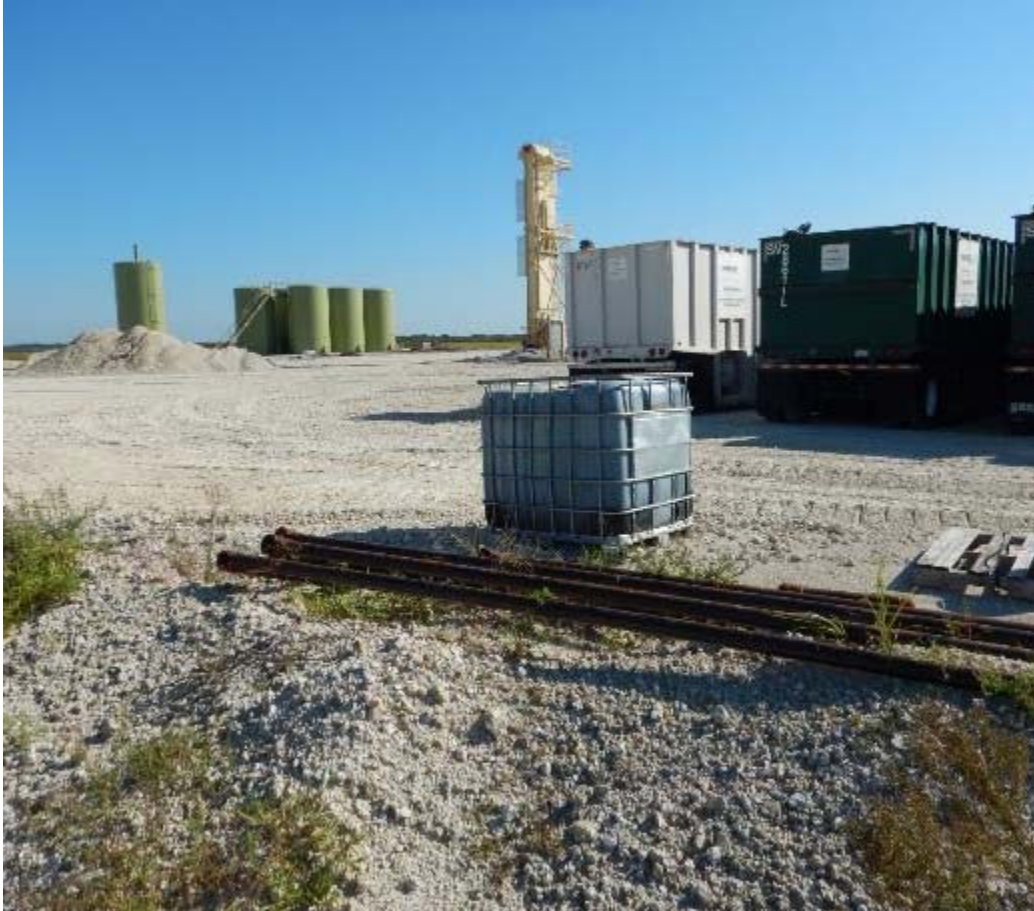
Photograph 67

Notes: Noted 7 barrels on pallets with no secondary containment

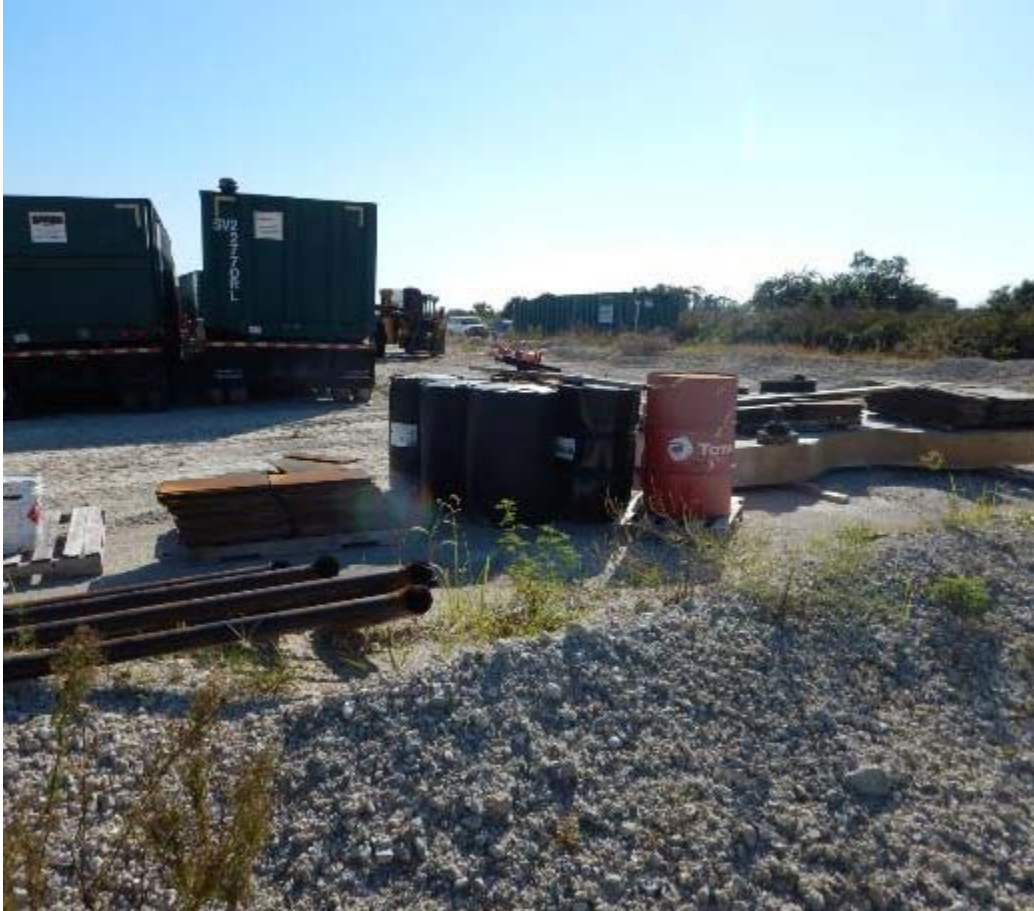
Photograph 68

Notes: Noted no secondary containment for chemical tote.

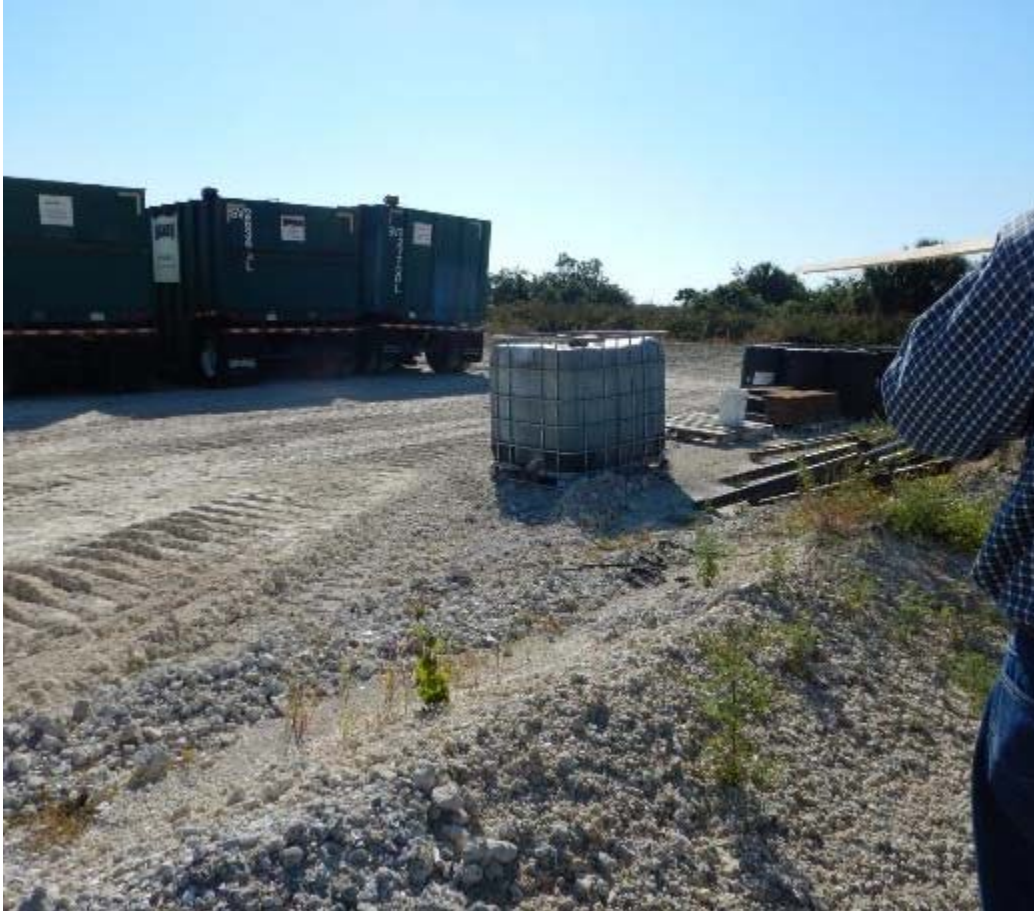
Photograph 69

Notes: Noted no secondary containment for chemical tote or barrels.
