National Transportation Safety Board Aviation Accident Preliminary Report

Location:	Palmer, AK	Accident Number:	WPR21FA143
Date & Time:	March 27, 2021, 18:35 Local	Registration:	N351SH
Aircraft:	Airbus Helicopters AS350-B3	Injuries:	5 Fatal, 1 Serious
Flight Conducted Under:	Part 135: Air taxi & commuter - Non-scheduled

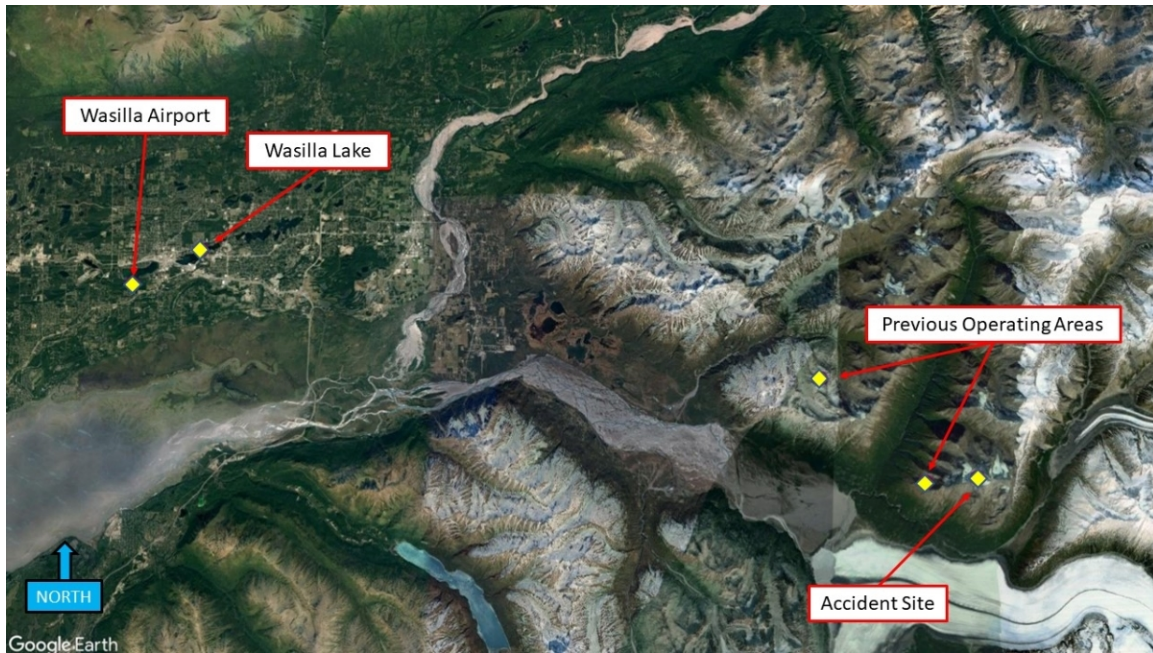
The data showed that the helicopter's final movements began about 1833 over a ridgeline at 6,266 ft msl (about 14 ft agl), at a groundspeed of 1 kt. The helicopter maintained a low altitude and groundspeed as it maneuvered over the ridgeline for the next few minutes. The data track ceased at 1836:42 near the final resting point of the main wreckage.

Figure 1: General flight areas from GPS Data

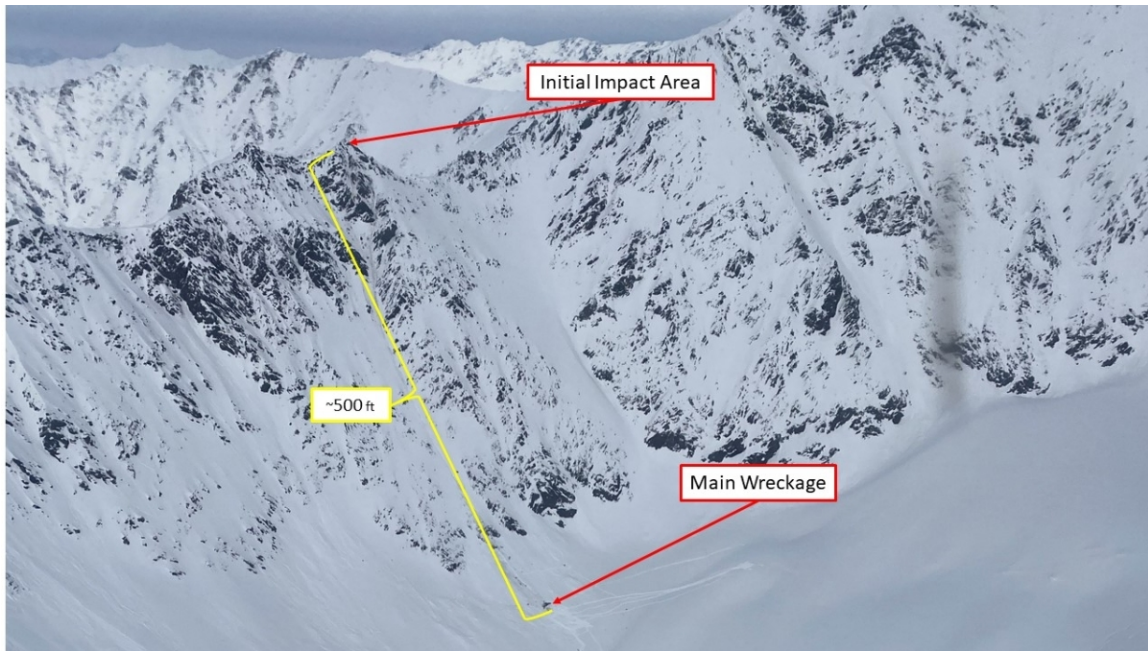
An aerial assessment of the accident site by a National Transportation Safety Board investigator the day after the accident revealed that the helicopter impacted terrain about 15 to 20 ft below the top of a ridge line. The total debris field extended about 900 ft downslope from the top of the ridge line.

Figure 2: Overview of the accident site.
