# Town of Carolina Beach Canal Drive Flooding & Vulnerability Assessment Study

Submitted by: Aptim Coastal Planning & Engineering of North Carolina, Inc.

Project No. 636236194 February 2019 Town of Carolina Beach

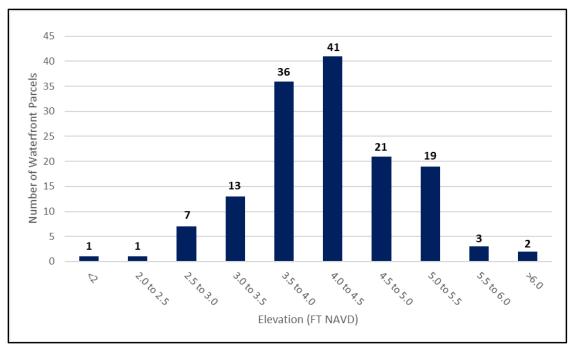
Figure 16 presents a summary of the elevations for all the structures surveyed and grouped using 0.5 foot elevation brackets. Considering the 30-year planning elevation ranges, approximately 72% or 104 of the structures have crest elevations below 4.7 ft. (low range), approximately 90% are at or below elevation 5.2 ft. (mid range) and 97% are at or below elevation 5.7 ft. (upper range).

Figure 16. Elevation Summary of All Structures/Shorelines.

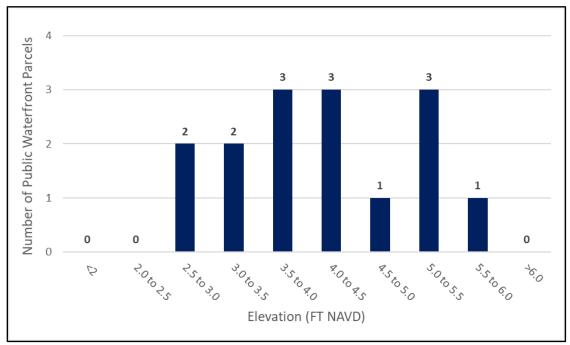
Figure 17 displays the distribution of elevations for the 15 public sites inspected during this study. Of the publically owned sites, 73% or 11 of the public sites (6 bulkheads and 5 vegetated shorelines) are below elevation 4.7 ft., approximately 87% are at or below elevation 5.2 ft. (mid range), and 93% are at or below elevation 5.7 ft. (upper range).

Figure 17. Elevation Summary of Public Structures/Shorelines.

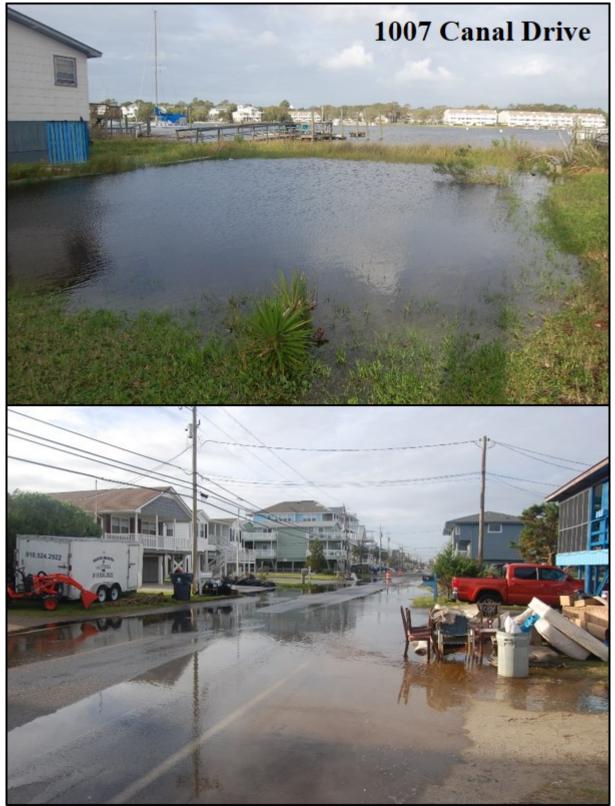
Examples of flooding of Canal Drive directly attributed to overtopping of bulkheads or inundation of lowlying parcels with no bulkhead are shown in Figure 18 and Figure 19. The property at 1007 Canal Drive shown in Figure 18 does not have a bulkhead and has an average elevation of 1.94 ft. NAVD, the lowest elevation along the Canal Drive shoreline. The photographs were taken shortly after high tide on October 9, 2018, water was observed flowing onto Canal Drive from the property as shown in the lower image of Figure 18. The photographs in Figure 19 show a similar situation on the property at 1013 Canal Drive with the exception that the water came around the timber bulkhead (average elevation 4.3 ft. NAVD) and entered from the neighboring property to the north that has an average shoreline elevation of 2.8 ft. NAVD and does not have a bulkhead. The lower image shows the water from the property flowing onto and ponding on Canal Drive.

Figure 18. View of the property at 1007 Canal Drive at high tide (upper); water flooding onto Canal Drive looking south from 1007 Canal Drive (lower).

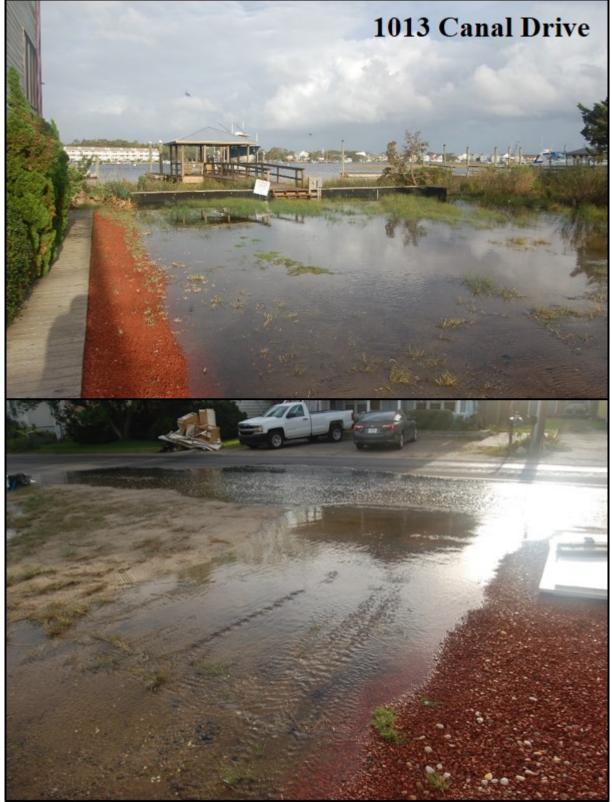
Figure 19. View of high tide flooding around bulkhead at 1013 Canal Drive (upper) and water flowing from the property onto Canal Drive (lower).

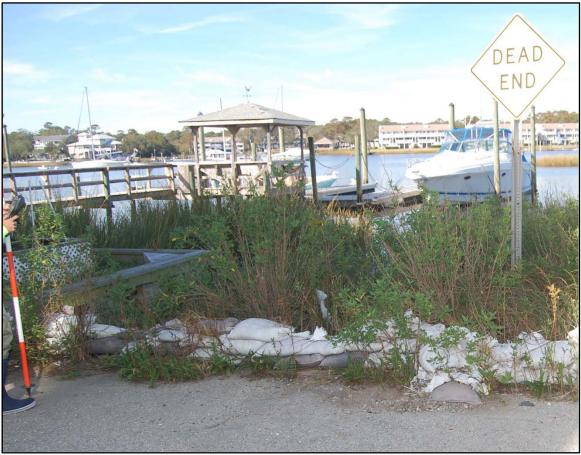
While the Town can improve publically owned bulkheads and install new bulkheads to mitigate overtopping and flooding, this effort alone will have limited impact without private owner improvements. For example, consider the structure at Scotch Bonnet Lane and Canal Drive (Figure 20). The existing average elevation of the publically owned sandbagged shoreline is 2.8 feet NAVD. The Town can install a bulkhead to the adopted future design elevation, but flooding will not be prevented until the adjoining bulkheads on either side with existing elevations of 3.6 ft. and 3.7 f.t NAVD are also raised to the adopted future design elevation.

Figure 20. View of the west end of Scotch Bonnet Lane.

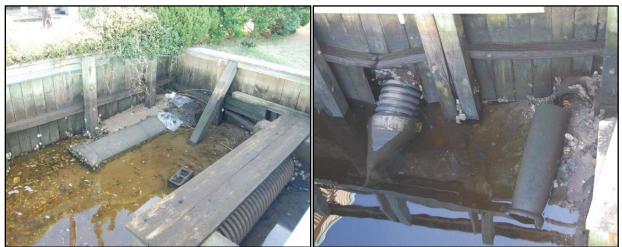
During the site investigations, what appeared to be old stormwater outfalls made out of clay or concrete pipes were observed at the Seagull Lane street end, Seahorse Lane street end, and at 909 Canal Drive. The old outfalls were located within several feet of more recently installed stormwater outfalls with backflow prevention devices. Although the old outfalls appeared to be abandoned if not properly sealed or disconnected from the system they could provide a means for water to backflow into the stormwater system. It is not known whether these old outfalls are still connected to the system, this information is only provided to inform the Town of their existence. The photographs in Figure 23 show the relic outfall pipes adjacent to the more recently installed stormwater outfalls.

Figure 23. Abandoned Stormwater Outfall Pipes. (left: 909 Canal Drive, right: Street End at Seagull Lane and Canal Drive)

- 1. It is recommended that all abandoned stormwater outfalls along the Carolina Beach Yacht Basin that have not been removed be inspected to ensure that they are no longer connected to the system. Abandoned stormwater outfalls that have not been removed, filled, or properly disconnected from the stormwater system could circumvent the Town's effort of backflow prevention.

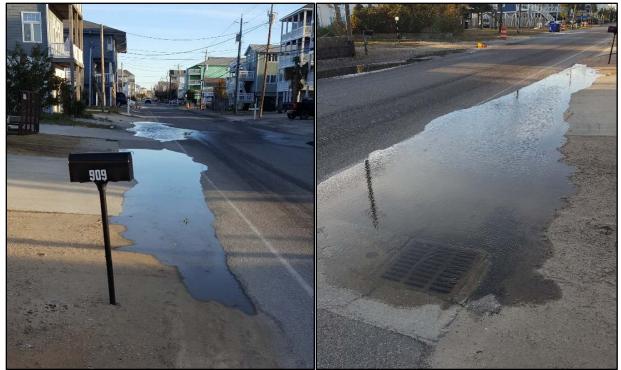
The photographs in Figure 24 show water coming up through the street inlets in front of 909 and 911 Canal Drive during a high tide on the morning of January 22, 2019. There is a WaStop® backflow prevention device installed on the outfall at this location; however, there is also an abandoned outfall as this location as shown in Figure 23.

Figure 24. Water Coming Up Through Street Inlets During High Tide at 909 and 911 Canal Drive.
