EPA Level 4 Investigation

**Gopher Resource
Tampa Plant**

June 30, 2021

**Prepared By:
EPC Air Division Staff**

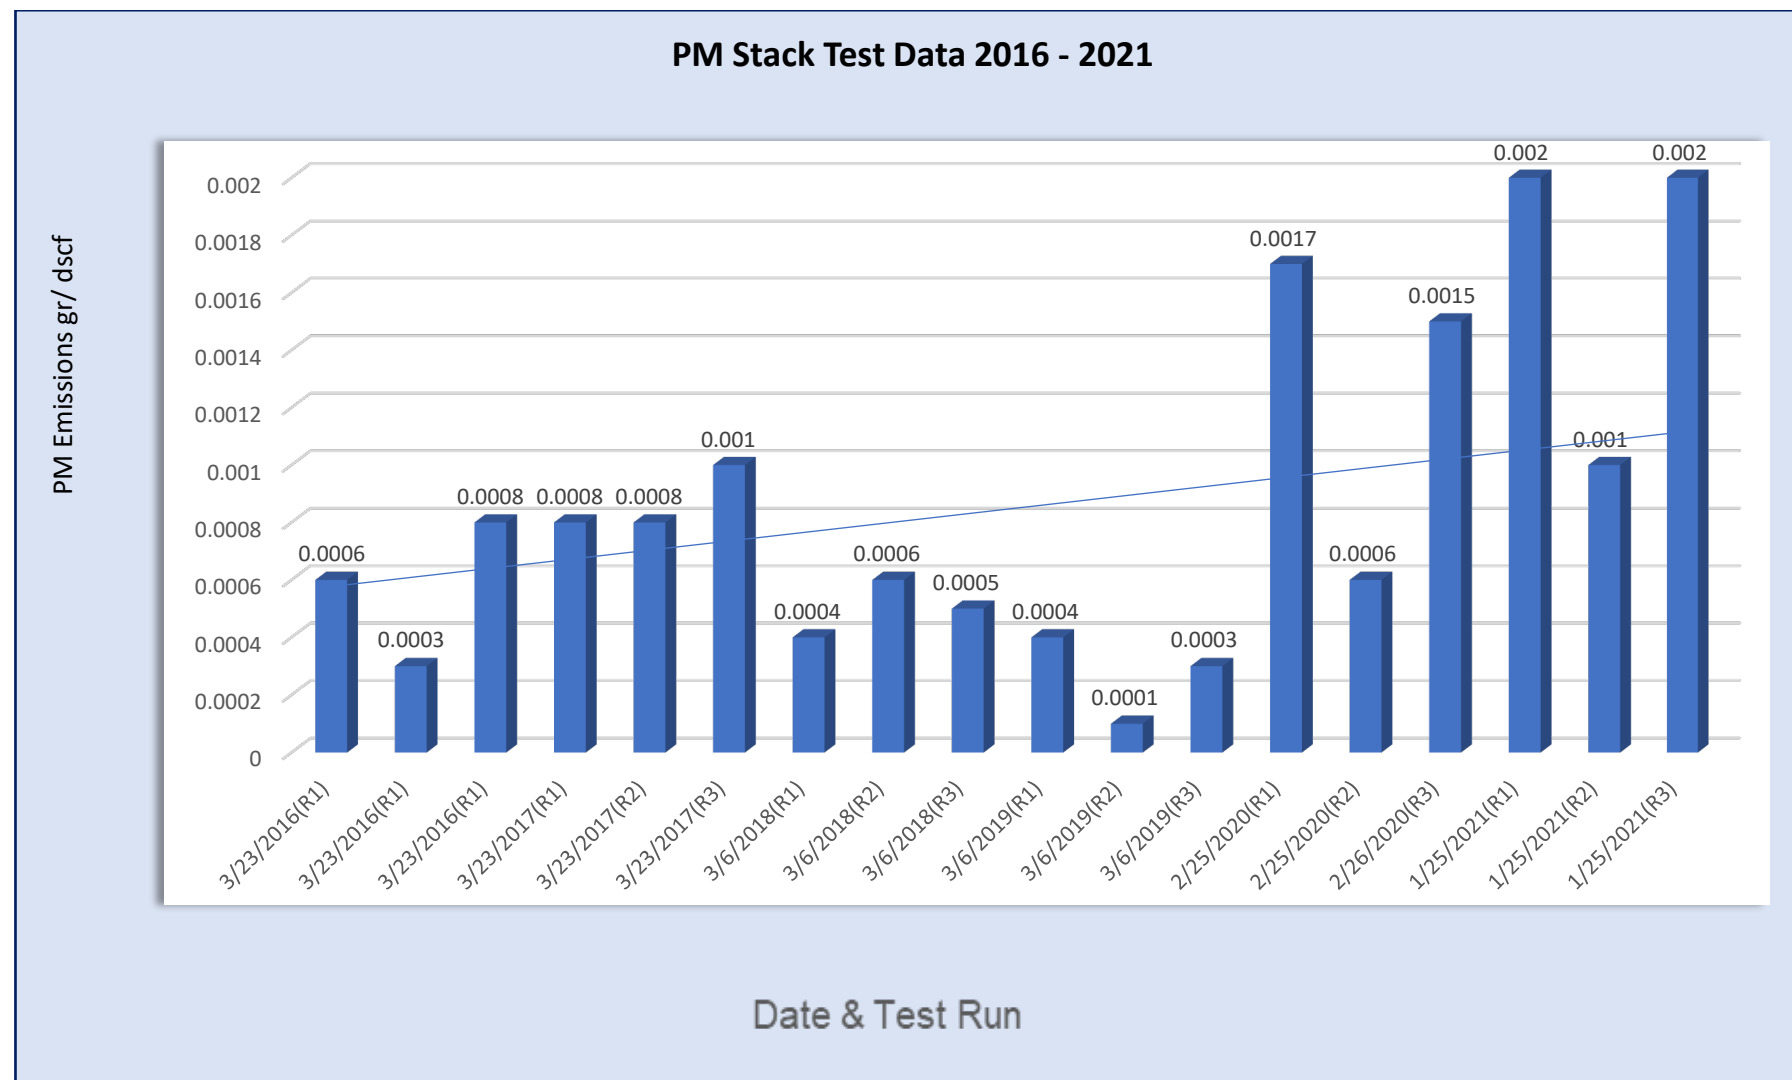
Graph No. 1

While emissions testing results were well below the permitted limits, from 2016 to 2021, average PM emissions grain loading (gr/DSCF) for each test has increased ~194%. The most recent Pb test was on 2/25/20. A review of the data from 2016 to 2020 shows average Pb emission grain loading (mg/DSCM) for each test has increased ~436%. Overall average airflow throughout the system has remained unchanged. The graphs are below (Graph Nos. 1, 2, and 3) and show how the individual runs of PM increased from 0.0003 gr/DSCF on March 23, 2016 to 0.002 gr/DSCF on January 25, 2021. There was no Pb test in 2021, but the increase in Pb was from 0.006 mg/DSCM on March 23, 2016 to 0.081 mg/DSCM on February 25, 2020.

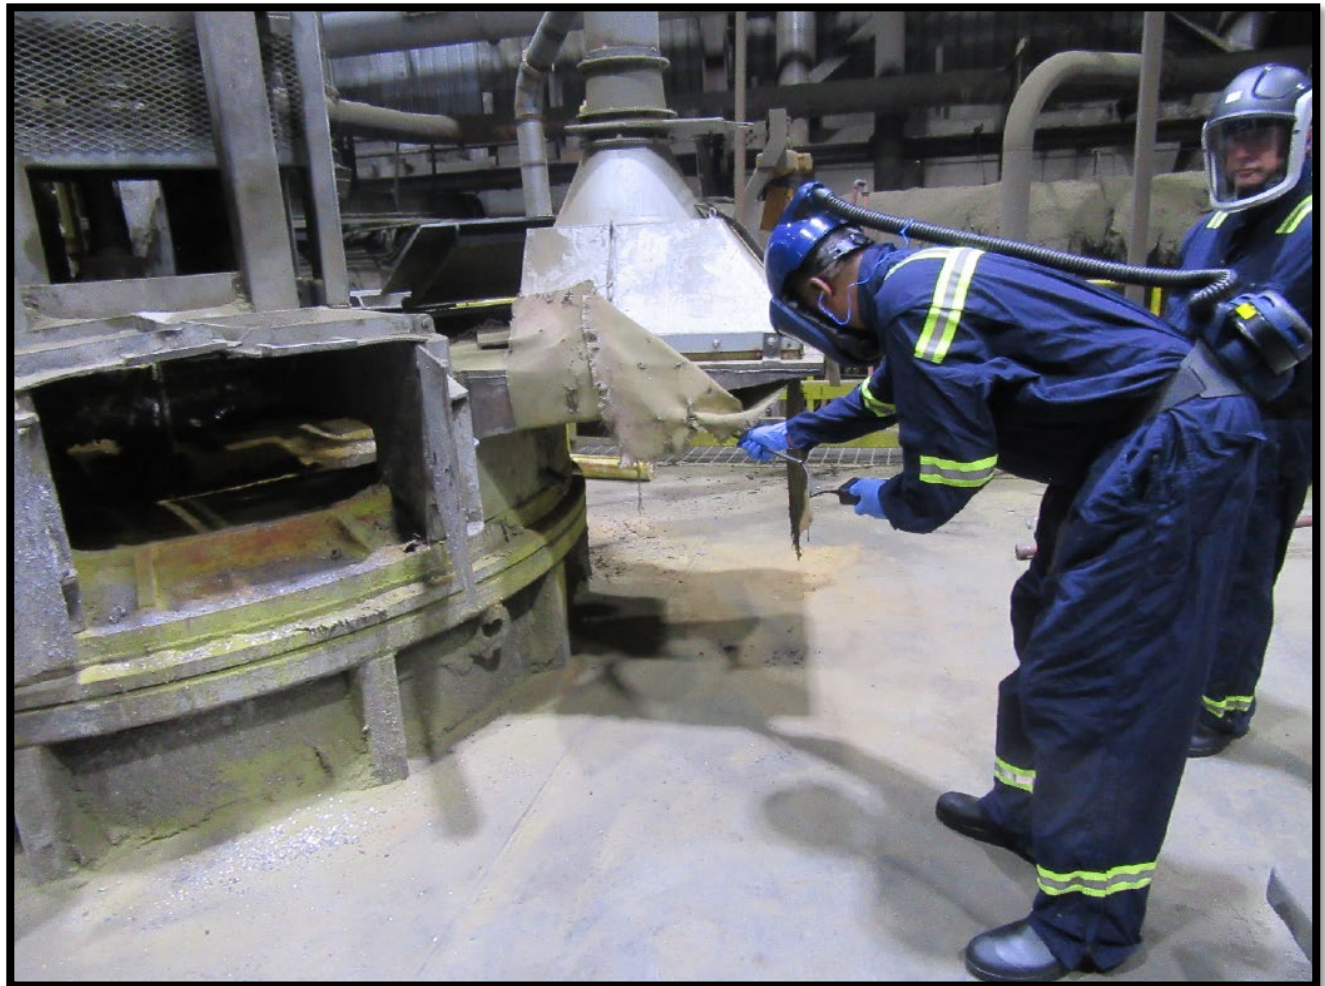
We began our inspection with a walkthrough of the Refining Area where we noted the 10 Refining Kettles. Each appeared to have a direct evacuation to a ventilation system but included an additional hood pickup point for Manual Drossing. We didn't observe any active refining for Refining Kettles Nos. 1-8. So, we took several hood velocity readings on Refining Kettle No. 4. The duct velocity of the Main Duct ranged from 132 - 141 fpm near the middle of the duct. The face velocity of the Manual

Drossing Hood was ~ 43 fpm near the middle of the hood. The face velocity of the access door of the kettle ranged from 43 – 62 fpm across the opening. Refining Kettle No. 8 enclosure appeared partially disassembled.

Photo #5 - Refining Kettle No.4 Hood Face Velocity Measurements

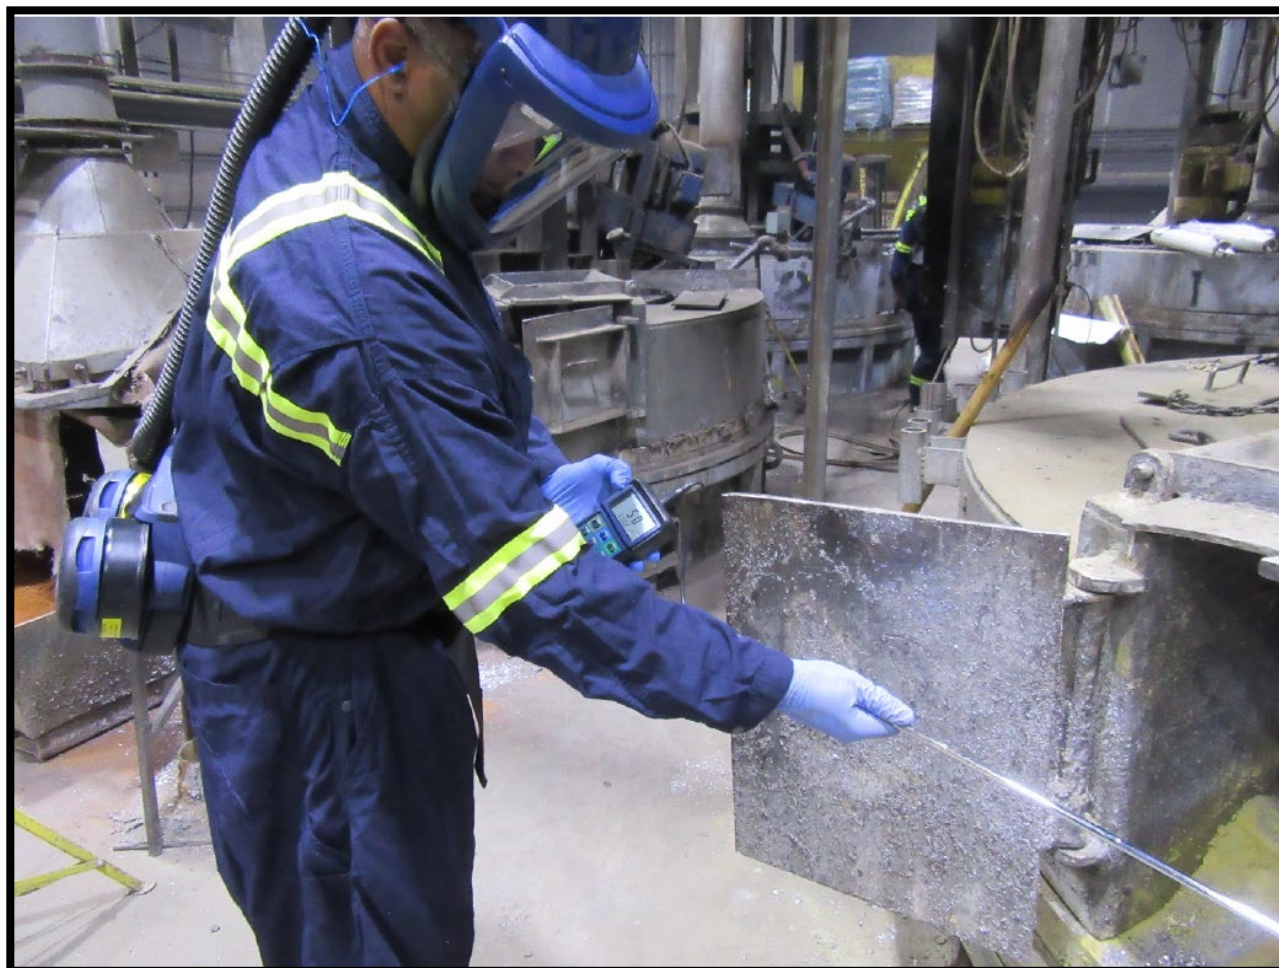
Photo #6 - Refining Kettle No.4 Door Velocity Measurements

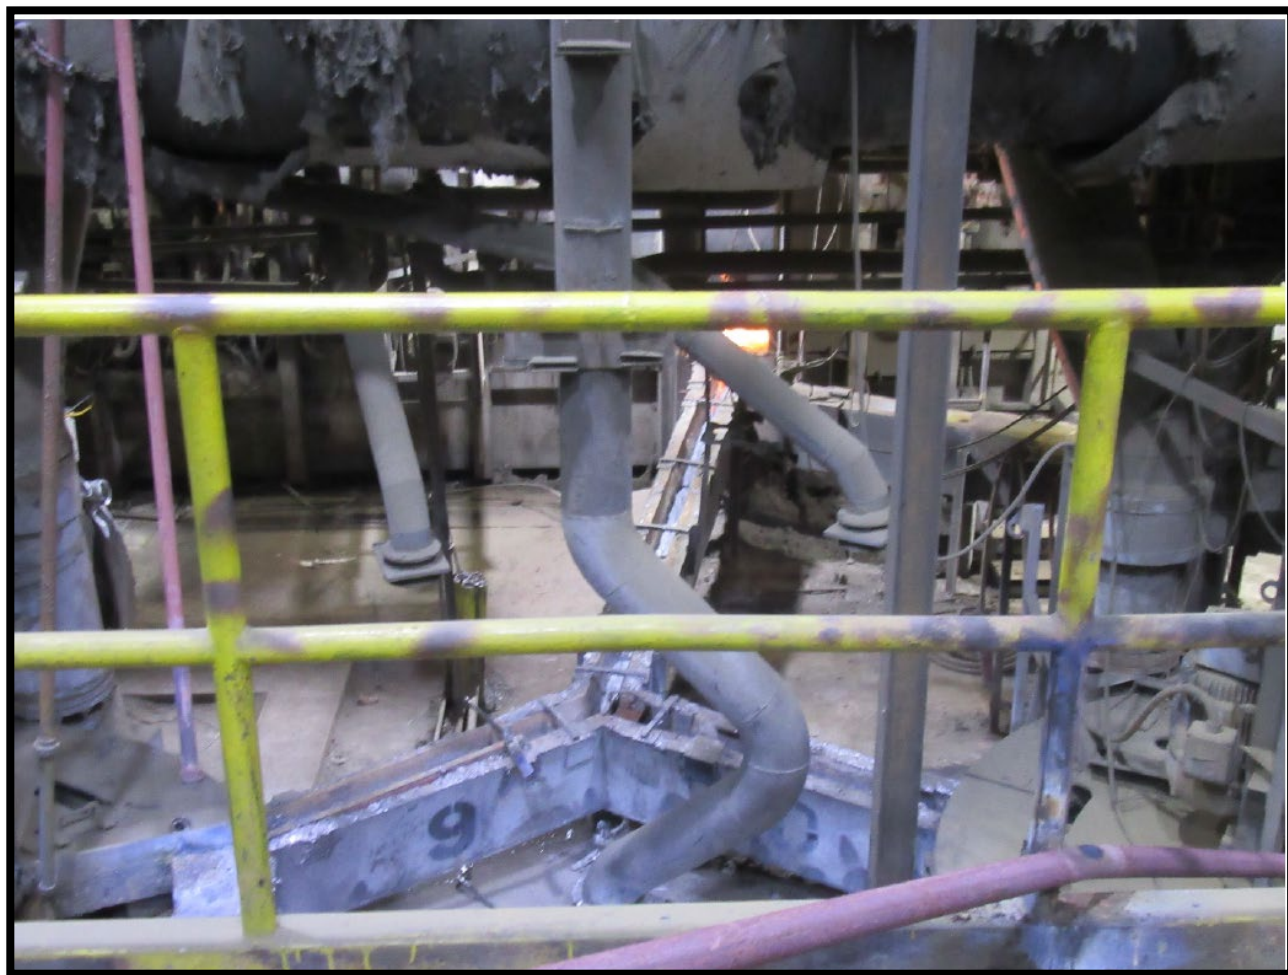
As we walked over to the Reverberatory Furnace Lead Tapping Area, we noted that there were no Launder duct hoods, and each slide gate for the ducts were in the closed position, which appeared to partially confirm TBT Allegation No. 6. We then proceeded to the Reverberatory Furnace Lead Tapping and noted a hood enclosure ventilating the Lead Tapping. The furnace was operating, and there didn't appear to be any visible fugitive emissions escaping from the hood. We didn't detect any CO or SO₂ concentrations. Launder No. 1 was directing lead from the Reverberatory Furnace to Launder Nos. 2 and 3. Launder No. 2 was directing lead to Refining Kettle Nos. 10 with Launder No. 3 directing lead to Refining Kettle No. 9.

Photo #7 - Reverberatory Furnace Lead Tapping Launders

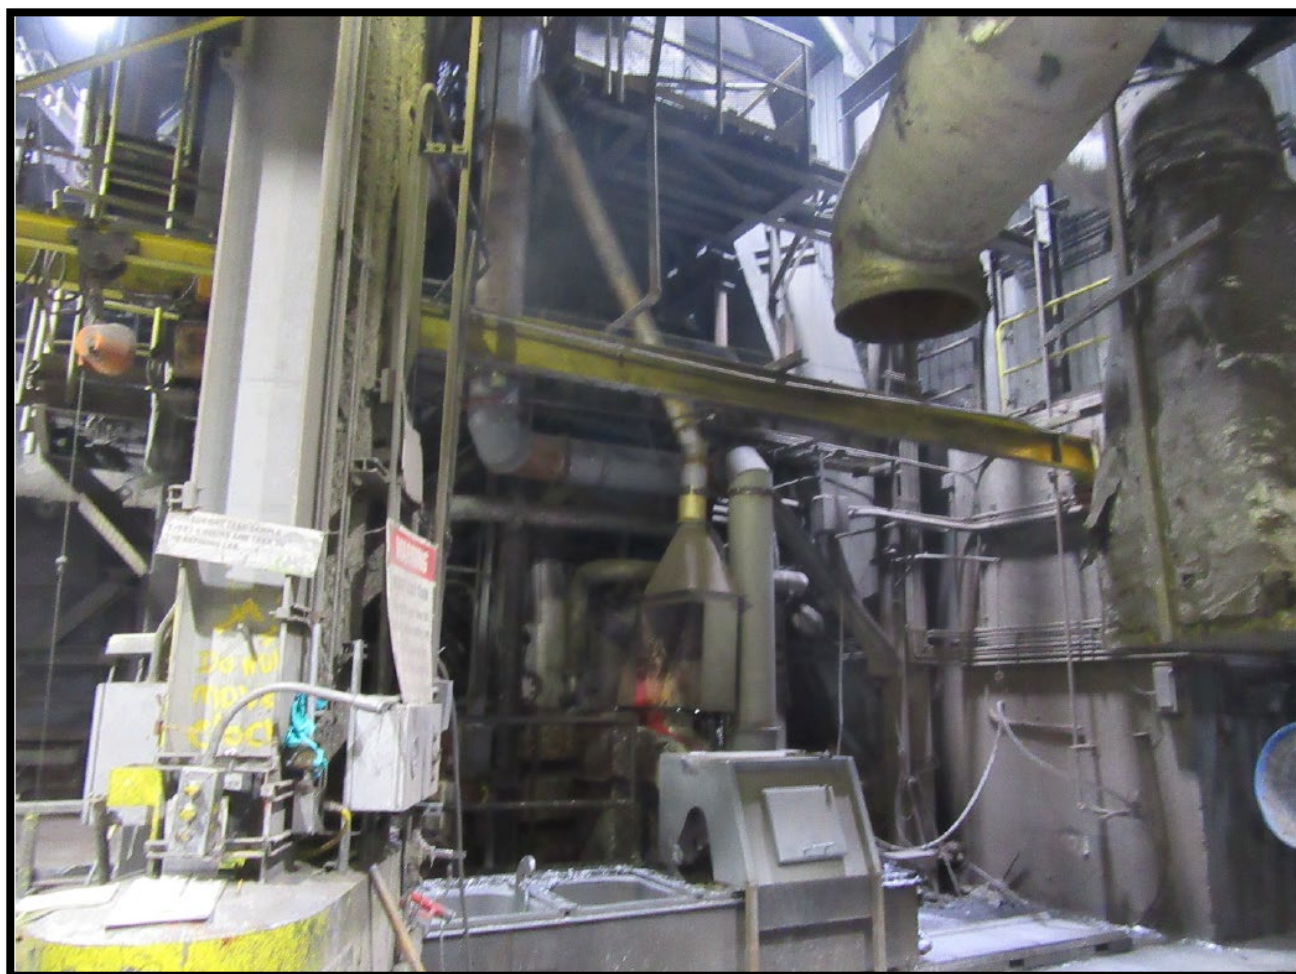
We then walked over to the Blast Furnace and noted a partial enclosure hood over the Lead Tapping Spout, as well as an enclosure hood over the pour mold. As we proceeded to the Reverberatory Furnace Slag Tapping, we noted a large enclosure hood covering the pour mold and the previous pour mold. As stated previously, the Reverberatory Furnace was operating, and we noted visible emissions around the Slag Tapping. We measured CO concentrations of ~16 ppm using the Escorcon Monitor and SO₂ concentrations of ~0.2 ppm using the Ventis Pro 5 Monitor near the hood enclosure.

Photo #9 - Blast Furnace Lead Tapping

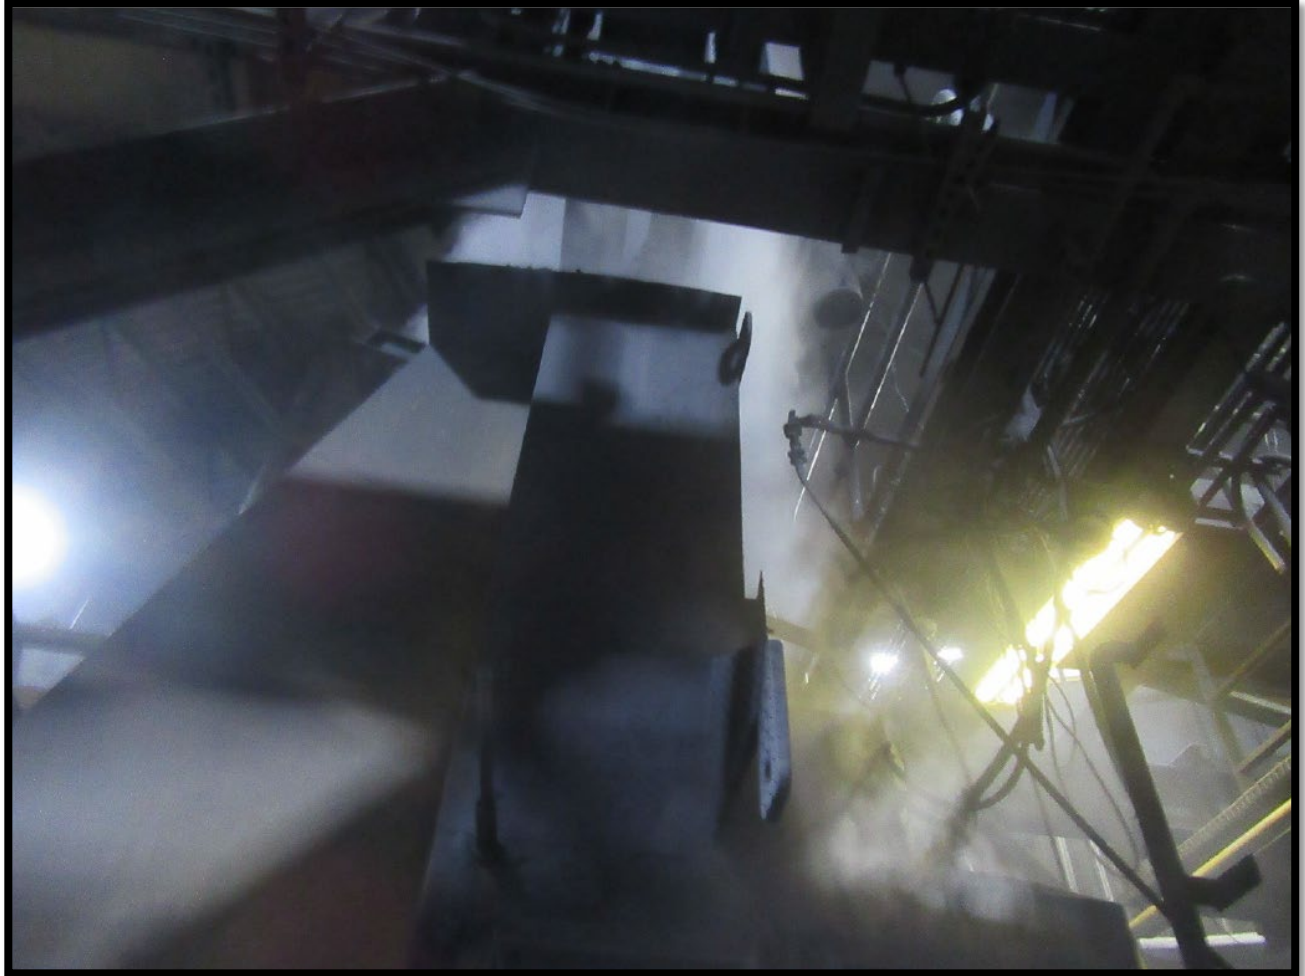
We then observed visible emissions emanating from around the Skip Hoist enclosure on the upper floors. We took CO and SO₂ readings a few feet from the door of the chute doors using the Eagle 2 CO Monitor and the Ventis Pro 5. Within a few seconds, the alarms sounded and, after about a minute, the CO readings peaked over 100 ppm and the SO₂ readings peaked at ~9.2 ppm. This appeared to confirm the

Photo #11 - Blast Furnace Skip Hoist Visible Emissions

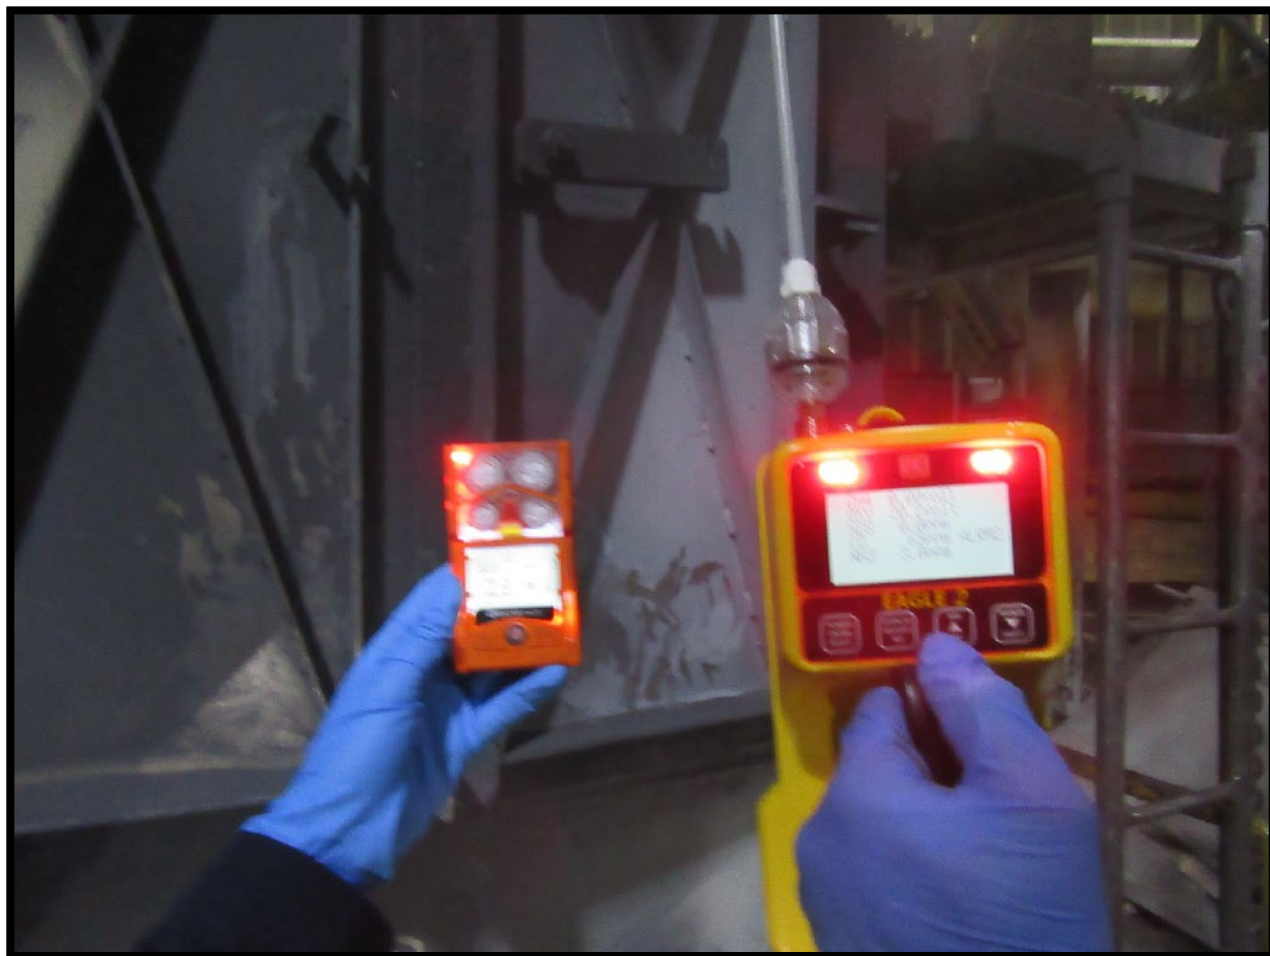
TBT Allegation No. 8 may have existed prior to the Hygiene Ventilation Baghouse System Upgrades in 2020 – 2021.

Photo #12 - SO₂ and CO Emissions From Blast Furnace Skip Hoist

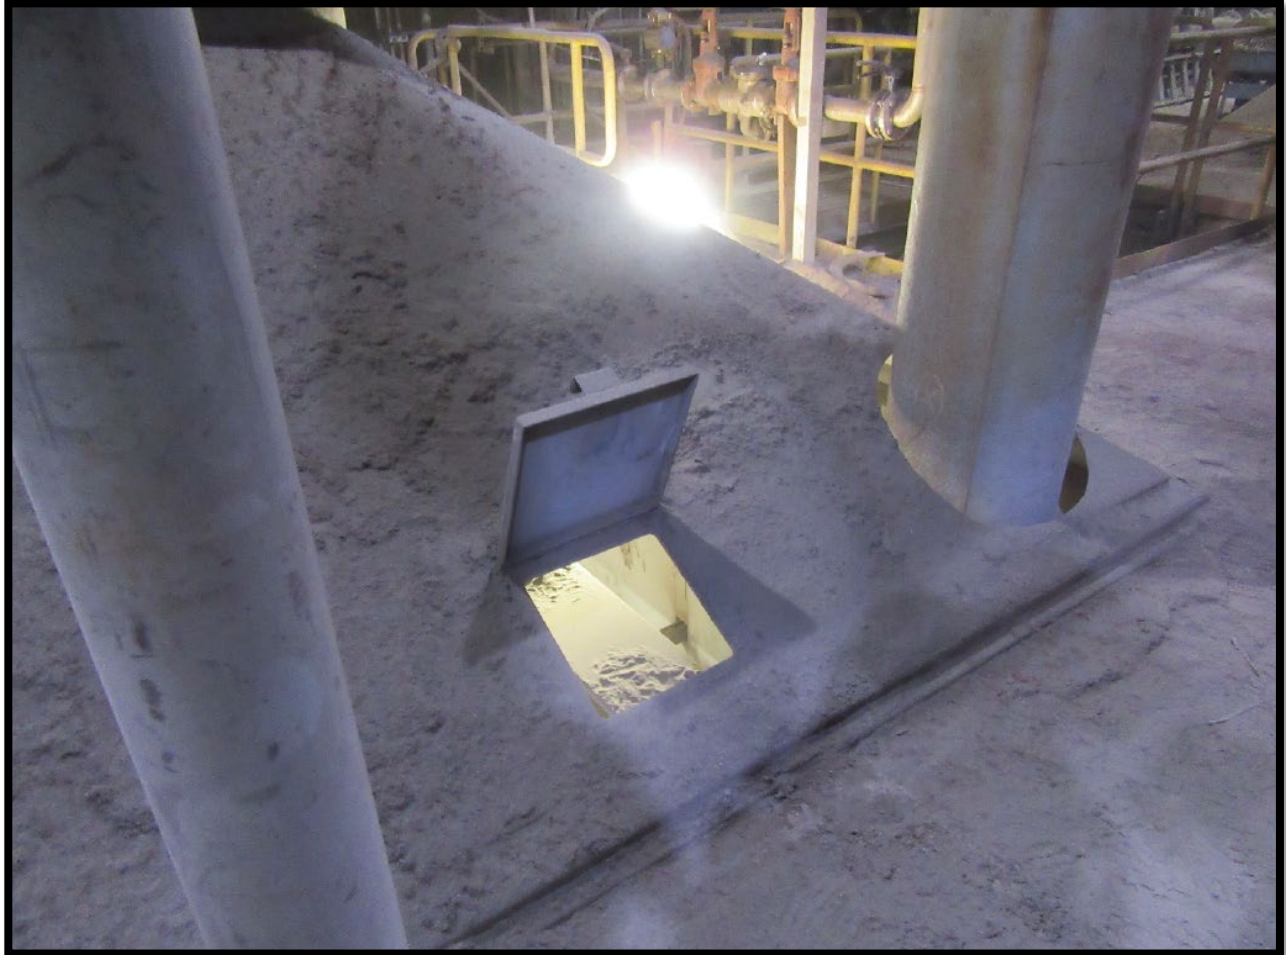
Photo #13 - Dust on Hoods Above Reverberatory Furnace Area

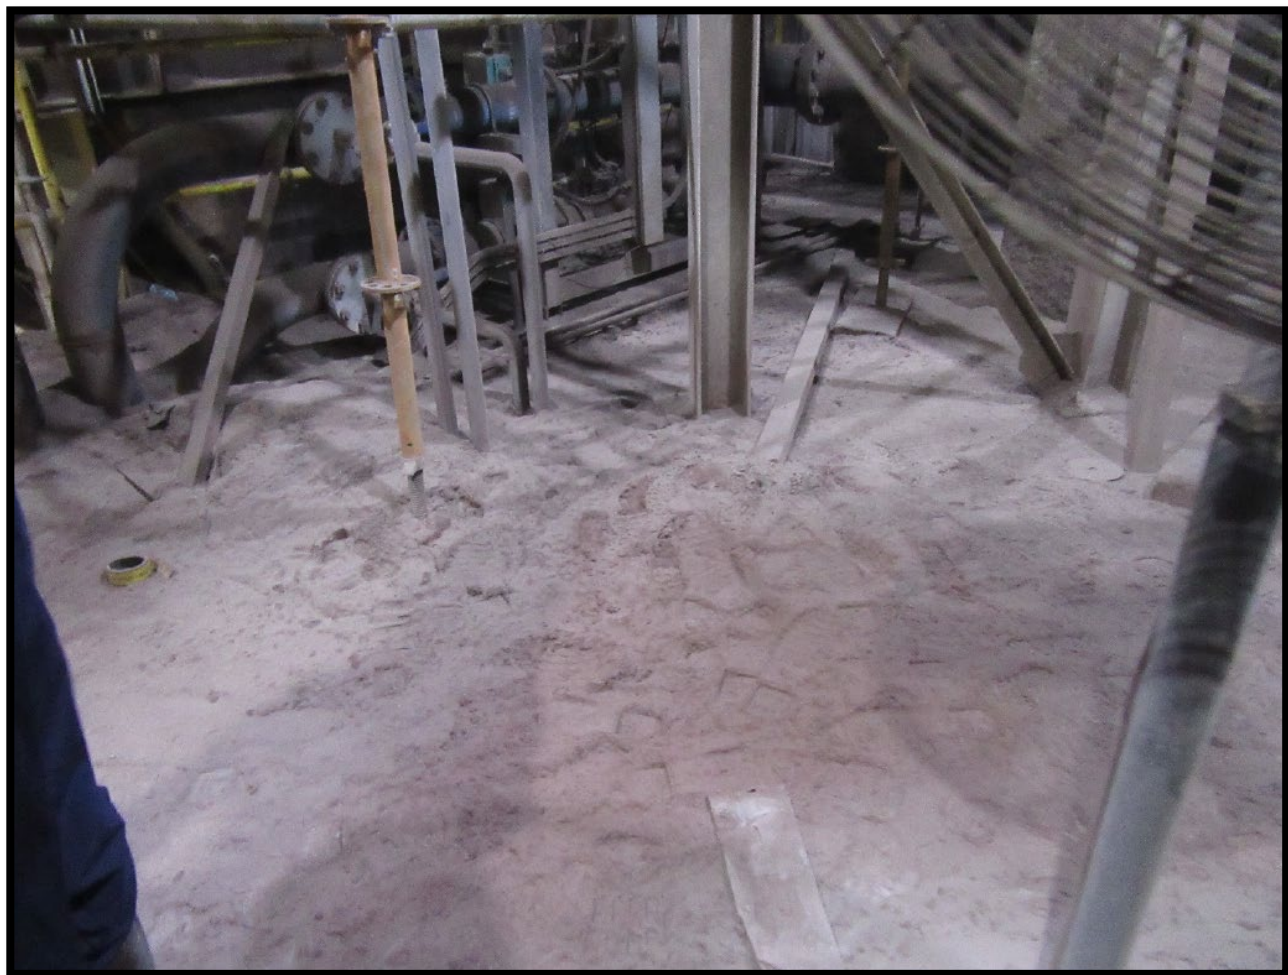
Photo #14 - Dust on Floor Above Reverberatory Furnace Area

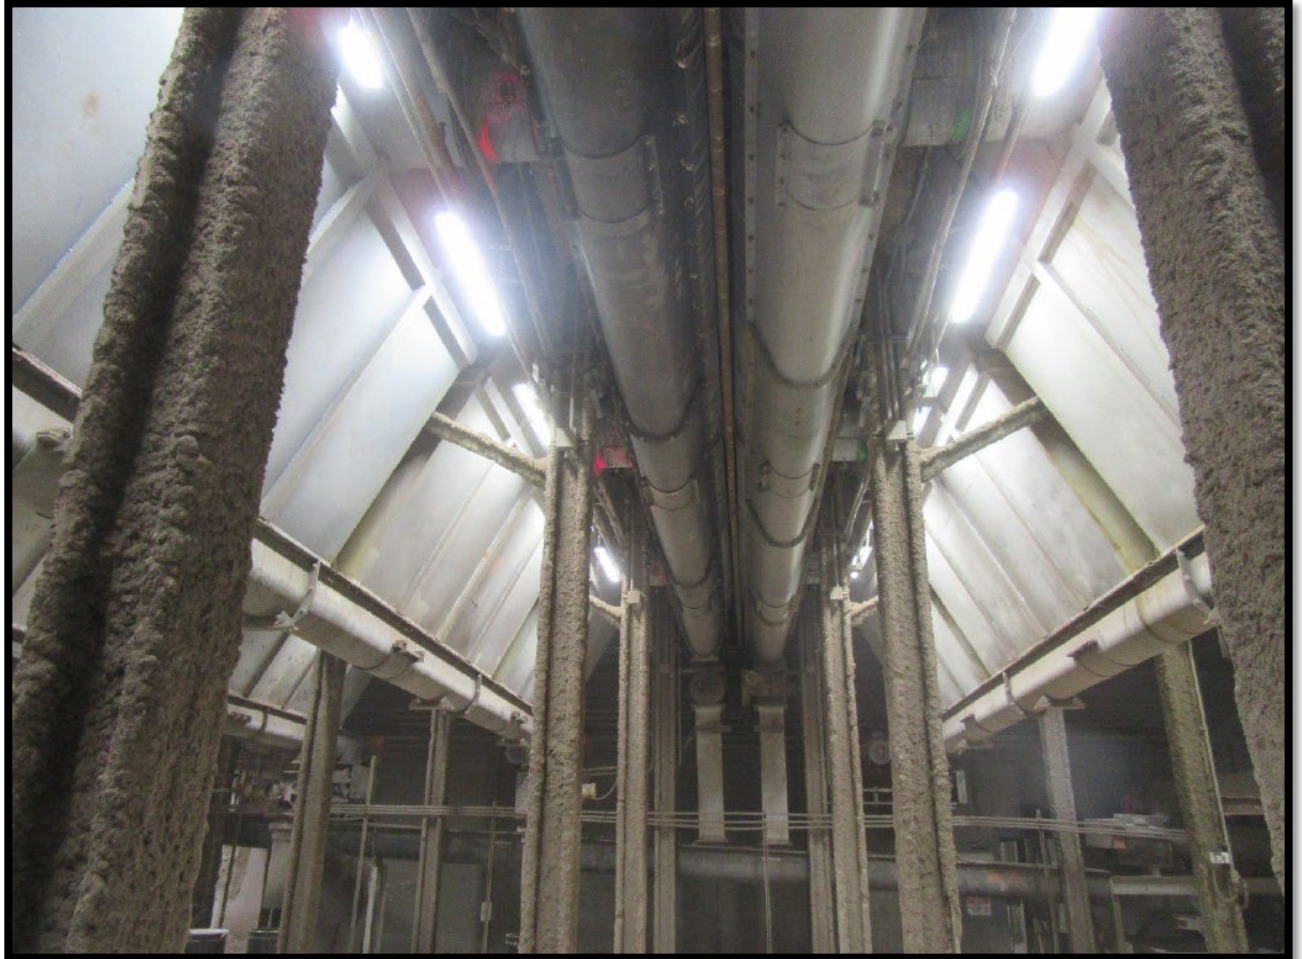
We then proceeded over to the Hygiene Shaker Baghouse System Hoppers. We noted a number of patches on the bottom of the screw conveyors and at least one discharge chute from the conveyor to a 55-gallon drum. We took CO, NH₃, and SO₂ readings with the RKI Eagle 2 measuring 0 ppm for CO and 3.5 ppm for NH₃, with the Ventis Pro 5 measuring ~0.5 ppm for SO₂. The SO₂ and CO readings appear to confirm TBT Allegation No. 9, when considered in the context of the Hygiene Baghouse Ventilation System changes we observed. However, the NH₃ should be investigated further as an air pollutant. Gopher Resource has an Industrial Wastewater Facility Permit (FL0687138 MI) from FDEP for stormwater, which requires monitoring for NH₃. According to the files, from 48,000 to 170,000 gallons per day (gpd) of stormwater can be used in the manufacturing process.

Photo #15 - Hoppers for Hygiene Shaker Baghouses

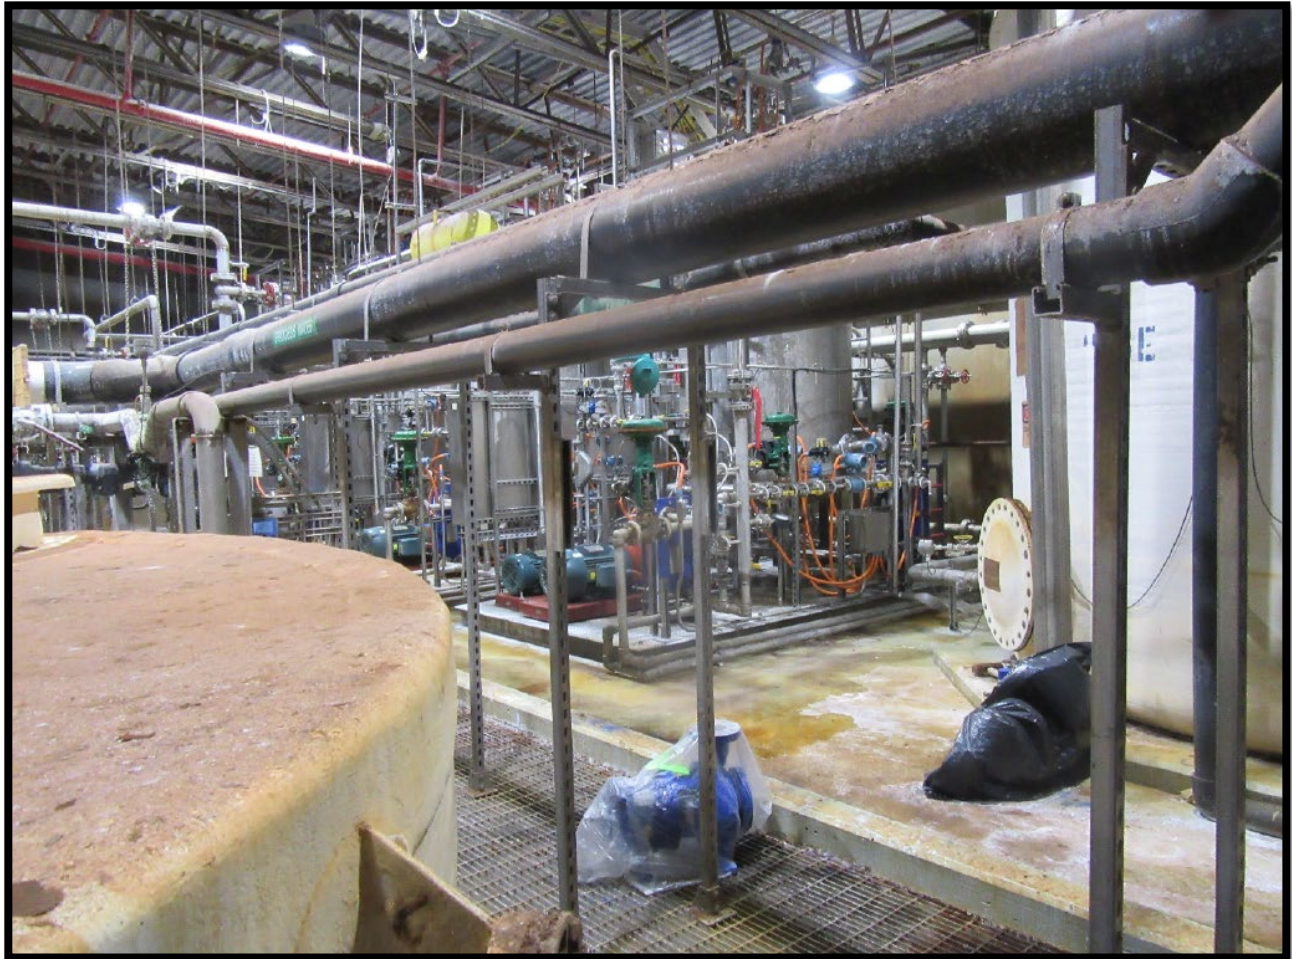
Ms. Manhin and Mr. Soich accompanied us on another walk-through of the Battery Breaking, Desulfurization System, and WWTP. There are 3 Desulfurization Tanks, which feed the Lead Storage Area and WWTP. As we proceeded to the WWTP, we observed 4 SO₂ Monitors located in each corner of the WWTP. We utilized Gopher's Ventis Pro 5 SO₂ Monitor, which didn't detect any SO₂ in any of the areas.

Photo #16 - Oxidation & Reactor Tanks in WWTP

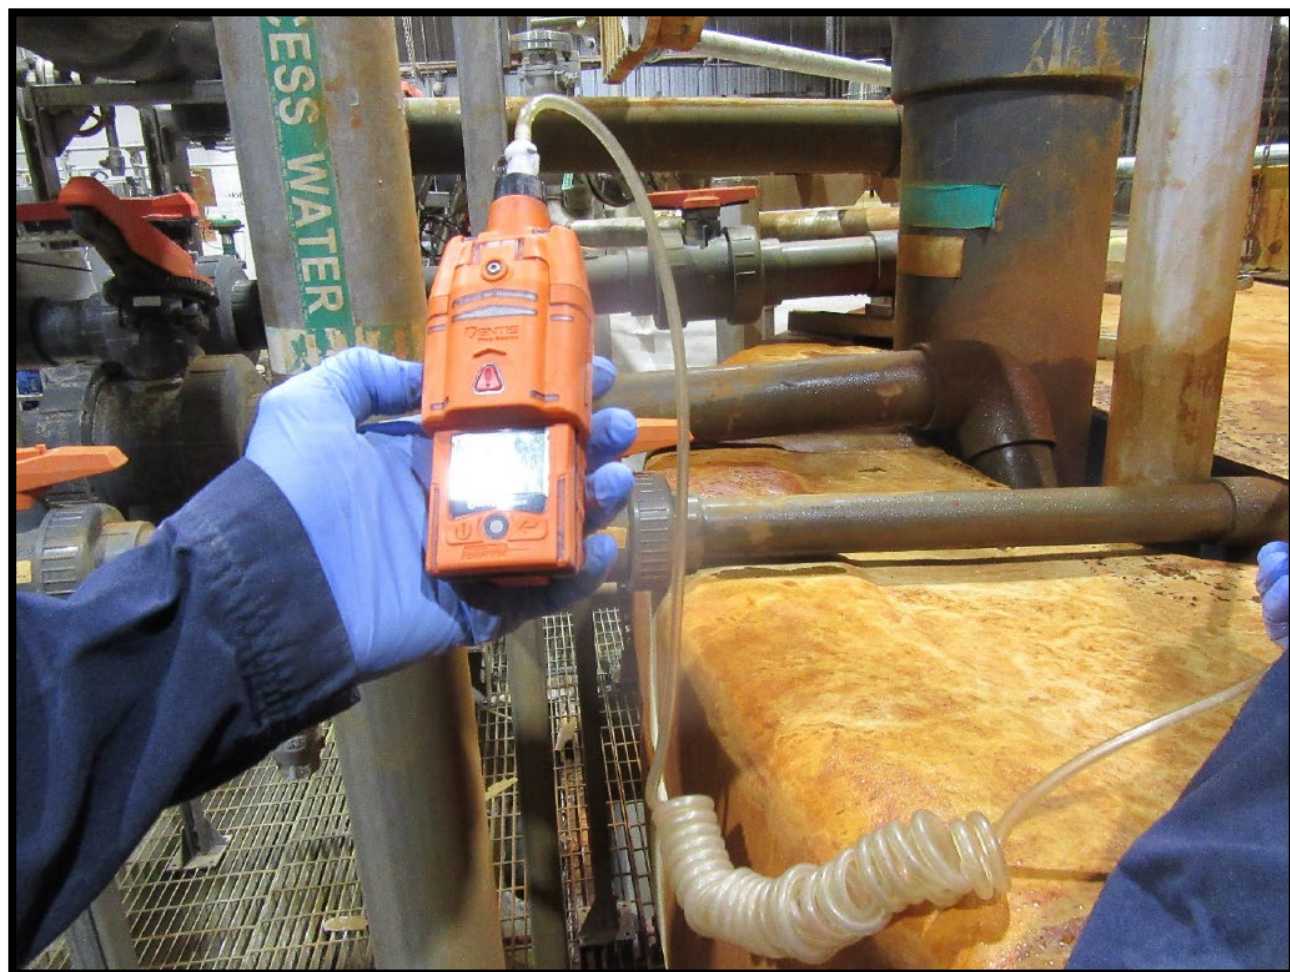
Photo #17 - WWTP SO₂ Sampling
