From: Materials Testing Laboratory
To: President, Court of Inquiry

Subj: USS THRESHER (SS(N)593); debris removed from area of casualty,
report on

Encl: (1) Examination and Tests Upon Debris Retrieved from Area of
USS THRESHER (SS(N)593) Casualty (2 copies)

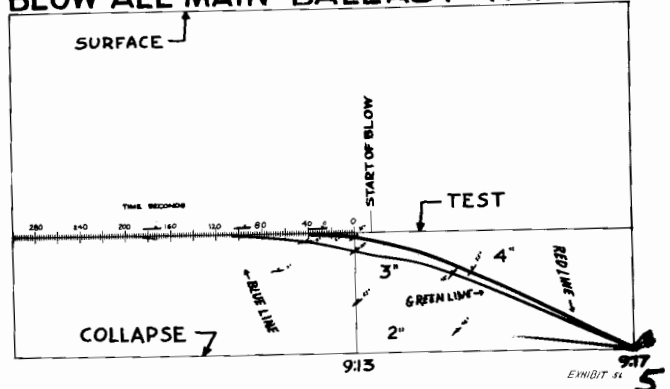
CAPTAIN'S AIR BANK BLOW ALL MAIN BALLAST TANKS

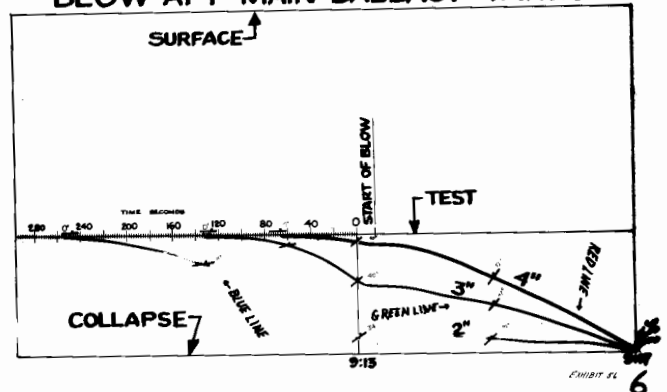
3 AIR BANKS BLOW AFT MAIN BALLAST TANKS

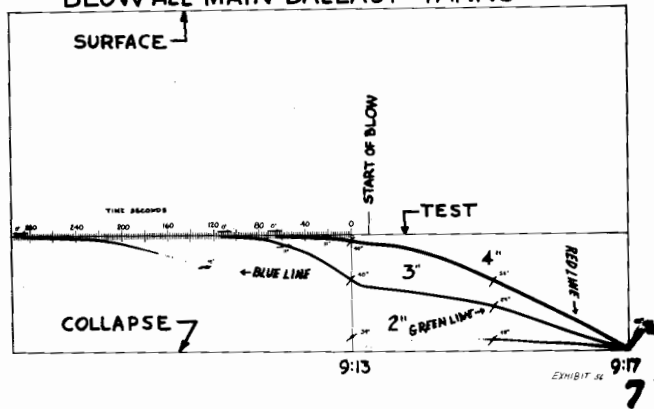
3 AIR BANKS BLOW ALL MAIN BALLAST TANKS

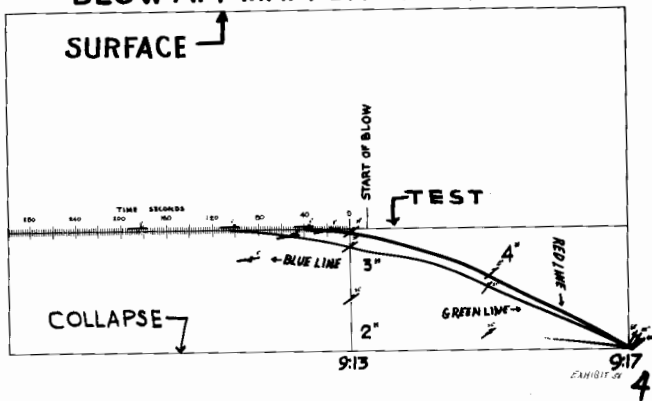
CAPTAIN'S AIR BANK BLOW AFT MAIN BALLAST BANK

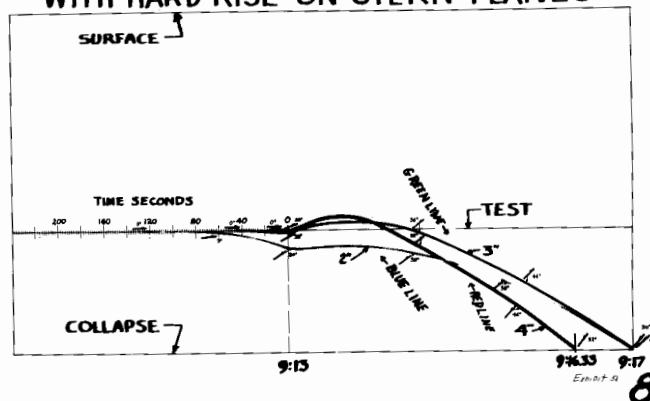
NOT BLOWING MAIN BALLAST TANKS WITH HARD RISE ON STERN PLANES

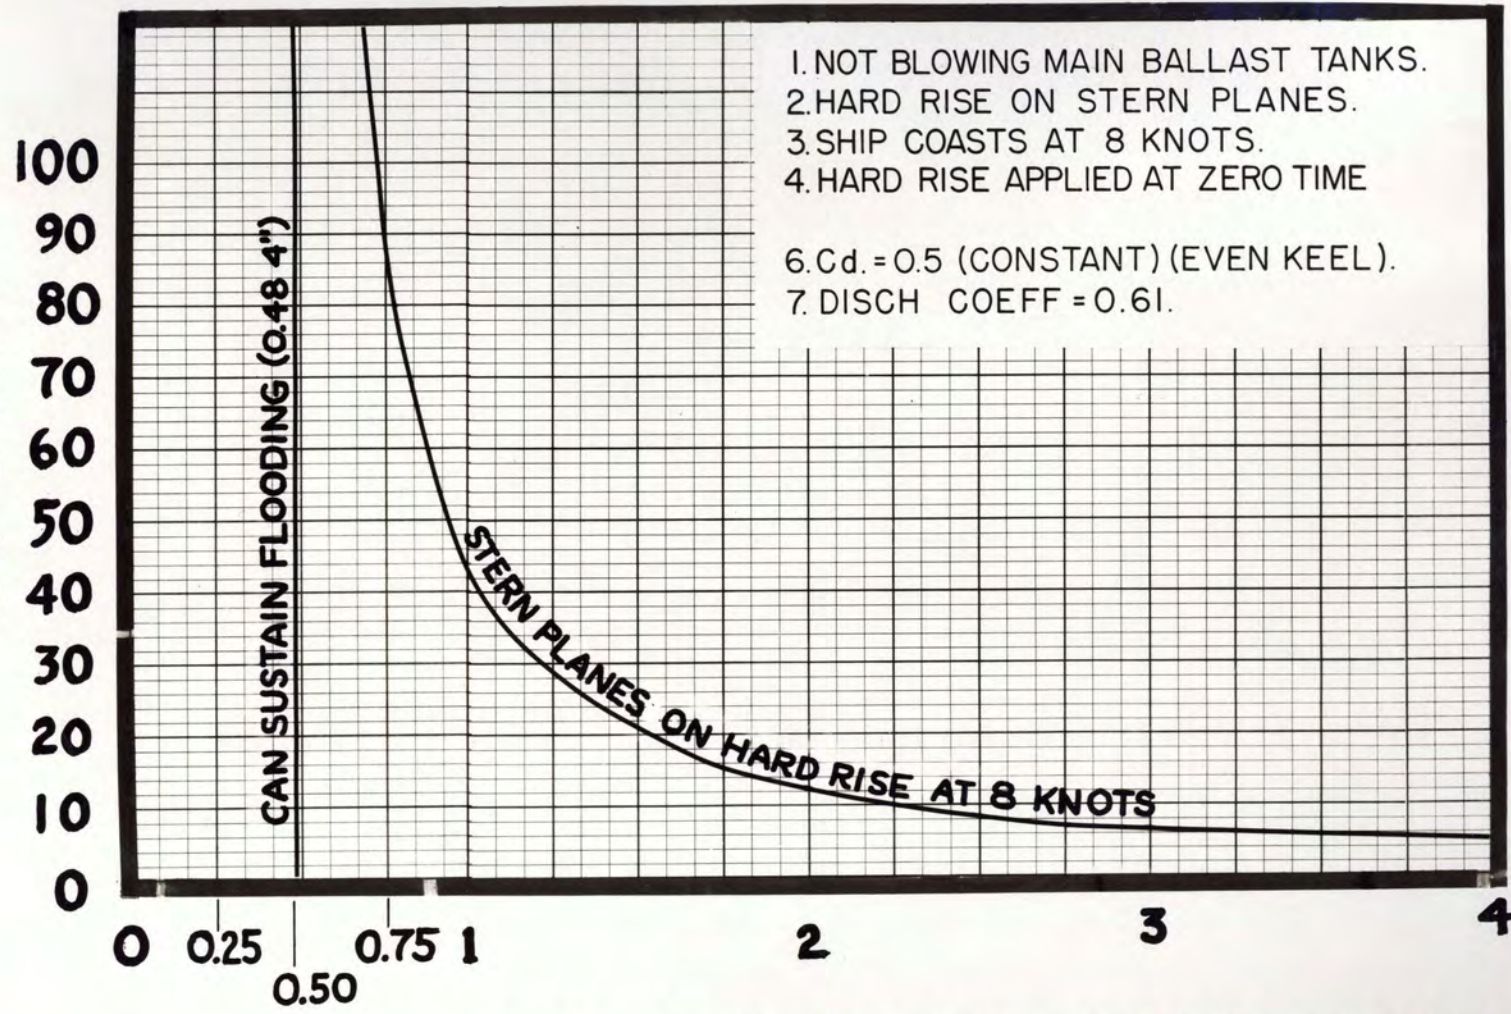
LENGTH OF TIME FLOODING CAN CONTINUE & STILL SURFACE (SECONDS)

SIZE OF HOLE-DIAMETER (INCHES)

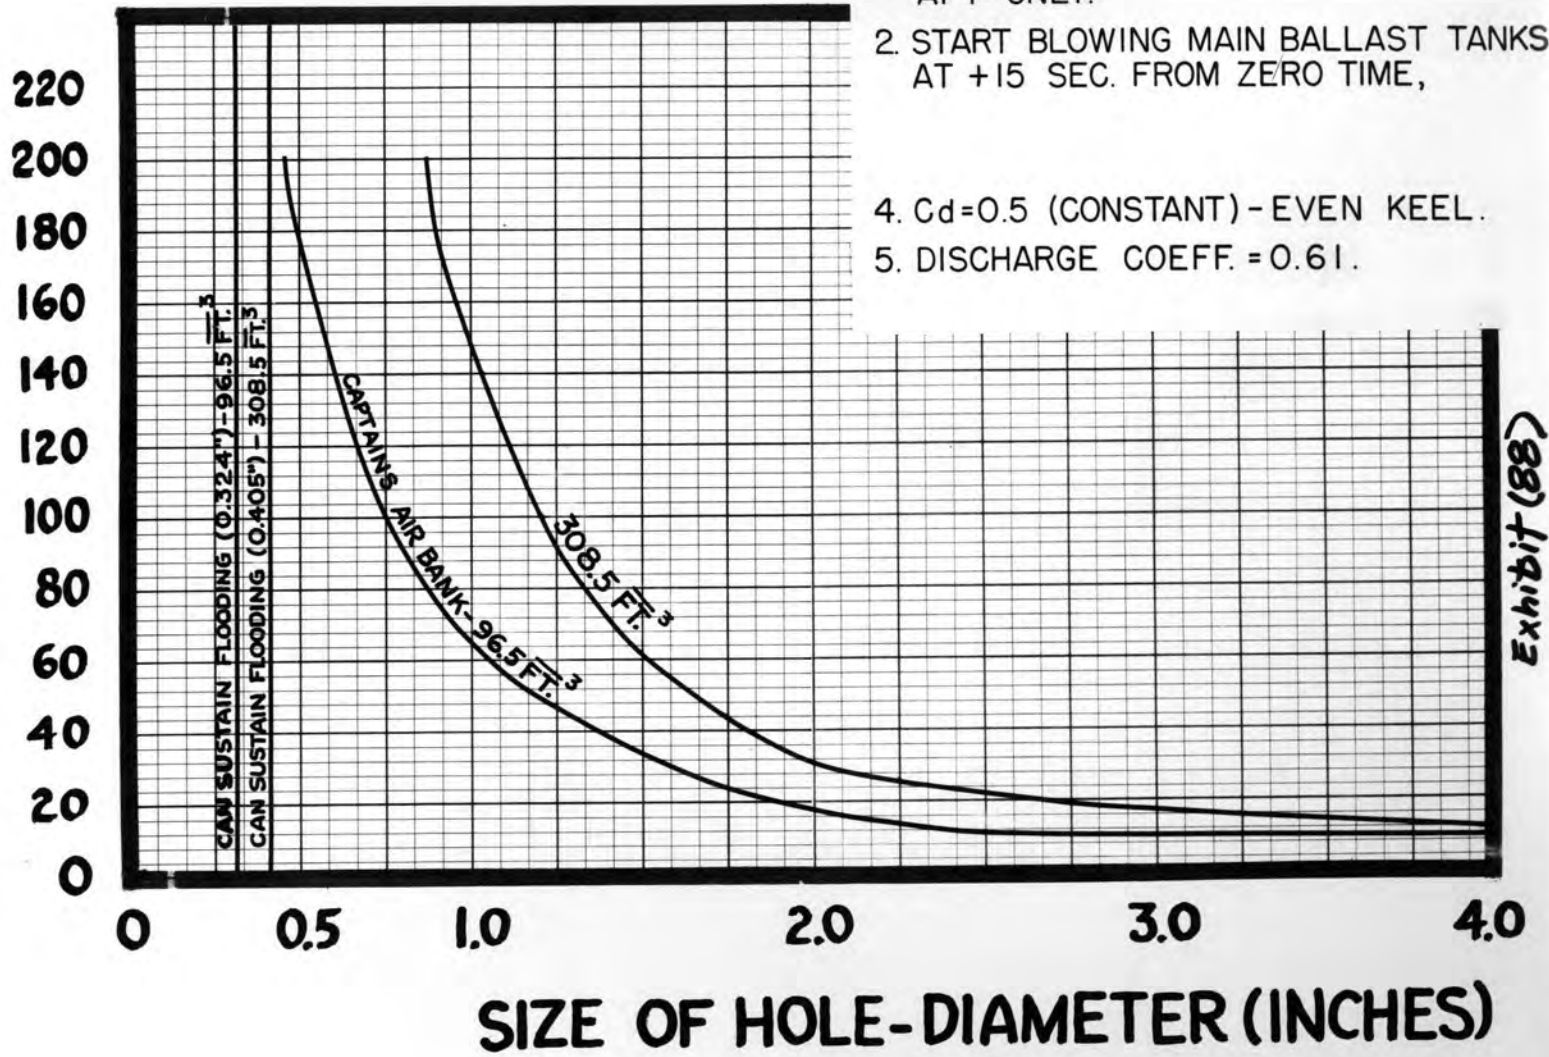
LENGTH OF TIME FLOODING CAN CONTINUE & STILL SURFACE (SECONDS)

1. BLOWING MAIN BALLAST TANKS AFT ONLY.
2. START BLOWING MAIN BALLAST TANKS AT +15 SEC. FROM ZERO TIME,
4. $C_d=0.5$ (CONSTANT) - EVEN KEEL.
5. DISCHARGE COEFF. = 0.61.
