City and County of San Francisco Department of Building Inspection

September 10, 2021

Subject: 301 Mission Retrofit Monitoring Report 019: Results as of September 7, 2021

STAFF FIELD REPORT

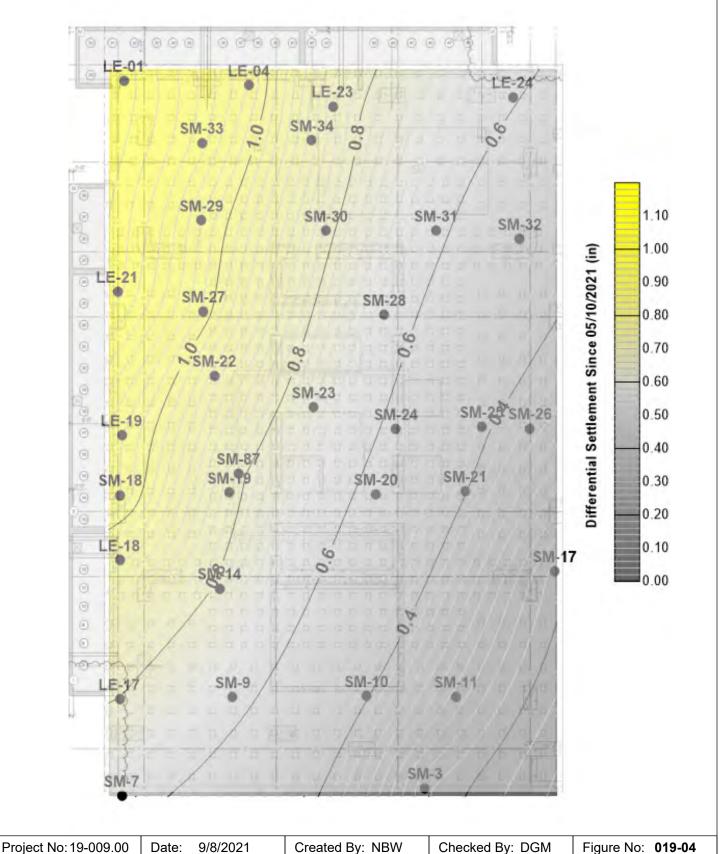
SETTLEMENT CONTOURS SINCE 05/10/2021 THROUGH 09/07/2021

Figure 02 presents the historical settlement data interpreted from settlement markers installed on the B-1 Level of 301 Mission Tower. In addition, data from surveys performed during the retrofit are included. Figure 03A presents settlement data since the start of production pile installation (May 12, 2021; baseline readings on May 10, 2021) through September 7, 2021. The presentation of data on Figure 03A has been updated to clarify the intent. Figure 03B presents settlement data since January 11, 2021, through September 7, 2021. Figure 04 presents current settlement contours (in inches) on August 30, 2021.
