# Operational Review

Structure Fire Argus Fire Protection, Onehunga

Address :  
314 Neilson Street Onehunga

Incident Date:  
21<sup>st</sup> April 2019

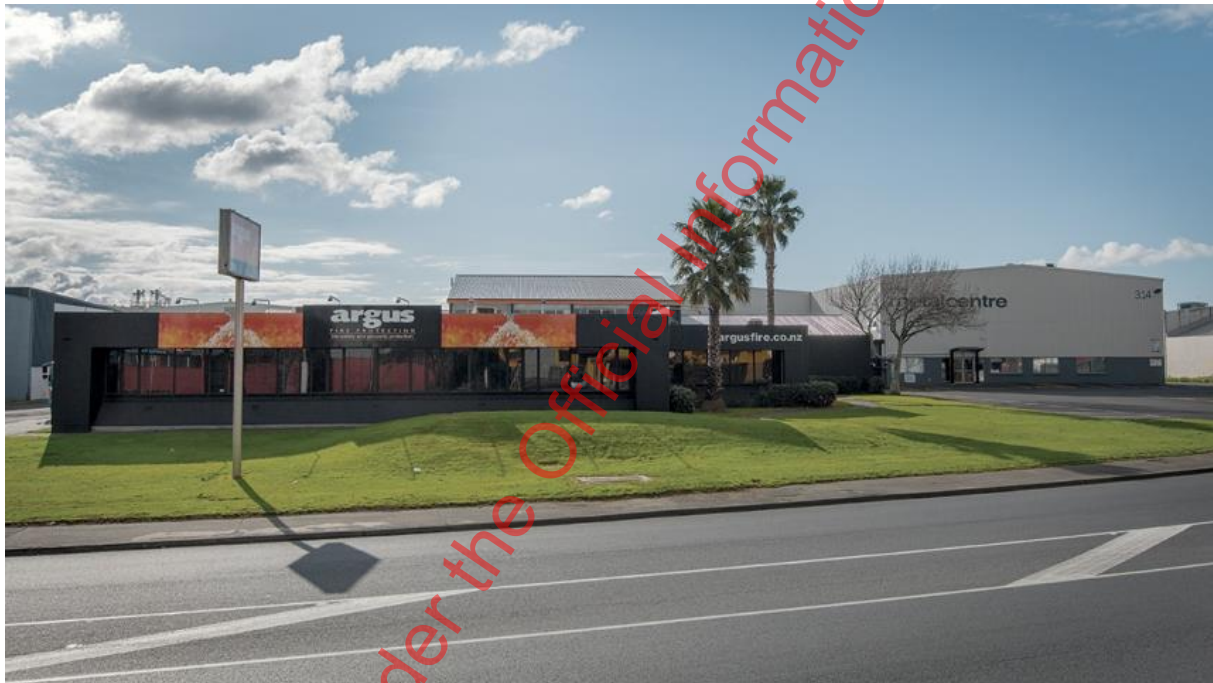
*314 Neilson St Onehunga, pre-fire on 21 April 2019*

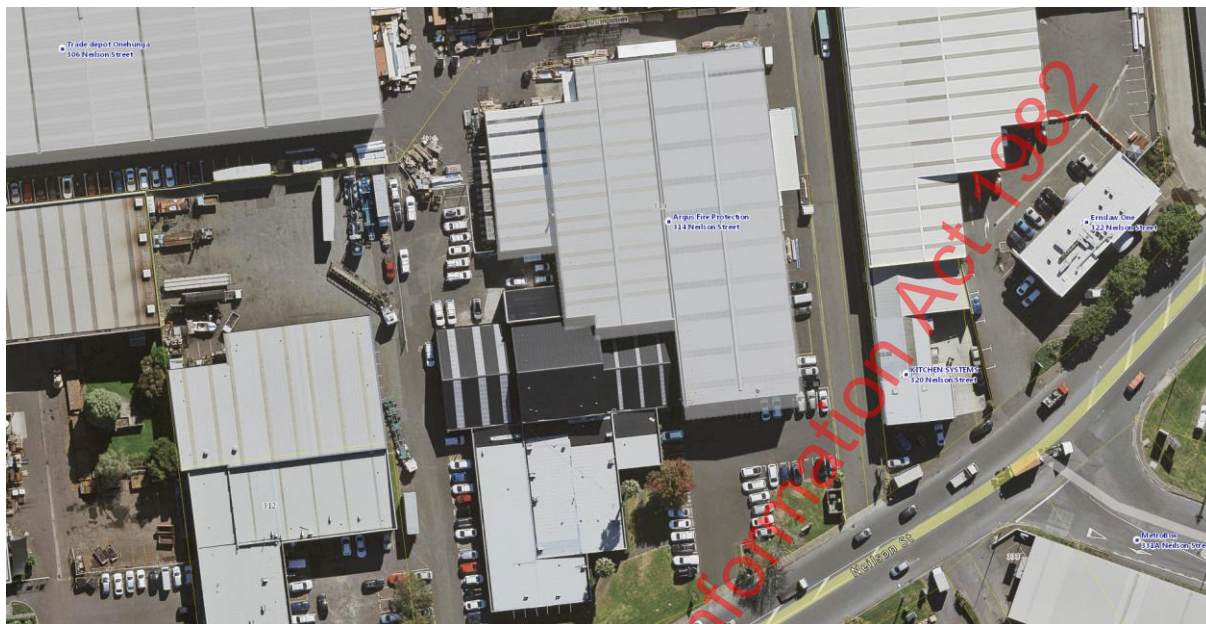
Shows the entire building complex and exposures

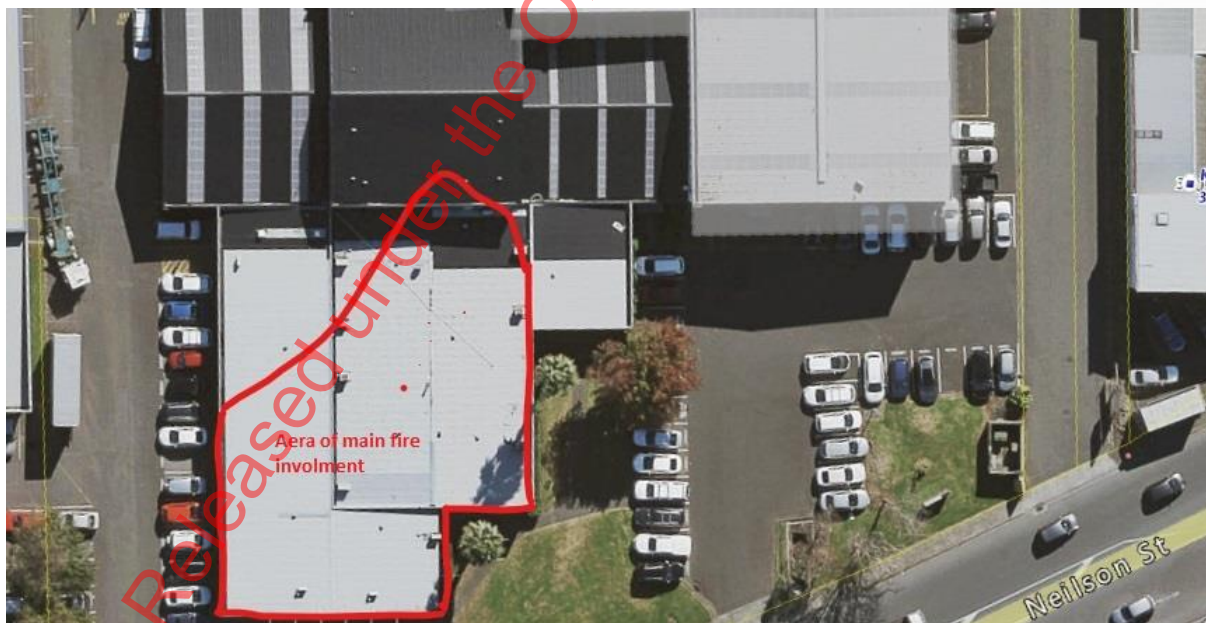
Shows main area of fire involvement when OENH221 arrived
