Subj: COMMAND INVESTIGATION INTO THE FACTS AND CIRCUMSTANCES  
SURROUNDING THE FIRE ONBOARD USS BONHOMME RICHARD (LHD 6) ON  
OR ABOUT 12 JULY 2020

# COMMAND INVESTIGATION

On 12 July 2020, a fire set USS BONHOMME RICHARD (LHD-6) ablaze for more than four days, and left the ship damaged beyond economical repair. Although the fire was started by an act of arson, the ship was lost due to an inability to extinguish the fire. In the 19 months executing the ship's maintenance availability, repeated failures allowed for the accumulation of significant risk and an inadequately prepared crew, which led to an ineffective fire response. There were four key focus areas to this final outcome:

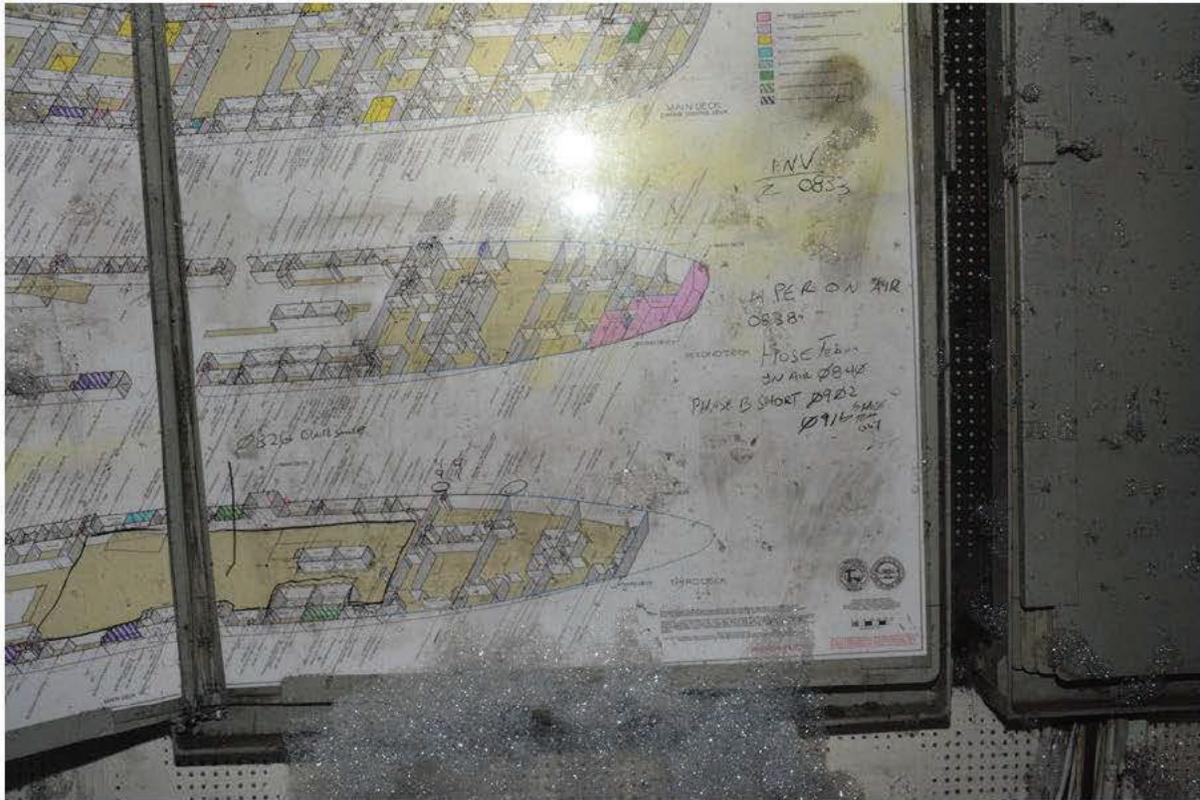
35. DC Central DC plates indicate that at 0838, a four-man team went donned SCBAs and went on air. At 0840, the DC Central DC plates indicate that a hose team went on air. In handwritten notes, the EDO also logged a six-man team on air at 0904. (See Figure 4, which depicts the BONHOMME RICHARD DC plates in DC Central). [Encl 69]

Figure 4 depicts the BONHOMME RICHARD DC plates in DC Central.

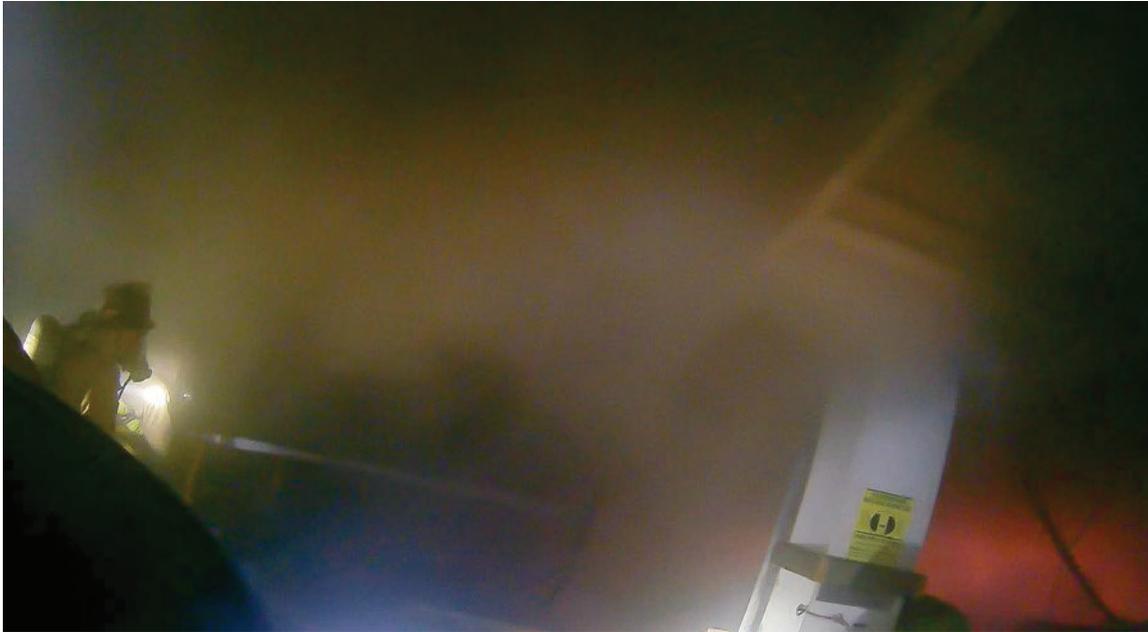
Figure 11 shows a screen capture from SDFD Firefighter (b) (6) 's helmet-mounted camera footage. This image captures the first time agent was applied to fire on 12 July 2020, as SDFD teams applied firefighting water to the radiant fire in Upper V at approximately 0951.

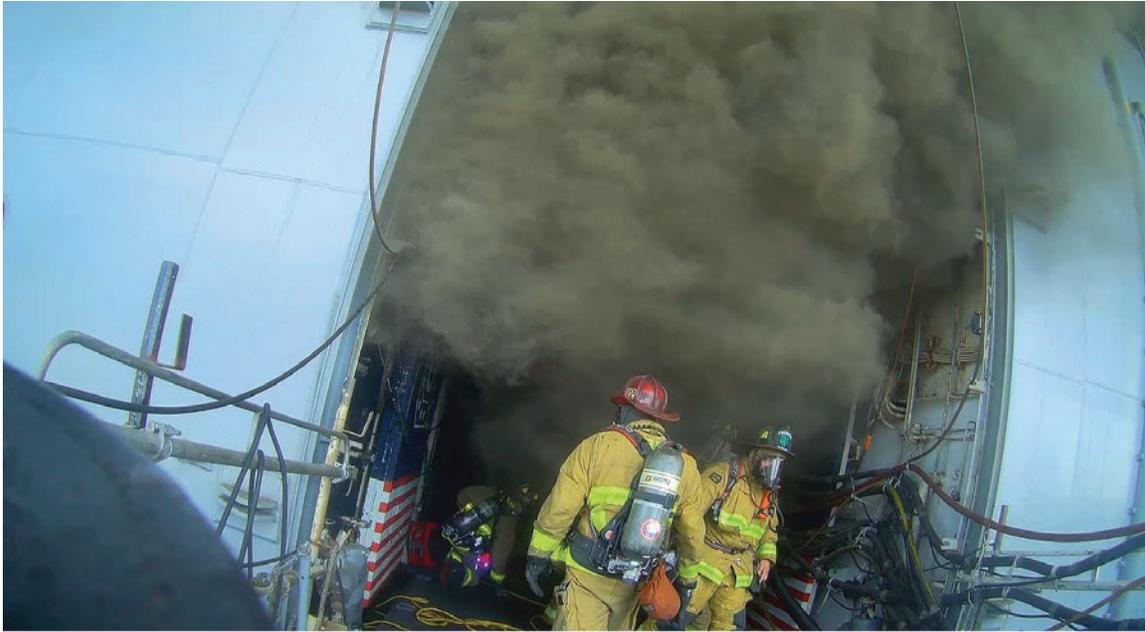
94. As the firefighting efforts continued, SDFD (b) (6) and SDFD (b) (6) observed smoke conditions were deteriorating. The fire transitioned to producing heavy black smoke with a yellow tinge, and multiple SDFD firefighters observed smoke being pulled back into the ship. At approximately 1035, SDFD (b) (6) informed the Assistant Operations Chief, NCFD (b) (6), that firefighters had “lost the space” (referring to Upper V). He then informed the firefighting teams, “This compartment is about to blast, get what you can, get what you can.” NCFD (b) (6) radioed his concerns to SDFD (b) (6) and announced his intention to begin withdrawing the attack teams from the ship. Additionally, FEDFIRE (b) (6) received a report from FEDFIRE (b) (6) about the change in smoke conditions. FEDFIRE (b) (6) also noticed the smoke had become very heavy and black. Based on these reports, FEDFIRE (b) (6) also made the call to evacuate and pull all gear off the ship. At 1037, the ICP officially ordered all firefighting teams to evacuate BONHOMME RICHARD. [Encl 126, 141, 148, 164, 181, 229, 230, 239, 240, 241]

Figure 12 shows a screen capture from SDFD Firefighter (b) (6)'s helmet-mounted camera footage, illustrating smoke conditions at approximately 1035.

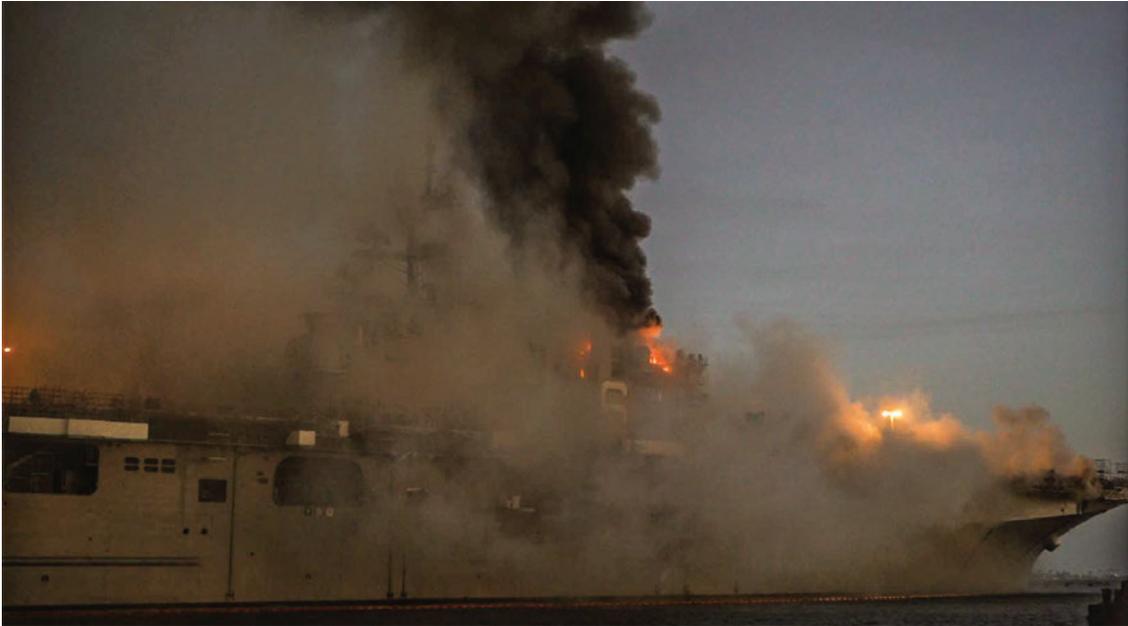
160. At 1954, the fire was observed to be venting out of the superstructure and continued to burn out of control, with an active fire visible from BONHOMME RICHARD's stacks. There were no FEDFIRE personnel or Sailors aboard BONHOMME RICHARD at this time. [Encl 249, 297, 377, 384]

Figure 15 shows BONHOMME RICHARD burning in the evening on 12 July 2020.

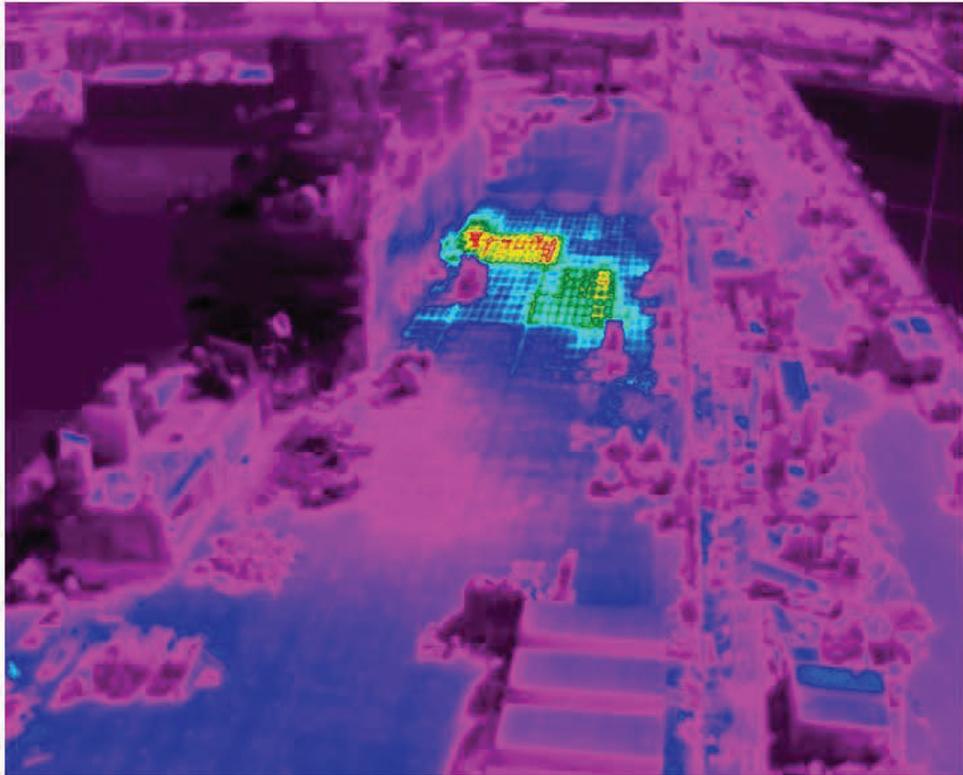
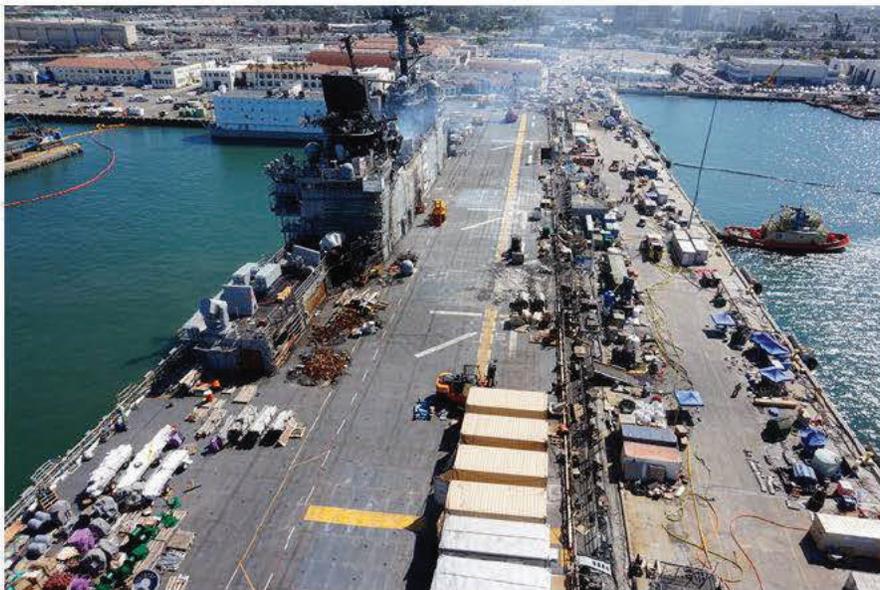
NBSD approval. This drone was subsequently used to identify hot spots for targeted firefighting efforts. US Fire Pump recommended cutting targeted holes in the ship to gain access to compartments with excessive heat or active fire. The first cuts started later that day at approximately 1737. [Encl 34, 141, 249, 314, 392, 394, 407, 409, 410, 411, 412, 413]

Figure 19 show US Fire Pump forward-looking infrared (FLIR) imagery of BONHOMME RICHARD, compared to a standard photograph taken simultaneously by the same drone.

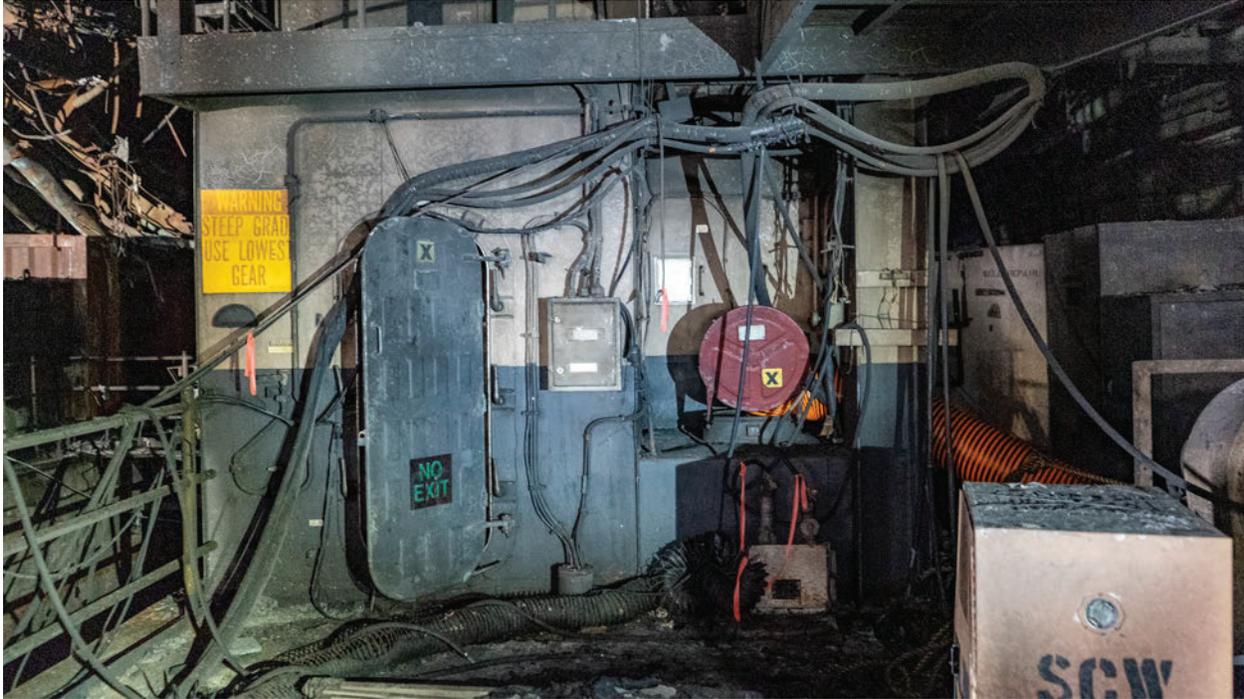
393. None of the 100 IET drills conducted from 23 July 2019 to 12 July 2020 employed AFFF. [Encl 44, 574]

Figure 29, Still photo of AFFF push-buttons for sprinkler groups 15 and 16 serving Lower V (16 on left; 15 on right). These push-buttons are in Upper V amidships. An open hatch obstructs visibility of the push-buttons.

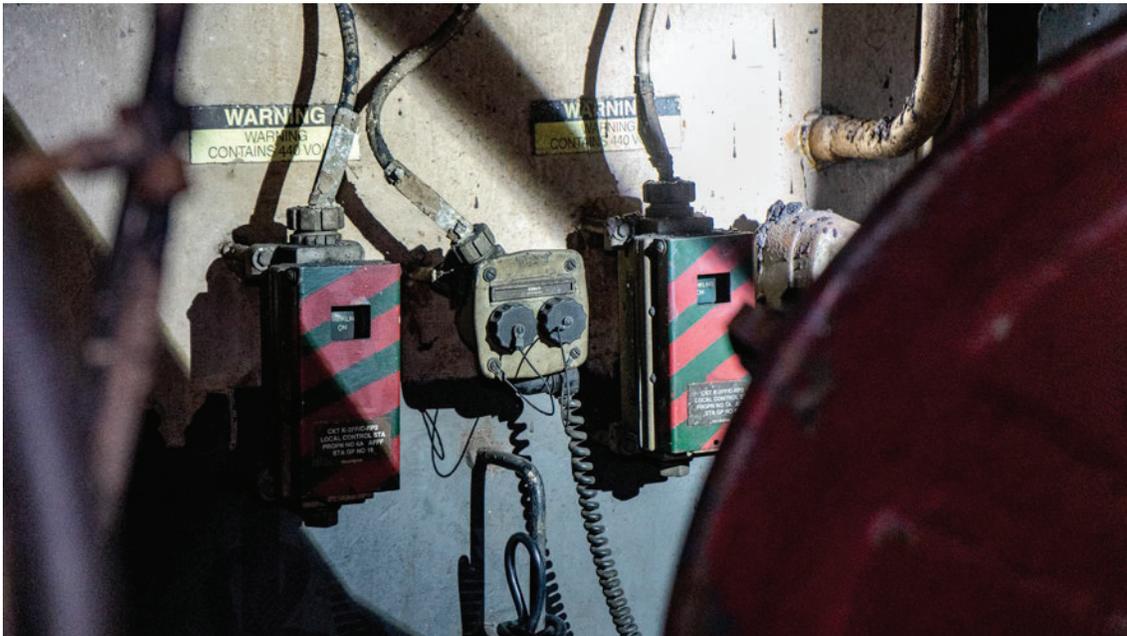
Figure 30, Still photo of AFFF push-buttons for sprinkler groups 15 and 16 serving Lower V with covers closed (16 on left; 15 on right). These push-buttons are in Upper V amidships. The photo shows proximity to open hatch, which obstructs visibility of the push

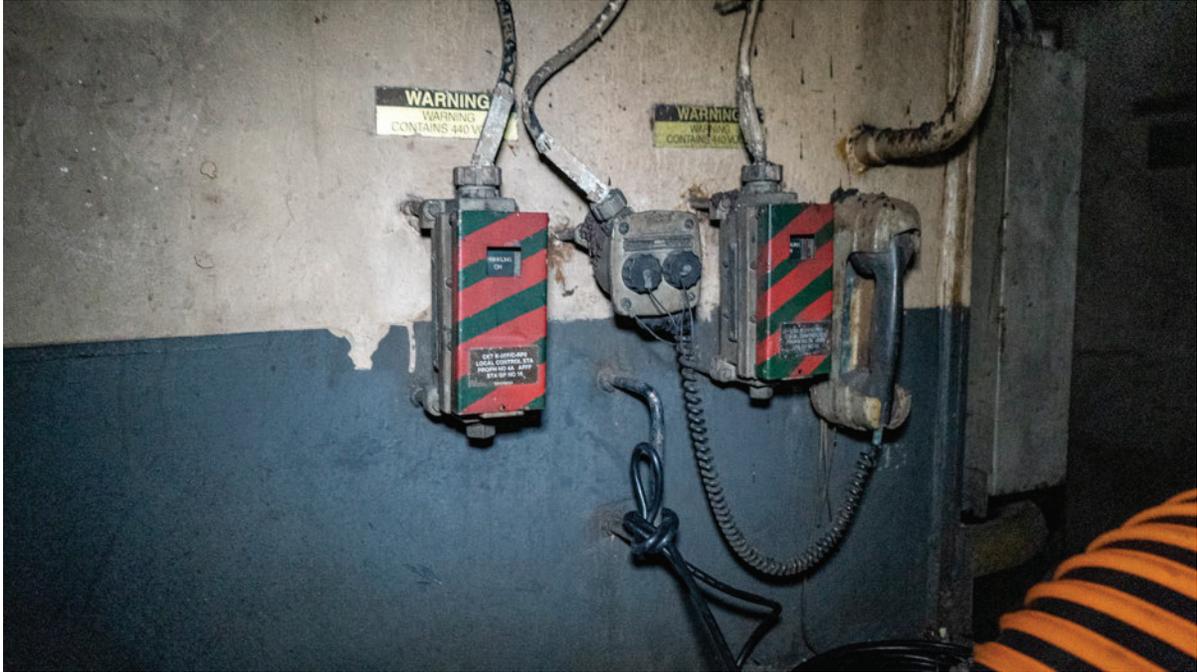
Figure 31, Still photo of AFFF push-buttons for sprinkler groups 15 and 16 serving Lower V with covers closed (16 on left; 15 on right). These push-buttons are in Upper V amidships.

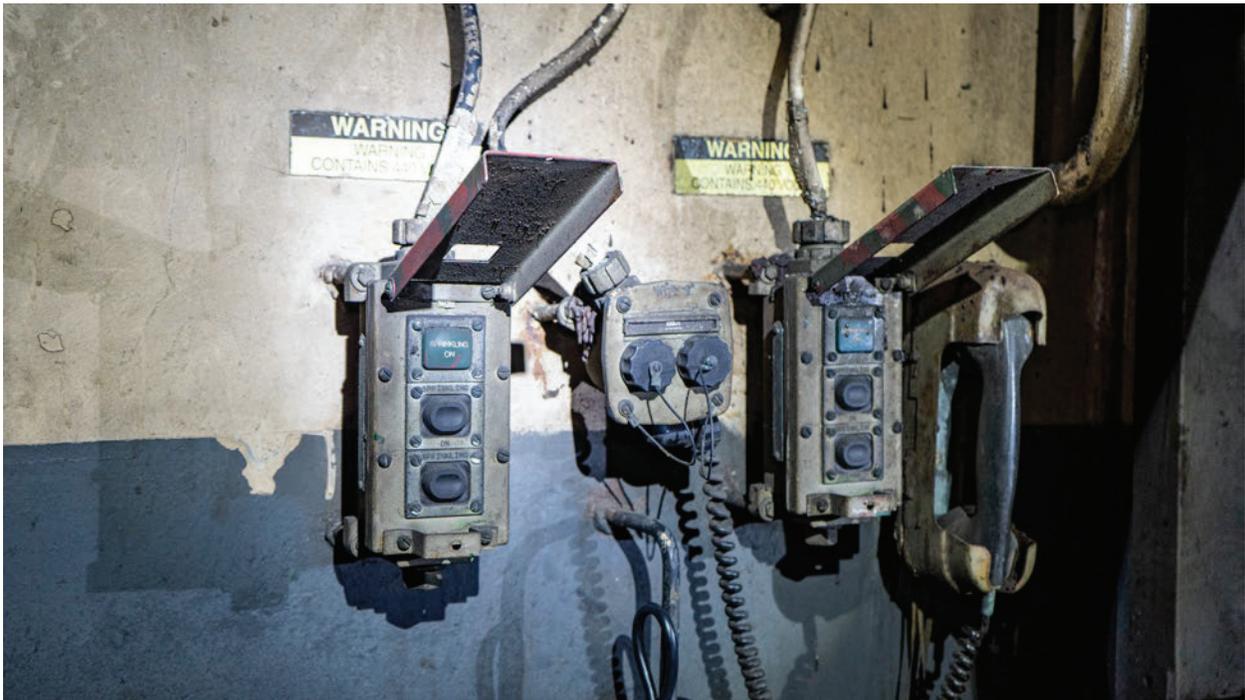
Figure 32, Still photo of AFFF push-buttons for sprinkler groups 15 and 16 serving Lower V with covers open (16 on left; 15 on right). These push-buttons are in Upper V amidships.

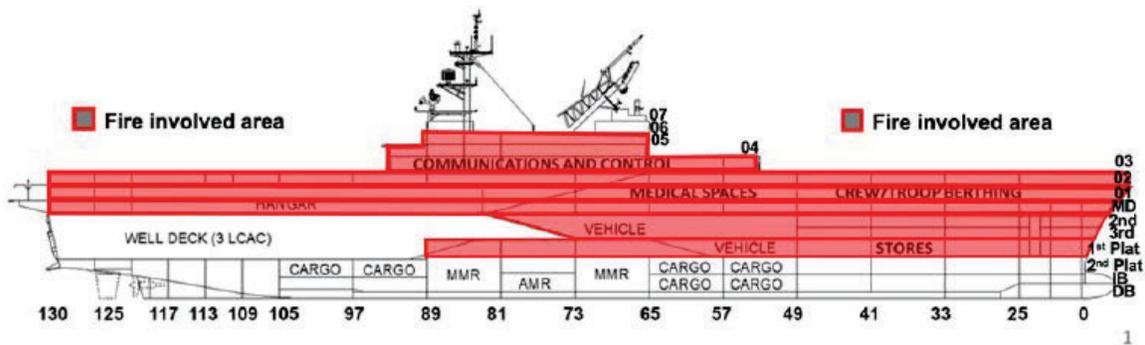
1040. To determine the full scope of damage to BONHOMME RICHARD, the MA initially divided the ship into zones, with the intent to assess each compartment within a respective zone for structural, fire/heat, or water damage. Due to the catastrophic nature of the actual damage conditions, the MA modified their initial compartment-by-compartment assessment to instead provide a gross assessment of groups of compartments. In many areas, the damage was so extensive that the MA was unable to identify specific compartments, as the fire and explosions created large open areas spanning several decks. Overall, the MA concluded that approximately 63 percent of BONHOMME RICHARD was impacted by the fire. [Encl 731, 994]

Figure 41 is a MA diagram indicating the fire-involved areas of BONHOMME RICHARD.

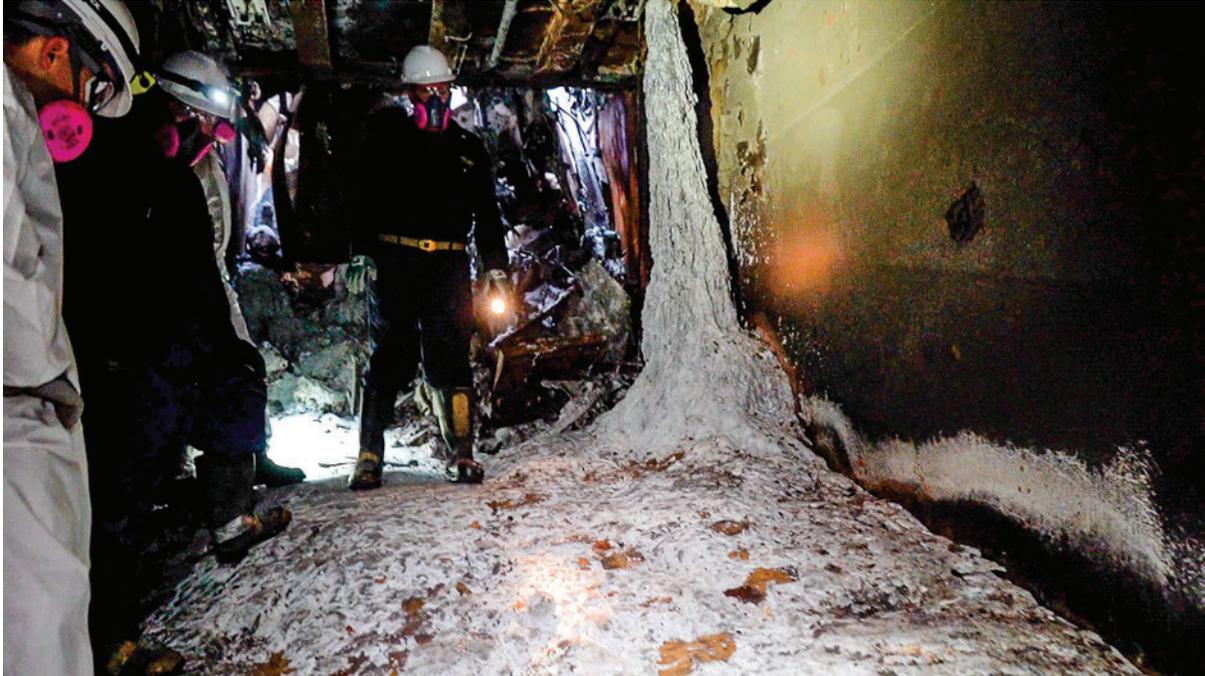
1041. The damage to the island is particularly notable, as the interior of the island is constructed primarily of aluminum, which has a lower melting point than carbon steel. The island was completely hollowed-out by the fire, transforming nearly a third of the 300-ton structural mass into molten aluminum. This molten aluminum drained through the island’s Flight-Deck level foundation penetrations onto the decks below, creating lava-like flow across lower-level steel decks and through vertical deck penetrations. No material remaining within the island is salvageable, as the fire essentially left exterior bulkheads with no other support structure. Due to the lack of structural integrity, should the ship be towed on the open-ocean, the island must either be removed or buttressed. [Encl 731, 995, 996, 997, 998]

Figure 42 shows investigation team members examining a solidified aluminum flow.

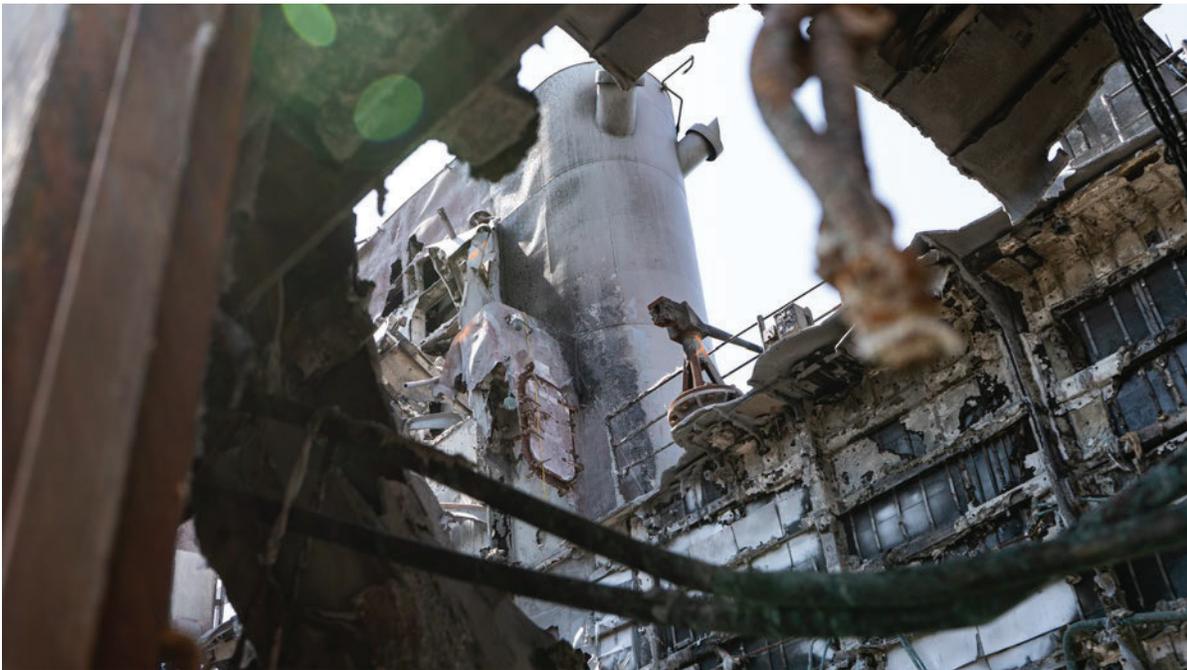
Figure 43 shows the island's interior, illustrating that the overhead has completely burned away.

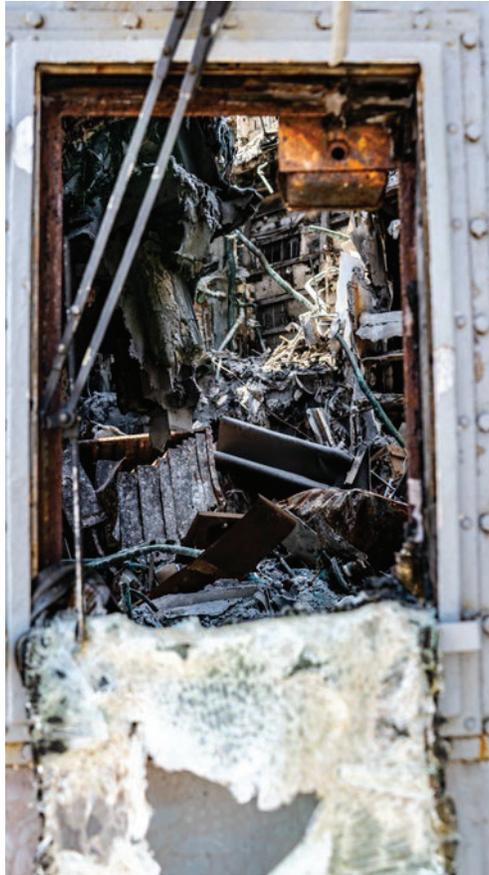
Figure 44 is another photograph of the island's interior.

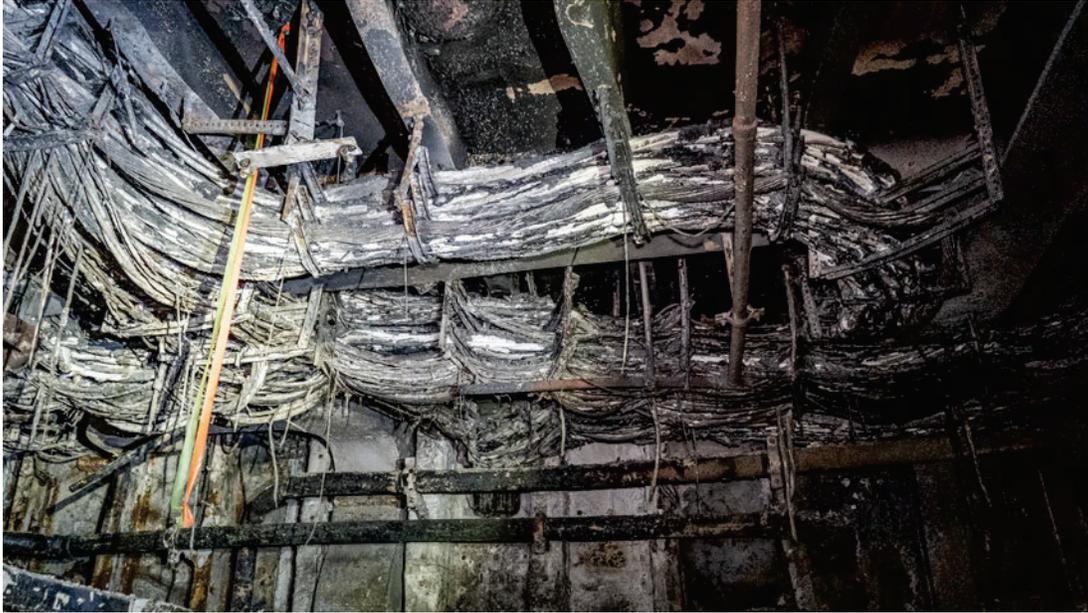
Figure 45 shows burned cableways in the Lower Vehicle Stowage Area (Lower V).

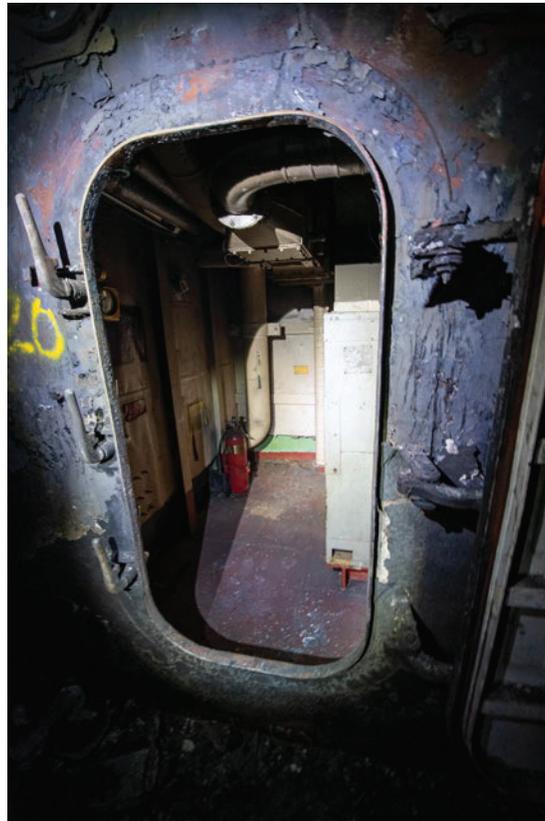
Figure 47 shows two compartments separated by a closed hatch. One compartment was severely damaged, while the adjacent compartment suffered minor damage.
