INDIANA UTILITY REGULATORY COMMISSION

APPLICANT'S SUBMISSION OF DIRECT TESTIMONY OF
JOHN BIGALBAL

STG1 Failure on Start-Up

Analysis Title: STG1 Startup Failure
Principle Analyst: Holcombe Baird
Analysis Sponsor: Kevin Cook
Analysis Dates: May 2, 2021 - July 8, 2021
Report Date: August 20, 2021

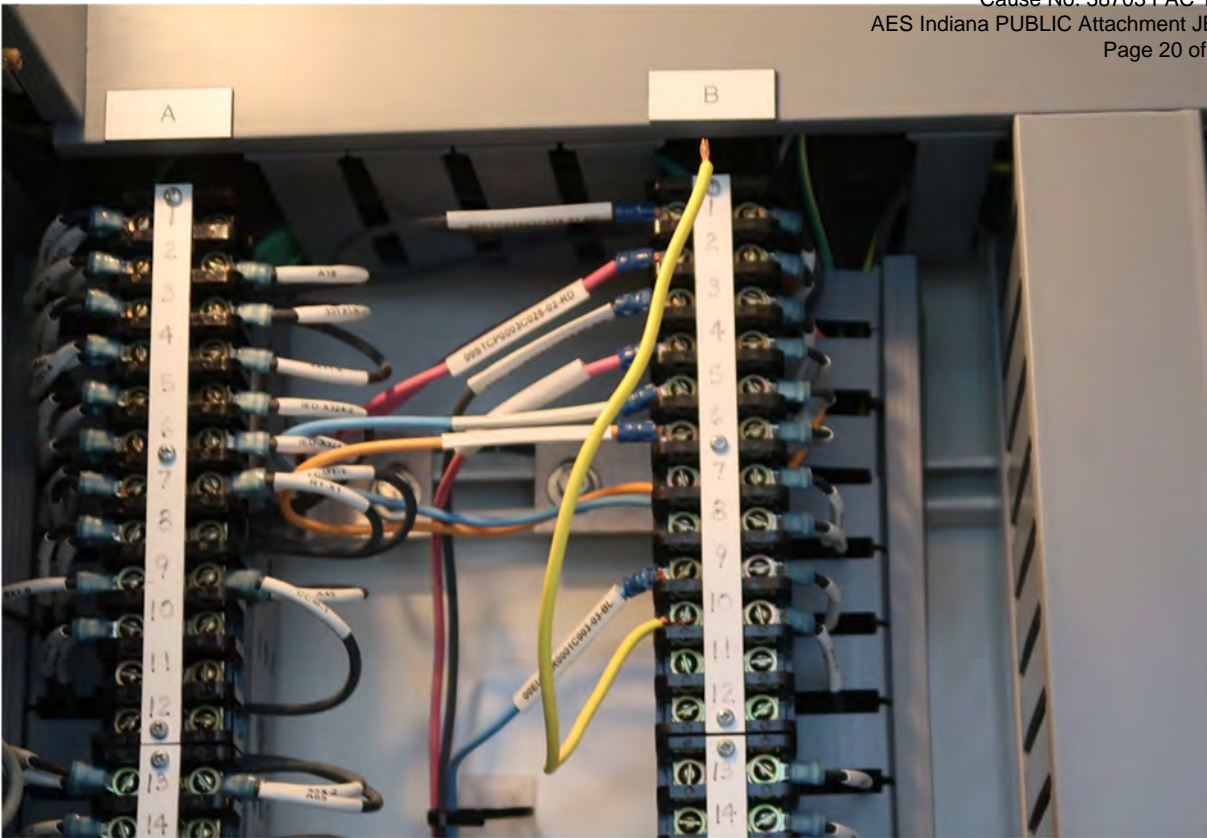
Not until the following week, after an in-depth electrical engineering review of the various wiring diagrams, was it determined the correct connections for the loose yellow jumper wire in the Generator Circuit Breaker cabinet should have been between terminal B10 and B3.

The RCA Team findings confirmed the disconnected wire was the reason behind the failure to complete the Synchronization to the grid. The RCA team hypothesized how and why the yellow jumper wire could have become disconnected. (Refer to Hypotheses for jumper wire becoming disconnected in the Logic Tree section of this report) The hypotheses can be grouped into three general categories: an intentional action, an accidental action, or an independent action. In verifying a need to disconnect the jumper to perform the testing operations of the 52G Relay, the ABB technician and the AES technicians stated they did not need to disconnect the yellow jumper wire to perform their respective testing. The ABB

technician stated he observed the yellow jumper wire was disconnected when he started working on the Generator Circuit Breaker cabinet on April 16, 2021. His observation was not reported until he was interviewed as part of the RCA investigation. Inside the Generator Circuit Breaker cabinet on the left wall near the yellow jumper wire, there was another jumper wire with one end disconnected. (Refer to Photograph 5) This jumper had the crimped-on ring lug. Exposed, bare conductors should be called out as a safety hazard from possible electric shock. On the right side of rear panel there were several wires landed without crimp-on ring lugs. (Refer to Photograph 6) The wires may have been left behind from where instrumentation was attached during commissioning. These issues seem to project a message such conditions are not important or even normal. This is supported by the fact the loose end of the yellow jumper wire was not recognized as an issue to be reported and properly addressed.

Photograph 3, Loose yellow jumper wire in STG 52G Breaker Cabinet

- 20 • Re-terminate the disconnected wire in the generator breaker (52G Breaker) cabinet
21 using OEM recommended standards including terminal ring lugs - to be completed
22 prior to return to service.

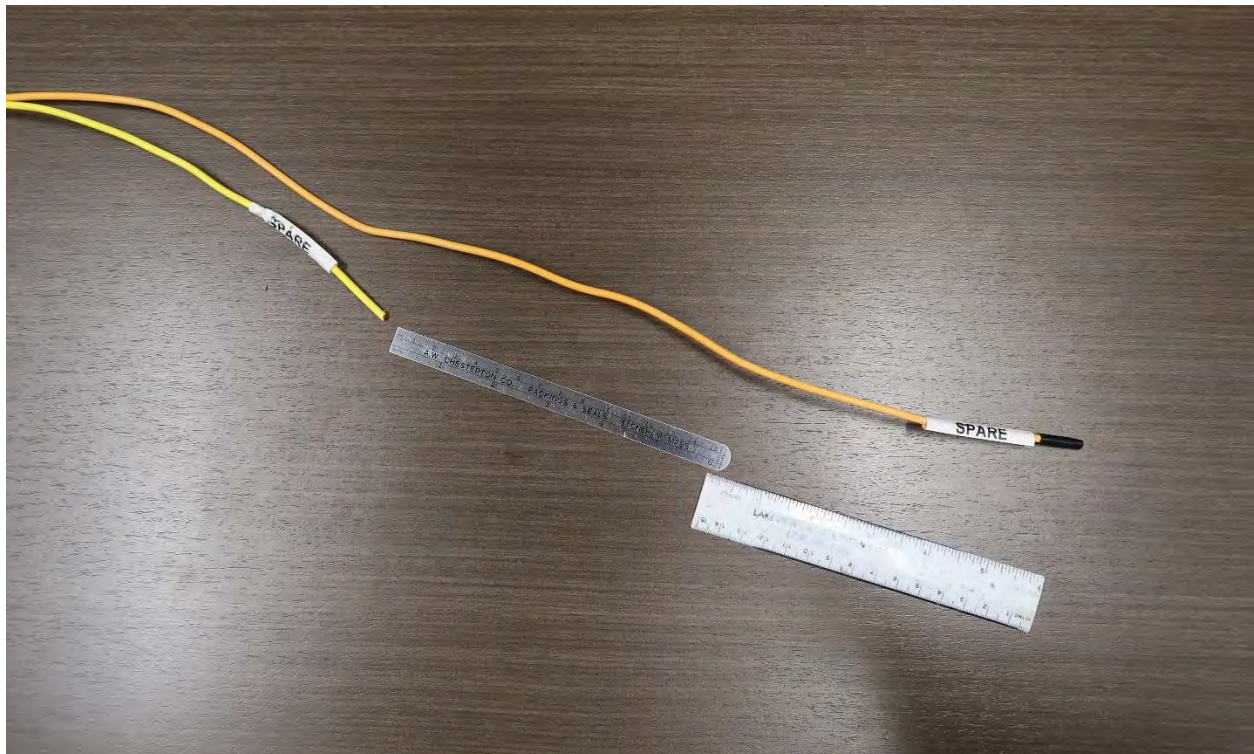
Photograph 4, Source of yellow jumper wire, found in STG 52G Breaker Cabinet.

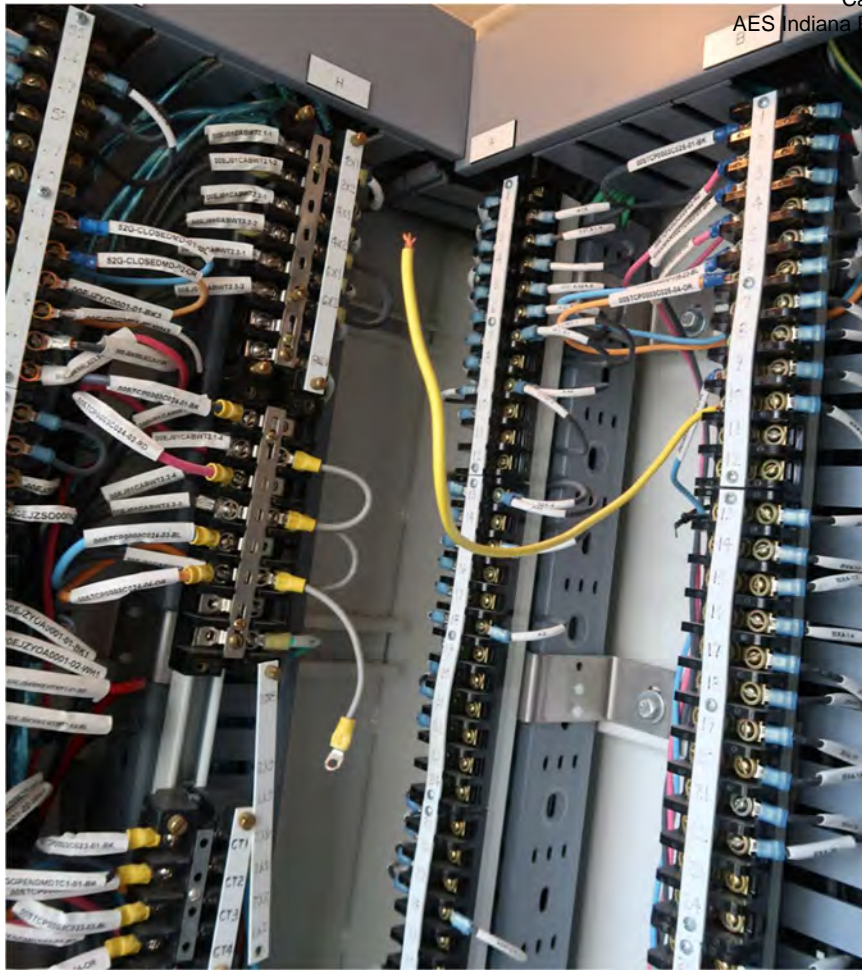
While performing the field verification, the RCA team discovered several discrepancies between the documentation and what was observed physically in place. They also found some incidents where the installation did not adhere to best practices for a reliable electrical protection control system. Two examples of conditions found were insulated ring lugs not used on CT sensor connecting circuits, and incorrect rated wire type was used for jumper connections between terminals. The issues were documented and reported to the site management team.

Photograph 5, Bare conductors in STG 52G Breaker cabinet

- 1 • Clean up wiring in the field breaker (41E Breaker) cabinets to remove wiring with
2 exposed conductors and other identified deficiencies – to be completed prior to return
3 to service.
- 4 • Establish 86 series lockout relay reset Standard Operating Procedure (“SOP”) in
5 accordance with industry best practices – SOP is being developed and will be
6 completed prior to return to service.
- 7 • Establish operational pre-startup step to confirm agreement in status indicators for the
8 generator (52G Breaker) and field (41E Breaker) breakers – startup procedure is in the
9 process of being amended to include this step and will be completed prior to return to
10 service.

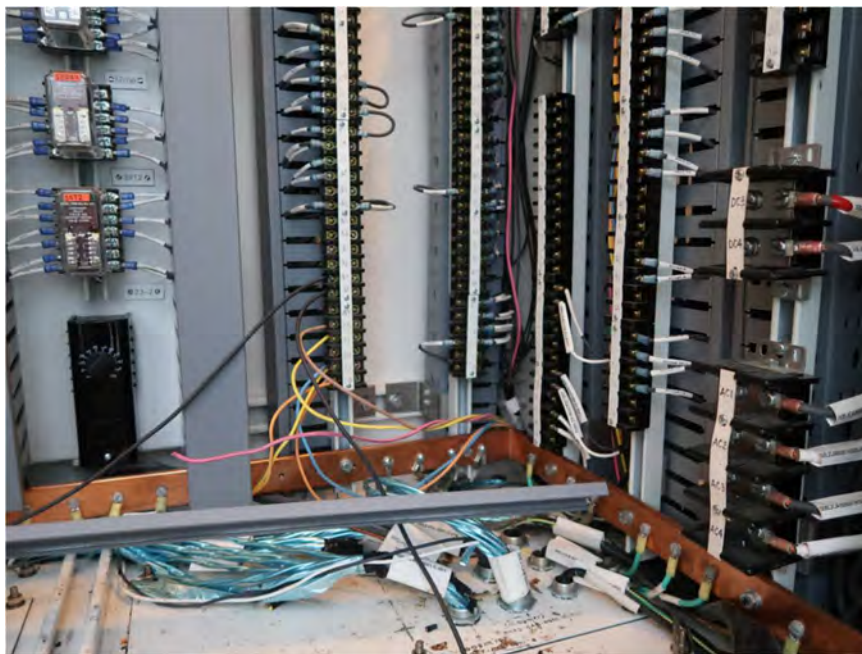
Photograph 6, STG 52G Breaker Cabinet condition

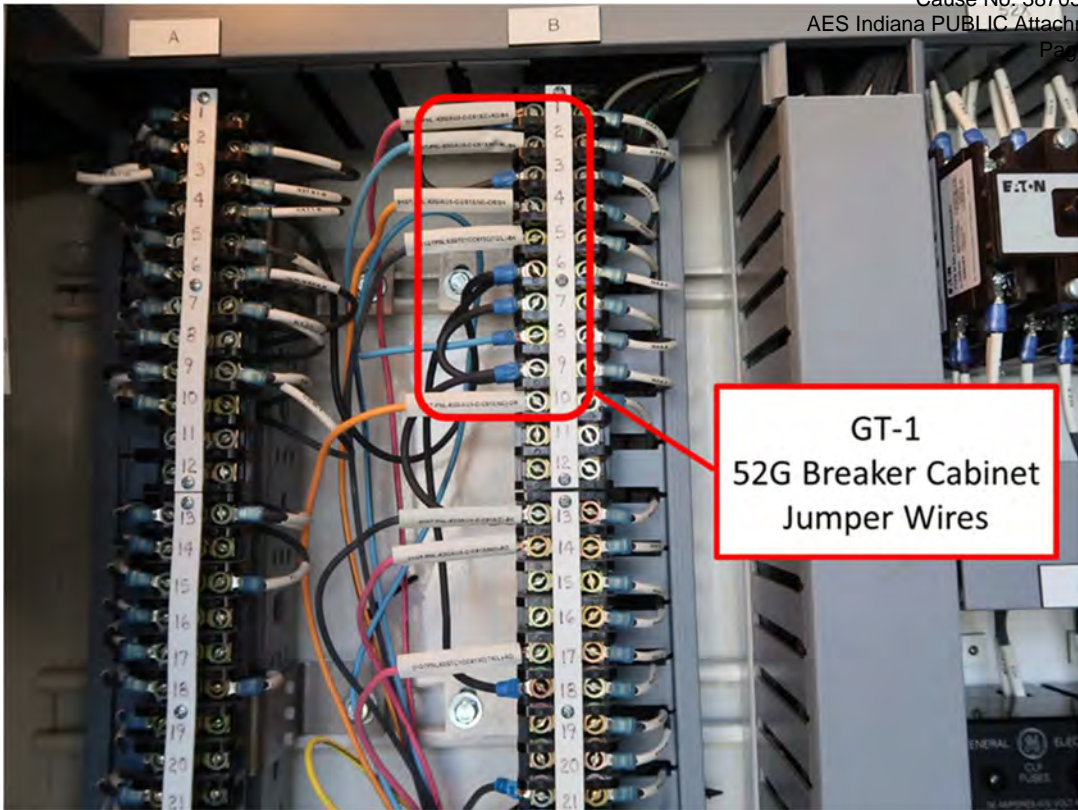
Photograph 7, GT-1 Jumper Wires (black color wire) on B-Terminals

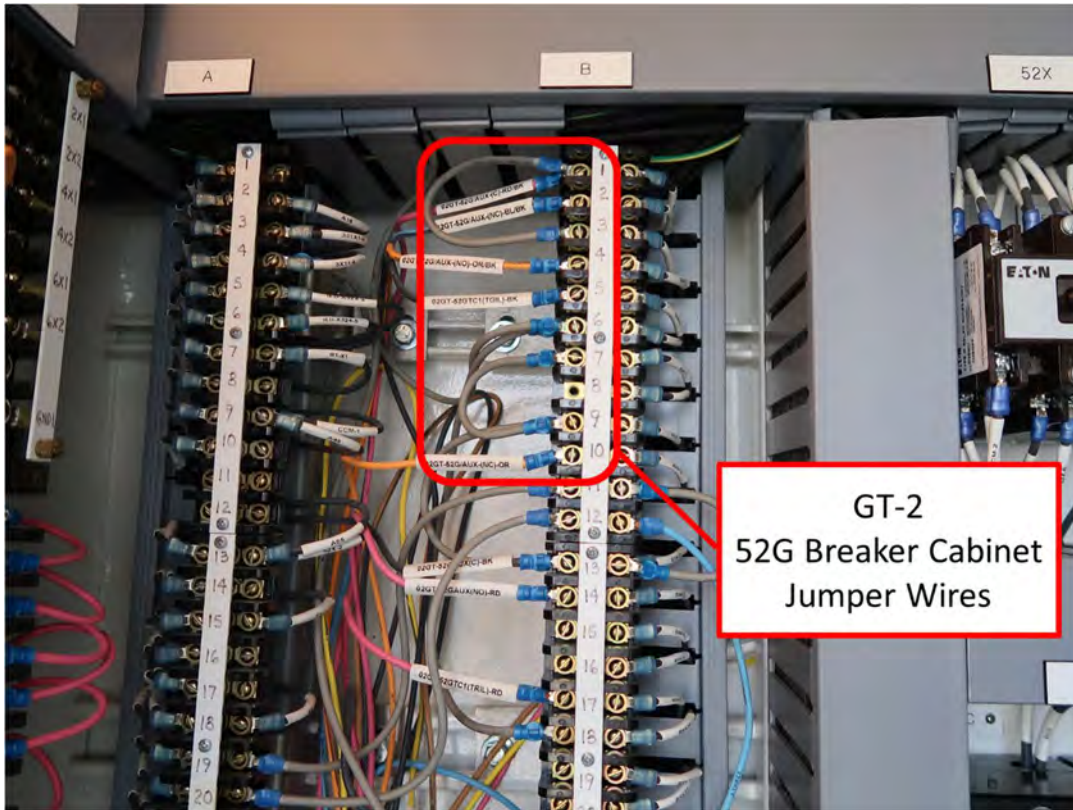
Photograph 8, GT-2 Jumper Wires (grey color wire) on B-Terminals

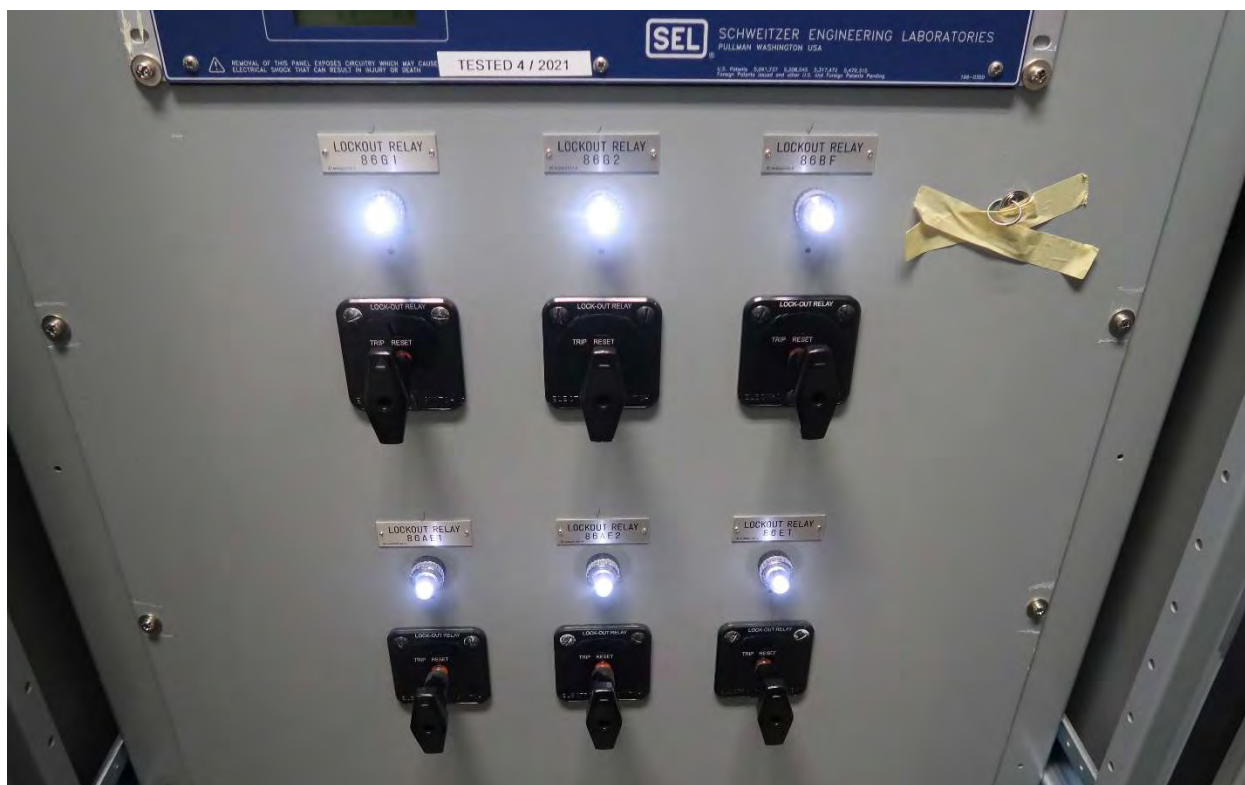
Interviews with the operators and technicians revealed it is current practice for the technicians to reset a tripped 86 Series Lockout after a presumed cause has been identified. If the Lockout Relay does not re-trip, the STG is returned into operation. If the reset 86 Series Lockout does re-trip, further investigation is then performed to identify and resolve the source initiating the trip. On April 25th, a coordinated investigative effort between the operators and the technicians into the reason for the 86G1 and 86G2 Lockout trips did not take place. As a result, the potentially damaging conditions presented when the 41E Breaker remained closed was not considered prior to resetting the tripped 86G1 and 86G2 Lockouts. Nor were the system conditions monitored after the protection circuits were re-energized when the 86G1 and 86G2 Lockouts were reset.

Photograph 12, STG 86 Series Lockouts Trip/Reset levers

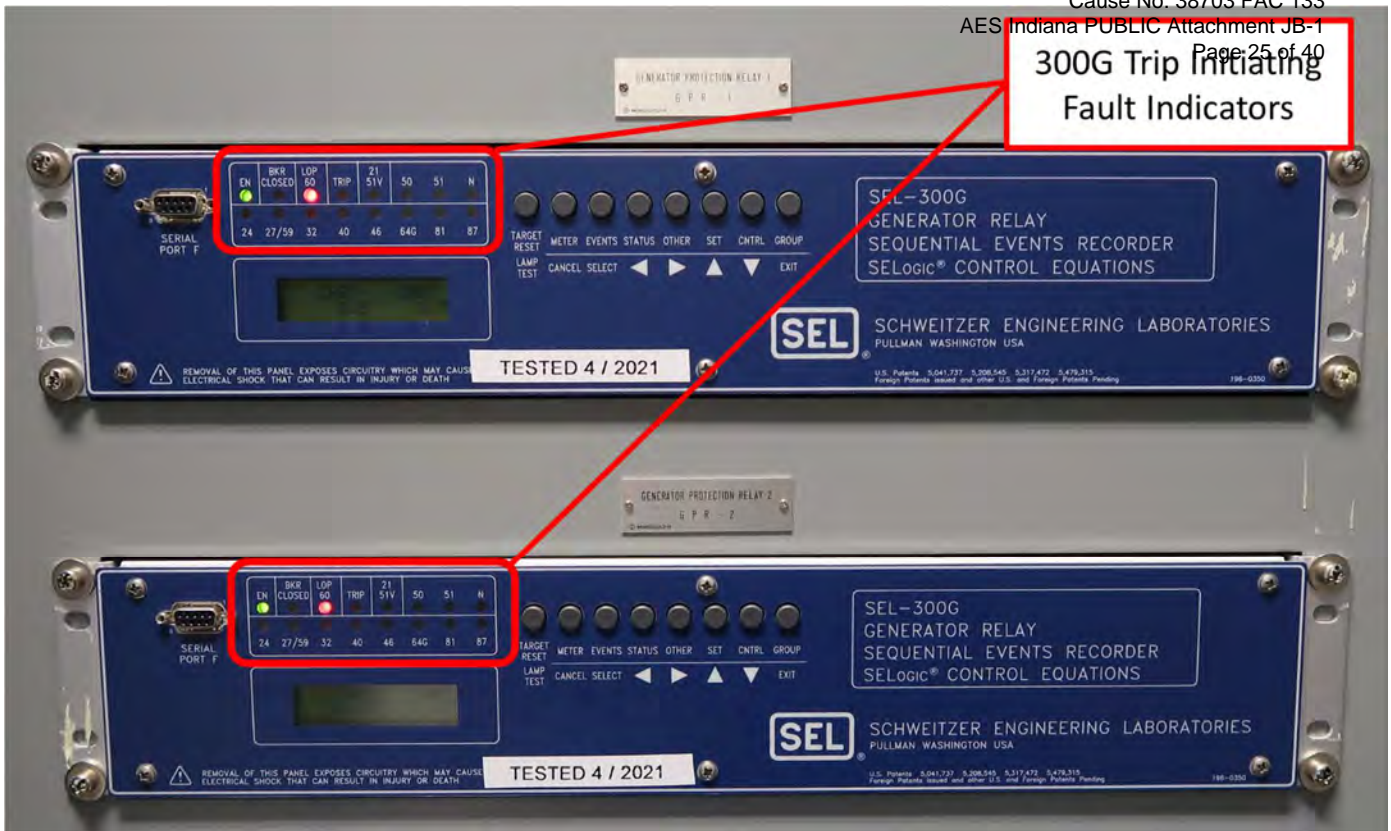
Photograph 13, STG 300G-SEL Monitor displays

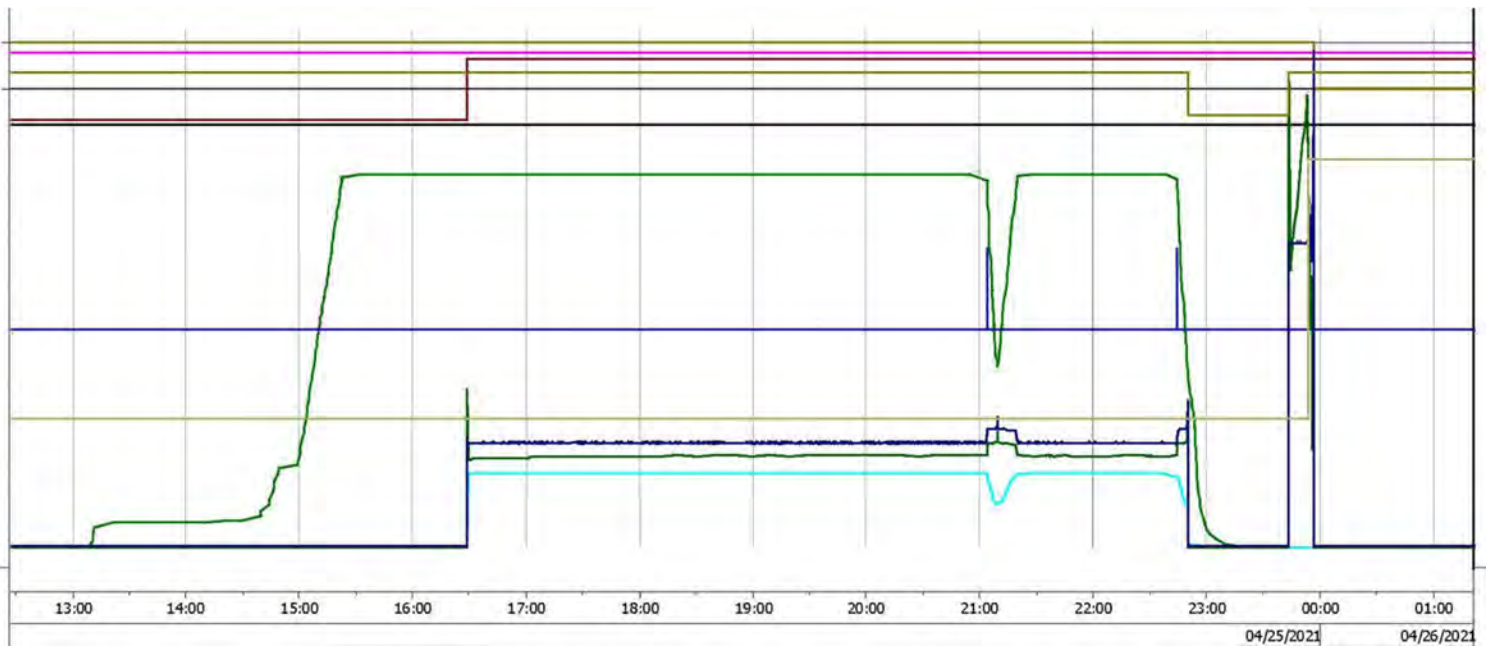
The RCA investigation into the STG failure to synchronize to the grid began with a review of the historical data trends of signals for 41E Breaker, 52G Breaker, turbine speed, turbine trip, generator parameters and fault signals to understand the sequence of events on April 25th. (Refer to Figure 2)

Figure 2, Trend data from April 25, 2021

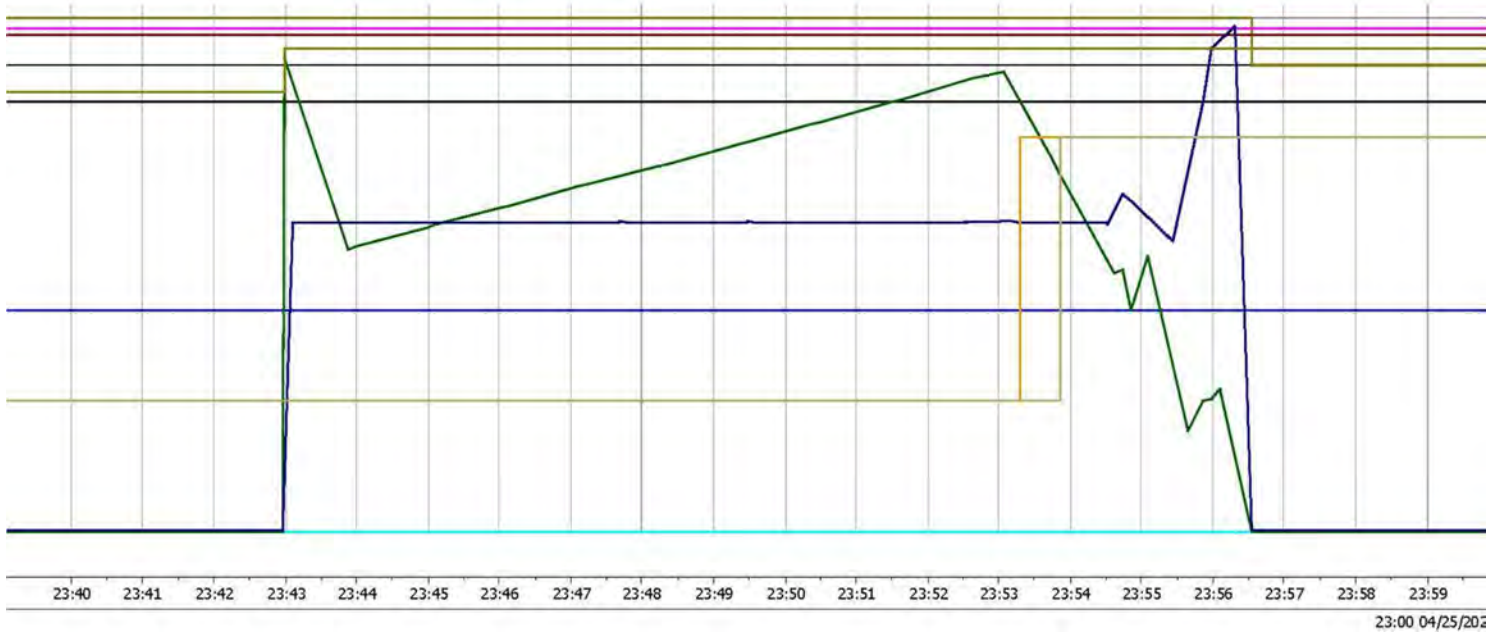
The investigation into the short to ground failure of the generator field revealed physical damage to the copper conductors in the generator field. This damage was due to the exposure of the field to excitation current without the benefit of hydrogen flow cooling as the field was not rotating at operational speed.

Figure 18, Trend data of Generator Field damage event

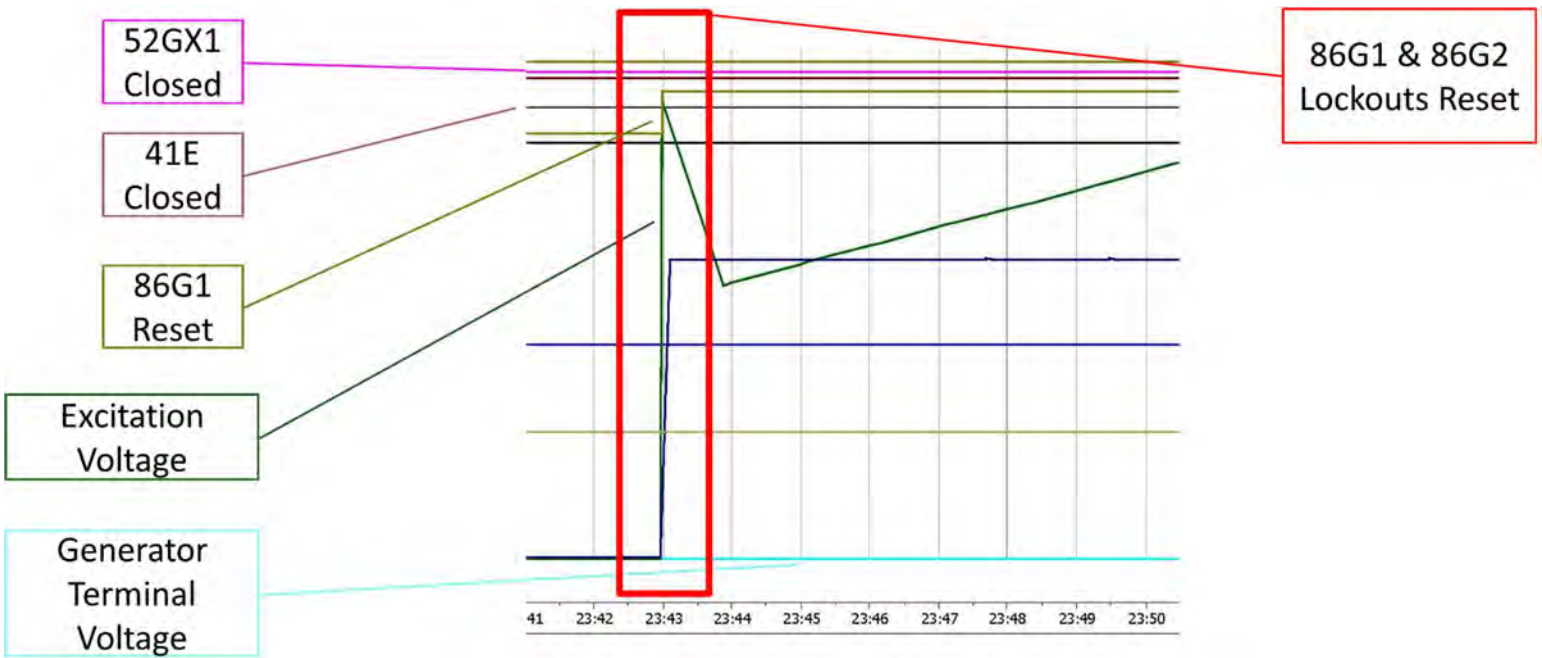
When the 86G1 and 86G2 Lockouts were manually reset at 11:43pm Sunday evening, the conditions for the AVR to send excitation voltage to the field were met, the 5A Breaker for the Excitation transformer was closed, the 41E Breaker was closed, and there was demand for current based on indication the 52G Breaker was closed, and the exciter controls thought the generator was connected to the power grid. The AVR increased excitation voltage to produce terminal voltage. As the excitation voltage climbed, the insulation between the copper conductors began to breakdown, destabilizing the current through the conductors. This was recorded by the 64F1 and 64F2 Relays as they indicated a fault to ground in the field. As the current increased, the temperature of the copper material increased until melting occurred. Finally, the 86ET Lockout tripped when it detected abnormal conditions in the excitation transformer, sending a signal to open the 5A Breaker which stopped the electrical flow through the 41E Breaker to the field.

Figure 19, Trend data when 86G1 and 86G2 Lockout Relays were reset.

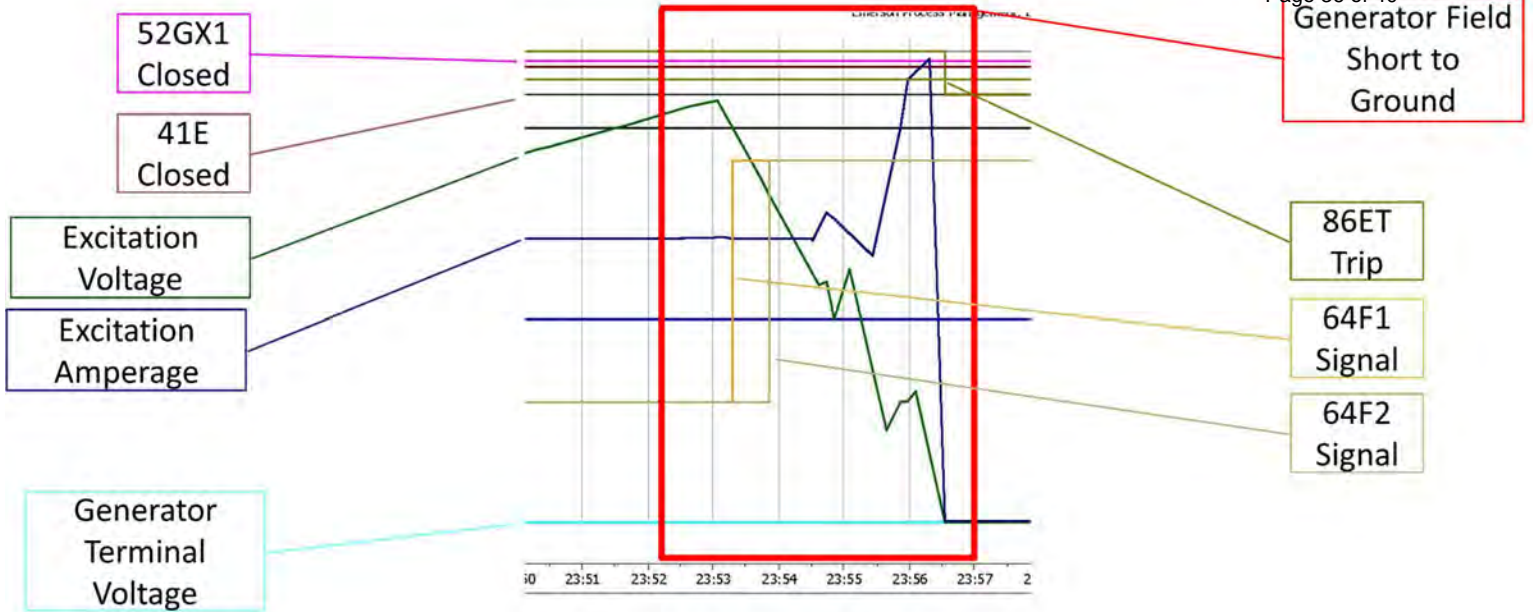
Figure 20, Trend data showing insulation failure, 64F1, 64F2 and 86ET trips.

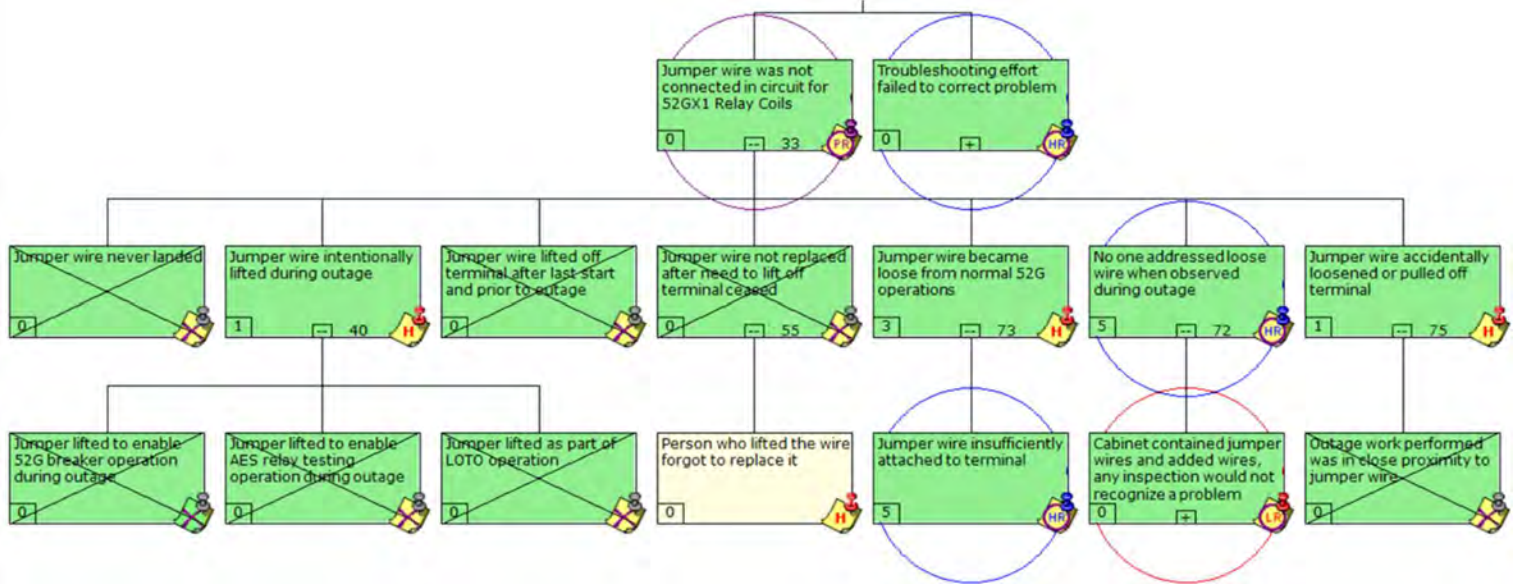
Hypotheses for jumper wire becoming disconnected.
