Supplemental Report

REFERENCE: US Steel – No. 2 Control Room Deluge Piping Evaluation
Insured: US Steel
Location of Incident: Clairton, Pennsylvania
Date of Incident: December 24, 2018
Sedgwick File Number: PGH19110240
EDT File Number: HFD6062-85199

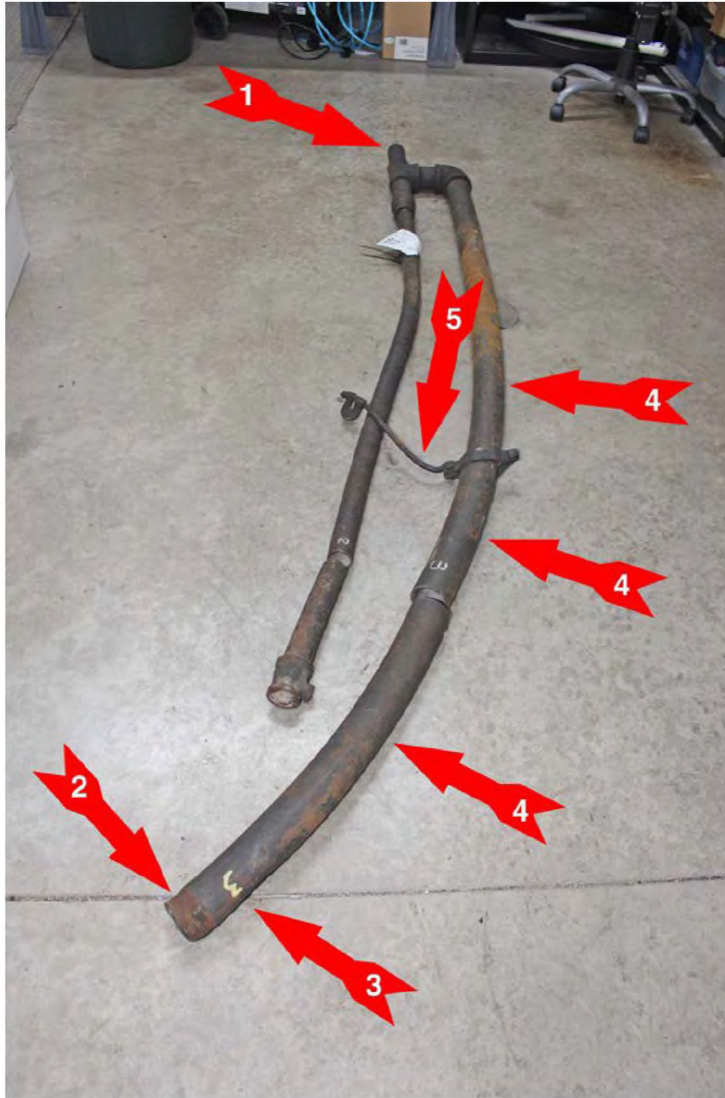
Figure 1	Pipe Section "C"
Arrow 1	Pipe Section "B" attachment point
Arrow 2	Pipe Section "D" attachment point
Arrow 3	Impact location
Arrows 4	Deformation due to heat
Arrow 5	Deformation of hanger due to heat

18. Pipe Section “C” is shown in Figure 1, with the intended attachment points for Pipe Section “B” and “D” identified by Arrow 1 and 2, respectively. The location of impact, between the threaded end of the 2½ inch header and the centrifuge is identified by Arrow 3. The deformation experienced by the header, identified by Arrows 4, took place after the pipe at fallen, due to the temperatures associated with the fire at C-521. Similar deformation had been experienced by the C-Clamp hanger still attached to the header, identified by Arrow 5. Note that the header had been cut, and the elbow to header joint disconnected (by US Steel Research) in order to facilitate shipment of the deluge pipes to EDT.

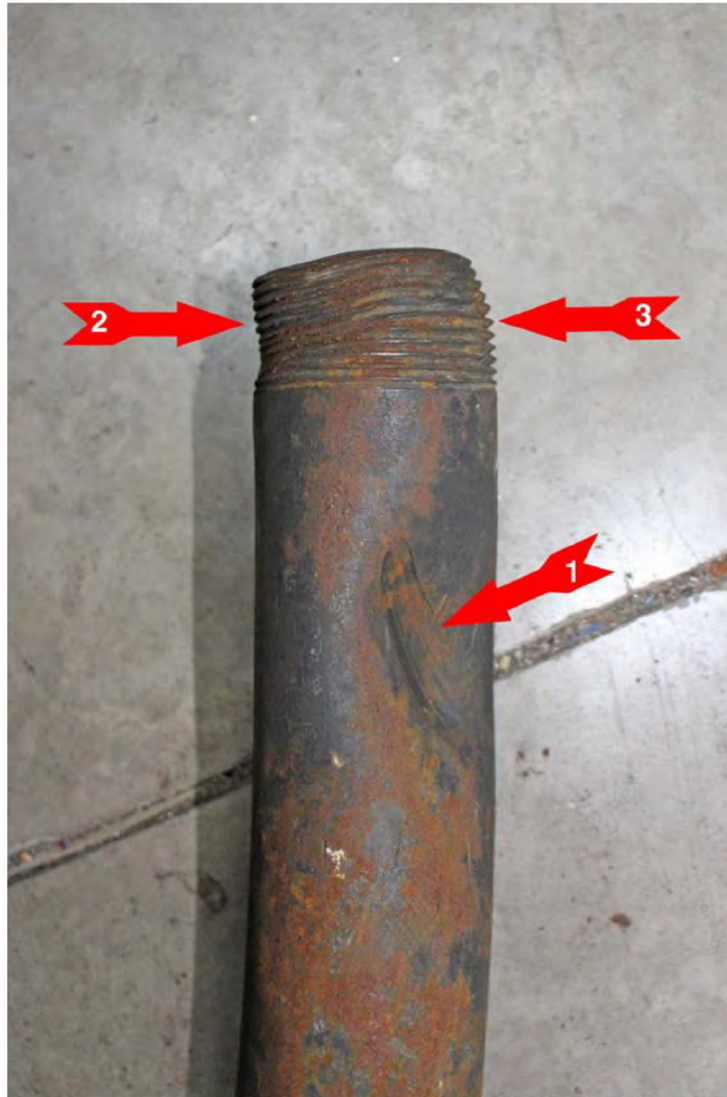
Figure 2	Threaded end of header
Arrow 1	Impact location
Arrow 2	Compressive bending at threads
Arrow 3	Tensile bending at threads

19. The threaded end of the header, intended to be attached to Pipe Section “D”, is shown in Figure 2, with the impact location identified by Arrow 1. The deformation experienced by the threads, identified by Arrow 2 (compressive bending) and Arrow 3 (tensile bending), indicates the orientation of the header at the time that the header fell: The location that had experienced the compressive bending (Arrow 2) is on the bottom of the pipe (facing the floor). Likewise, the location that had experienced the tensile bending (Arrow 3) is on the top of the pipe (facing the ceiling). As the header fell, while still attached to Pipe Section “D”, compressive bending took place on the bottom half of the header, resulting in the observed deformation at the threads. At some point, the bending deformation at the threads became sufficient to result in separation between header and Pipe Section “D”. Given the observed deformation to the threaded end of the header, the location of the impact is approximately near the top side of the header.

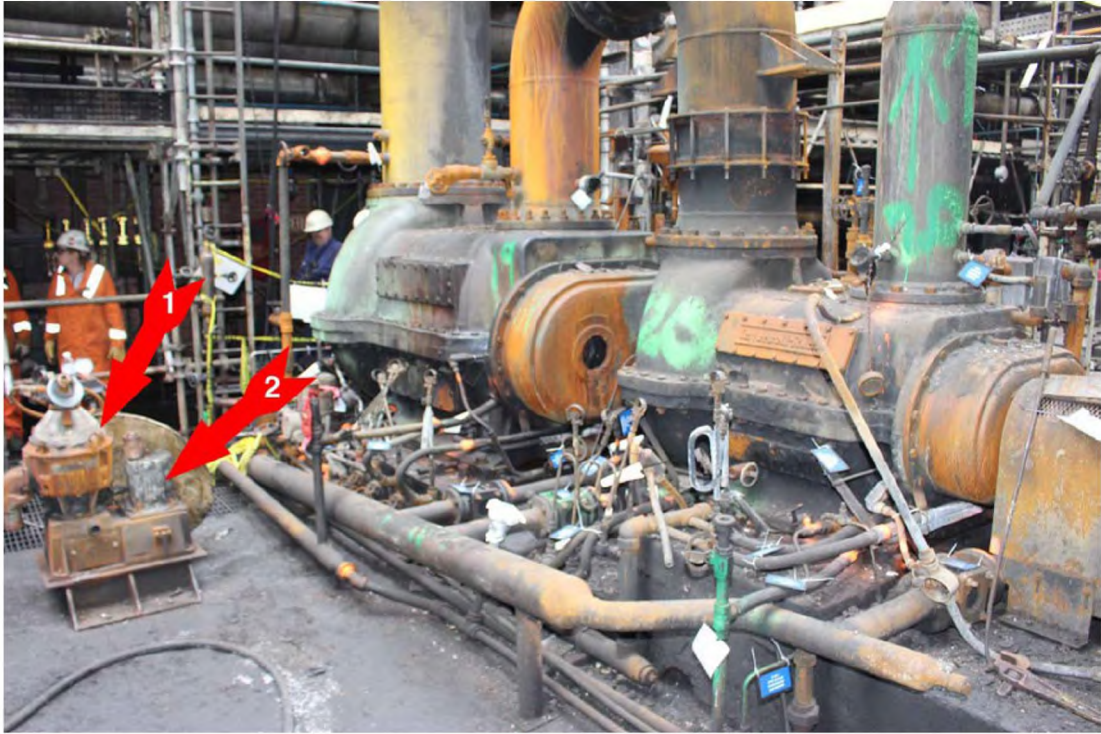
Figure 3 Centrifuge near C-521

20. Post incident photographs of Pipe Section “C” indicate that the threaded end of the header (intended to be attached to Pipe Section “D”) came to rest near the centrifuge shown in Figure 3. The impact damage experienced at the threaded end of Pipe Section “C” is consistent with striking an eye bolt on the centrifuge, identified by Arrow 1, and/or a drive motor housing or other component, identified by Arrow 2.³

- Arrow 1 Eye bolt on centrifuge
- Arrow 2 Damage to centrifuge drive motor housing

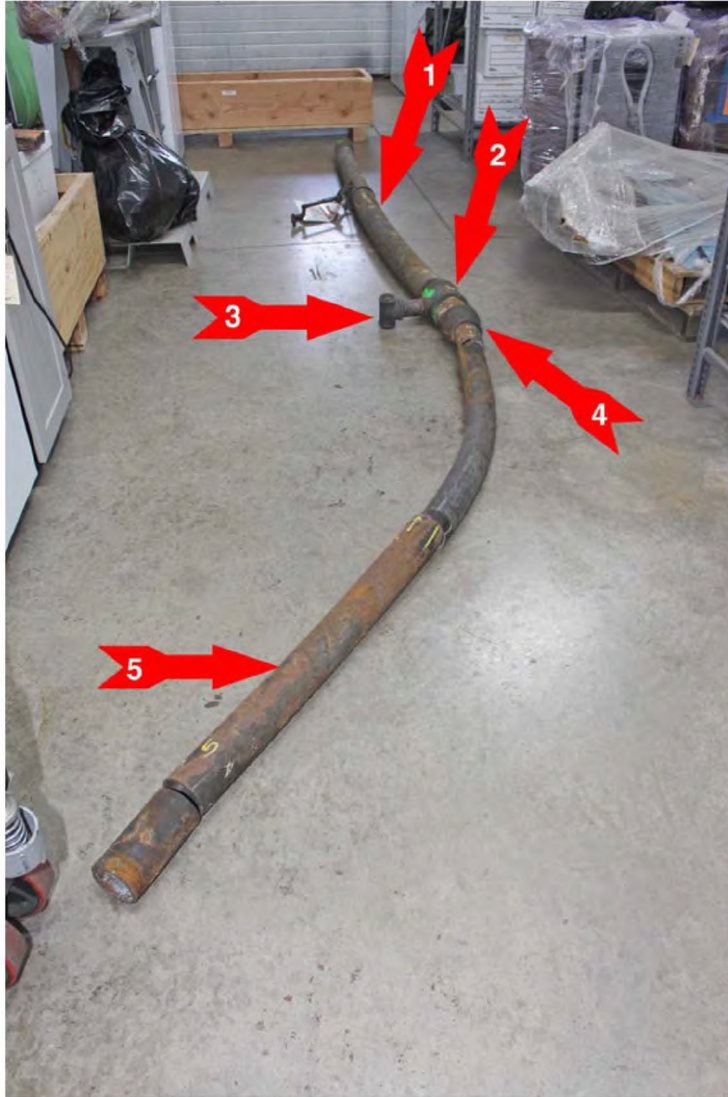
Figure 4 Pipe Section "E"

21. Pipe Section “E” is shown in Figure 4, with Arrow 1 and 2 identifying the 4-inch pipe and 4”x2”x4” reducing tee. The 1½”x2”x1½” reducing tee, used to transition the piping to the laterals, is identified by Arrow 3. The reducing fitting used to transition from the 4 inches

to 3-inch piping is identified by Arrow 4, with the 3-inch piping identified by Arrow 5. The 3-inch piping had experienced deformation due to the heat associated with the fire, after falling. Note that the 4-inch pipe had been detached at the reducing tee, and the 3-inch pipe cut to facilitate shipment to EDT.

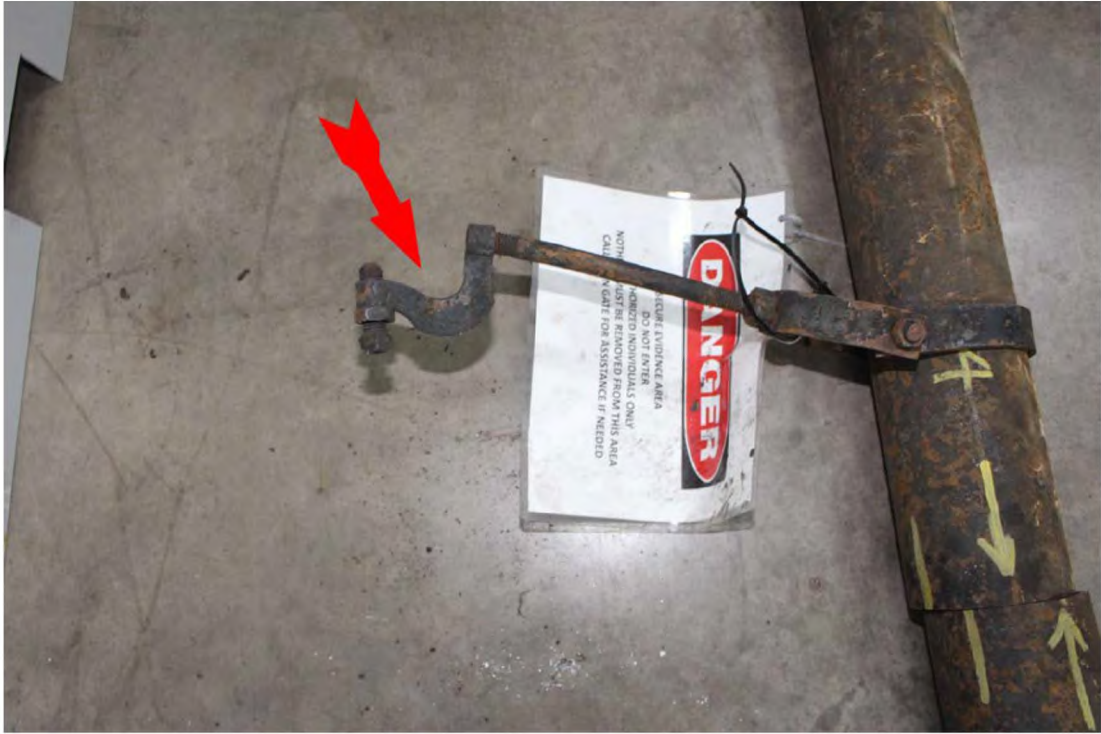
22. The C-Clamp type hanger (the hanger) used to suspend Pipe Section “E” is shown in Figure 5, having experienced an overload, similar to the overload experienced by Pipe Section “D”.

Figure 5 Overload deformation to hanger – Pipe Section “E”

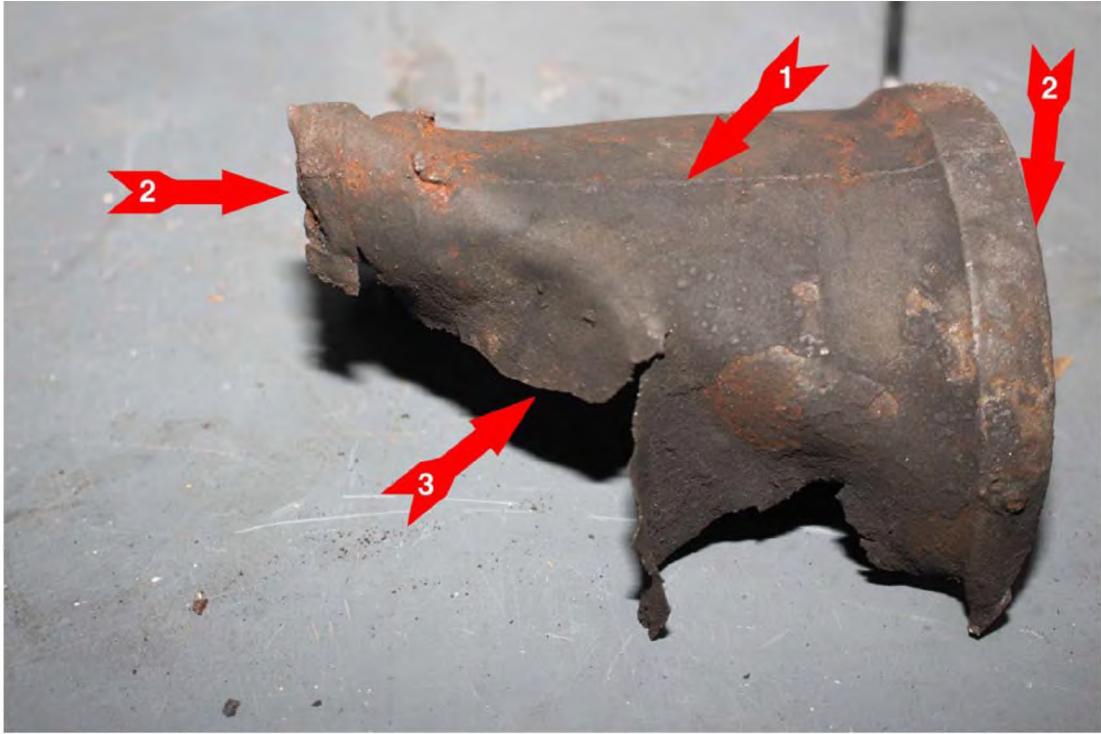
Figure 6 Corroded 4"x2"x4" Reducing Tee

23. The corroded 4”x2”x4” reducing tee is shown in Figure 6 through 11. A view of the bottom of the reducing tee is shown in Figure 6, with the underside (6 o’clock position) identified by Arrow 1, and the 4-inch inlet and outlet identified by Arrows 2. The reducing tee had experienced through wall corrosion and ductile tearing, identified by Arrow 3.

| Arrow 3 | Through-wall corrosion and ductile tearing |

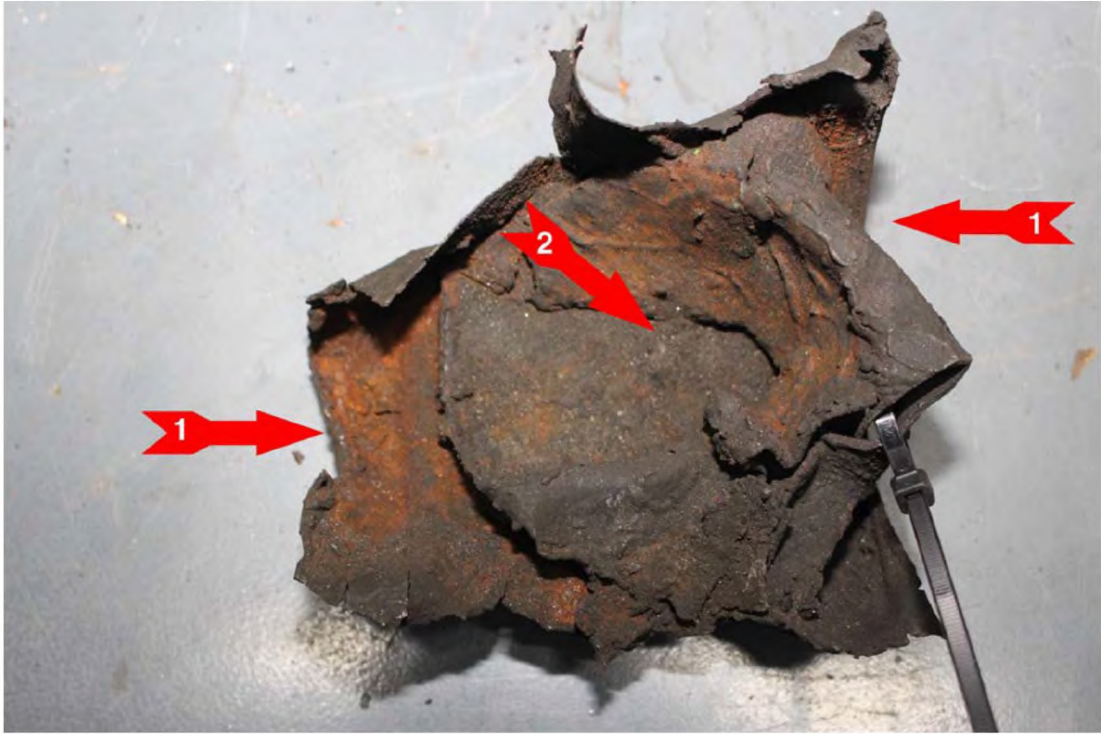
Figure 7 Corroded 4"x2"x4" Reducing Tee

24. The top side (2-inch branch) of the reducing tee is shown in Figure 7, with the 4-inch inlet and outlet identified by Arrows 1. The approximate location of the corroded and crushed portion of the 2-inch branch is identified by Arrow 2. The corrosion experienced by the top portion of the reducing tee is best described as extensive, with very little metal remaining.

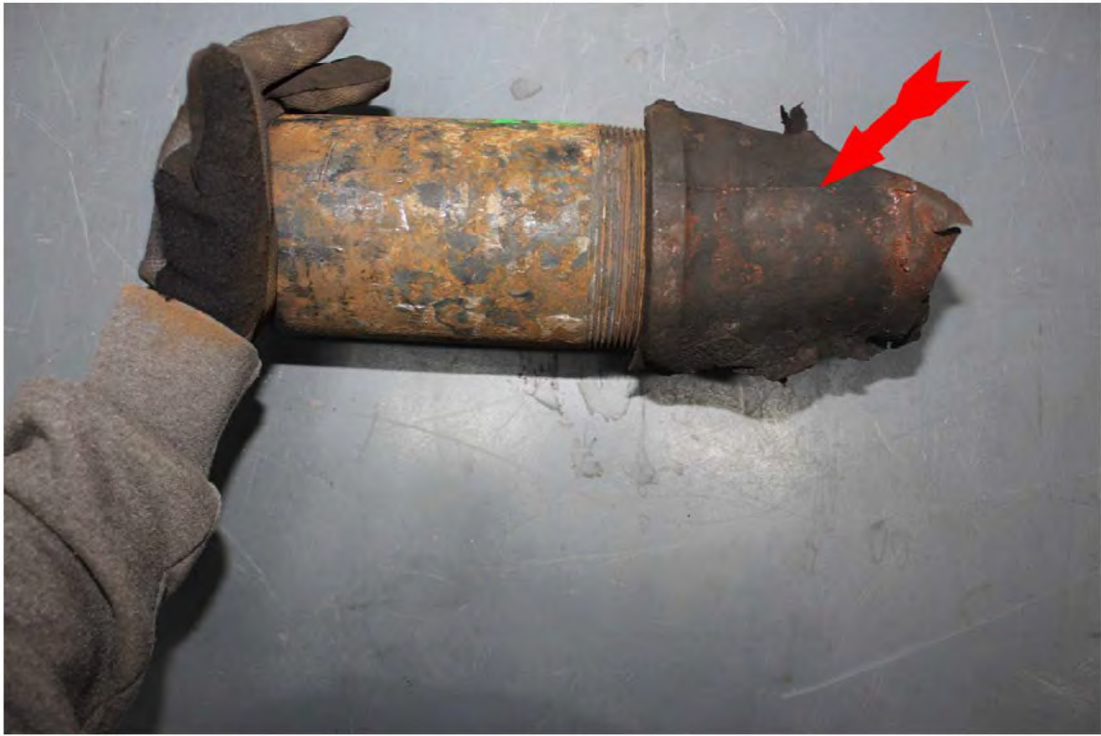
25. Figure 8 shows the corroded reducing tee joined to a threaded portion of 4-inch pipe that comprised Pipe Section “E”, confirming the inlet and outlet size of the reducing tee to be 4 inches.

Figure 8 Corroded 4"x2"x4" Reducing Tee attached to 4-inch threaded pipe

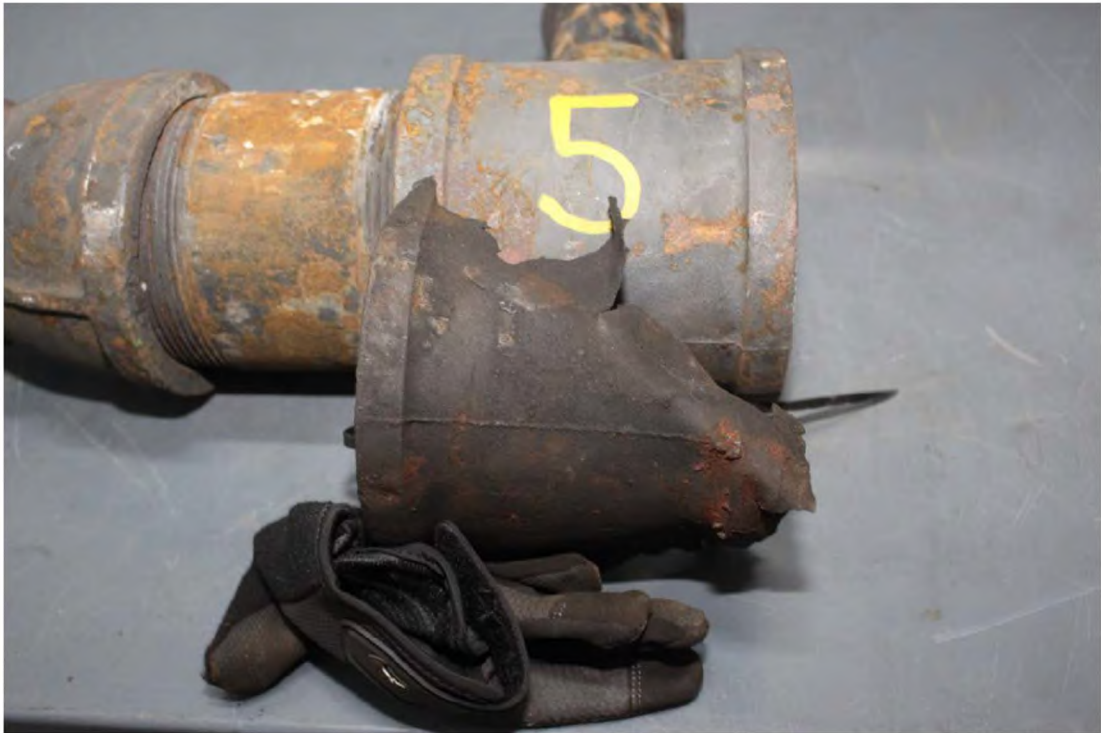
26. The corroded reducing tee was placed next to the 4”x2”x4” reducing tee comprising Pipe Section “E” as shown in Figure 9, further confirming that the corroded reducing tee is a 4”x2”x4” reducing tee, intended to be attached to the north end of Pipe Section “E”.

Figure 9 Corroded 4"x2"x4" Reducing Tee placed next to 4"x2"x4" reducing tee comprising Pipe Section "E"

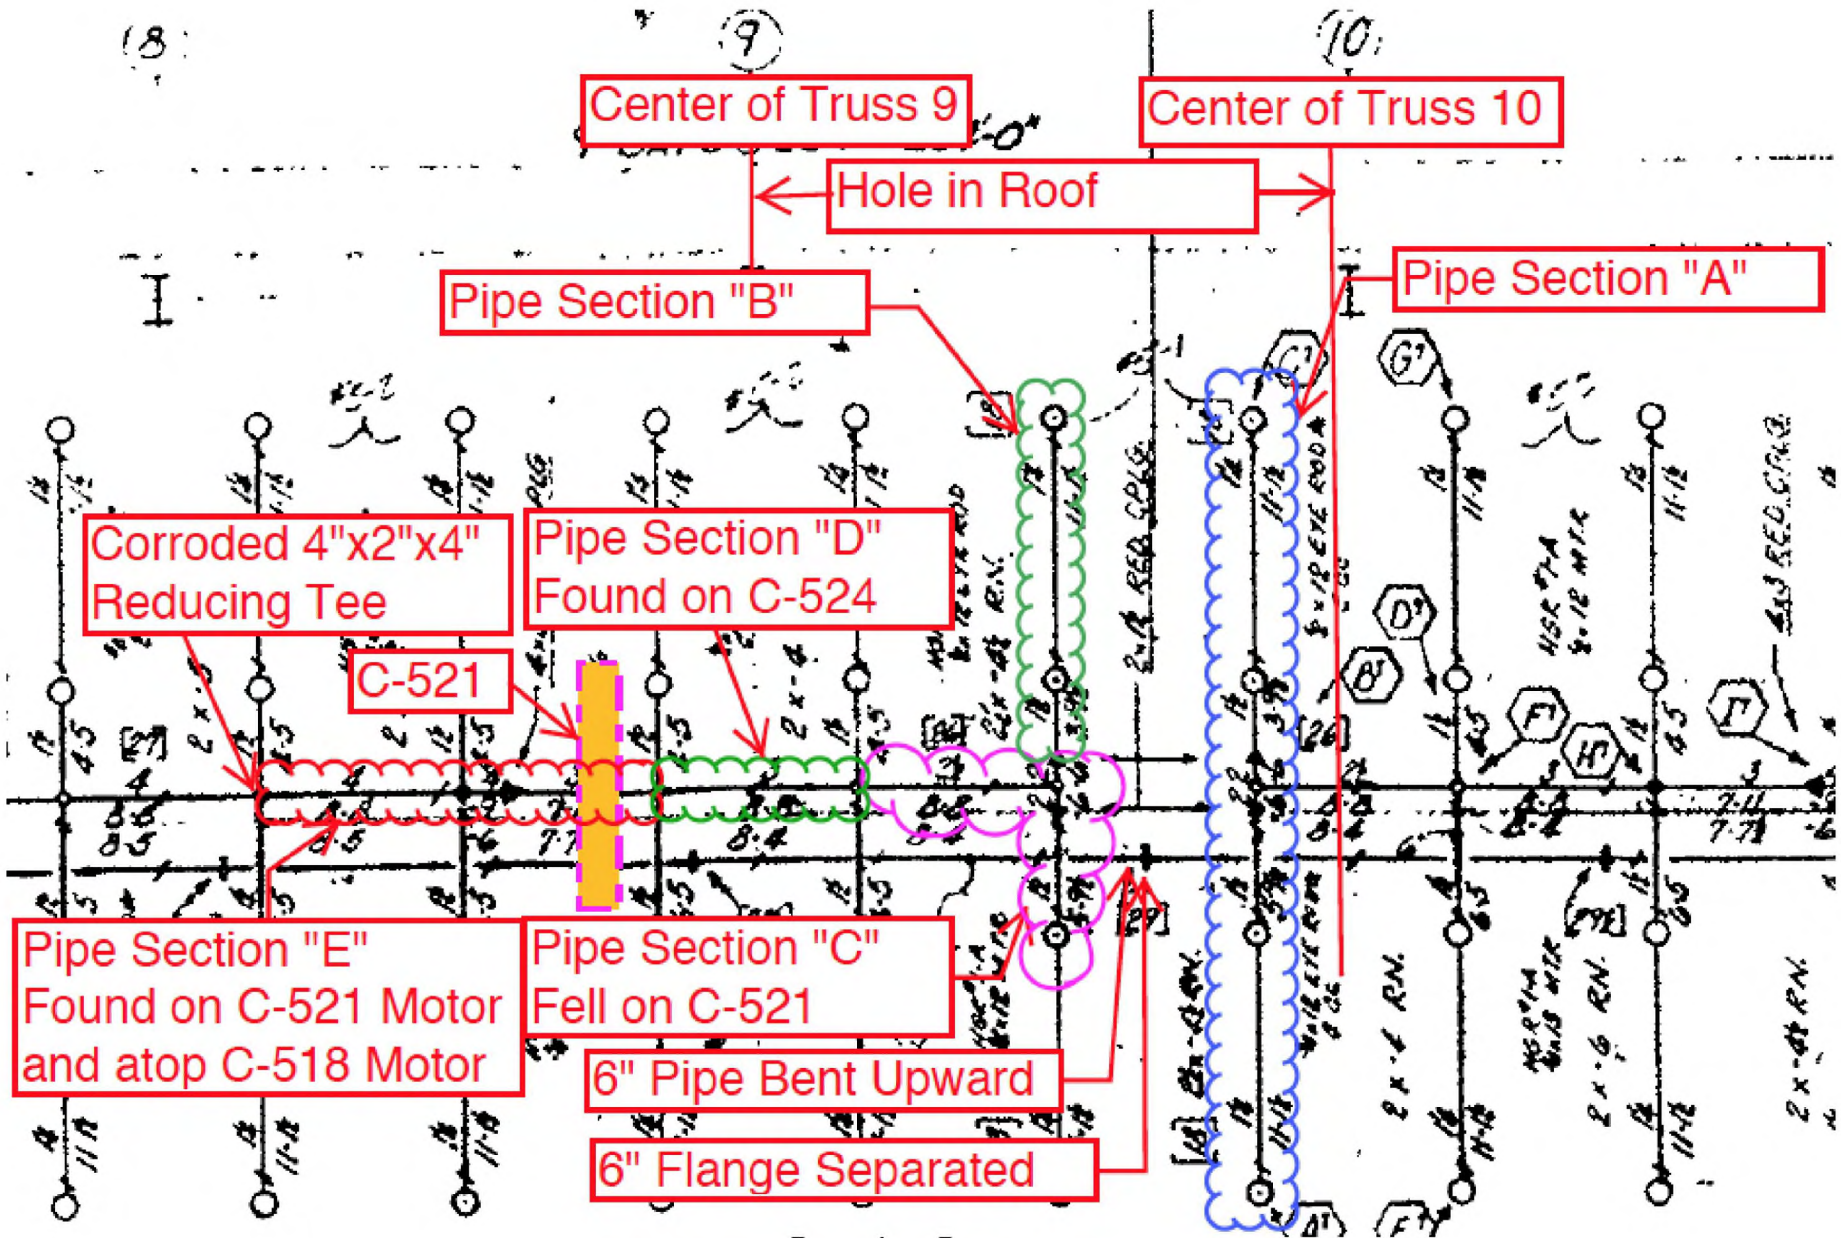
1. The drawing in Appendix I shows the portion of the deluge system piping above, and in the vicinity of C-521 and C-524, as viewed from above the No. 2 Control Room ceiling. A number of piping sections shown on the drawing are identified to provide a frame of reference, relative to the photographs. The drawing is referenced again in Section E of this report with regard to the sequence of piping detachment.

2. The deluge system above the vacuum machines is divided into a north and south section. Pipe Section “A” (blue color bubble), located just north of Truss 10, is an east-west lateral that is attached to the north end of the south section of the deluge system. Pipe Sections “B” and “C” (green and purple color bubble, respectively) were attached to the south end of the north section of the deluge system. The north section is supplied with water by a 6-inch pipe that originates at a control valve station, located at the far south end of No. 2 Control Room. The 6-inch pipe is connected by a series of flanges, one of which had separated at the time of the incident (identified as *6” Flange Separated* on drawing). The north end of the 6-inch pipe that had been connected to the 6-inch flange had bent upward at the time of the incident.

6. A 4"x2"x4" reducing tee that had experienced severe thinning, due to corrosion, (identified as corroded 4"x2"x4" reducing tee on the drawing) was found near C-521. Given the configuration of the deluge piping shown on the installation drawing, all indications are that the 4"x2"x4" reducing tee was attached to the north end of Pipe Section "E".
7. A portion of the roof for No. 2 Control Room had experienced a collapse between support Truss 9 and 10 (identified on the drawing as Hole in Roof).

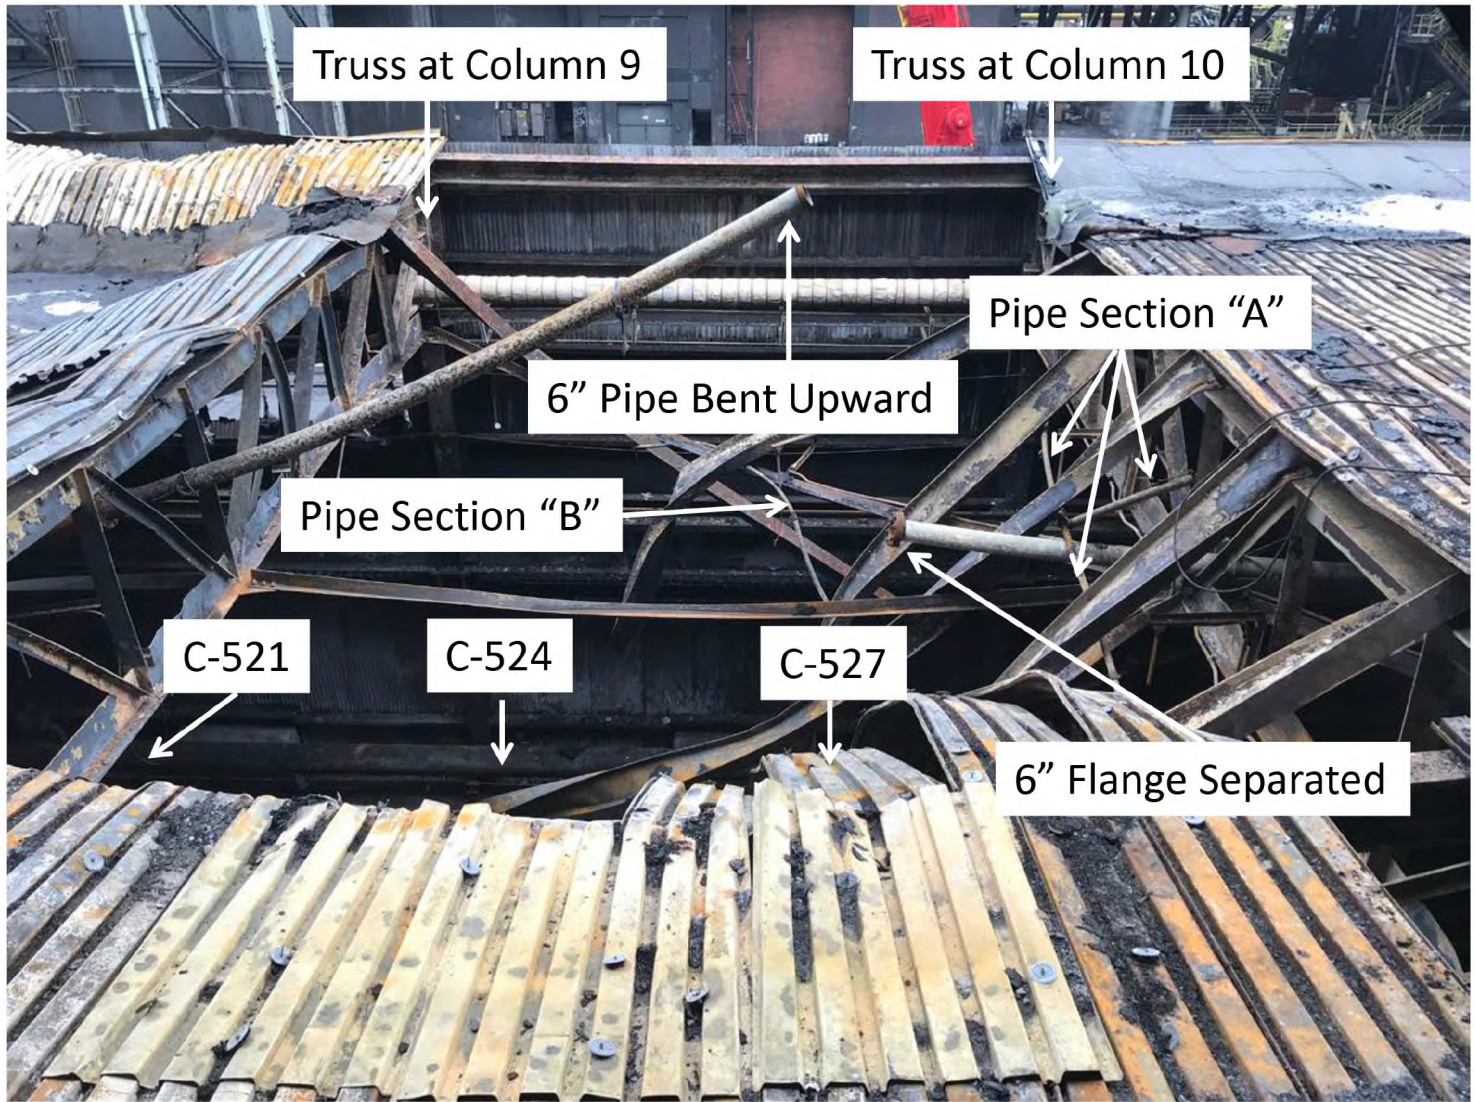
8. Photograph 1 shows a portion of the roof for No. 2 Control Room, located south of C-521, that had experienced collapse between the trusses for column 9 and 10. Vacuum machines C-524 and C-527 are located beneath the portion of the roof that had experienced the collapse. For reference, the north-most east-west lateral for the south section of the deluge system, is identified as Pipe Section "A". Further reference points to the deluge system drawing are identified by Pipe Section "B", which remained suspended after Pipe Section "C" had detached and fell on C-521, and the separated 6-inch pipe (6" Pipe Bent Upward/6" Flange Separated). The separation and deformation experienced by the 6-inch pipe is the result of the high temperatures associated with the fire.

Photograph 1 – Roof Collapse Near C-521

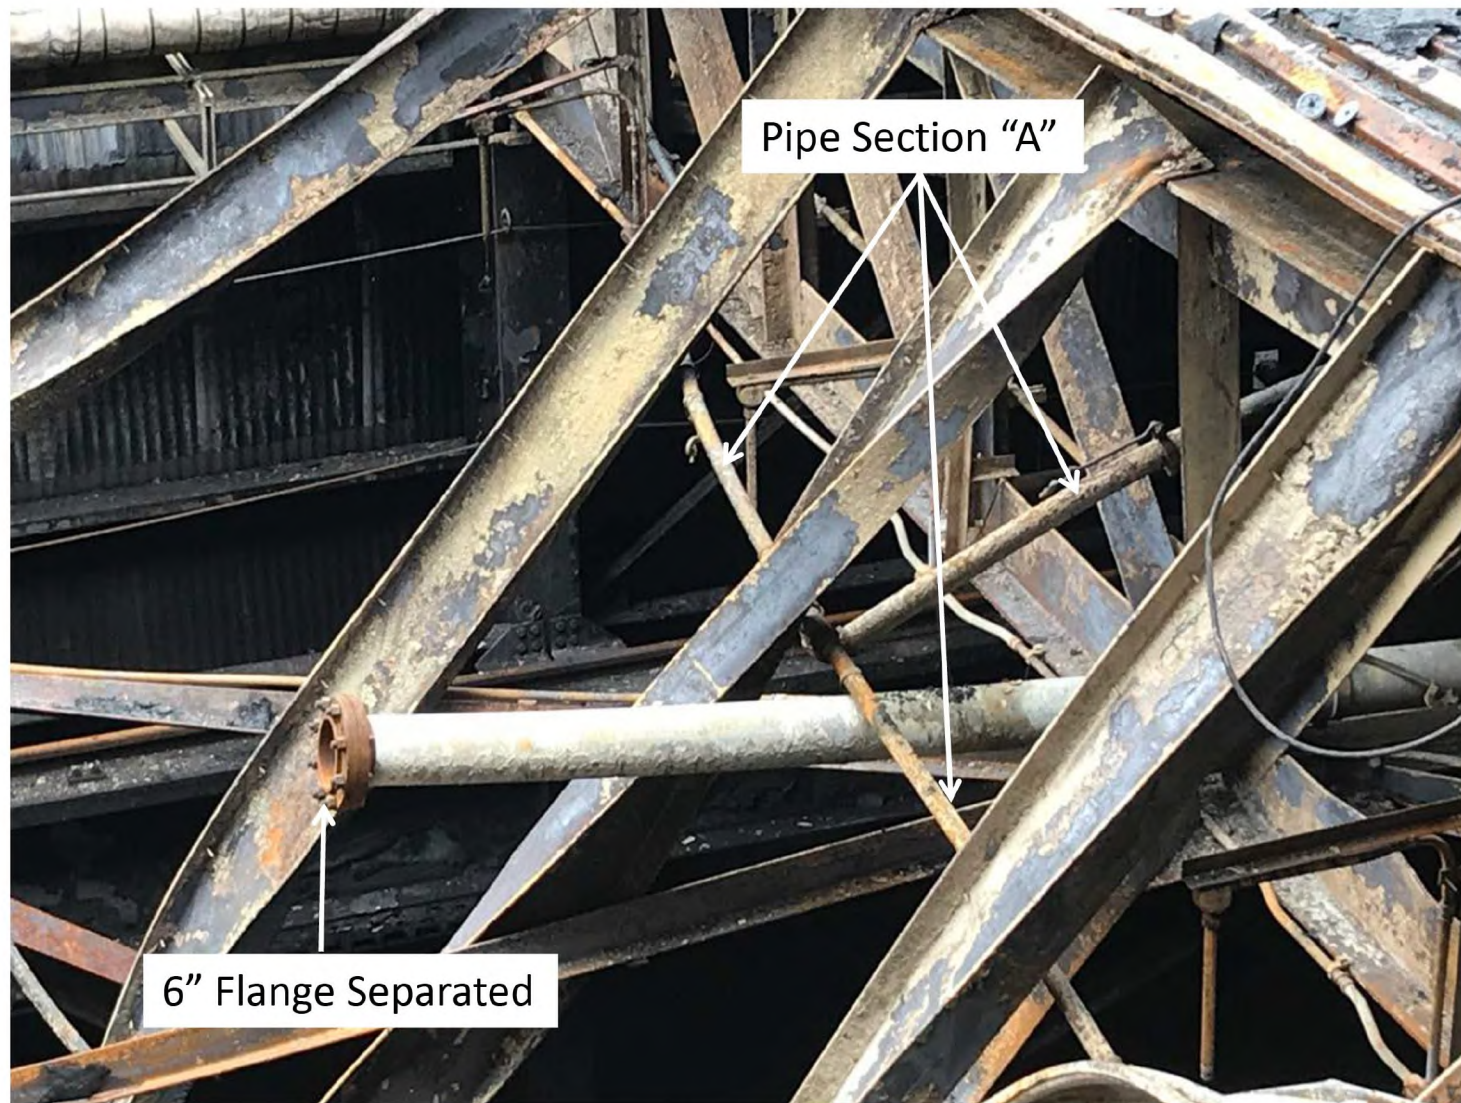
Photograph 2 – Pipe Section "A"

9. A closer view of Pipe Section "A" and the 6" separated flange is shown in Photograph 2. Note the deformation experienced by Pipe Section "A", indicative of high temperatures associated with the fire. Separation of the pipe at the 6-inch flange took place at the threaded joint between the pipe and flange due to high strains associated with the upward deformation of the north end of the 6-inch pipe.

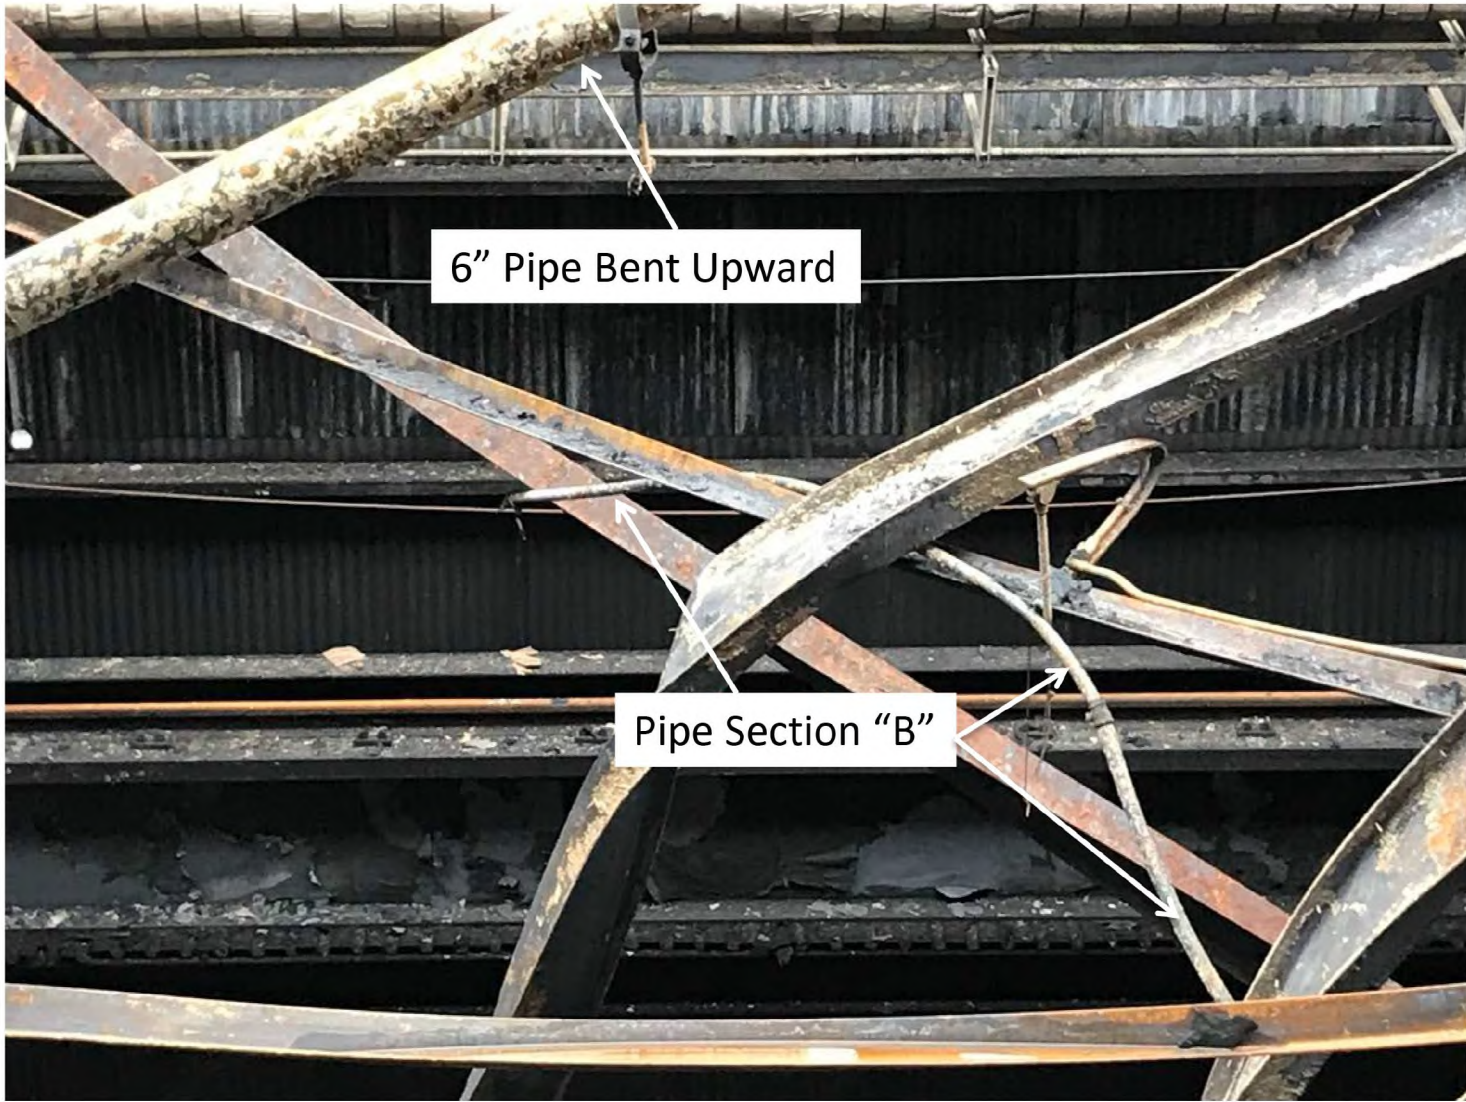
Photograph 3 – Pipe Section “B”

10. Photograph 3 shows a closer view of Pipe Section "B", having experienced severe deformation consistent with exposure to high temperatures. Note the severe deformation experienced by the structural members that comprised the ceiling for No. 2 Control Room.

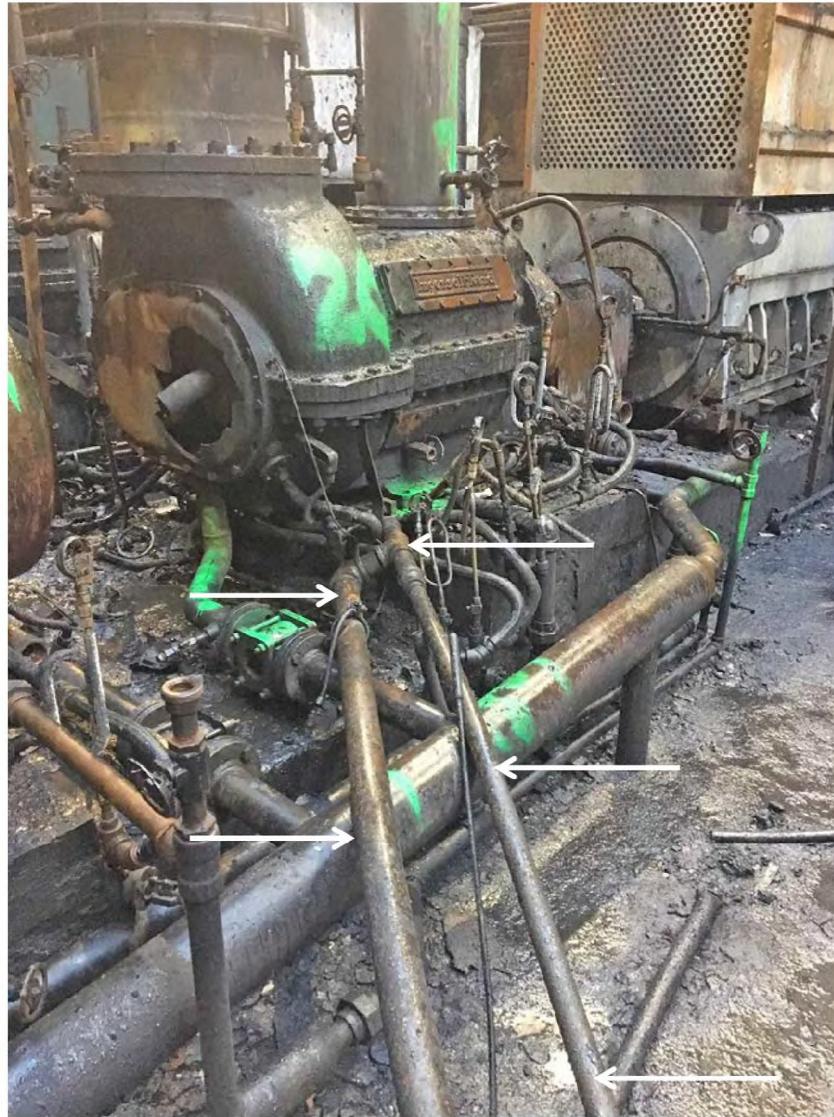
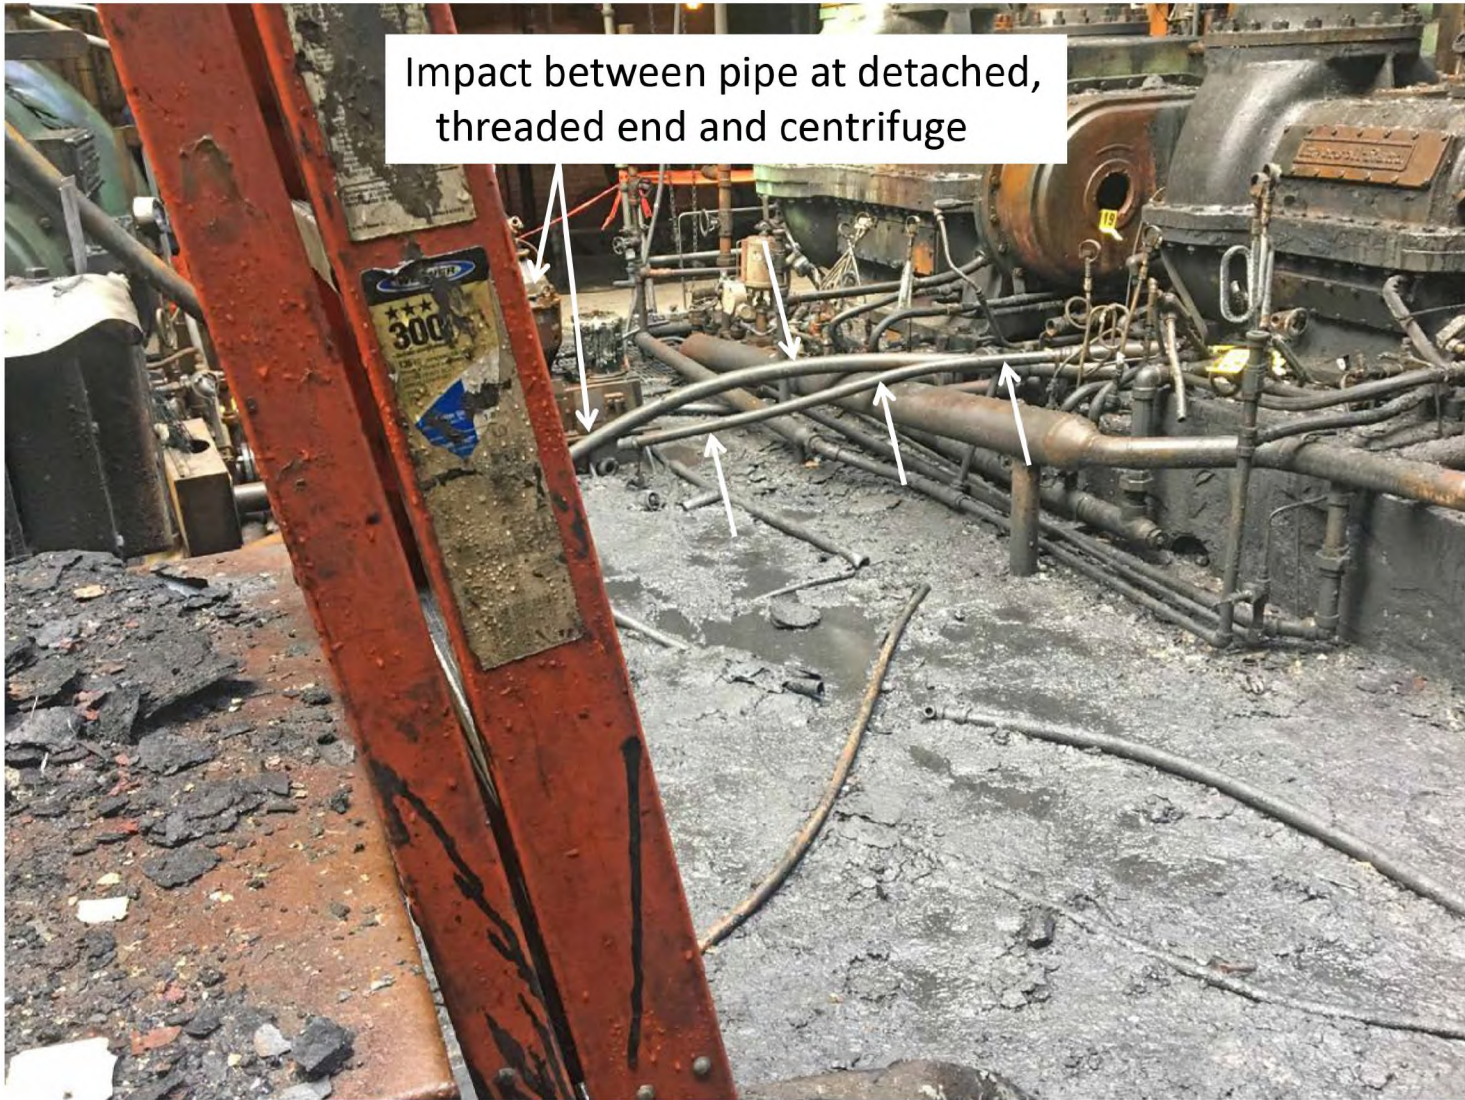
11. The detached Pipe Section "C", as found at C-521, is shown in Photographs 4 and 5. Later examination of the 2 1/2 inch header revealed an impact location near the detached threaded end, consistent with striking a piece of equipment known as a centrifuge, shown

in Photograph 5. Detailed photographs that confirm Pipe Section “C” had severed the lube oil pipe to C-521 are provided in the origin and cause report prepared by EDT.

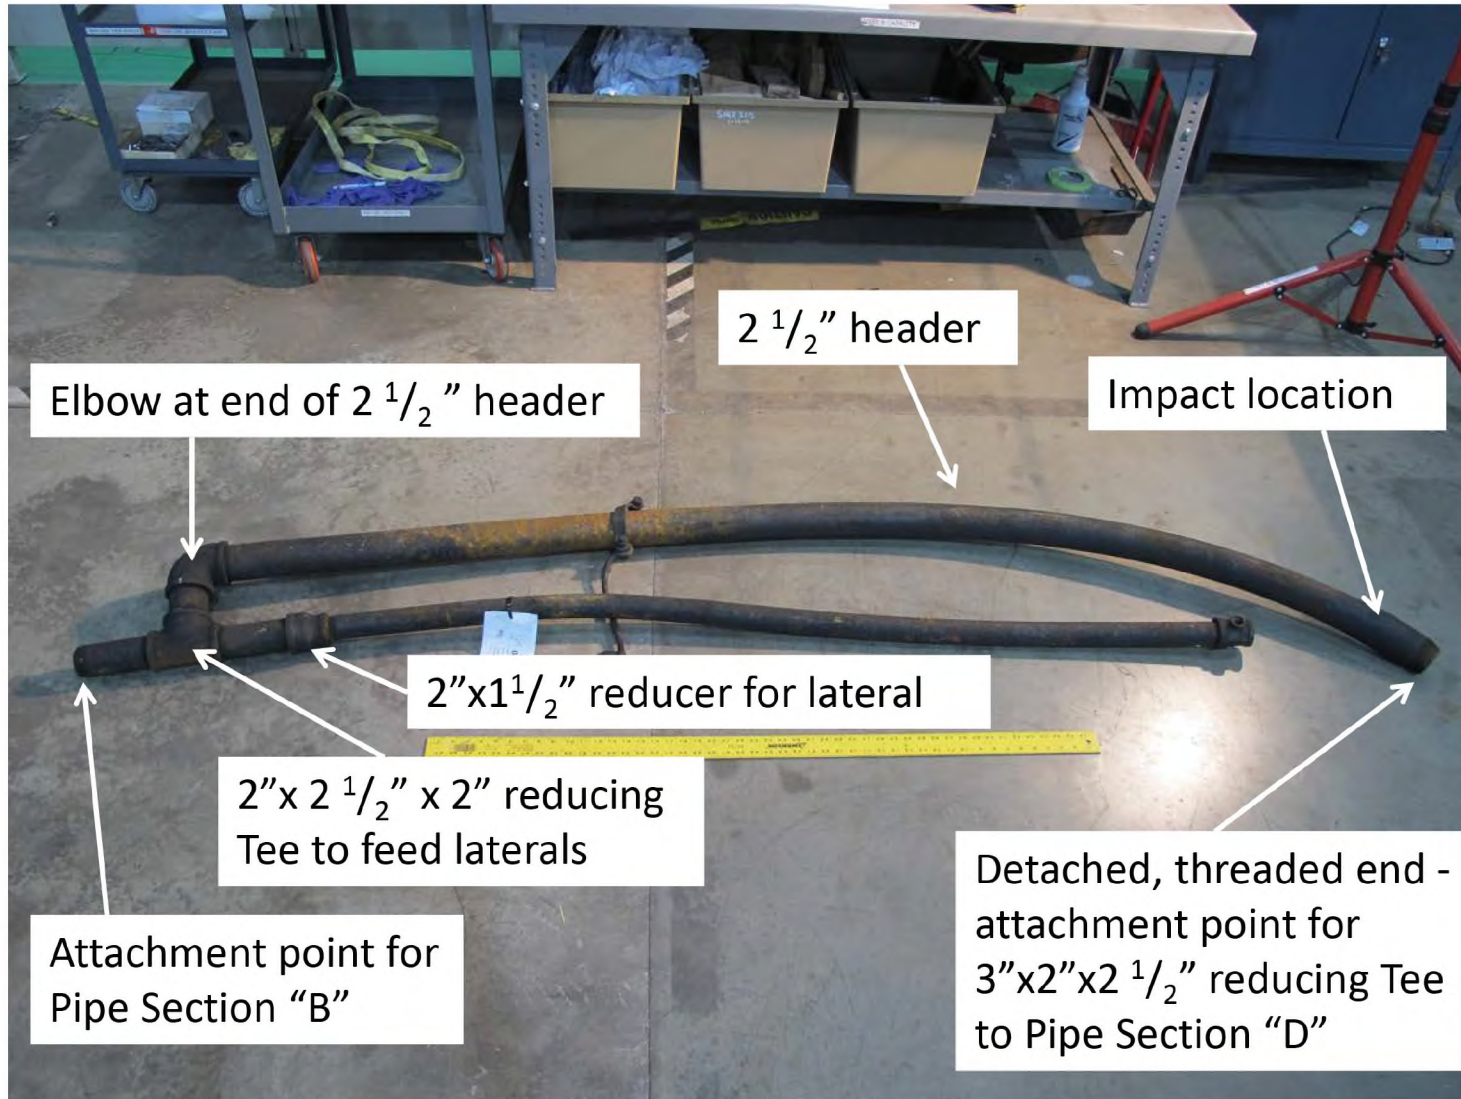
Photograph 6 - Pipe Section "C" – USS Research

12. Pipe Section “C” at USS Research is shown in Photograph 6, with the expected attachment locations identified for Pipe Section “B”, and the 3”x2”x2½” reducing tee for the transition from Pipe Section “D”. Pipe Section “C” is comprised of the 2½ inch header with an elbow attached at the end of the header, which transitions to the 2-inch east-west laterals using a 2”x2½”x2” reducing tee. A 2 inch by 1½ inch reducer is used to transition between the 2-inch pipe and the 1½ inch laterals. The location of the impact, discussed in the previous observation, is identified on the photograph.

Detached, threaded end - attachment point for 3"x2"x2 1/2" reducing Tee to Pipe Section "D"

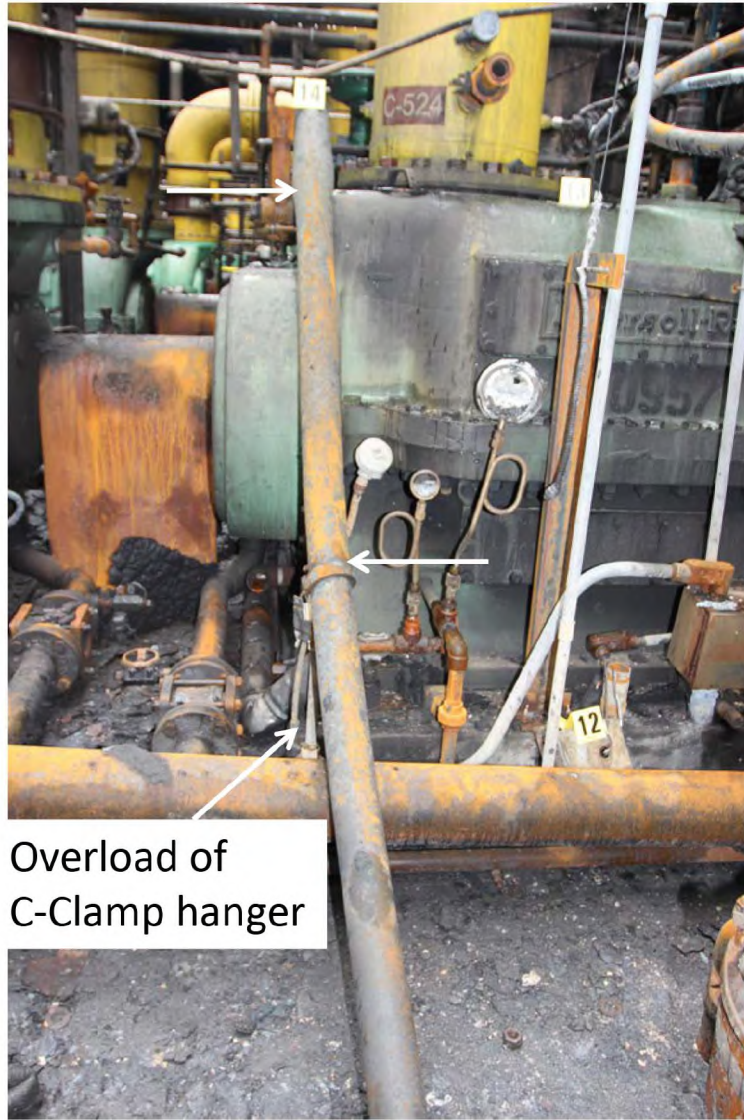
Photograph 7 - Pipe Section "D" – At C-524

13. Pipe Section “D” as found post incident, laying on the first stage of C-524, is shown in Photograph 7. A C-Clamp type hanger (the hanger), used to suspend the pipe from steelwork in the ceiling, had experienced an overload consistent with the application of a force greater than the design of the hanger.

Overload of
C-Clamp hanger
