Supplemental Report

REFERENCE: US Steel – No. 2 Control Room Deluge Piping Evaluation
Insured: US Steel
Location of Incident: Clairton, Pennsylvania
Date of Incident: December 24, 2018
Sedgwick File Number: PGH19110240
EDT File Number: HFD6062-85199

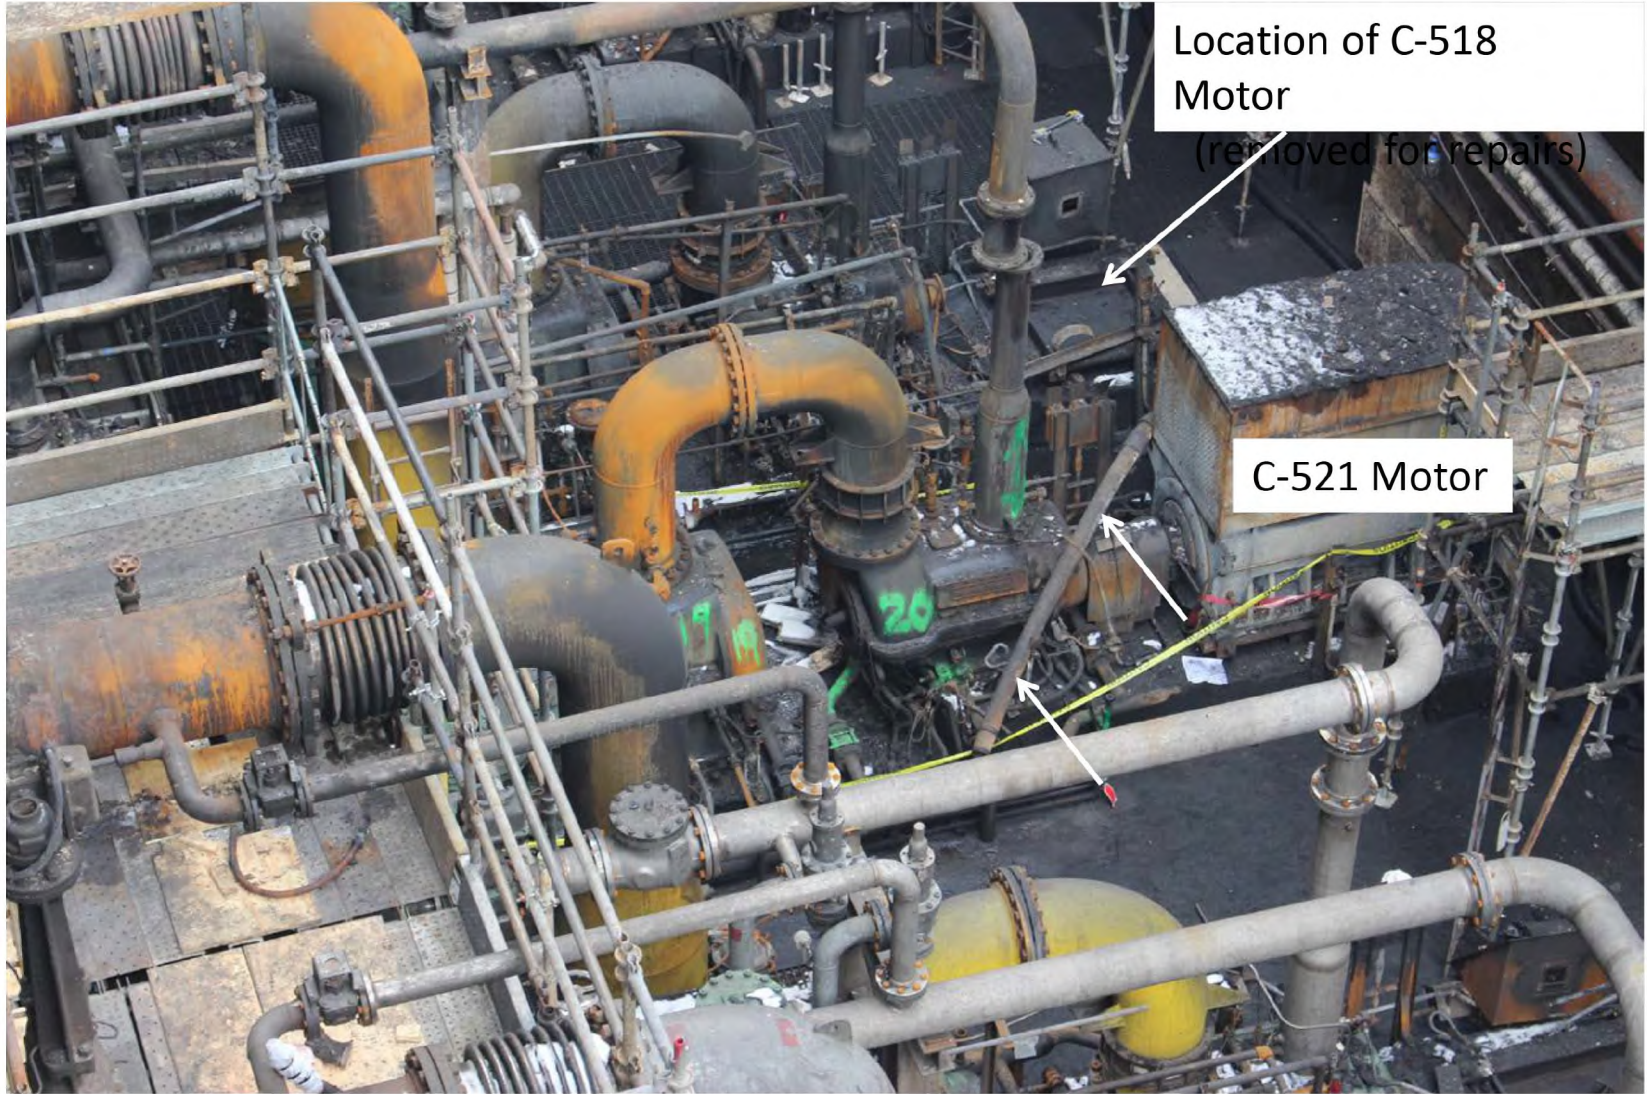
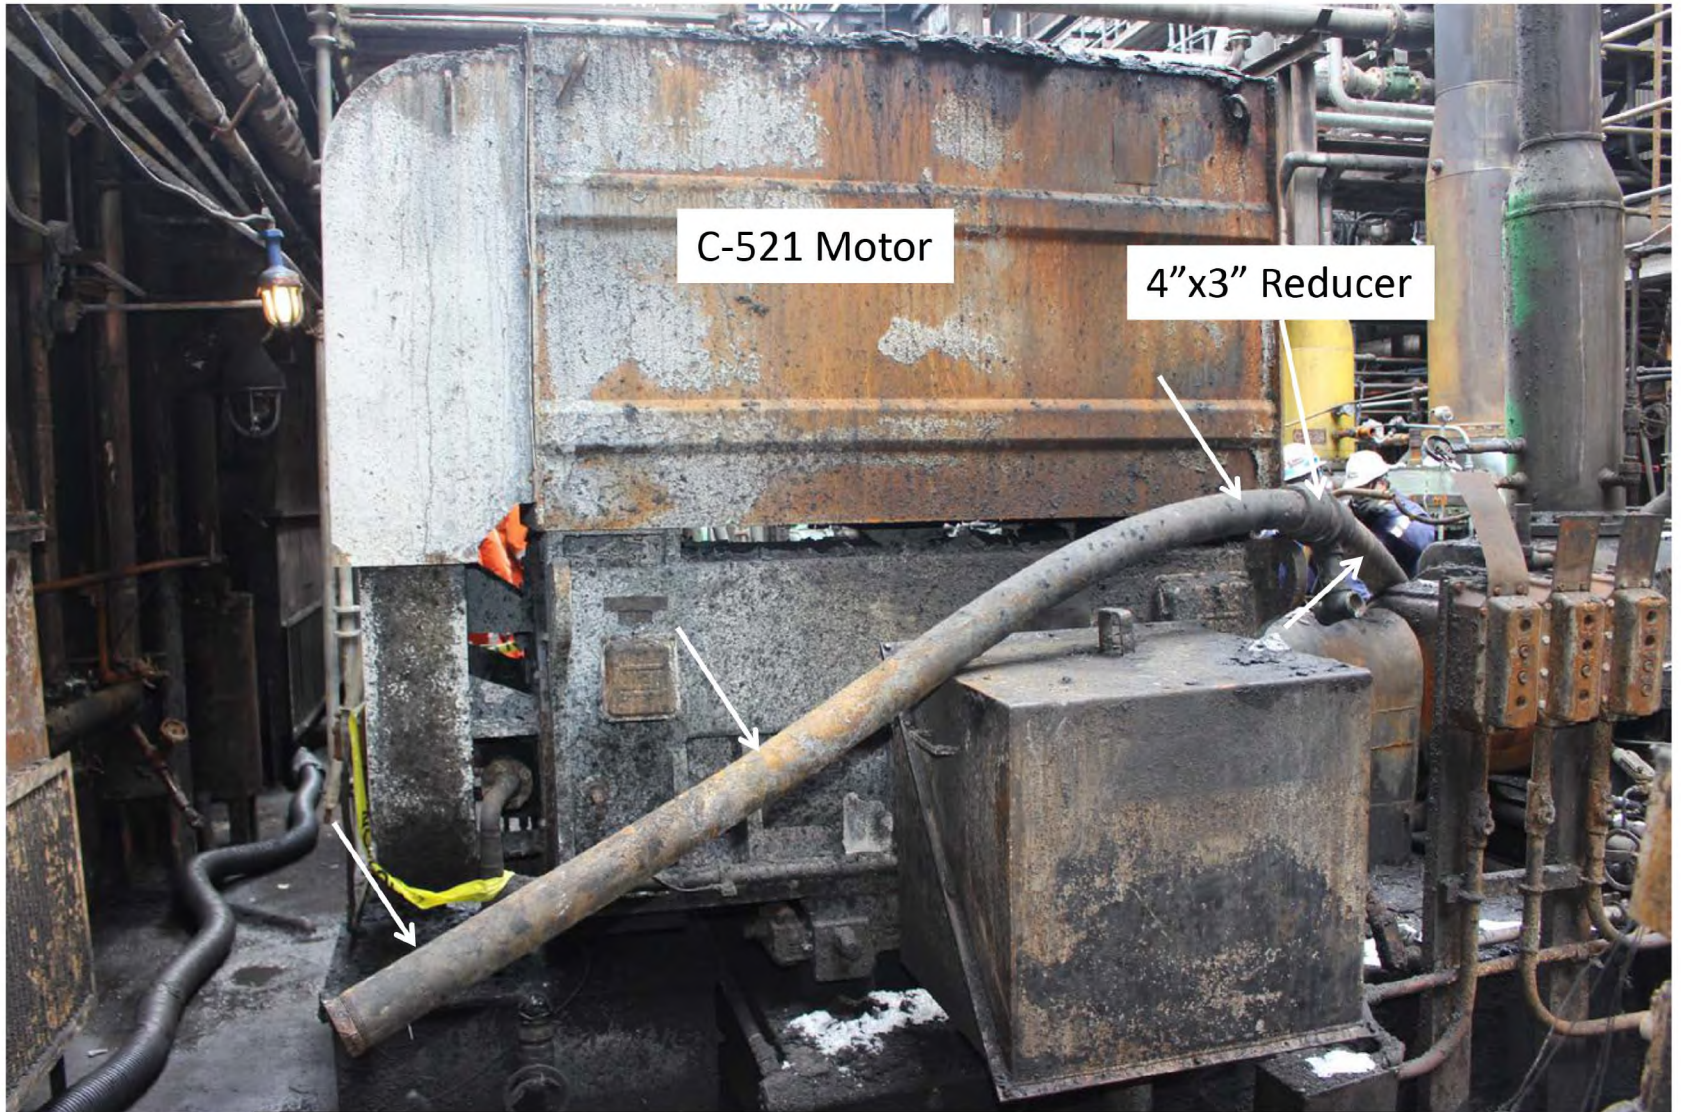
14. Photographs 8 and 9 show the position of Pipe Section “E”, as found during the site visit conducted by EDT, having been relocated between C-521 second stage and the drive motor. The pipe had been relocated in order to remove and repair the C-518 motor. In order to transport the pipe to USS Research, the portion of the pipe shown in Photograph 8 was detached from a 4 inch by 3-inch reducer fitting (4”x3” Reducer).

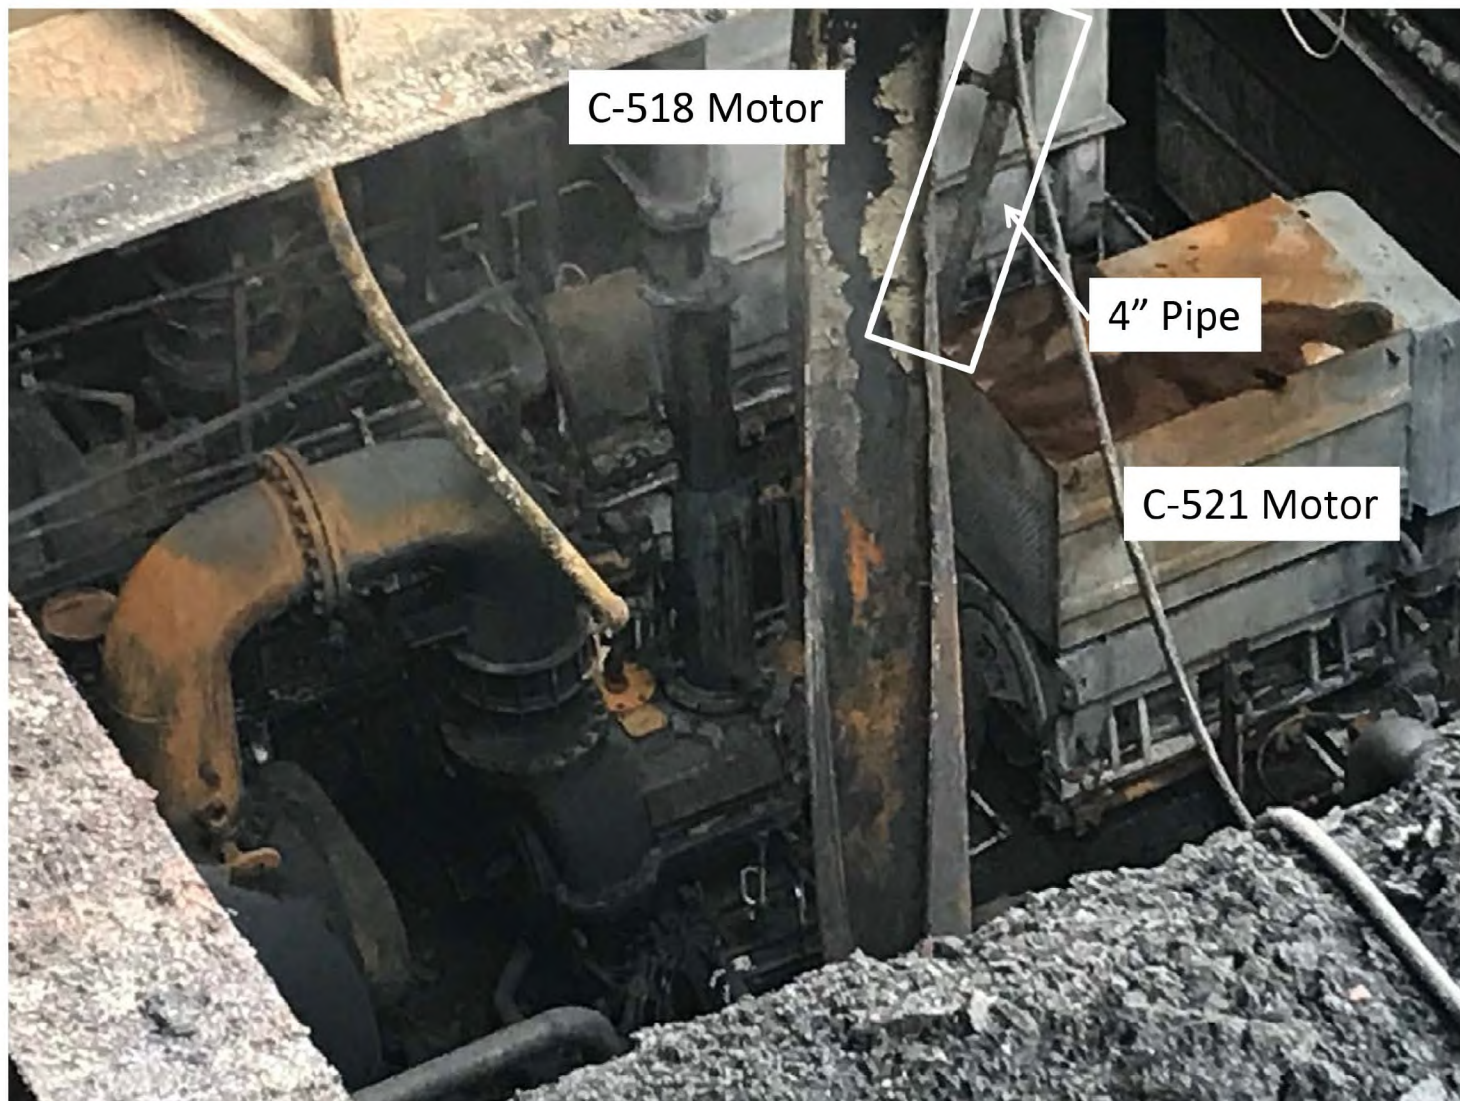
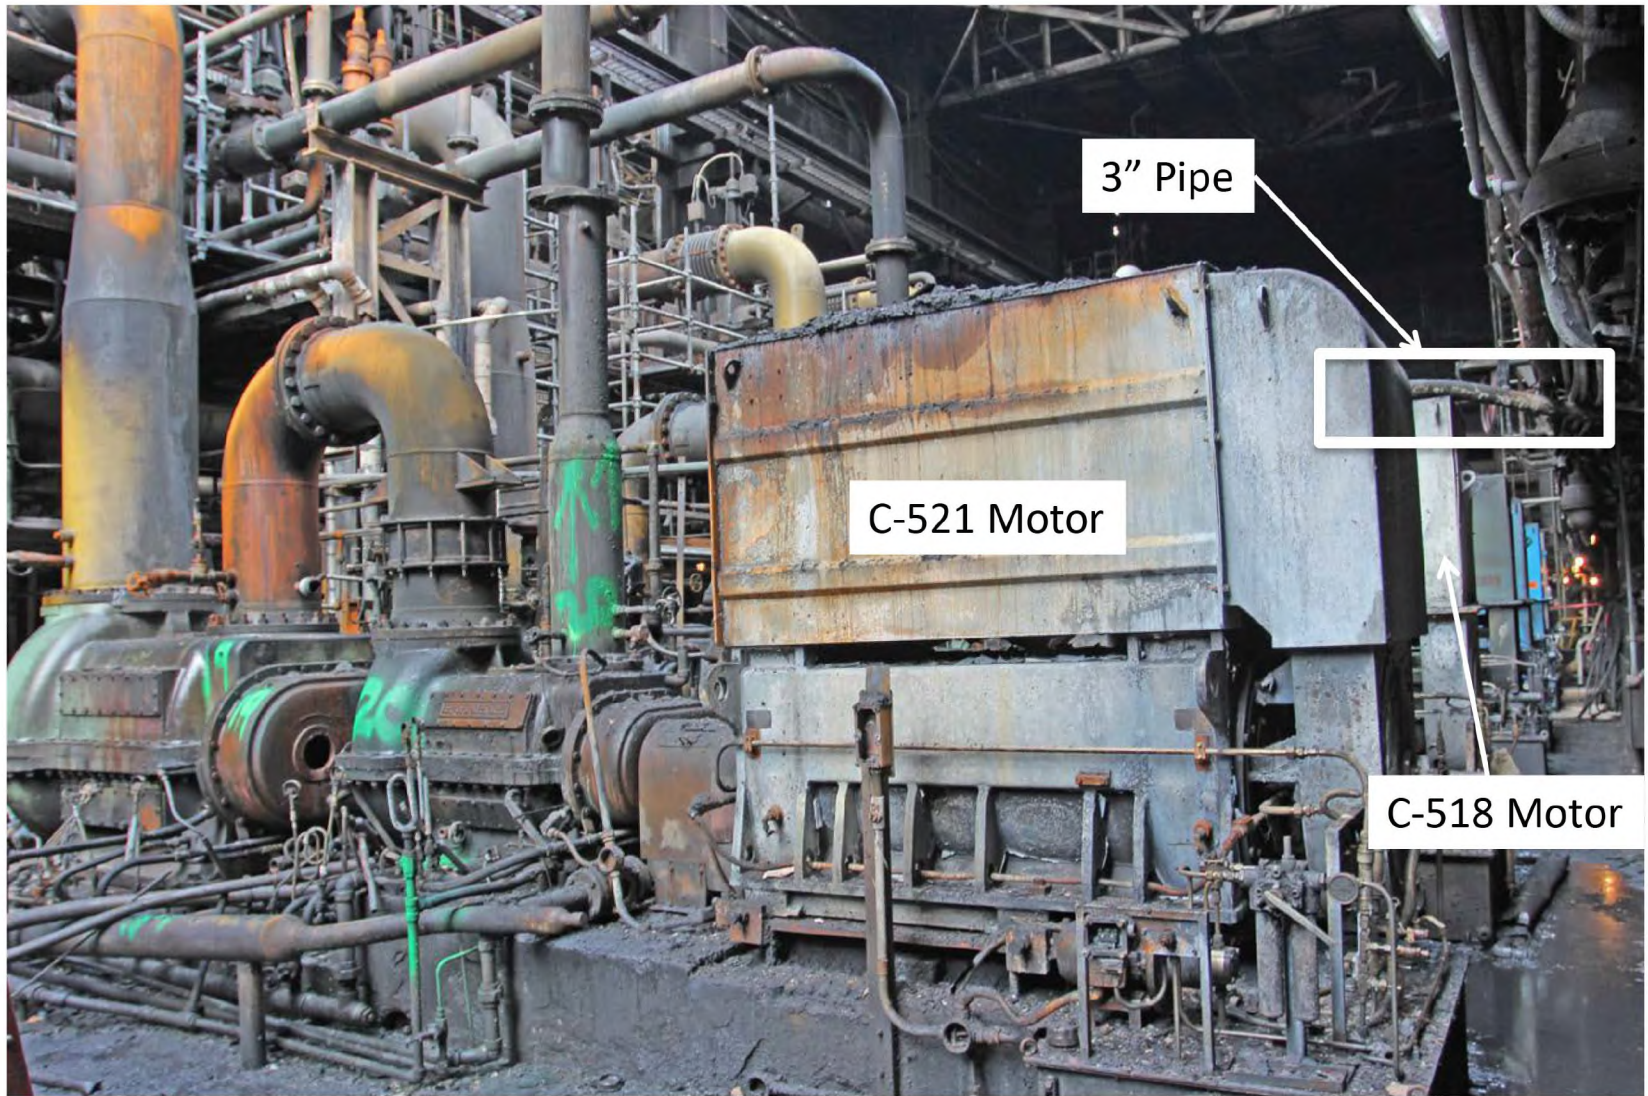
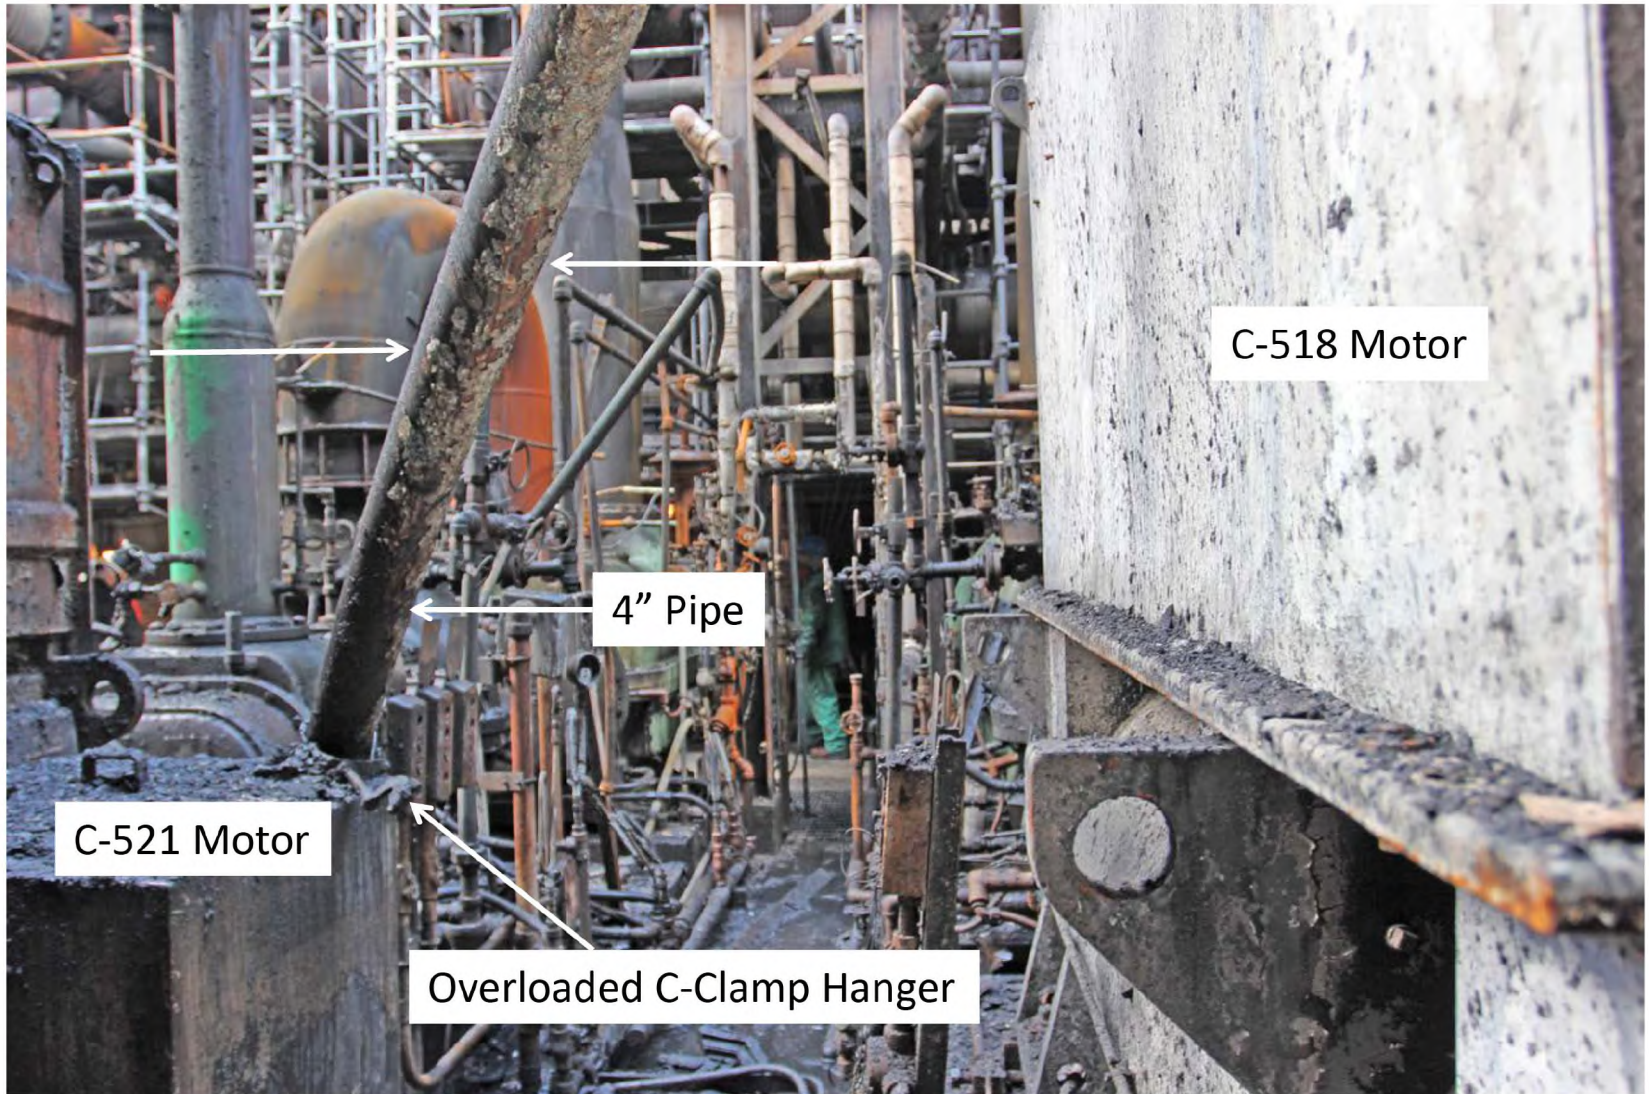
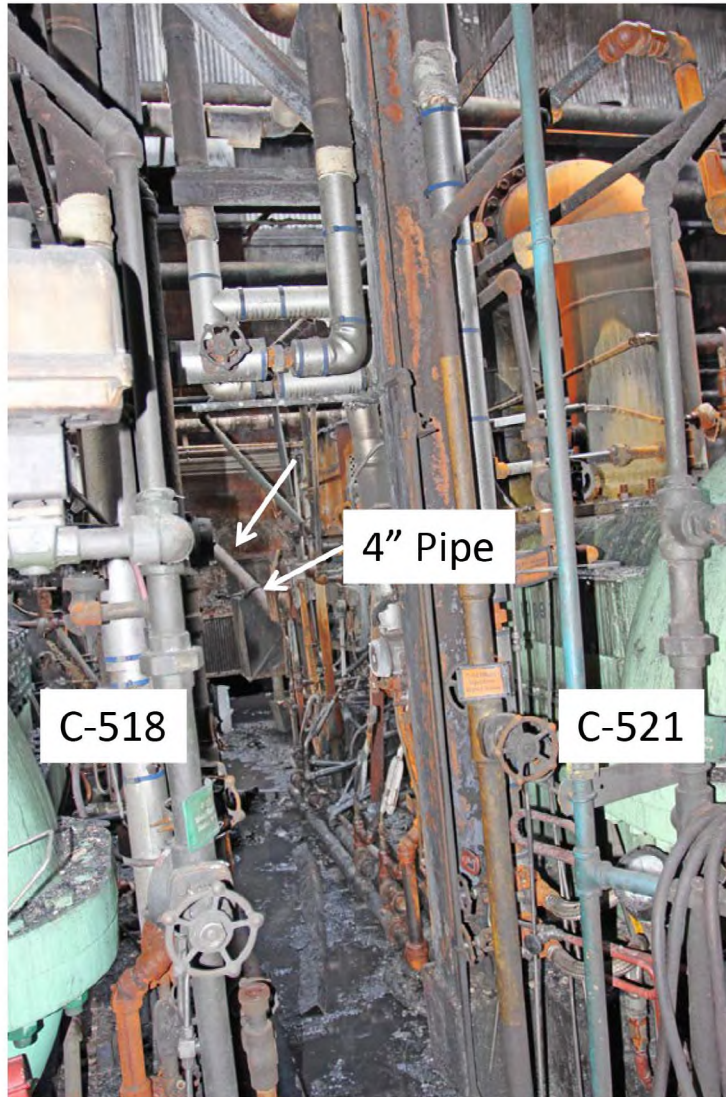
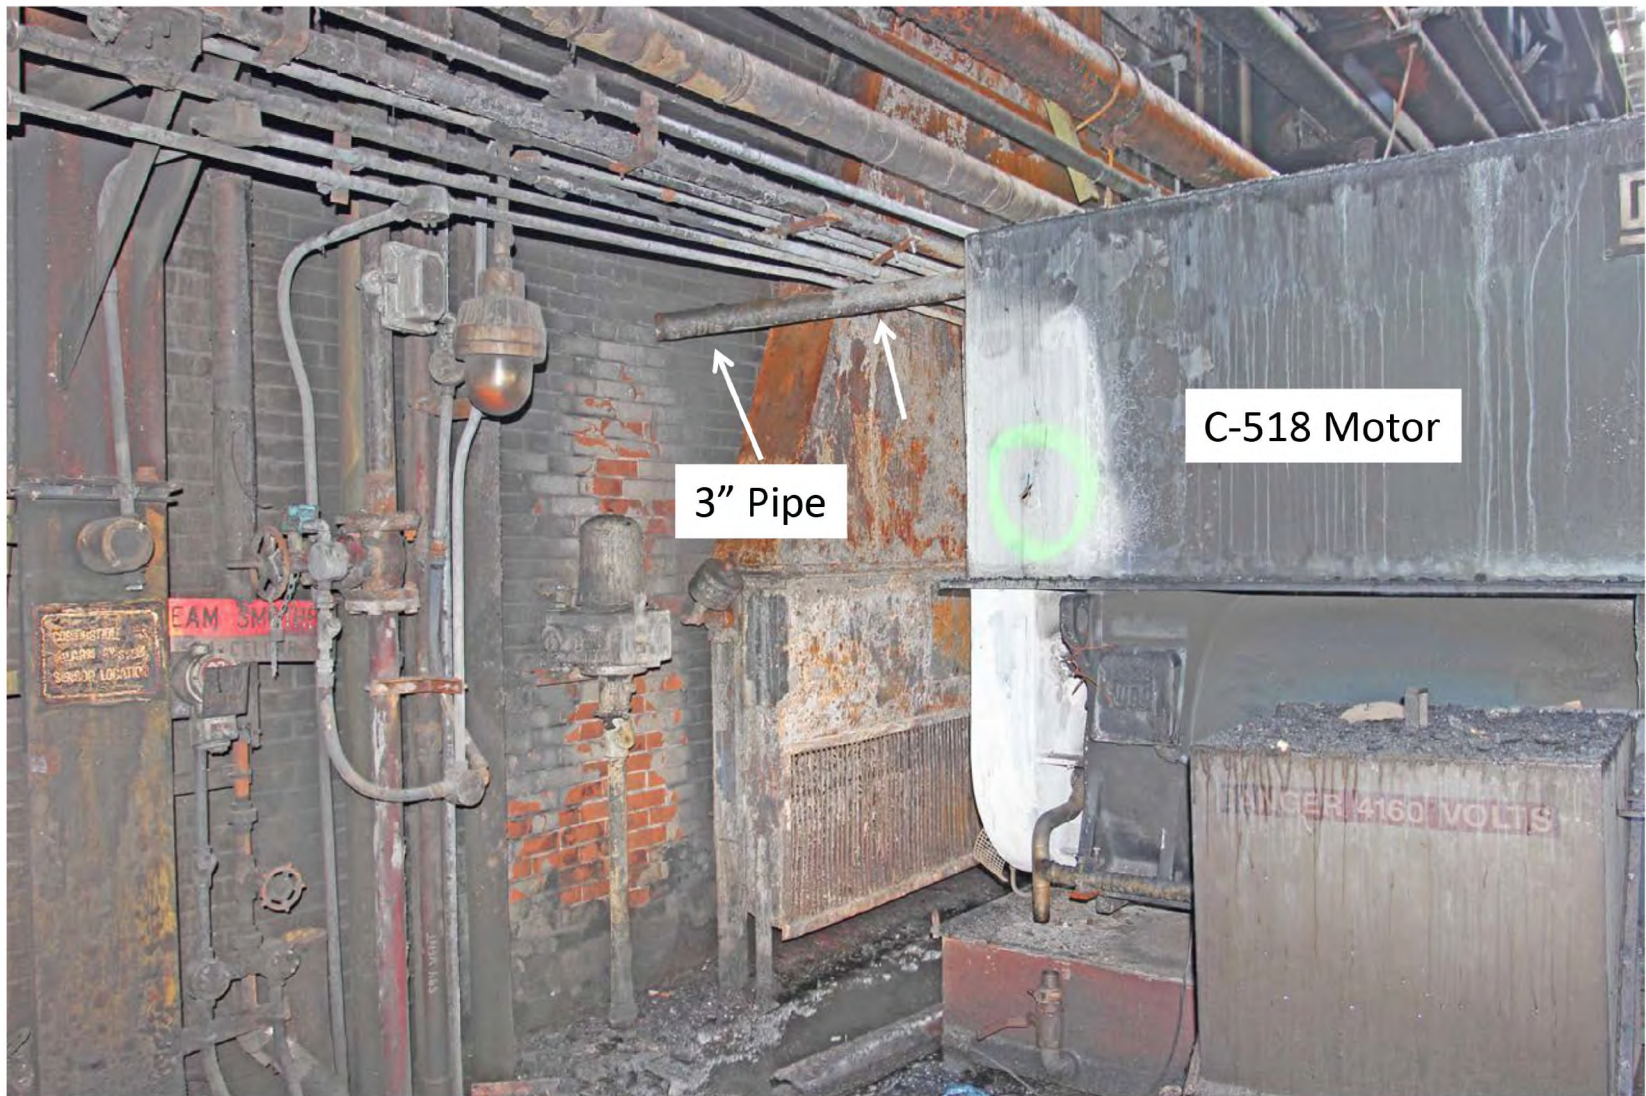
15. The position of Pipe Section “E”, at the time of the incident, is shown in Photographs 10 through 14, having fallen so as to result in the 4 inch piping being lodged against the north side of the C-521 motor, with the 3 inch section of the piping resting on top of the east end of the C-518 motor. The C-Clamp hanger (the hanger) used to suspend Pipe Section “E” had experienced an overload consistent with the application of a force greater than the design of the hanger.

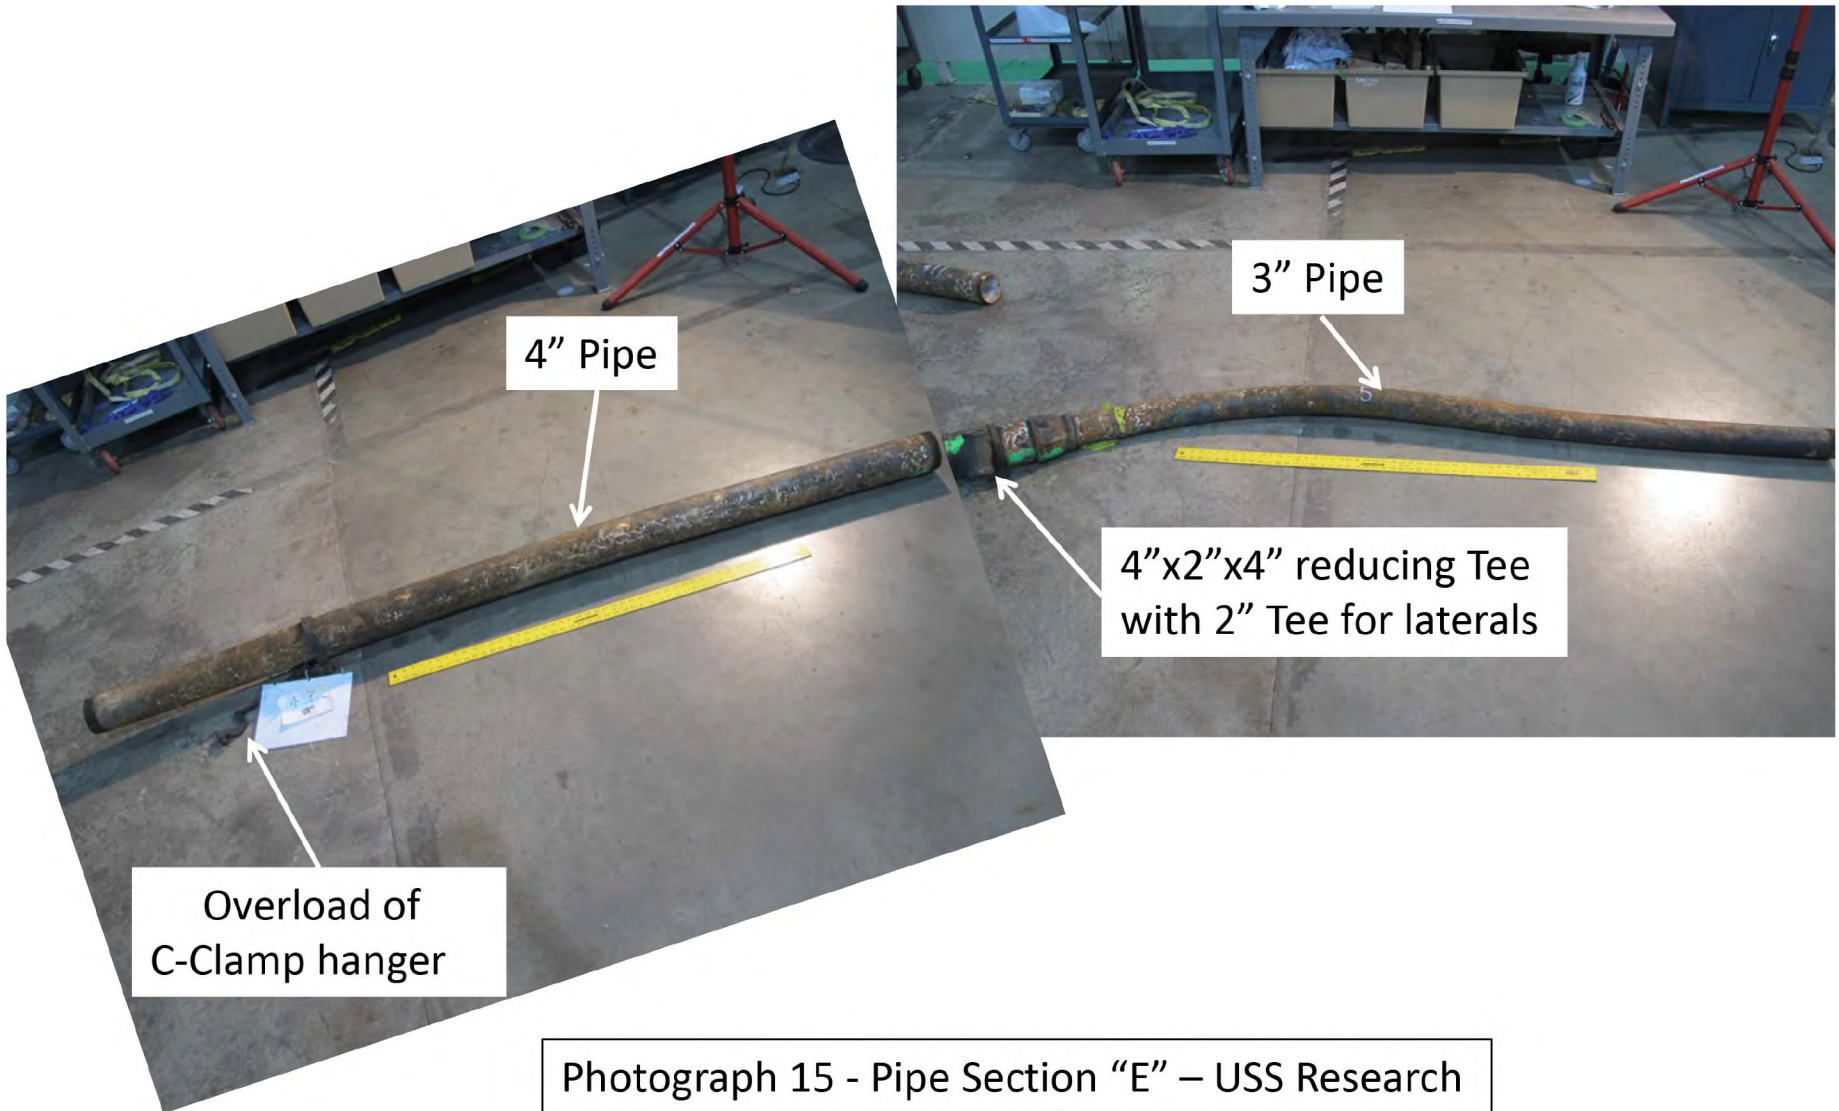
16. The two pieces of Pipe Section “E”, at USS Research are shown in Photograph 15, with the overload damage to the hanger identified. The 4-inch pipe had been disconnected at the 4”x2”x4” reducing tee to facilitate shipment to USS Research.

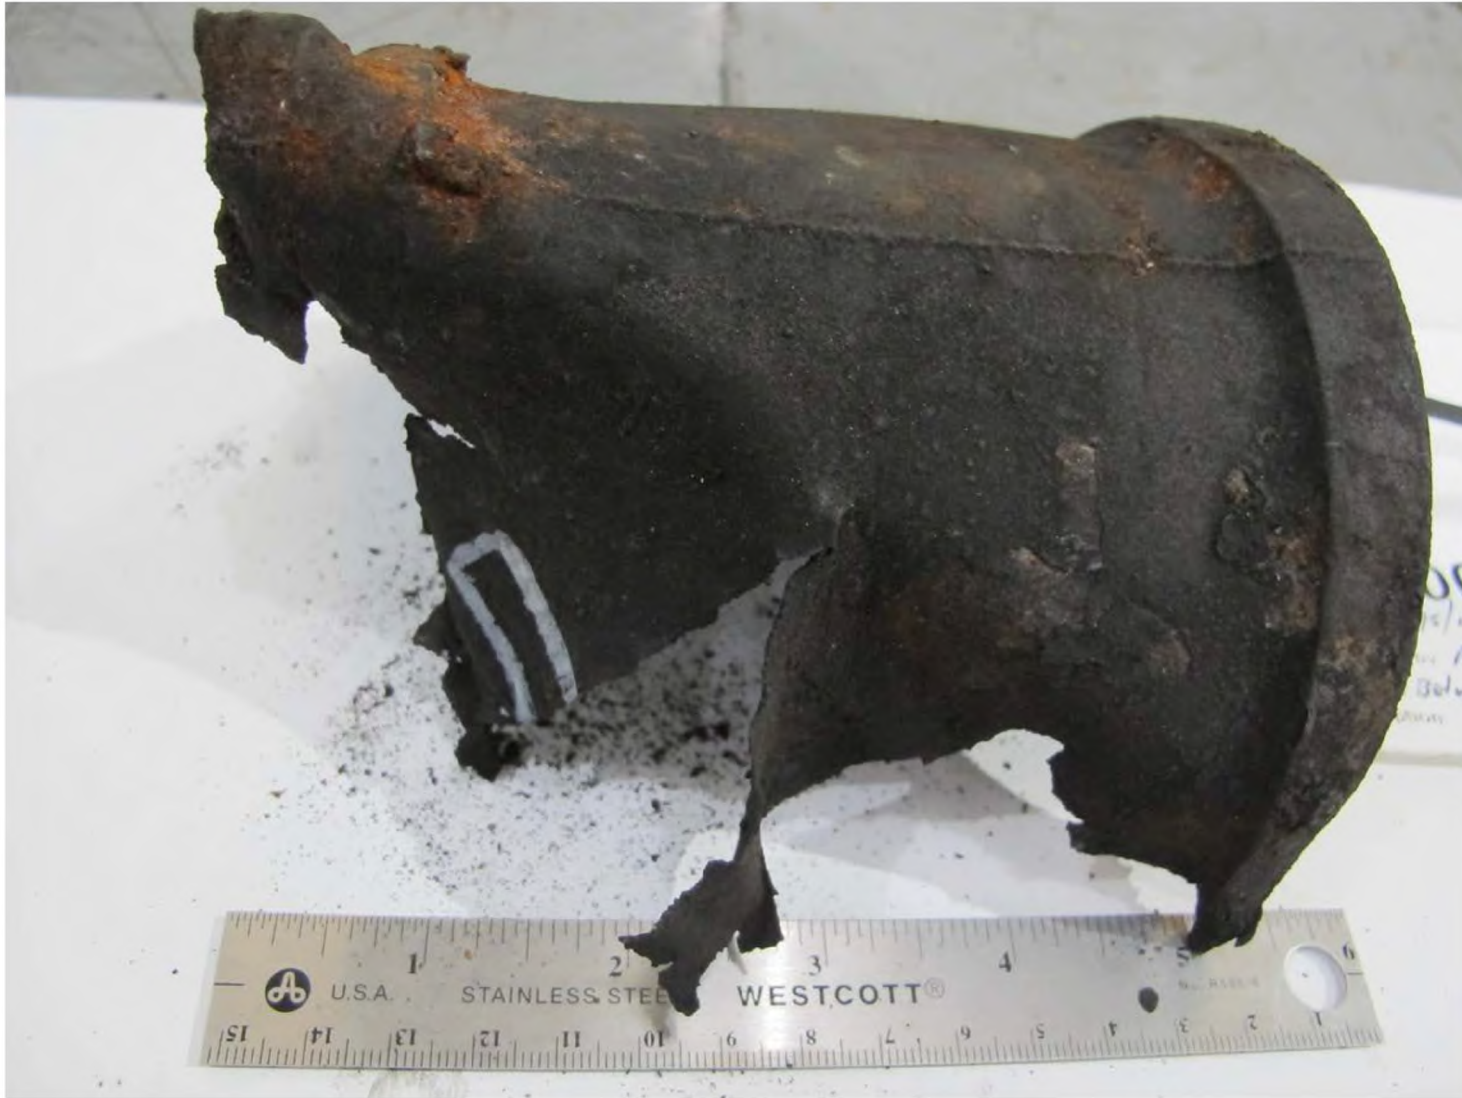
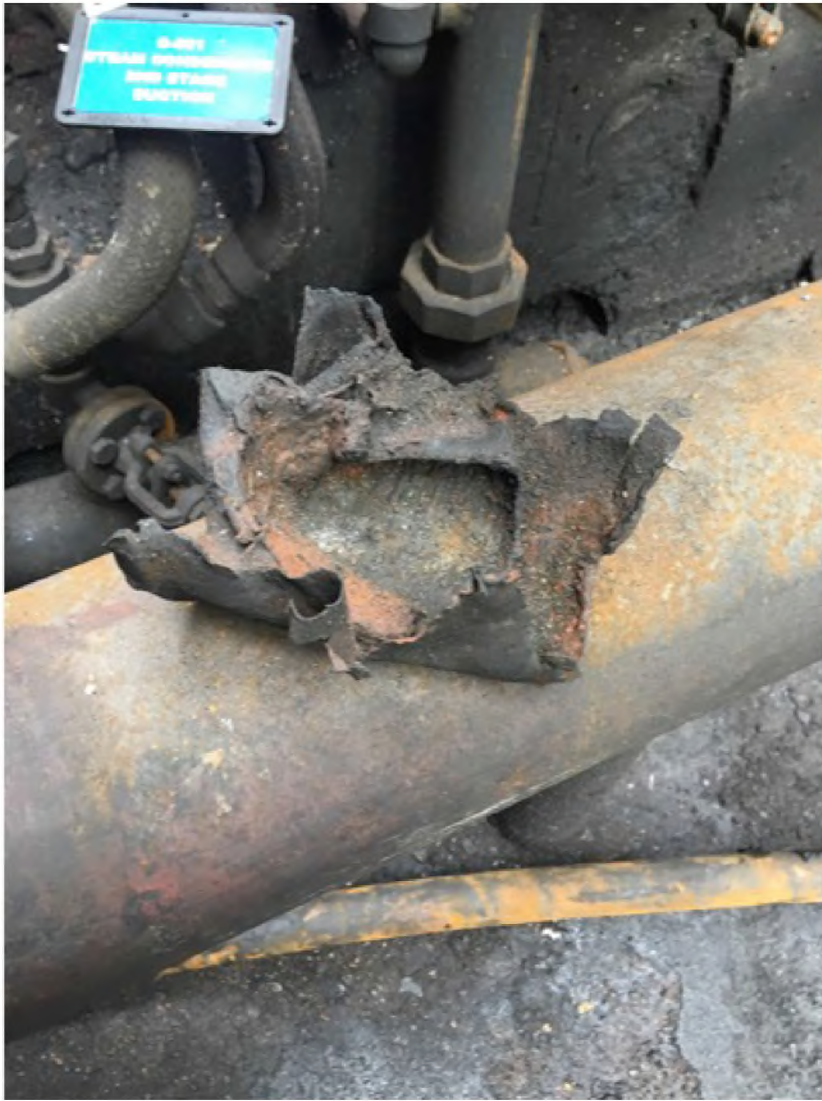
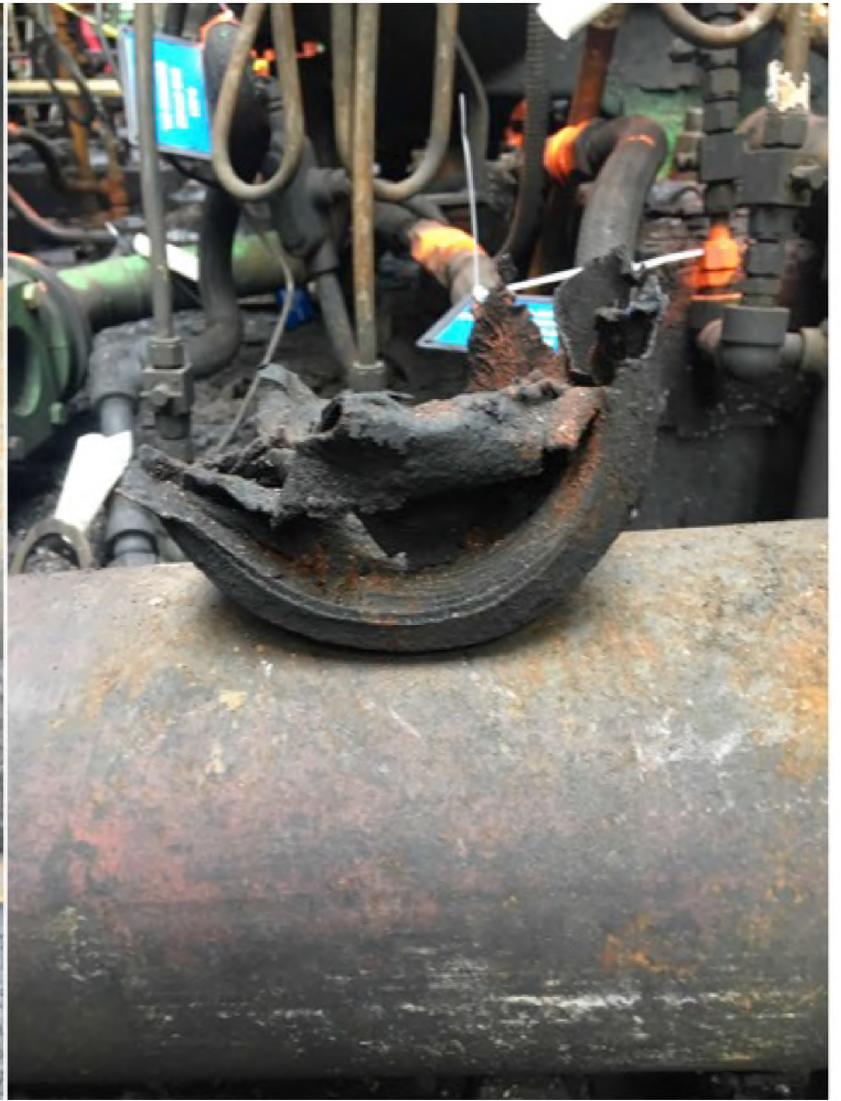
17. The corroded 4”x2”x4” reducing tee, found near C-521, is shown in Photographs 16 and 17, having experienced a ductile overload fracture due to severe corrosion/thinning of a portion of the wall of the tee. Note that the USS Research metallurgical report refers to the reducing tee as a coupling.

The extensive corrosion experienced by the 4"x2"x4" reducing tee (the reducing tee) was very localized. The top half of the reducing tee experienced external corrosion to the extent that no metal remained in some locations, transitioning to paper-thin metal near the 2-inch branch and sides of the reducing tee. A number of observations are noteworthy, regarding the corrosion experienced by the reducing tee:

3. A reducing tee fitting, located in the deluge system main 4-inch supply header, had experienced severe, localized corrosion due to exposure to corrosive water discharged onto the reducing tee as a result of a roof leak.
