Root Cause Analysis of the Uncontrolled Hydrocarbon Release from Aliso Canyon SS-25

May 16, 2019

MAIN REPORT

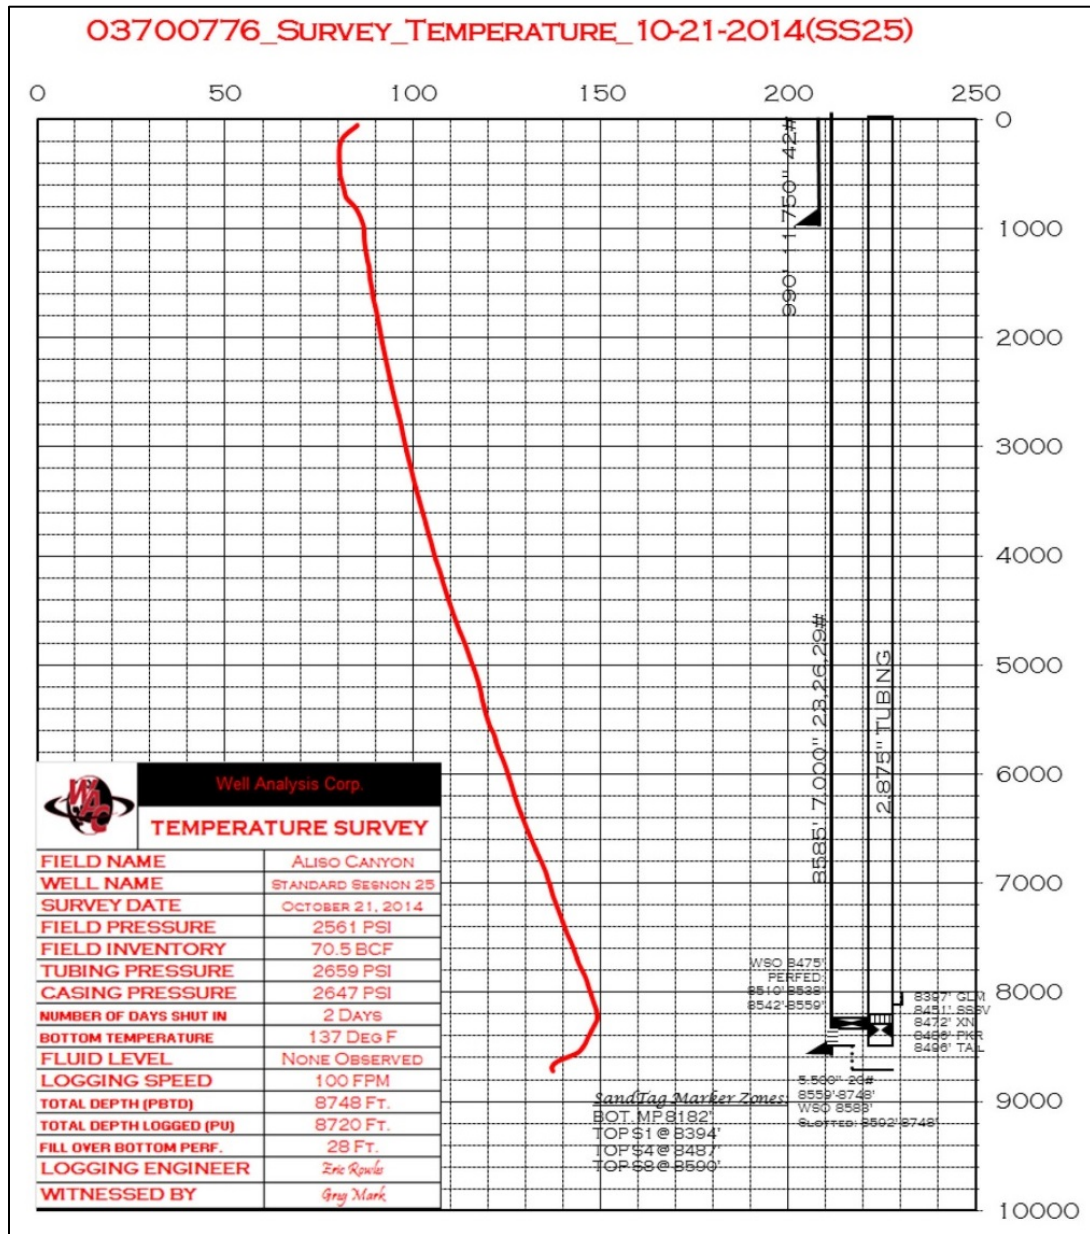
Figure 14: Temperature Survey on October 21, 2014

Figure 14 shows the temperature survey from October 21, 2014, the *last* survey before the incident of October 23, 2015, and shows no anomalies related to casing integrity. A cooling feature was found below approximately 8,200 ft related to gas injection and withdrawal, but it was not related to a casing integrity issue.

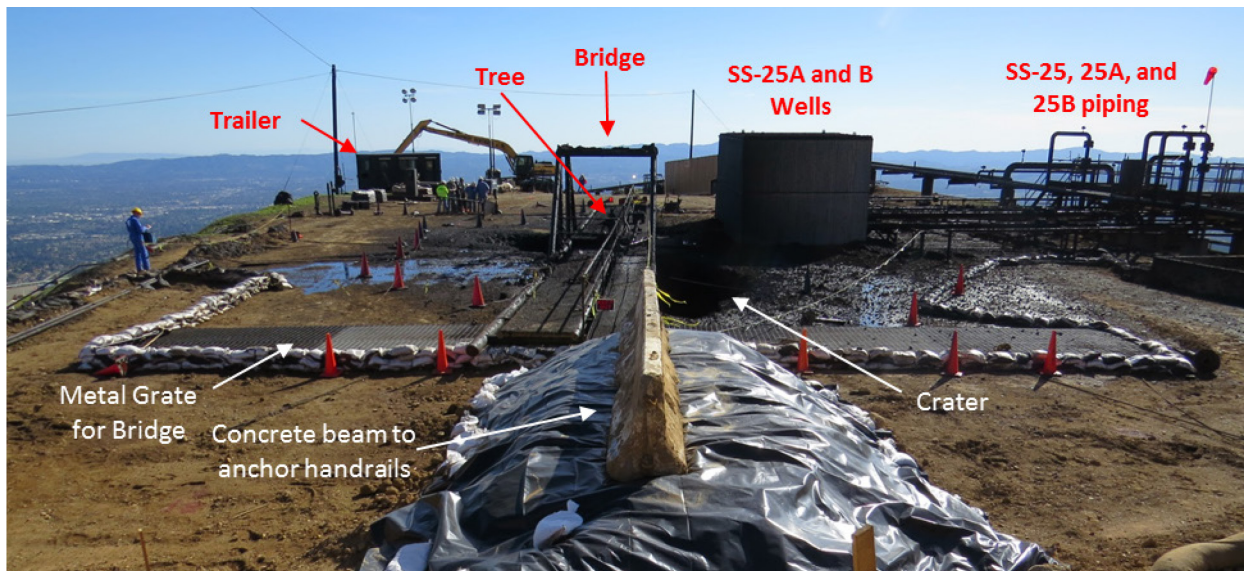
Figure 15: SS-25 Well Site Condition on February 25, 2016

Phase 1 was the first opportunity for the Blade team to observe and document the SS-25 well site. Figure 15 shows one of the initial images taken after the well site was opened to the Blade team. The image shows the SS-25 tree, crater, bridge spanning the crater, SS-25A and SS-25B heat shields, and piping for SS-25, SS-25A, and SS-25B. The majority of the non-permanent items shown in the image were removed throughout Phase 1 or during Phase 2. These items included the trailer, bridge, heat shields, sand bags, cones, and concrete beam.

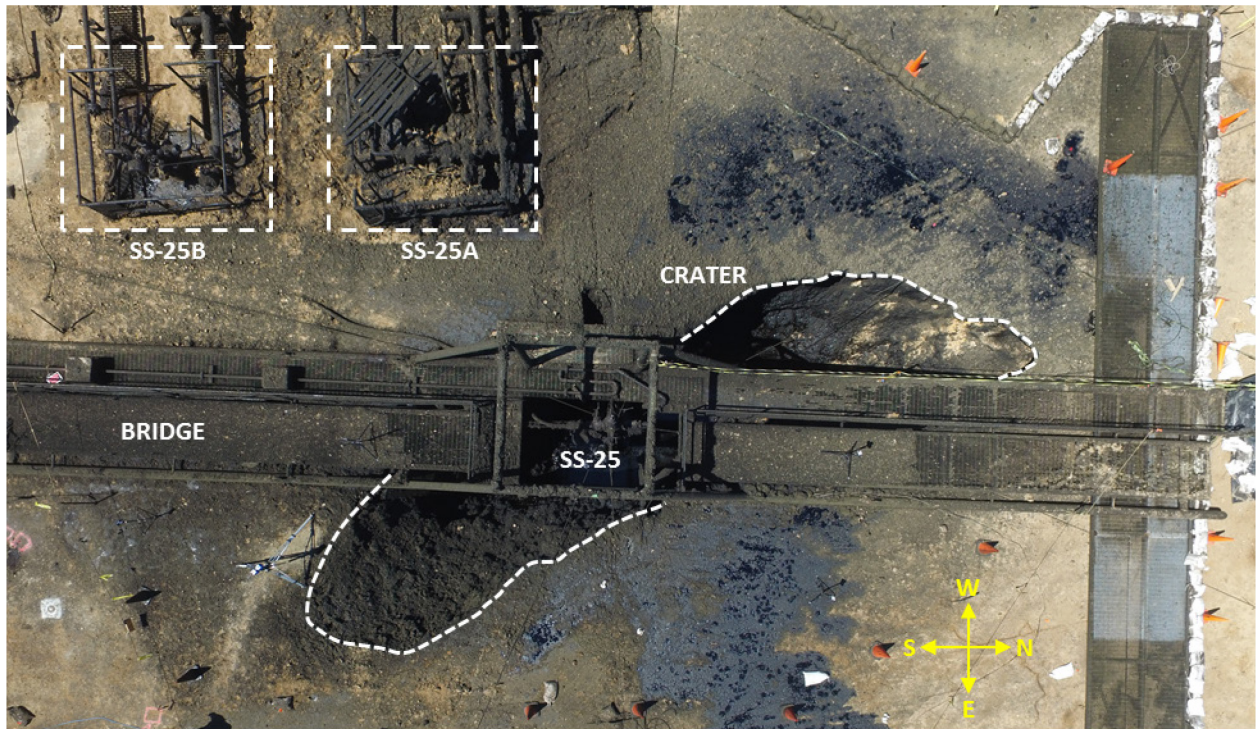
Figure 16: SS-25 Well Site Top View Aerial Photograph Post Blowout Taken on April 01, 2016

Formation of the crater occurred during various periods of the blowout. Figure 16 and Figure 17 show aerial photographs of the crater looking down and west, respectively. The images also show the SS-25A and SS-25B wellheads after removing the heat shields. The bridge and concrete beam were installed during the kill operations to provide access to the wellhead. The bridge provided a platform for personnel to connect lines and operate valves. The concrete beam was used to anchor a steel cable handrail.

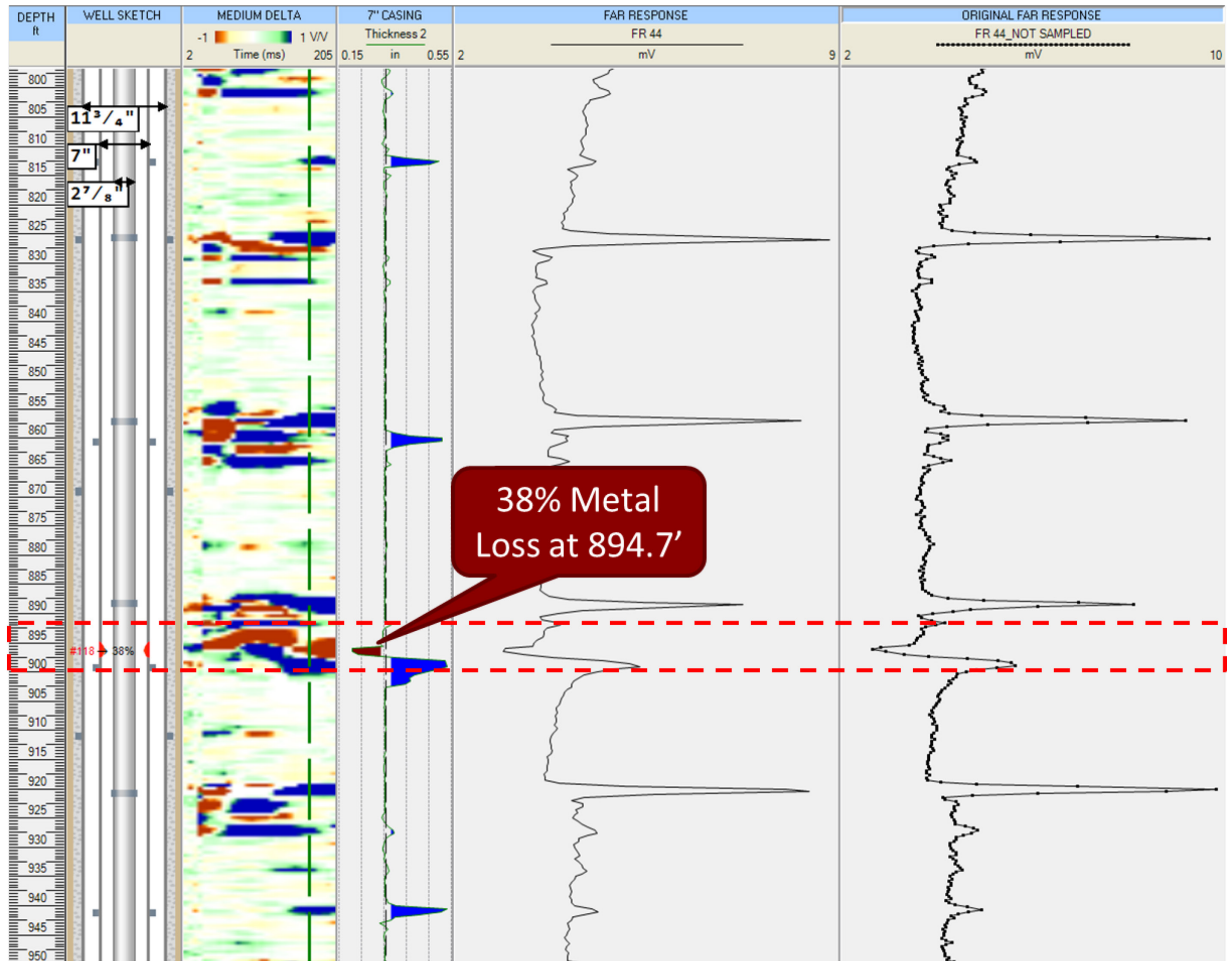
Figure 19: MID Results Showing 38% Metal Loss at Approximately 895 ft

During Phase 1, a Magnetic Imaging Defectoscope (MID) logging tool was used. This tool is designed to record the time response to electromagnetic pulses to detect metal loss or gain in up to three barriers. The MID tool was run within the 2 7/8 in. tubing (first barrier) to identify anomalies in the 7 in. casing (second barrier) and 11 3/4 in. casing (third barrier). The MID detected metal loss at several locations along the length of the 7 in. casing—the most notable one at 895ft MID log depth. Figure 19 shows the MID results at a depth of 895 ft. The well schematic in Figure 19 shows a 38% metal loss feature on the 7 in. casing, suggesting significant metal loss at that depth.

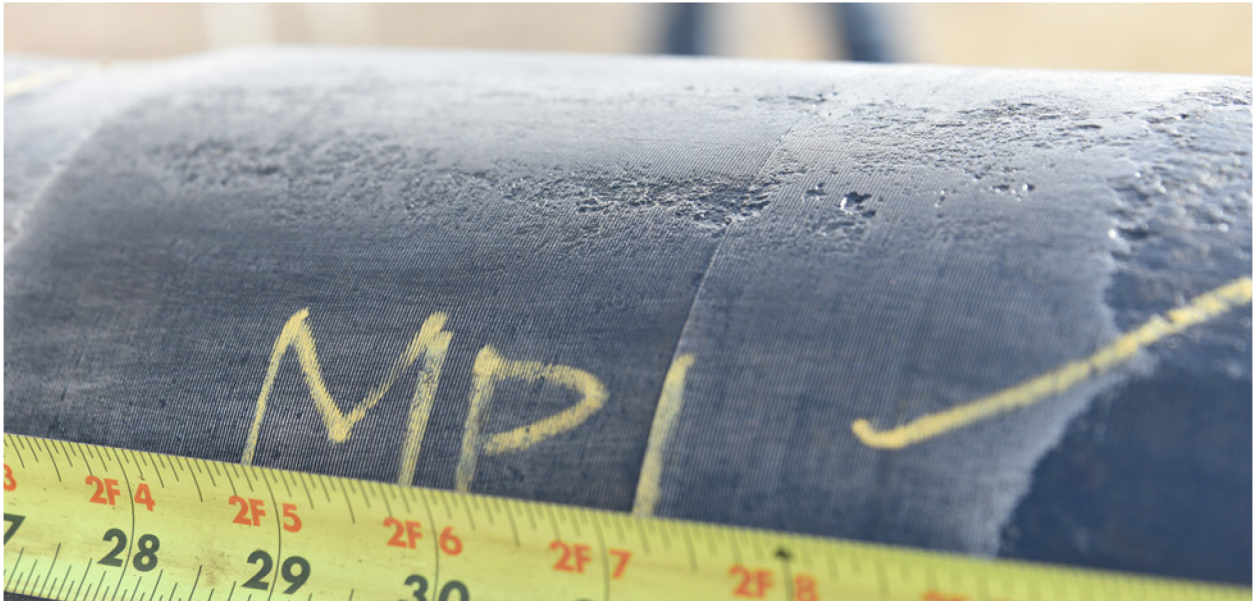
Figure 28: Shallow Metal Loss on Connection C014

Shallow metal loss was first identified on the C014 connection and was present on the remainder of the extracted casing pipe bodies and connections. Corrosion was identified on many of the connections below C014 with increasing severity. Figure 28 shows the shallow corrosion on the C014 connection. Figure 29 shows corrosion on the connections for (a) C019 and (b) C020. The corrosion is similar to C014's but more severe.

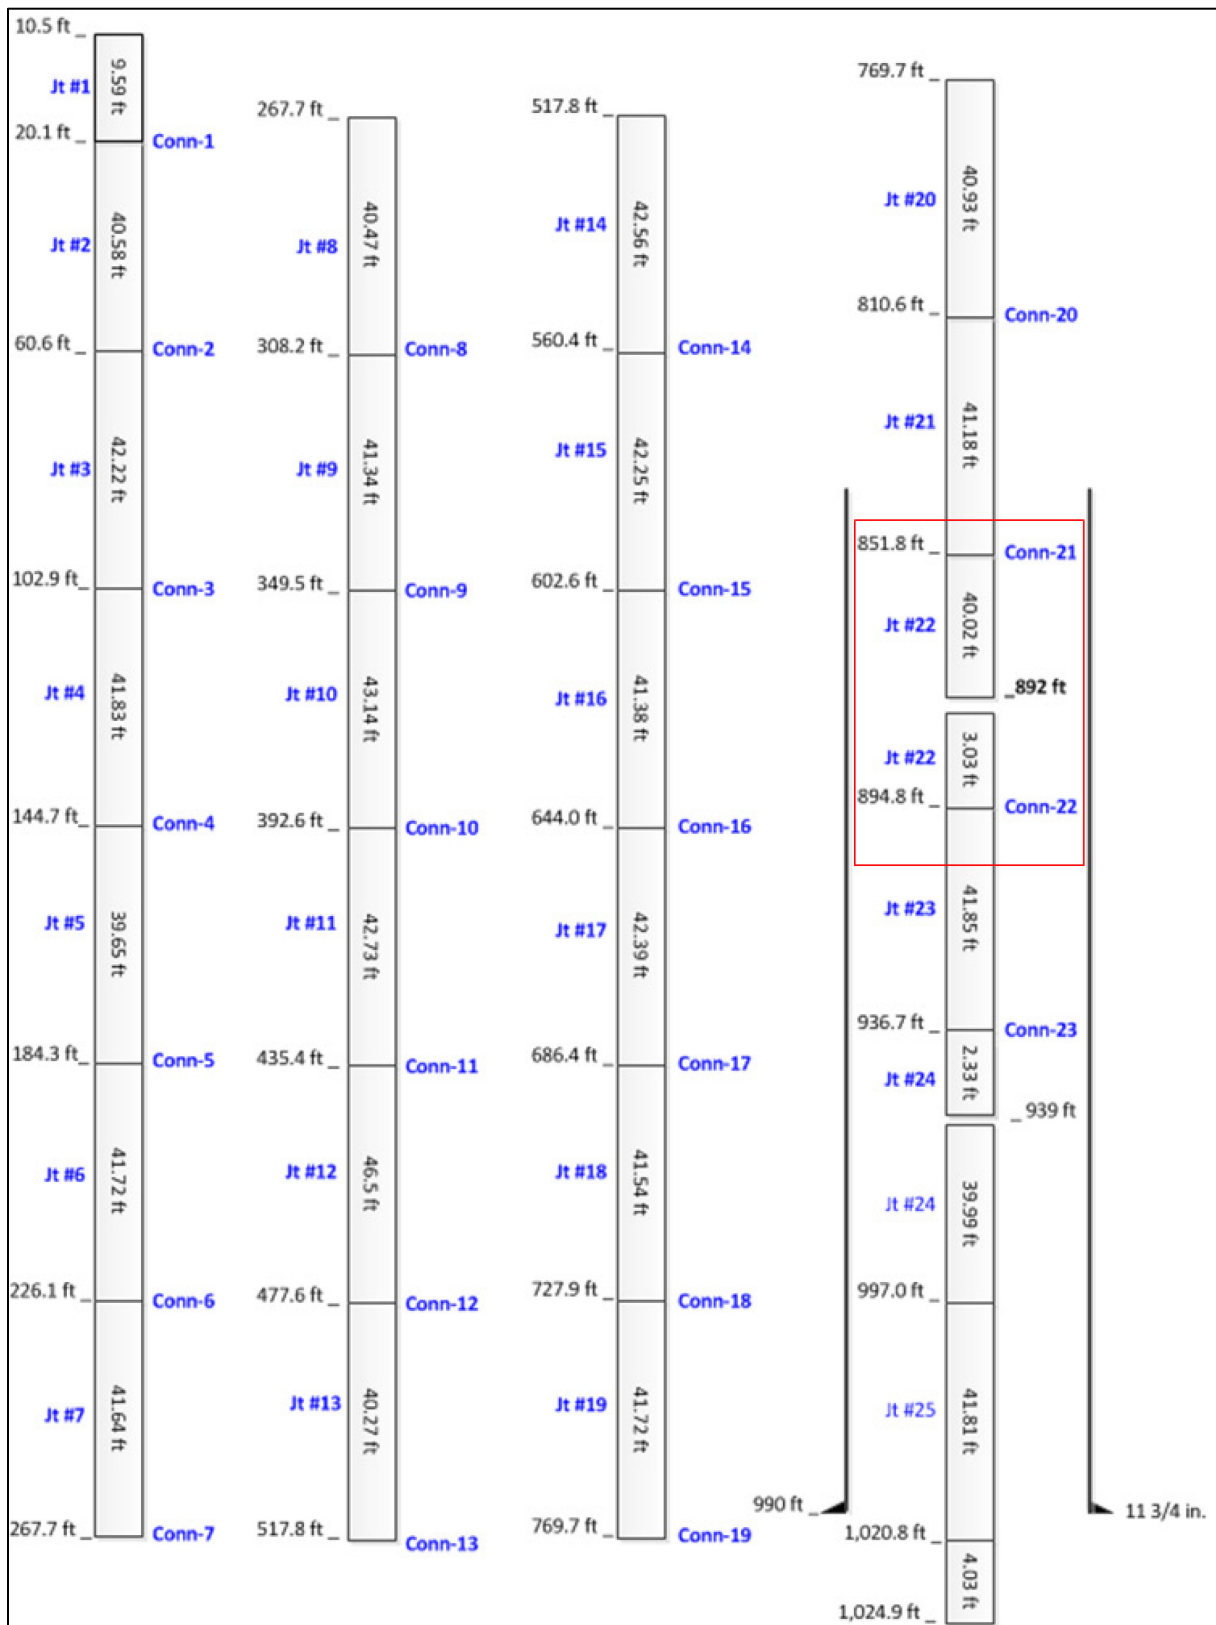
Figure 43: SS-25 7 in. Casing String Schematic

Figure 43 shows a schematic of the locations and depths for the 25 joints of 7 in. production casing extracted for the RCA. Depths are based on consolidation of data from downhole tools and physical measurements. The official depth for the circumferential parting is 892 ft, as the schematic shows. It is also apparent from Figure 43 that the 7 in. production casing was extracted from just below the shoe of the 11 3/4 in casing. Joint 24 and part of joint 25 were the last joint samples with OD corrosion as identified by the log data. Joint 22 exhibited the failure, which included the axial rupture and circumferential parting. Specimens taken from the axial rupture and circumferential parting were analyzed in detail to characterize the failure and define the failure sequence. Figure 44 shows the field photographs taken during extraction with a schematic of the axial rupture and circumferential parting. The image shows the failed casing oriented as it was in the well with the axial rupture below the circumferential parting.

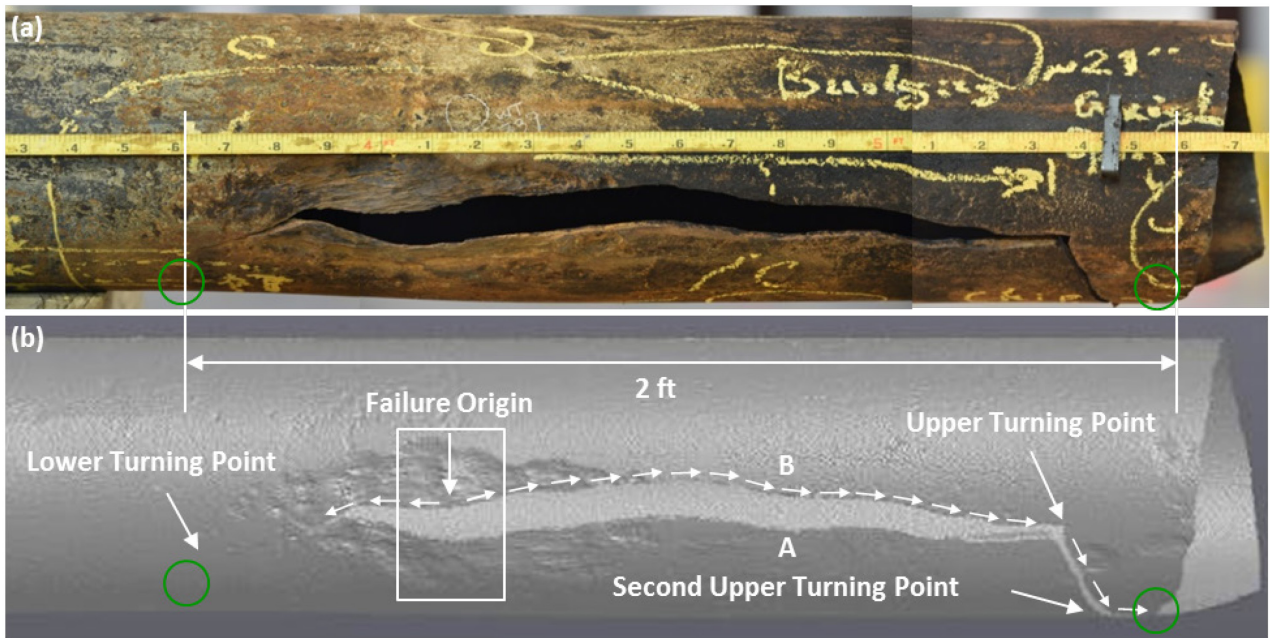
Figure 46: (a) Field Photo and (b) Laser Scan Indicating the Origin, Lower and Upper Turning Points, and Lower and Upper Arrest Points

Figure 46 (a) and (b) show a close-up and laser scan image of the axial rupture. The failure origin is indicated by the white box. The direction of crack propagation is indicated on both sides of the origin by white arrows. The upper and lower crack arrest points are indicated by the green circles.

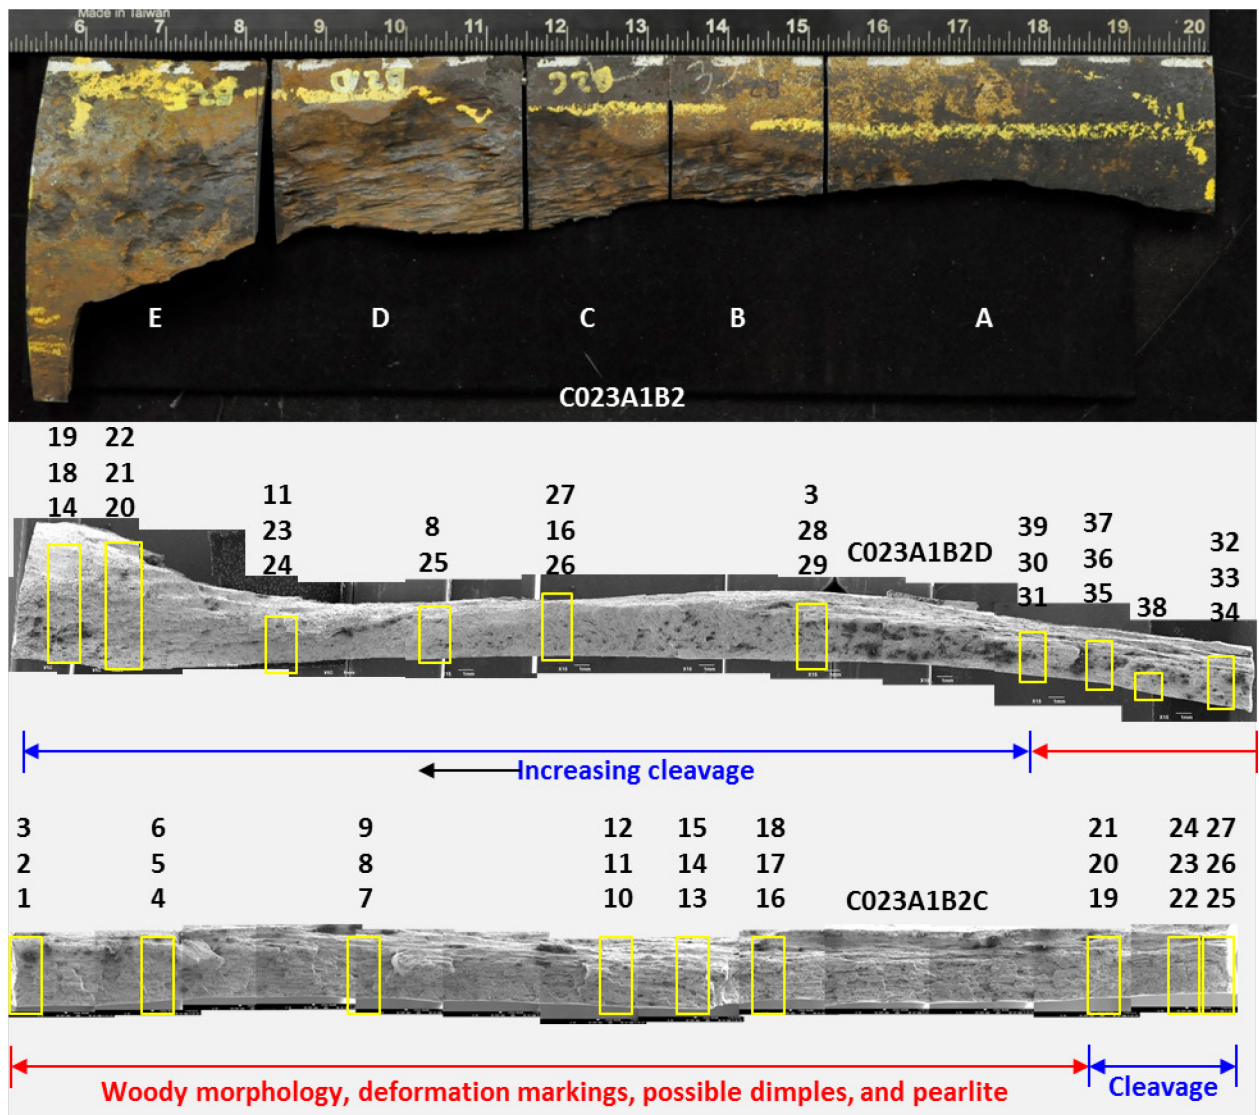
Figure 53: SEM Examination of the Cleaned Fracture Surfaces of C02A1B2C and B2D

A transition from ductile to a ductile–brittle mix was observed beginning at A19 (Figure 53). The transition showed a shift from a woody-type morphology to a mix of woody-type morphology and cleavage. The amount of cleavage facets appeared to increase from location A19 to A27. The observations implied that the speed of the axial rupture was increasing through the transition zone until the crack became fully unstable. Figure 56 is a SEM image from A19 showing the ductile–brittle mixed fracture mode. The images show areas of cleavage facets and deformation markings.

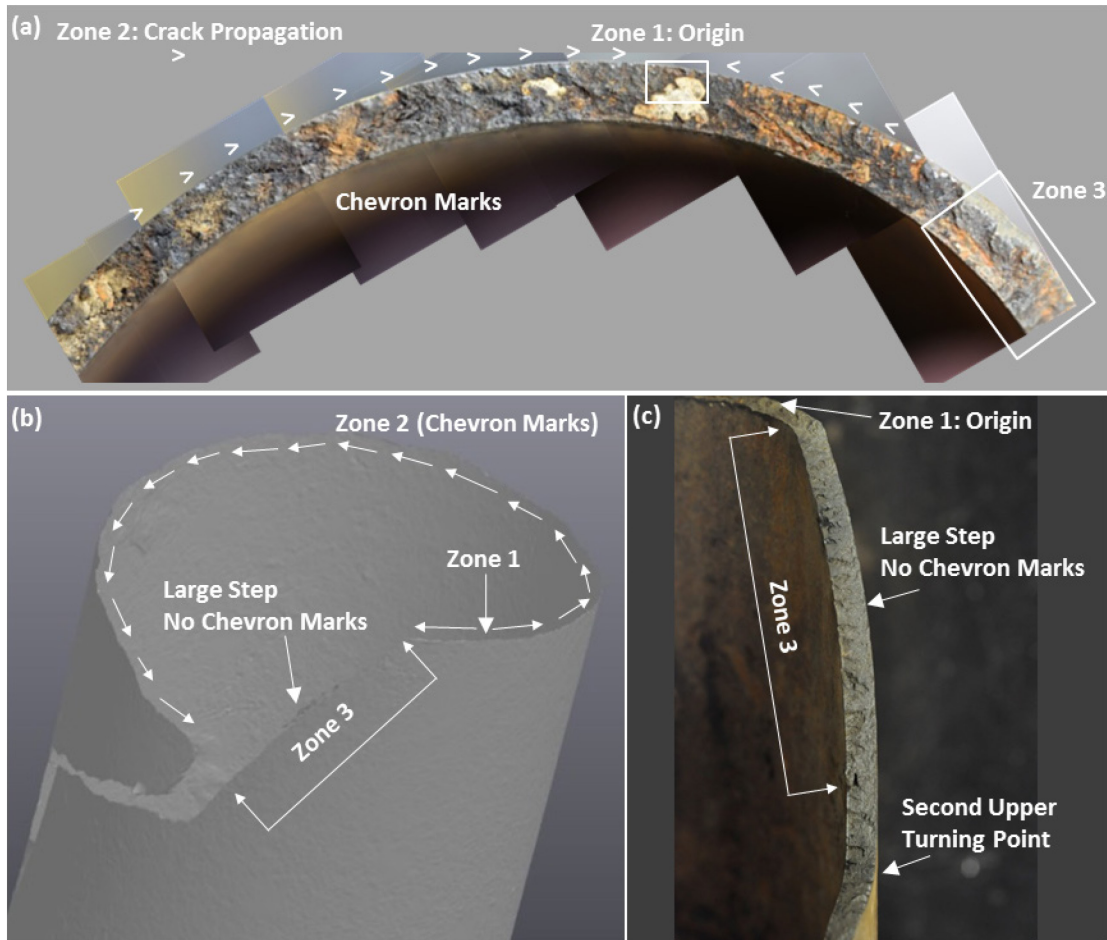
Figure 67: (a) Stereo Image (b) 3D Schematic of Zones (c) Macro Image of Three Zones

Figure 67 illustrates the three zones of the circumferential parting. Figure 67 (a) is a stereo image showing the three zones, origin, and the direction of the crack propagation. Figure 67 (b) is a 3D schematic showing the overall circumferential parting steps. Figure 67 (c) is a close-up of the Zone 3 fracture surface.

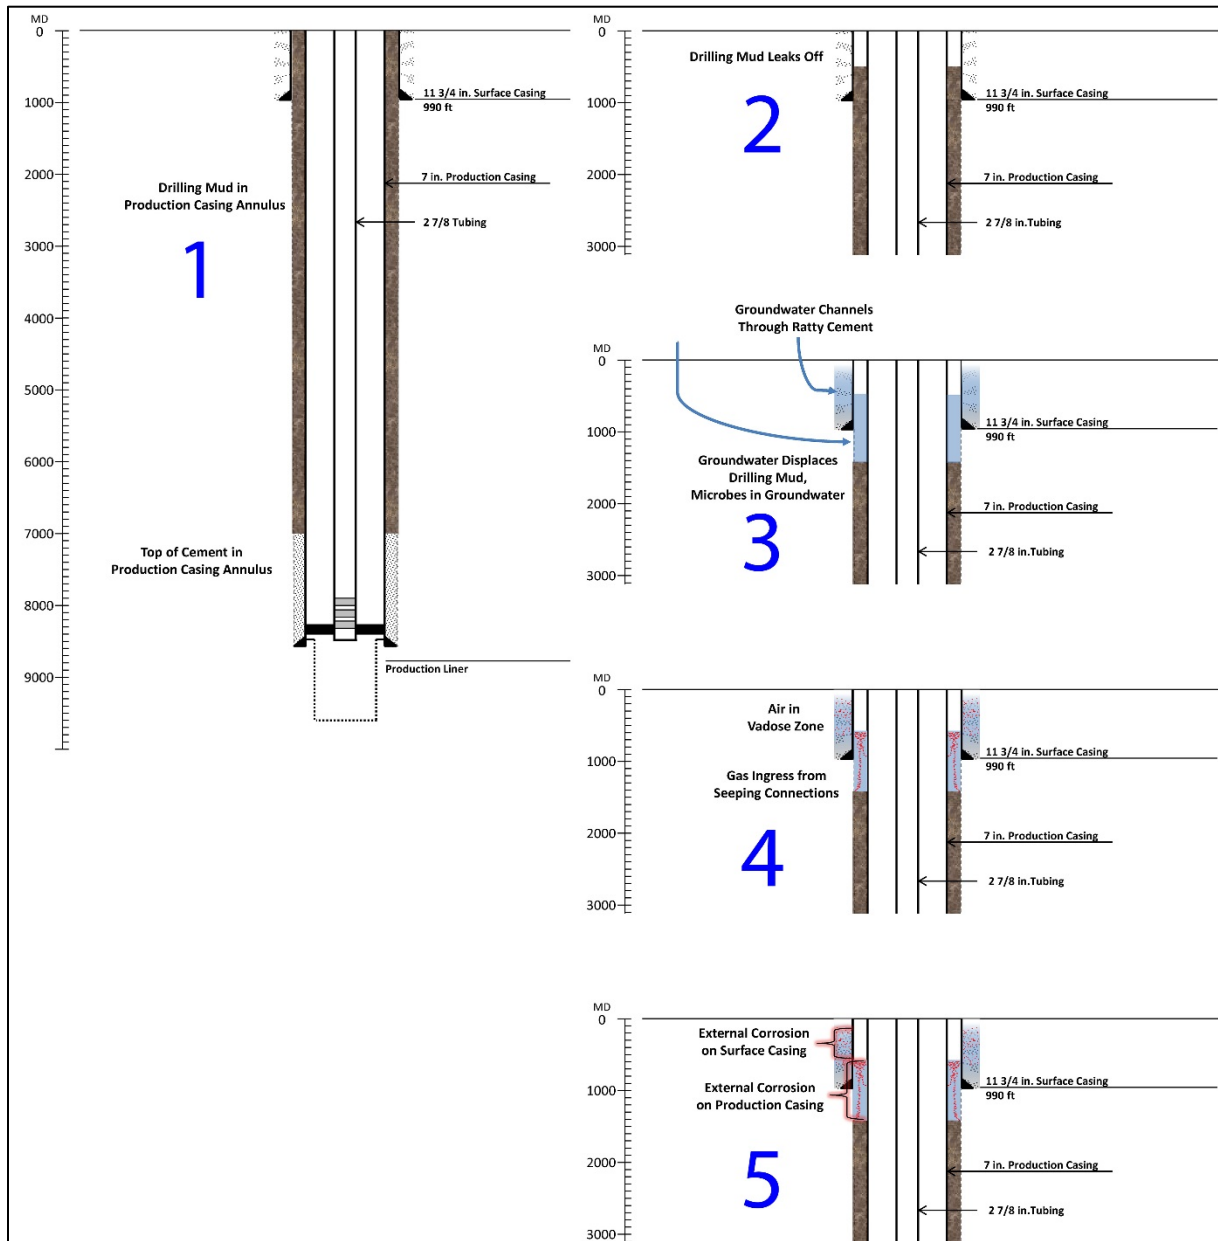
Figure 85: Likely Mechanism of Groundwater Ingress into the Surface Casing and Production Casing Annuli

The possible mechanism of the groundwater and drilling fluid interplay is depicted in Figure 85 that includes five steps. The first step, as shown in Figure 85, is the as is well completed condition with the drilling fluid in the 11 3/4 in. × 7 in. annulus. The second step is that over a period of time the drilling fluid would have leaked off into the formation. Over time in step 3, groundwater accesses the surface casing annulus and the OD of the 11 3/4 in. surface casing. The corrosion process would have initiated at this stage, especially as gas is seeping through connections. This finally results in external corrosion on the OD of the surface casing and the OD of the production casing. The fluid level in the surface casing annulus would have fluctuated with time and precipitation; however as discussed in the next section extensive 7 in. OD corrosion is observed from 700 feet and deeper.

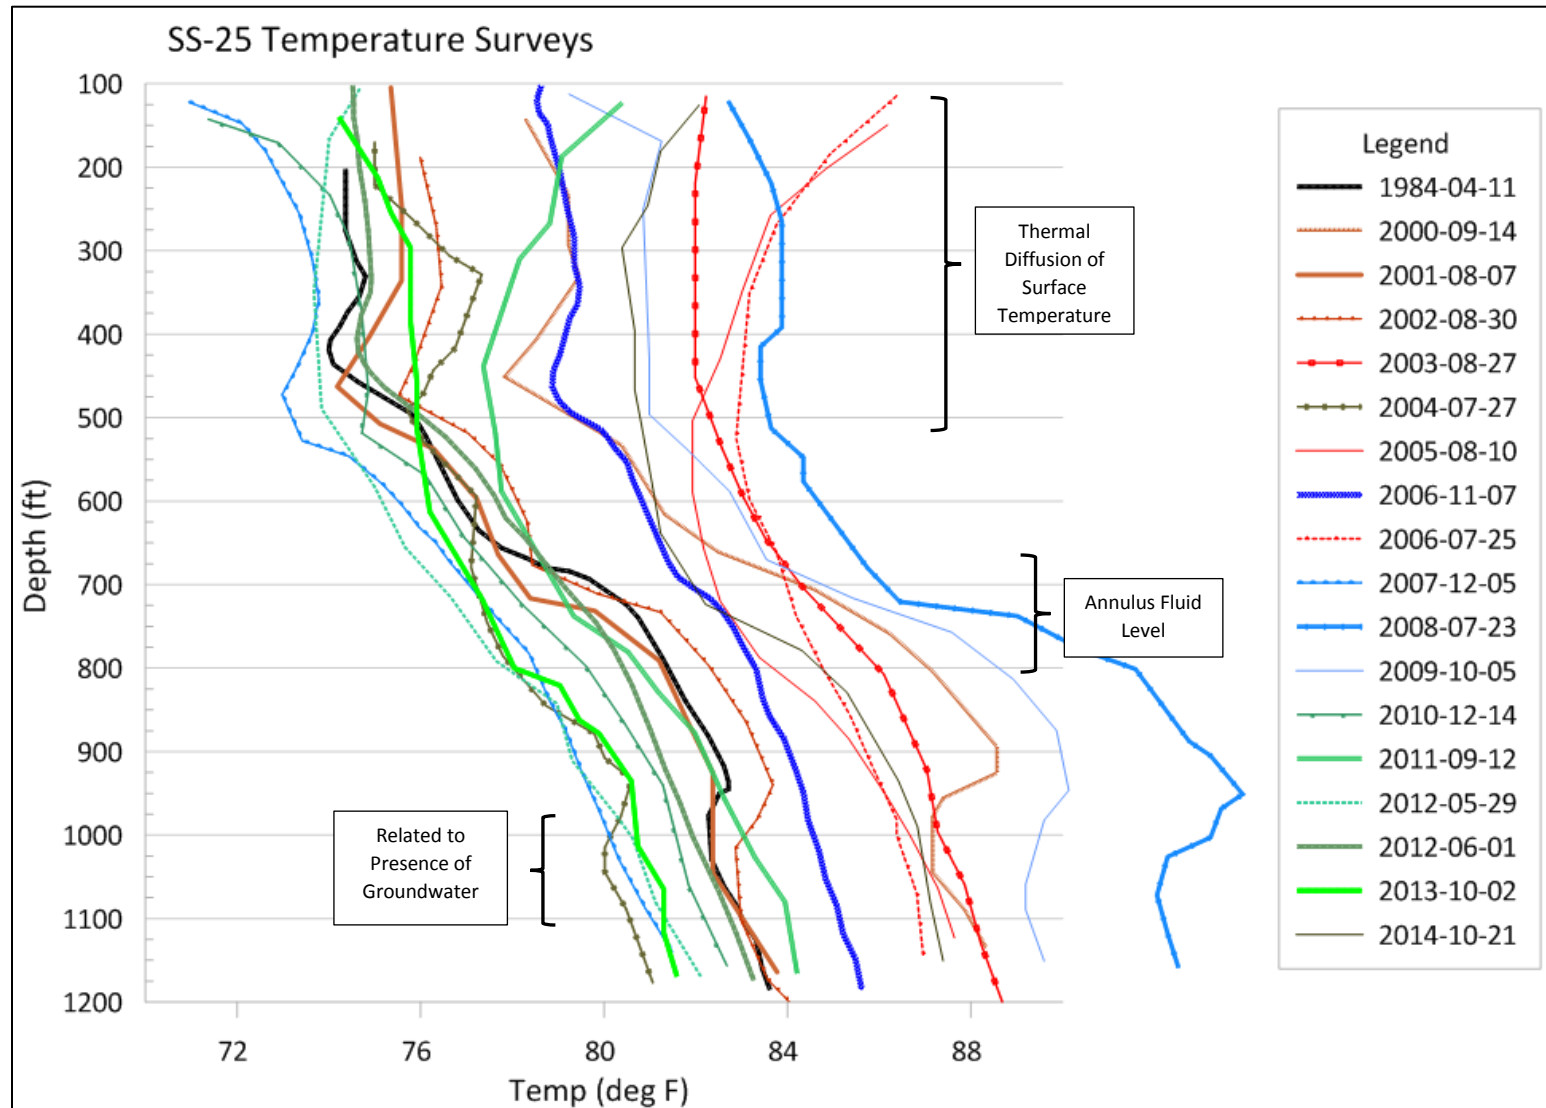
Figure 86: Pre-Incident Temperature Surveys - Interpretation of Deflections, Depths 100–1,200 ft

In order to further assess the fluctuating levels of water in the annulus and ingress of groundwater at the SS-25, temperature logs are discussed and shown in Figure 86. The temperature logs are magnified to a depth of 1,200 ft and the data from years 2000 to 2014 including 1984 are also shown. The smaller deflections are evident and there are three distinct zones that are apparent. The shallow low temperature regions are related to surface cooling at the SS-25 site, which is a knoll and is generally cooled at surface. There is another consistent deflection at around 700 ft and was likely due to the presence of surface casing fluid level. There is mild variation to that depth and may be due to variations in groundwater level. Finally, there is a smaller deflection at around 1,000 to 1,100 ft and probably due to ingress of groundwater. These are likely interpretations of the temperature logs; the deflections/deviations are consistent over the years. The surface casing fluid level is consistent with the presence of OD corrosion.

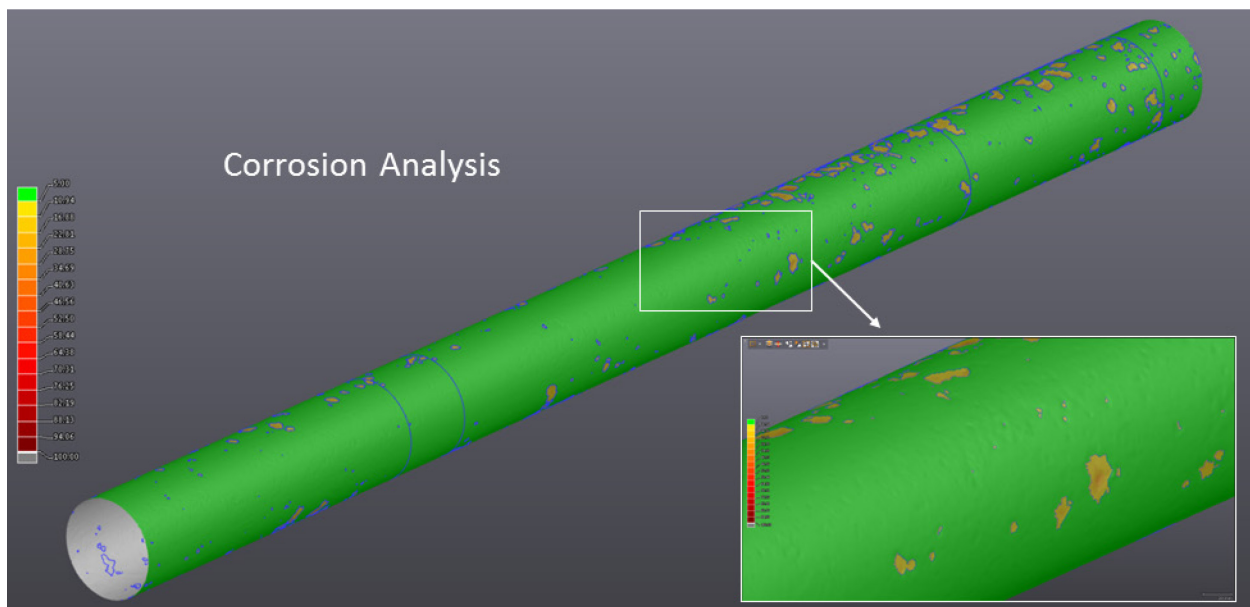
Figure 87: 3D Color Map of Corrosion Analysis Results for C018A

The 3D map of the corrosion on joint 18 is shown in Figure 87; all indications greater than 5% of nominal wall thickness are identified in the image. The nominal dimensions used for all the scans were 7 in. for the OD and 0.317 in. for the wall thickness.
