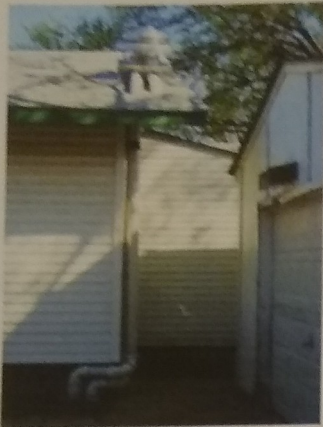
View of completed plumbing and power vent at SE corner of the residence; this system became operational in early **April 2016** and is in use a present date.

The pattern locations of the surface seep readings changed after the installation of the extraction system; in some instances, the system seemed to increase the methane volume in some locations, but the system did not remove the gas seep from areas necessary for re-instating the gas service to the residence.
