National Transportation Safety Board Aviation Accident Preliminary Report

| Location: | El Cajon, CA | Accident Number: | WPR22FA068 |
| Date & Time: | December 27, 2021, 19:14 Local | Registration: | N880Z |
| Aircraft: | GATES LEARJET CORPORATION 35A | Injuries: | 4 Fatal |

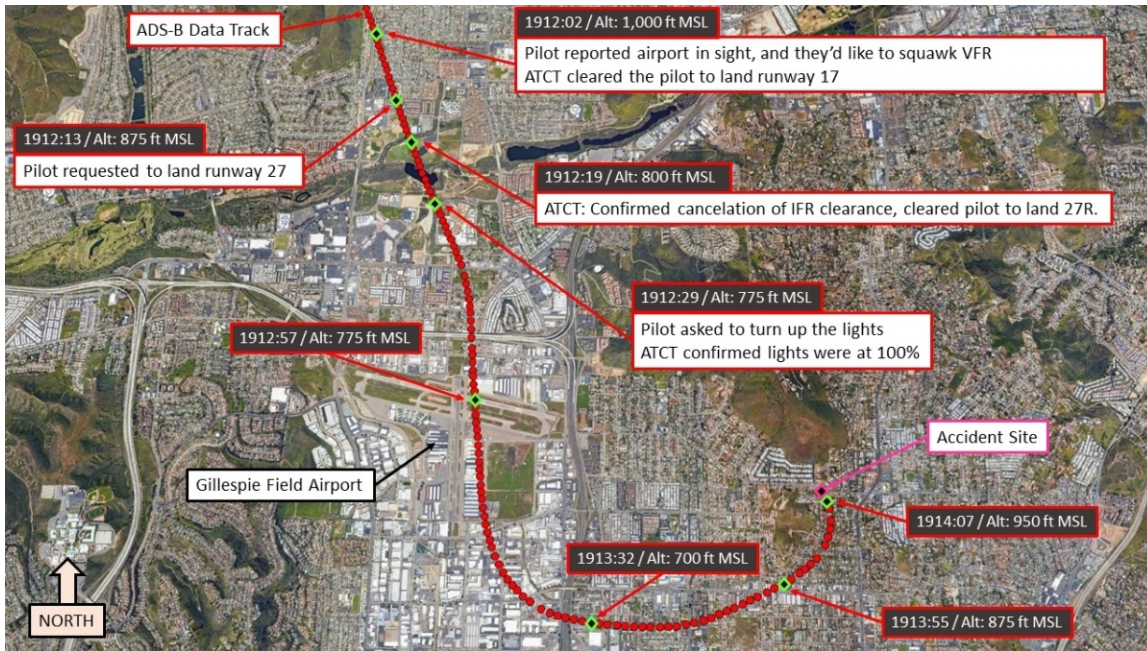
Preliminary Automatic Dependent Surveillance-Broadcast (ADS-B) data showed that after departure from SNA, the flight made a left turn out over the waters of the Pacific Ocean and flew generally south – southeast along the coast and ascended to a cruise barometric altitude of about 11,000 ft sea level (MSL). After the flight passed Carlsbad, California, the airplane turned left and began to descend toward SEE. As shown in figure 1, ADS-B data showed that the airplane overflew SEE at a barometric altitude of about 775 ft MSL (407 ft above ground level) and entered a left downwind for runway 27R. While on the downwind leg, the airplane descended to a barometric altitude of 700 ft MSL, then ascended to a barometric altitude of 950 ft MSL while on the base leg. The last recorded ADS-B target was at 1914:09, at a barometric altitude of 875 ft MSL.

Figure 1: Recorded ADS-B data with ATC communication annotations.
