UNITED STATES DISTRICT COURT
NORTHERN DISTRICT OF CALIFORNIA

PACIFIC GAS AND ELECTRIC
COMPANY,

**PG&E Independent
Monitor Report of
November 19, 2021**

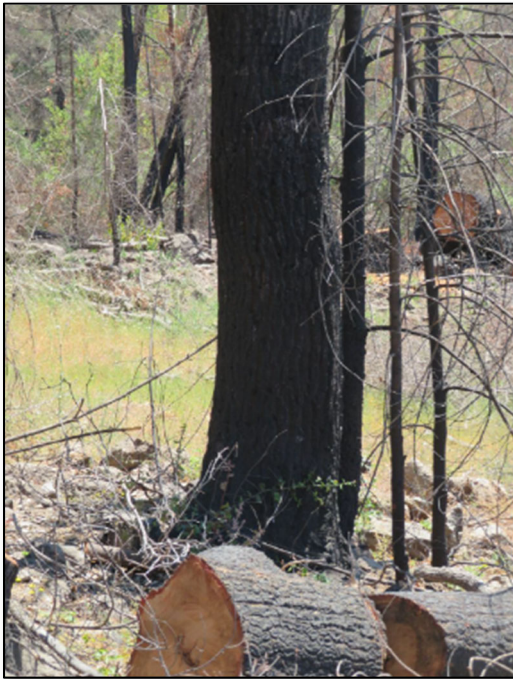
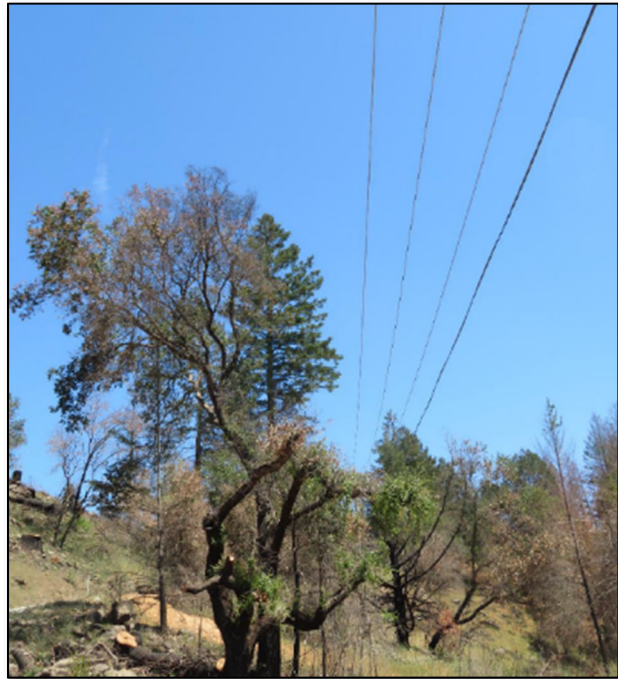
Below is a hazard tree with fire damage identified by the Monitor team.

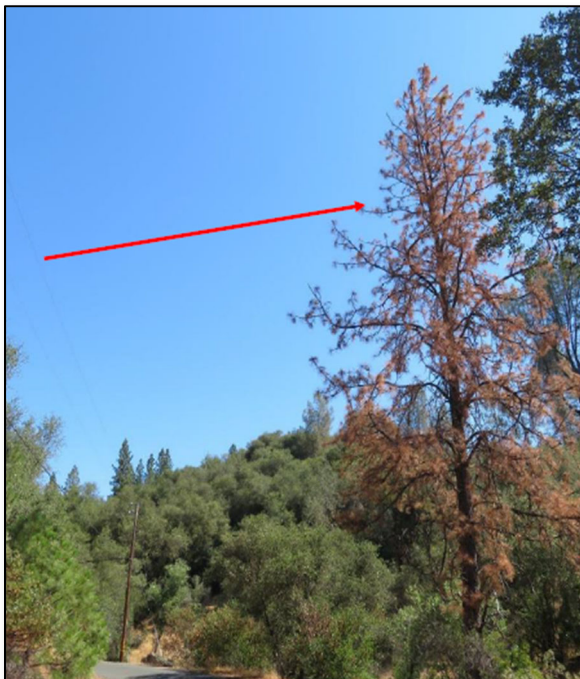
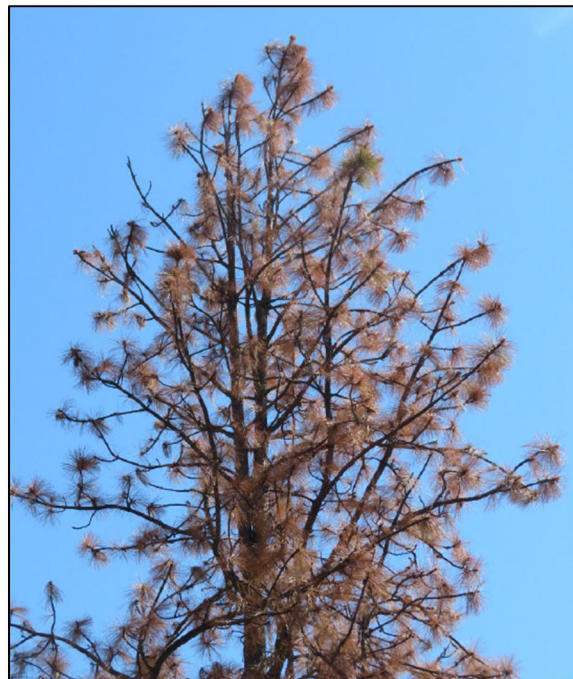
Below is a hazard tree that was dead or dying identified by the Monitor team.

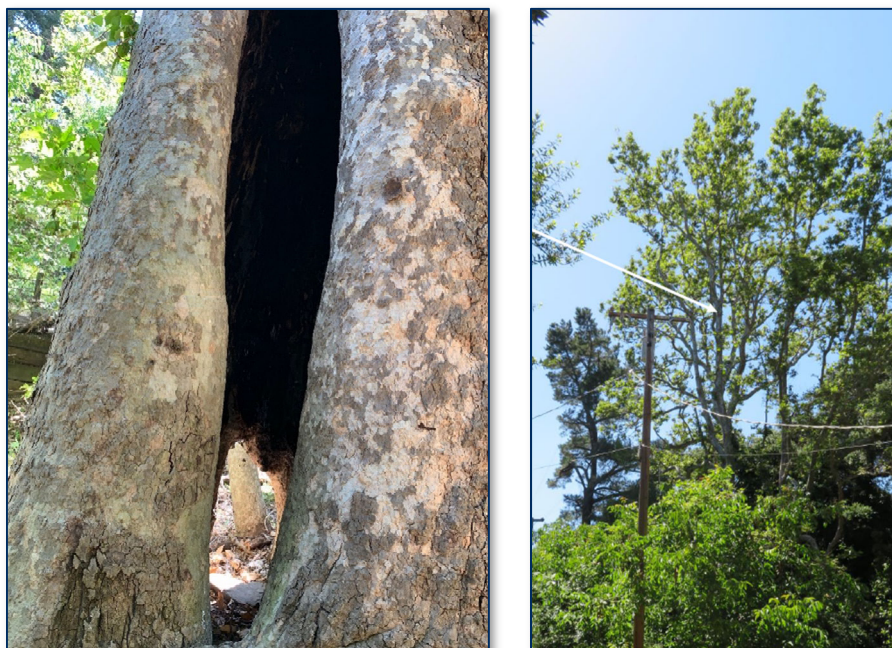
Below is a hazard tree with decayed cavities identified by the Monitor team.

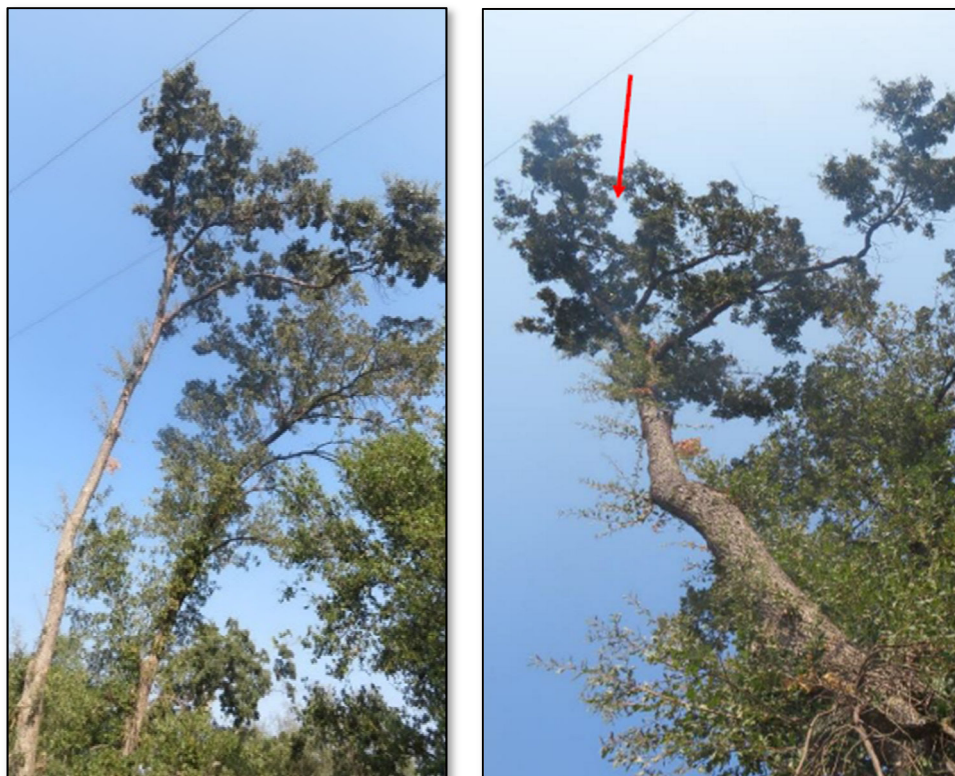
Below is a hazard tree with poor taper identified by the Monitor team.

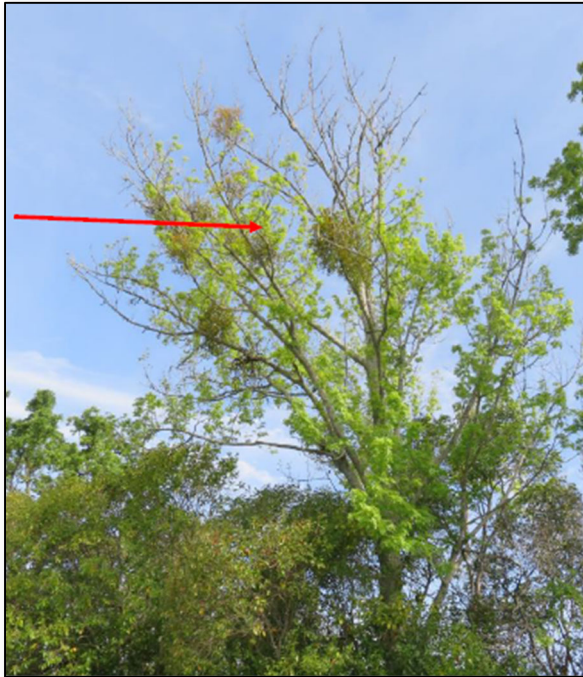
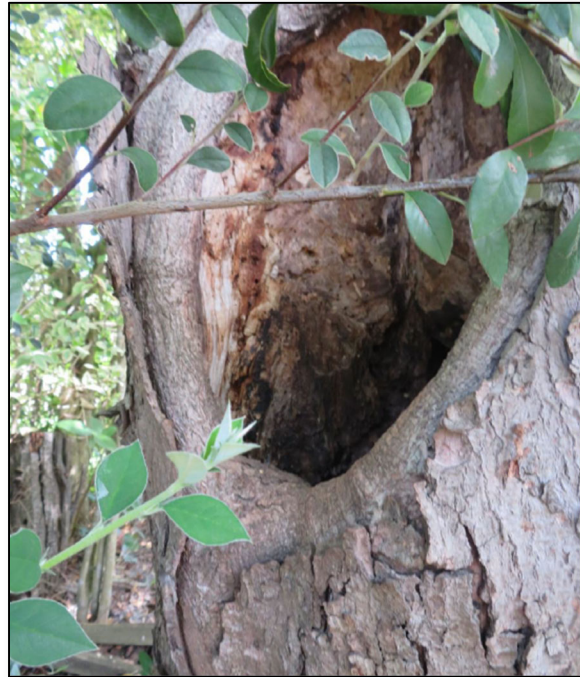
Below is a hazard tree with branch dieback and decayed cavities identified by the Monitor team.

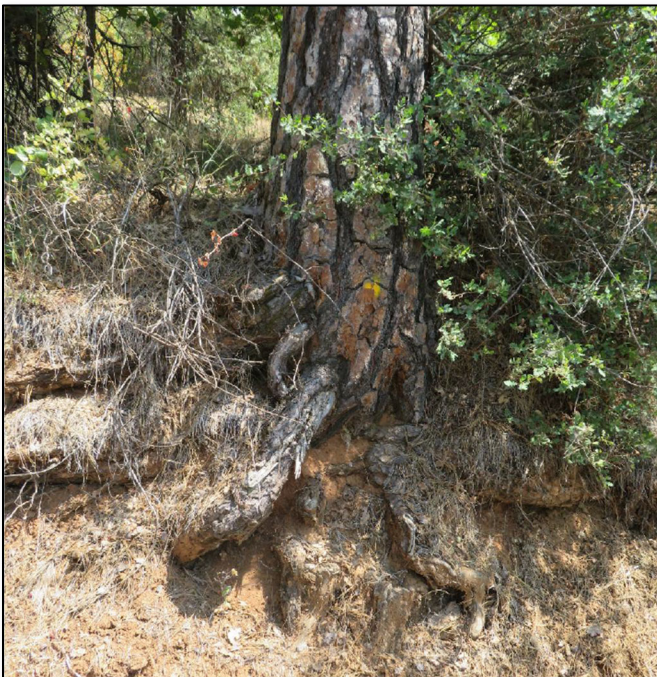
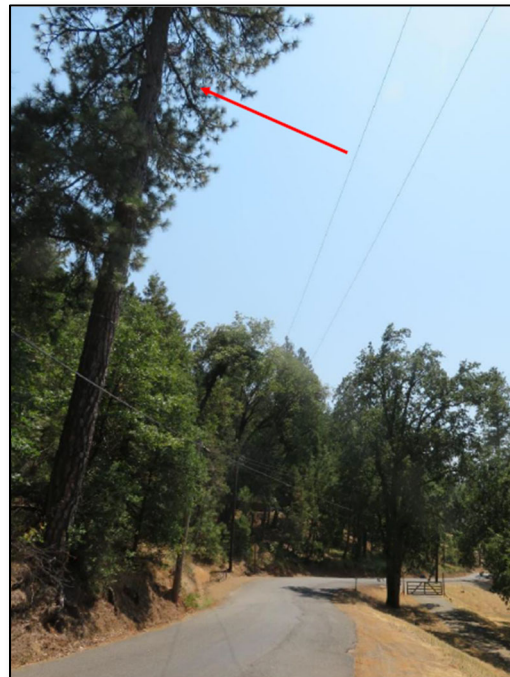
Below is a hazard tree with exposed roots identified by the Monitor team.

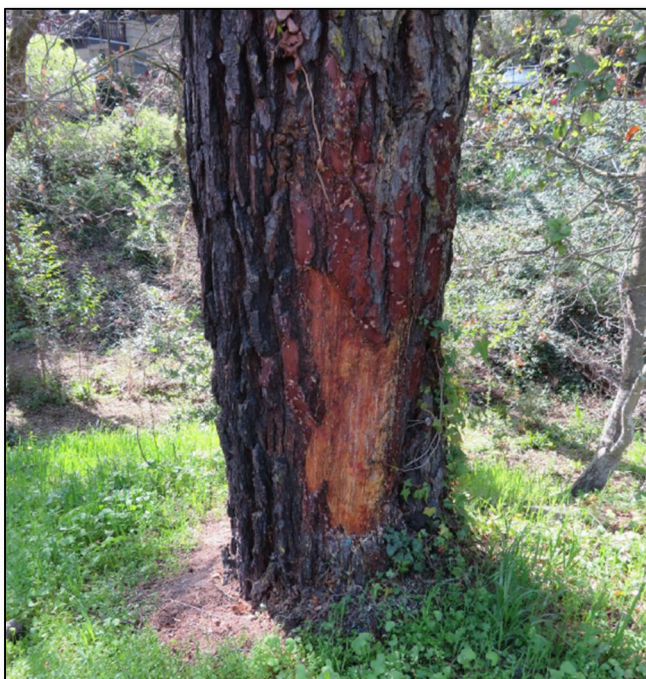
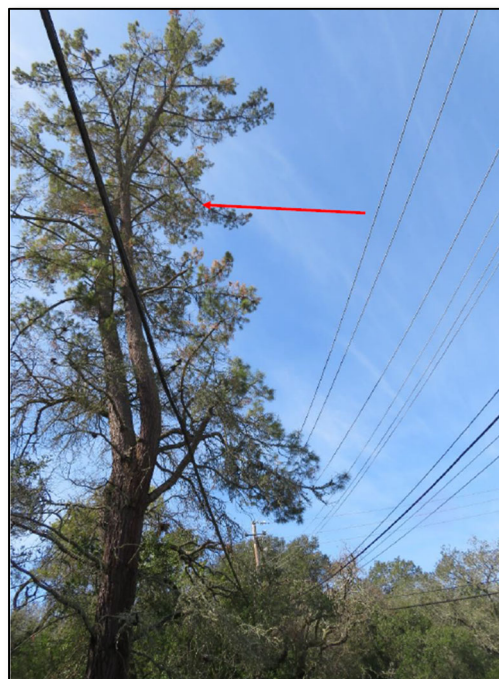
Below is a hazard tree with mechanical damage identified by the Monitor team

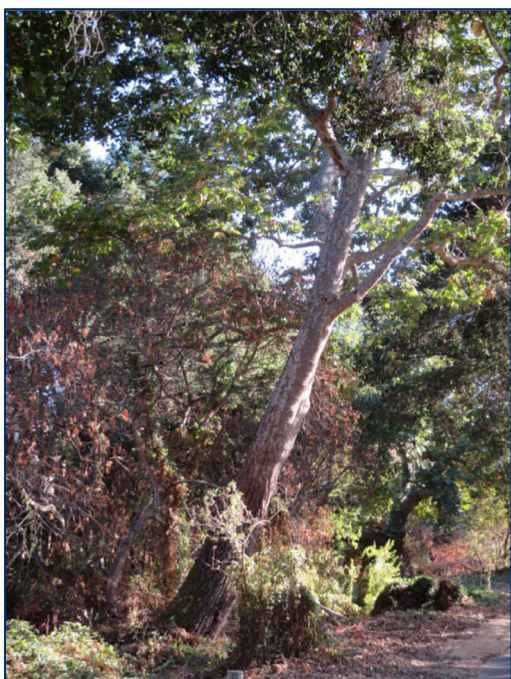
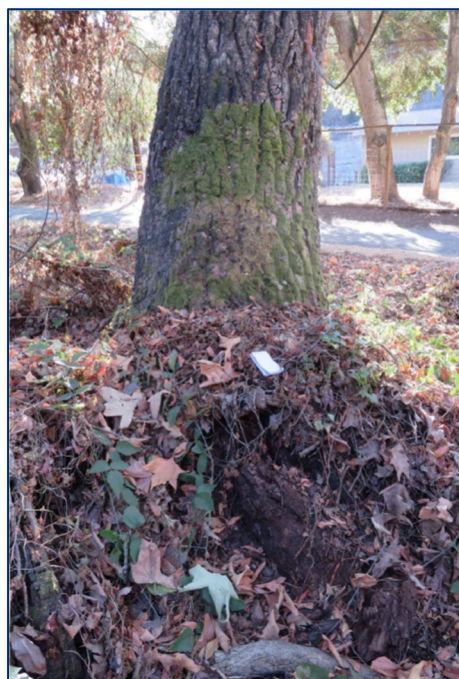
Below is a hazard tree uprooting at the base identified by the Monitor team.

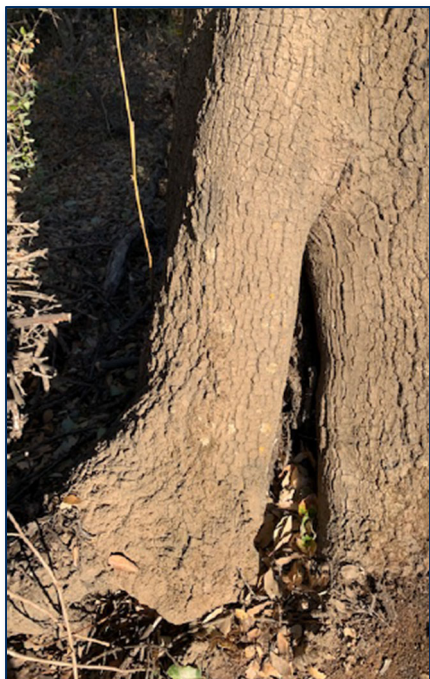
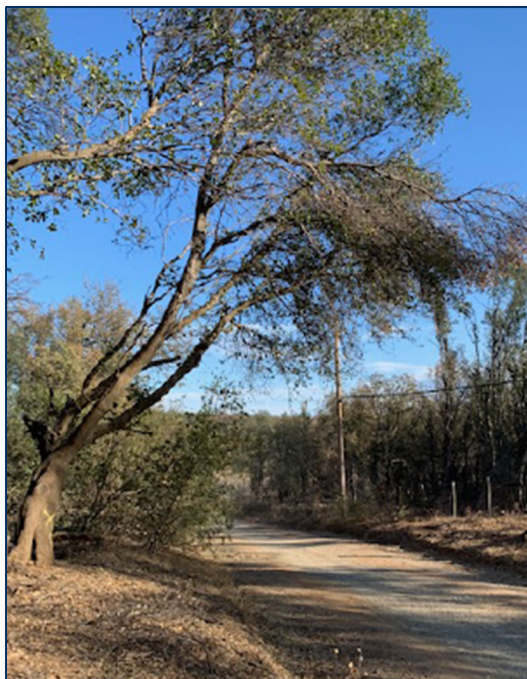
Below is a hazard tree with cavities, heart rot, and cracking identified by the Monitor team.

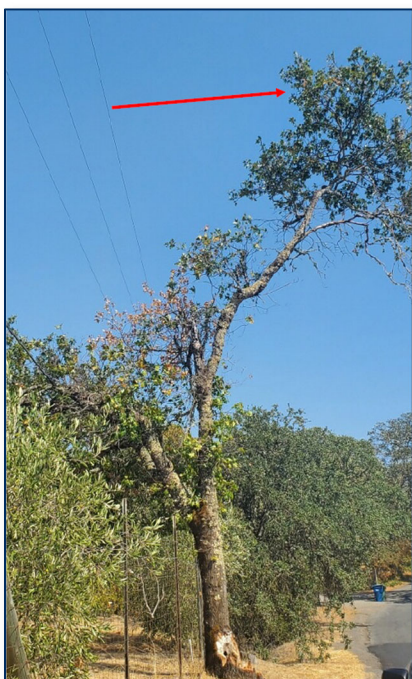
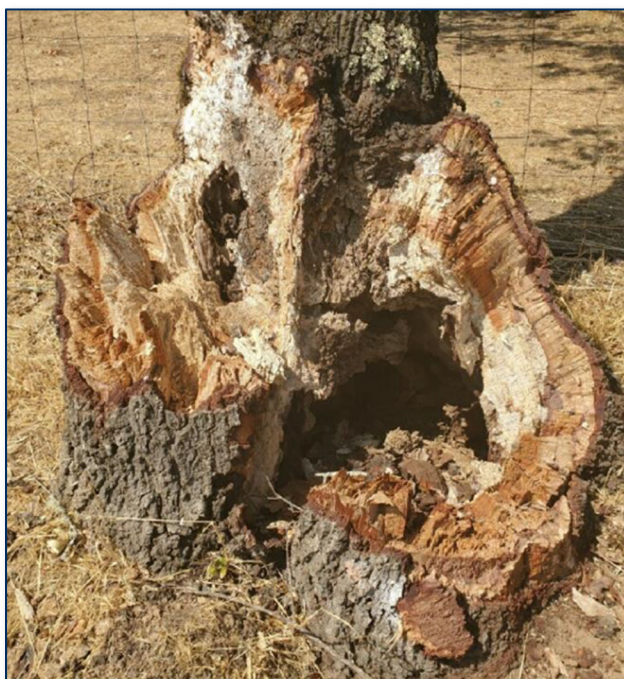
Below is a hazard tree with cavities and rotting identified by the Monitor team.

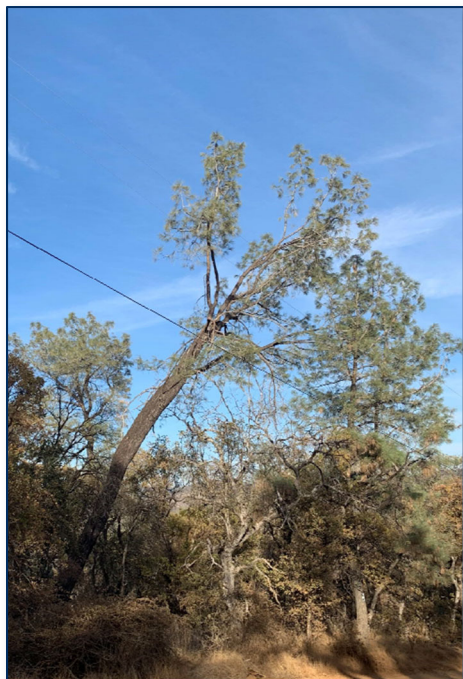
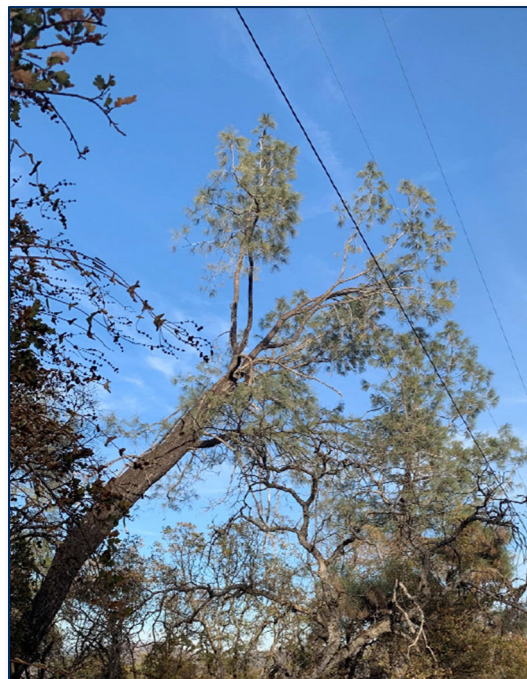
Below is a hazard tree with severe lean towards primary conductor identified by the Monitor team.

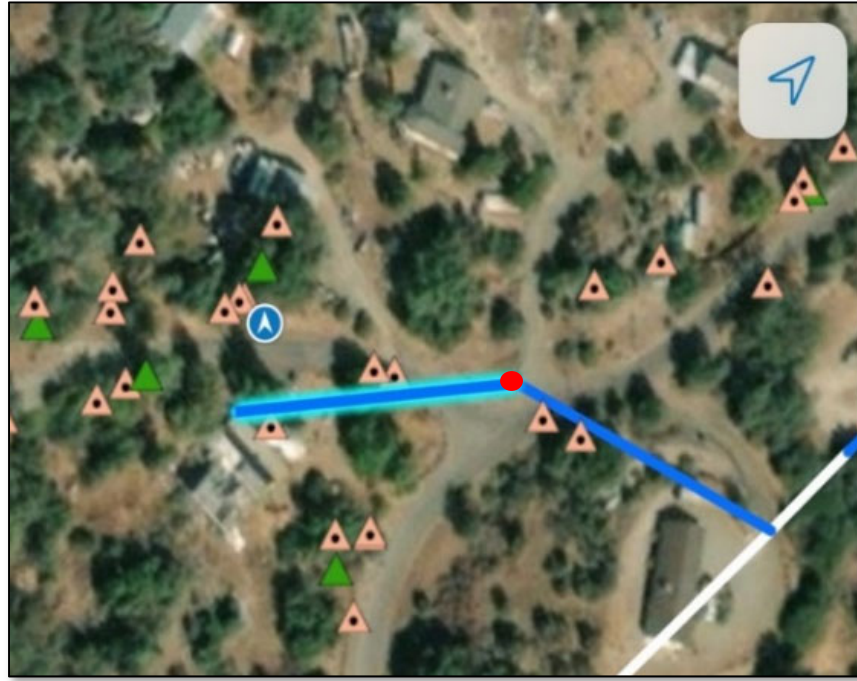
On CIP_BF126-A14_638206, the actual location of a pole (blue circle with white arrow) was ~200 feet away from the location of that pole on the Arc Collector map (red circle).

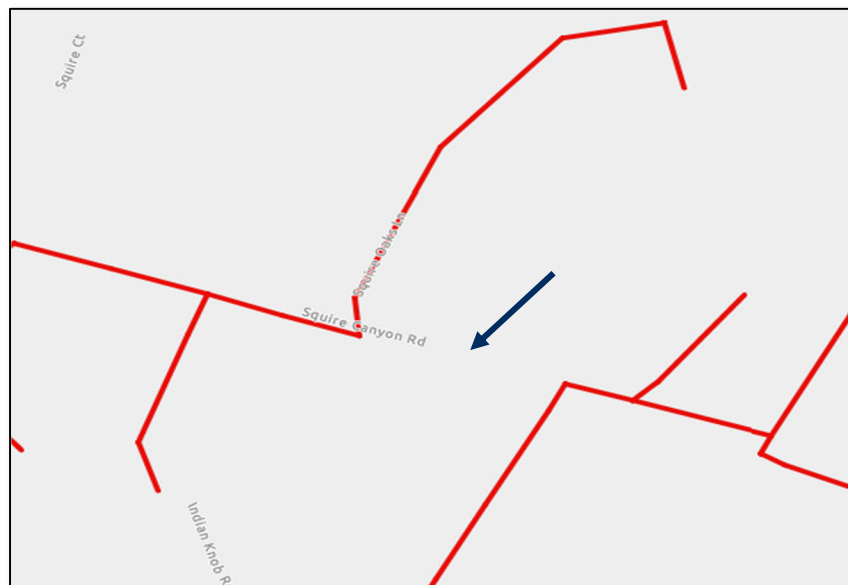
Near CIL_AY138-L08_143892, the Monitor team informed PG&E on 10/30/20 of a radial clearance issue on a segment that was missing from the Arc Collector map. That segment is still missing in 2021.

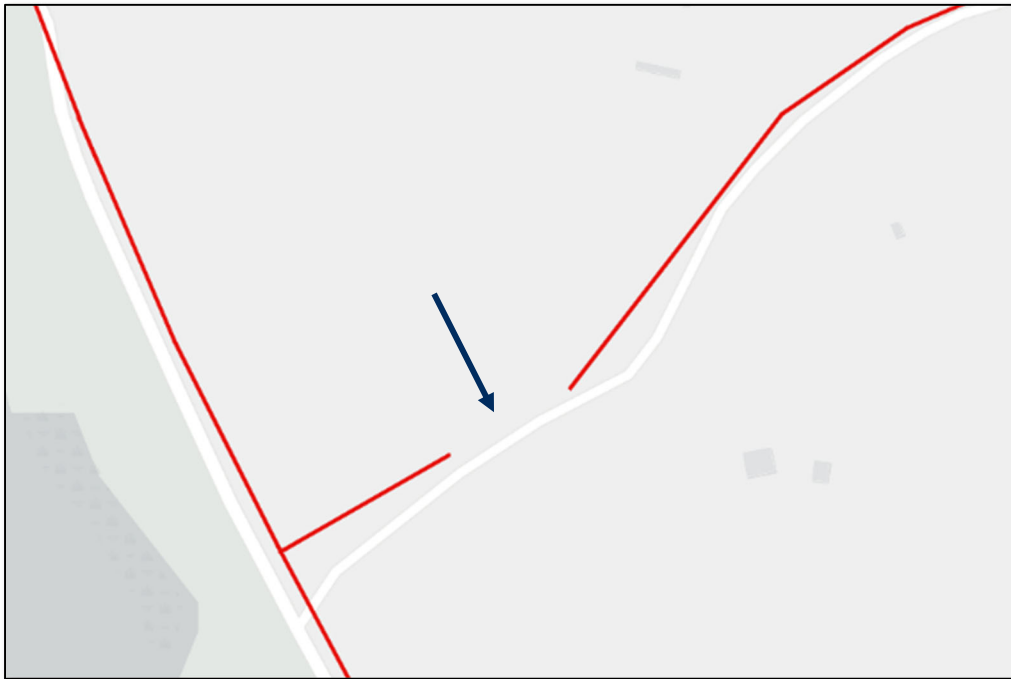
Near CIE_AJ120-I16_1746168, a segment was observed as missing from the Arc Collector map.

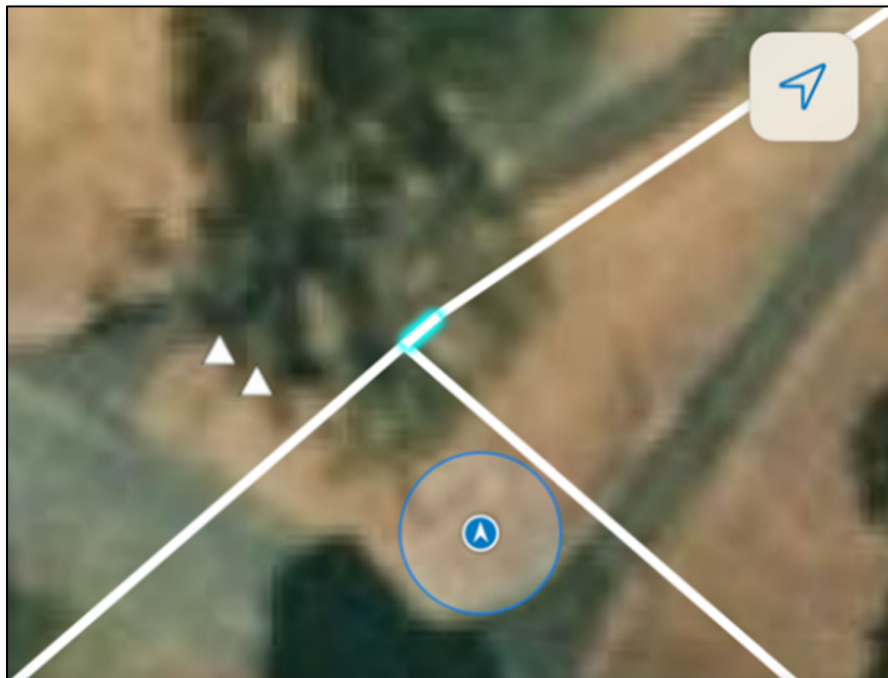
CIE_B127-B19_1727589 is a seven-foot long segment that does not correspond to a full span of primary conductor.

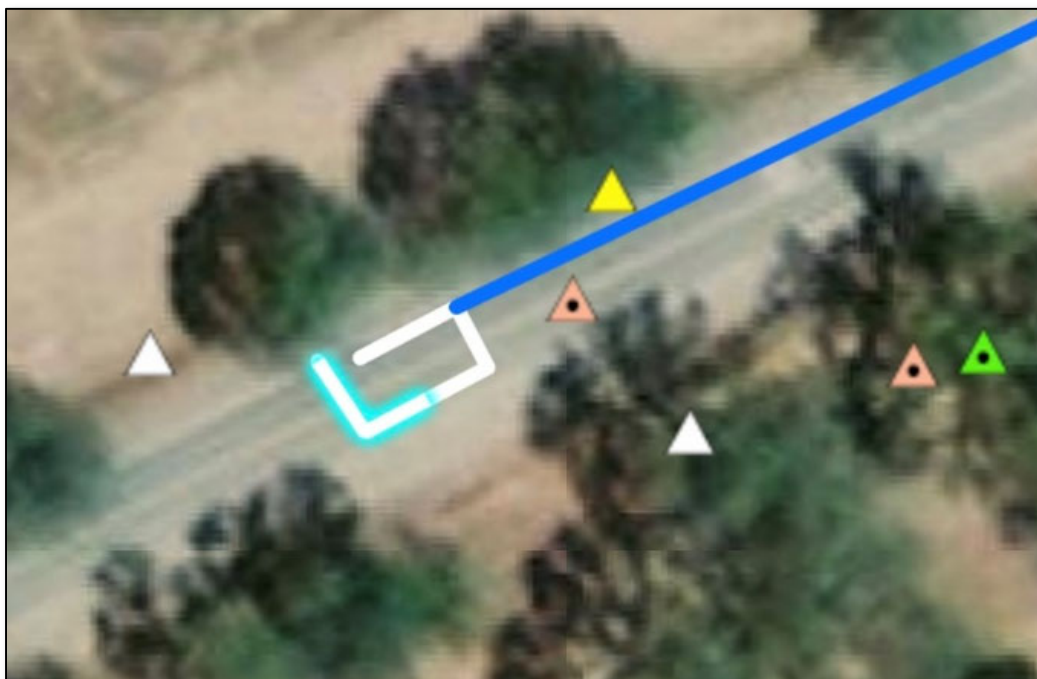
CIE_AO108-B15_1774125 (and the adjacent L-shaped segment) do not exist in the field.

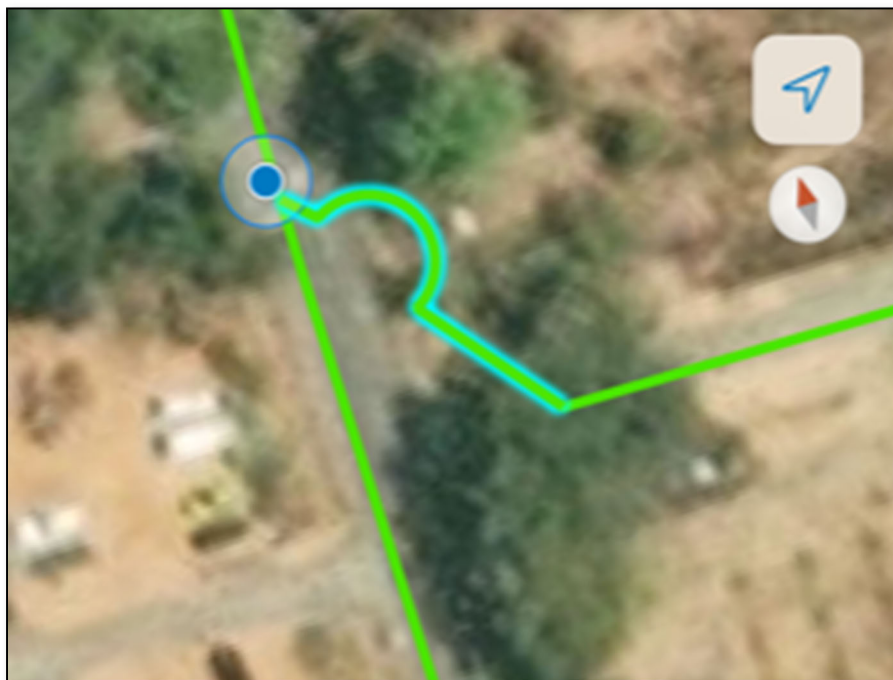
CIE_AP120-K24_1757184 appears curved on Arc Collector, but the segment is a straight line in the field.

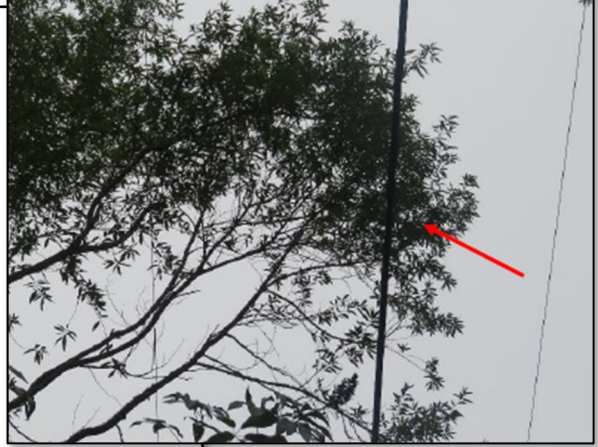
Near CIE_AJ120-K23_1744484, the Monitor team observed five trees that had been marked as “Tree Work Complete,” but the Monitor team observed that the prescribed tree work had not been performed.

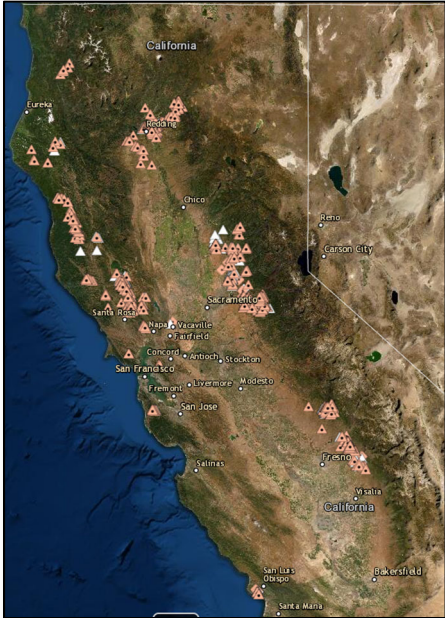
The below vegetation point record shows a tree with a Tree Assessment Tool result of “Abate” but a Status of “No Work Required Under EVM.” The map shows 1,541 vegetation point records in Arc Collector with the same discrepancy between the Tree Assessment Tool result and the Status.

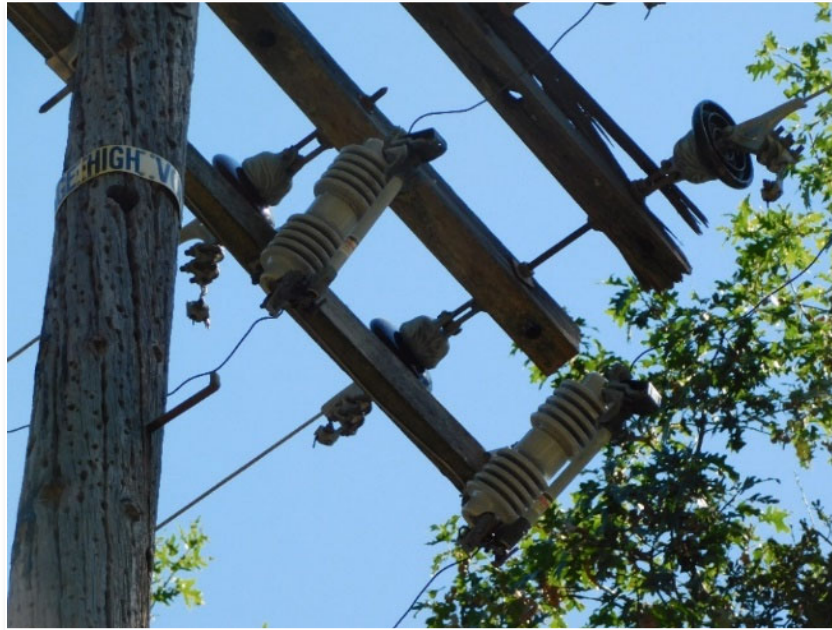
Below is a severely damaged crossarm the Monitor encountered in a Tier 3 HFTD. The Monitor team immediately reported this condition to PG&E, which then dispatched a field team that arrived on site within approximately two hours.

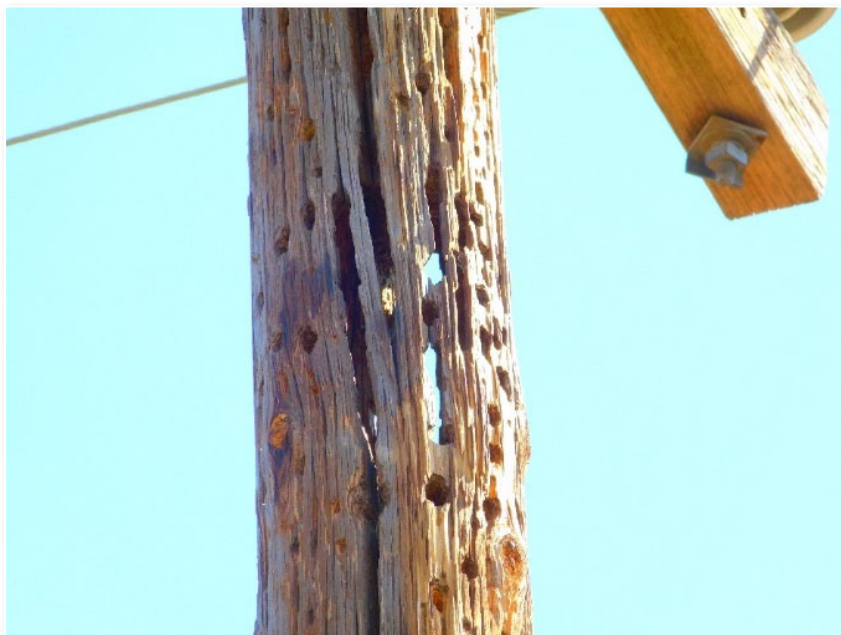
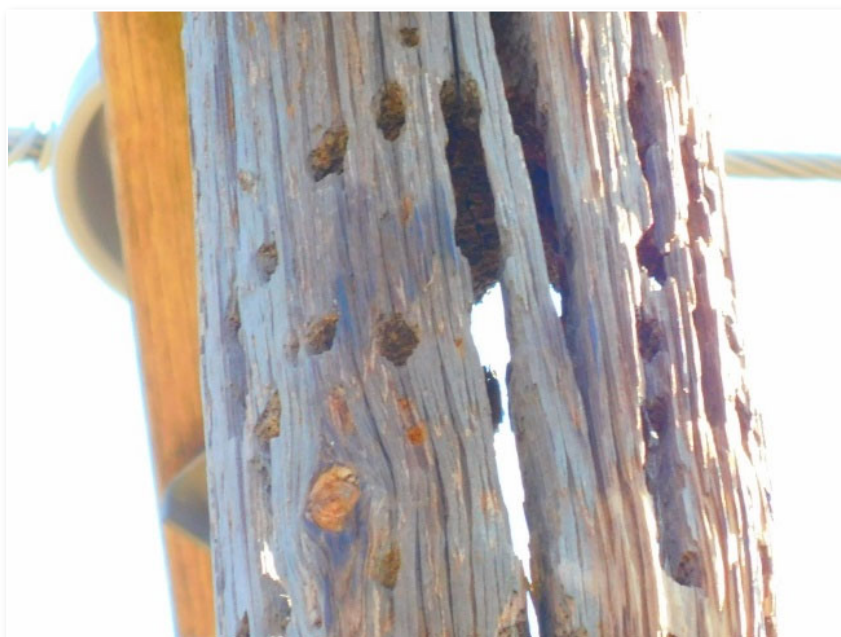
Below is a pole with severe cracking and decay that the Monitor team found in a Tier 2 area and immediately reported to PG&E. The Monitor team confirmed that PG&E replaced the pole the same day.

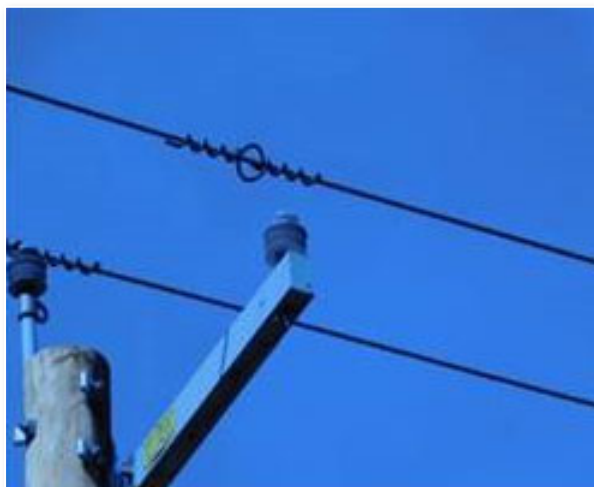
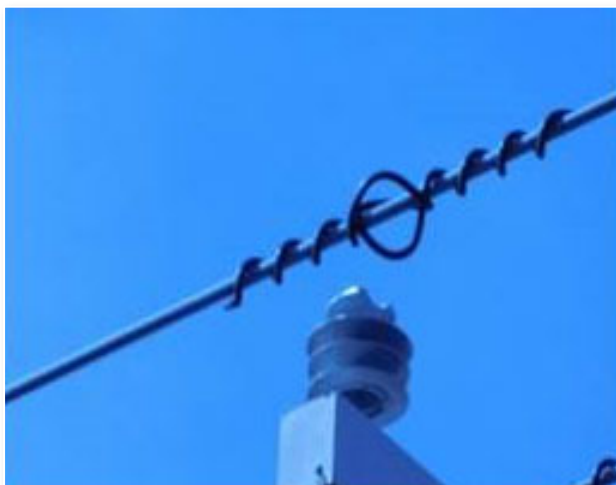
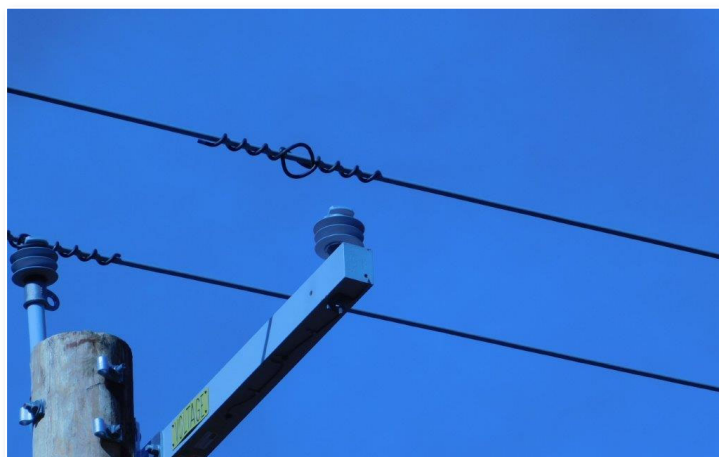
Below are floating conductors the Monitor team identified in Tier 3 areas and immediately reported to PG&E.

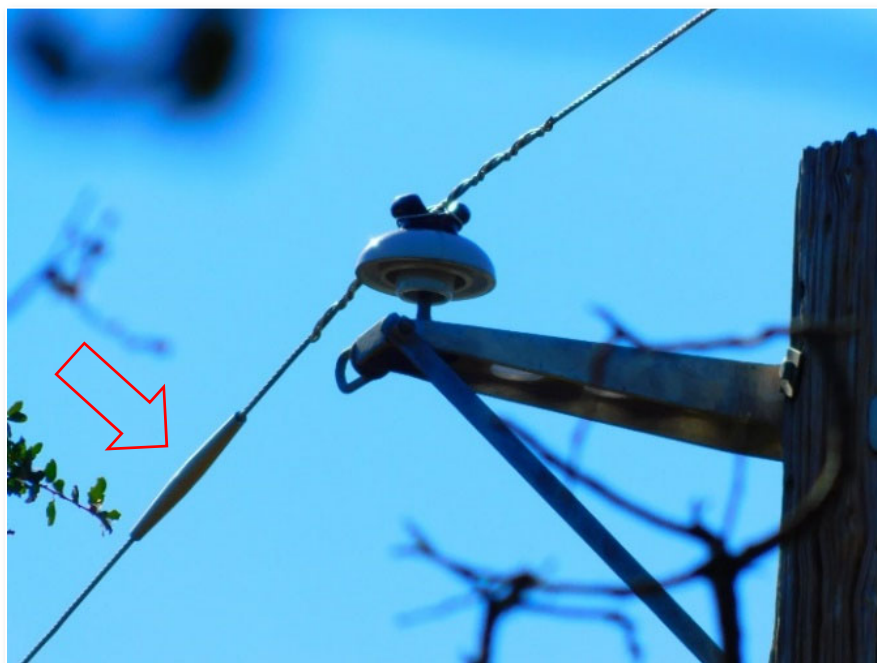
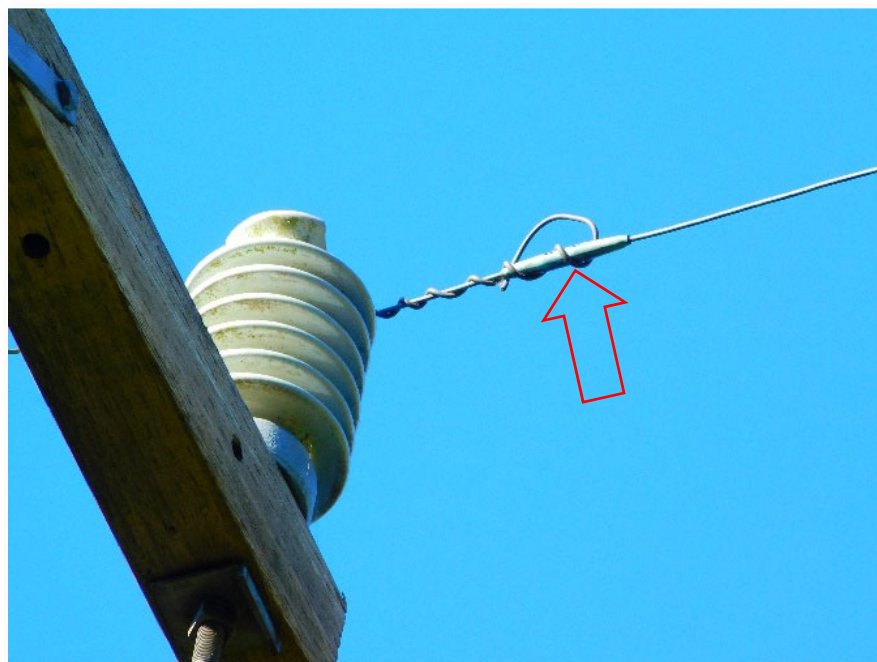
Below are conductors the Monitor team identified with splices tied in within 2' of an insulator.

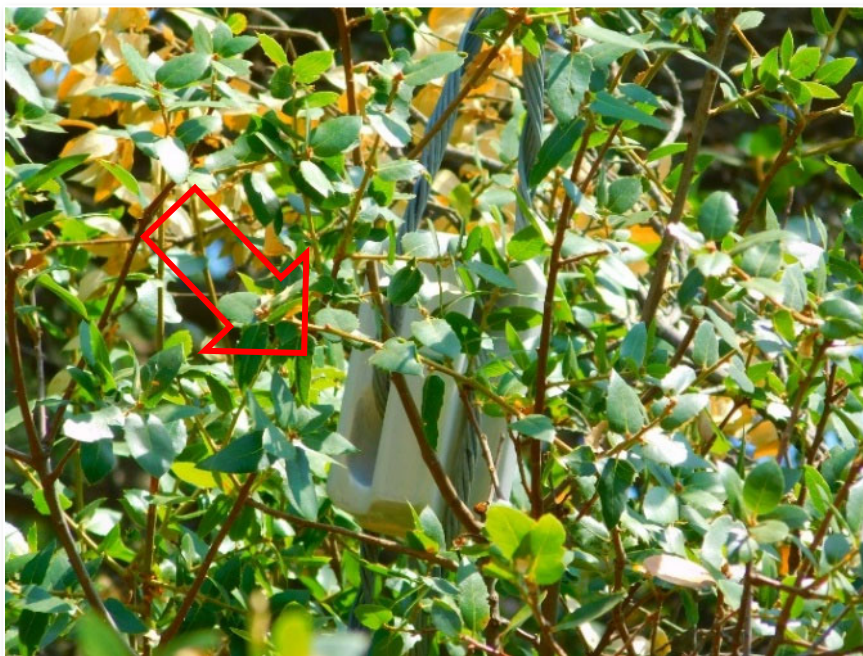
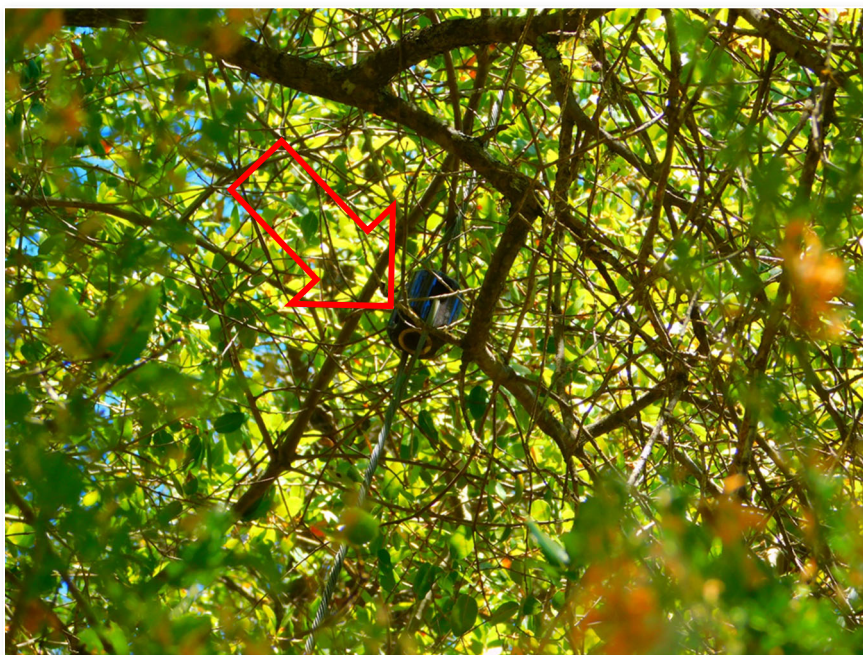
Below are examples found by the Monitor team where the guy wire was overgrown by vegetation.

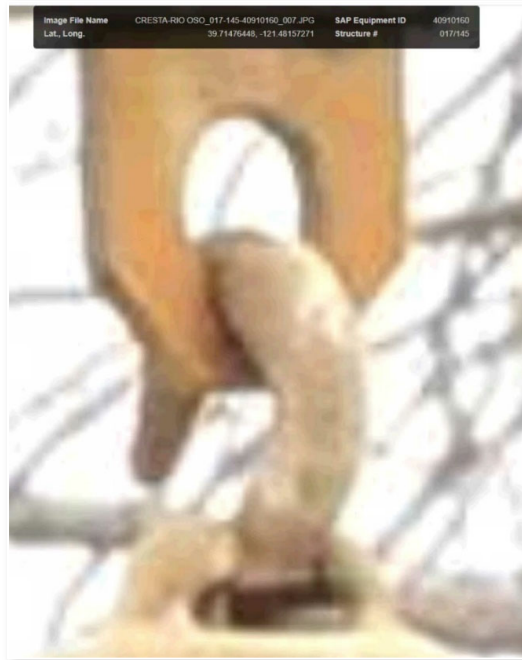
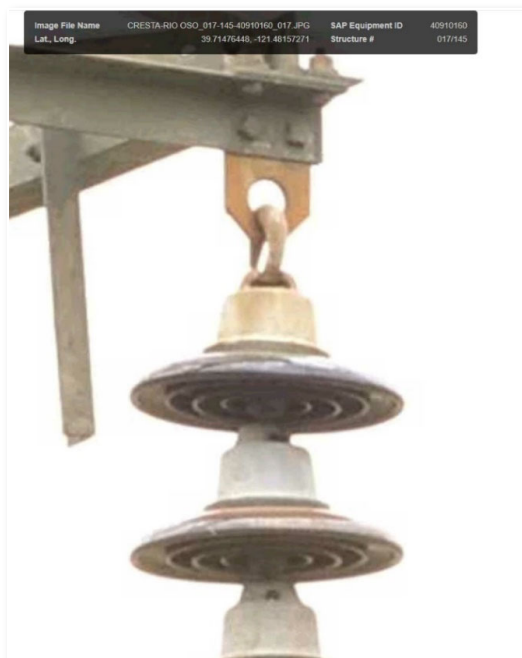
Below is a transmission structure on which the Monitor team observed a partially deteriorated C-hook and hanger plate.

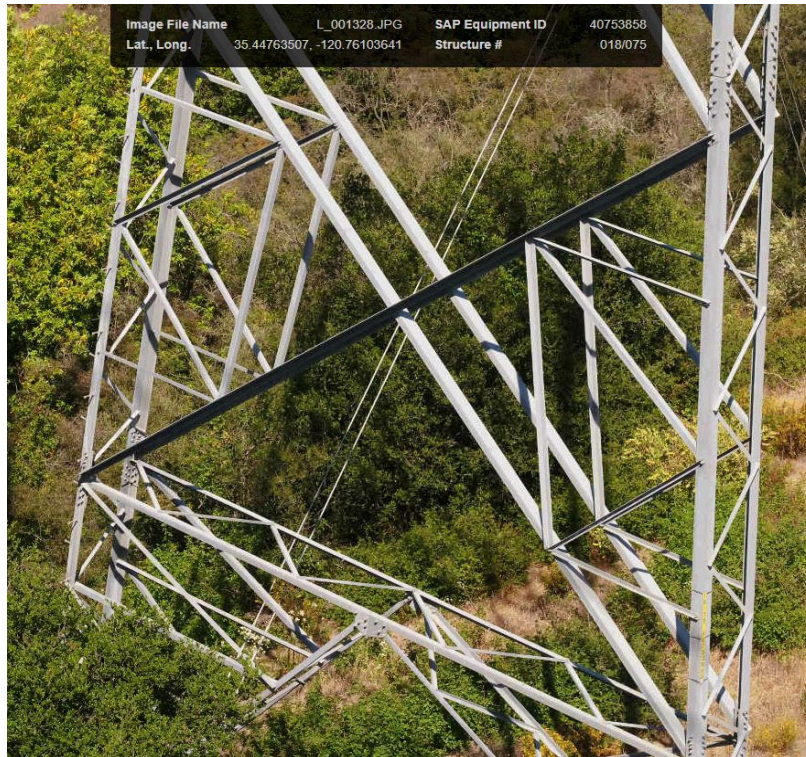
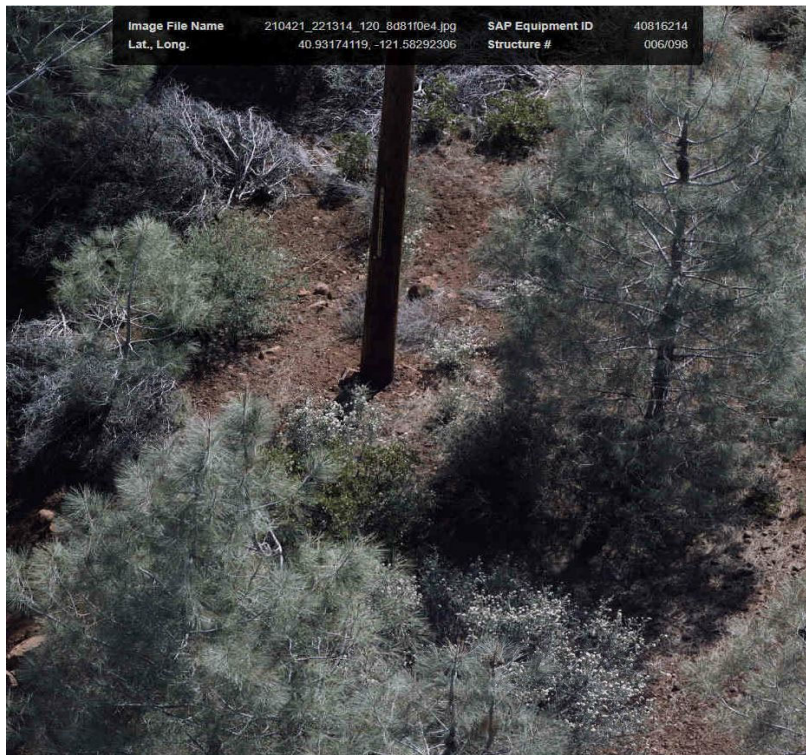
Below are structures the Monitor team identified that appeared to have vegetation present where PG&E inspectors did not note it.
