January 27, 2022

Subject: Landslide Damage Assessment
SURDI RESIDENCE
5008 139th Place SE
Bellevue, Washington 98006

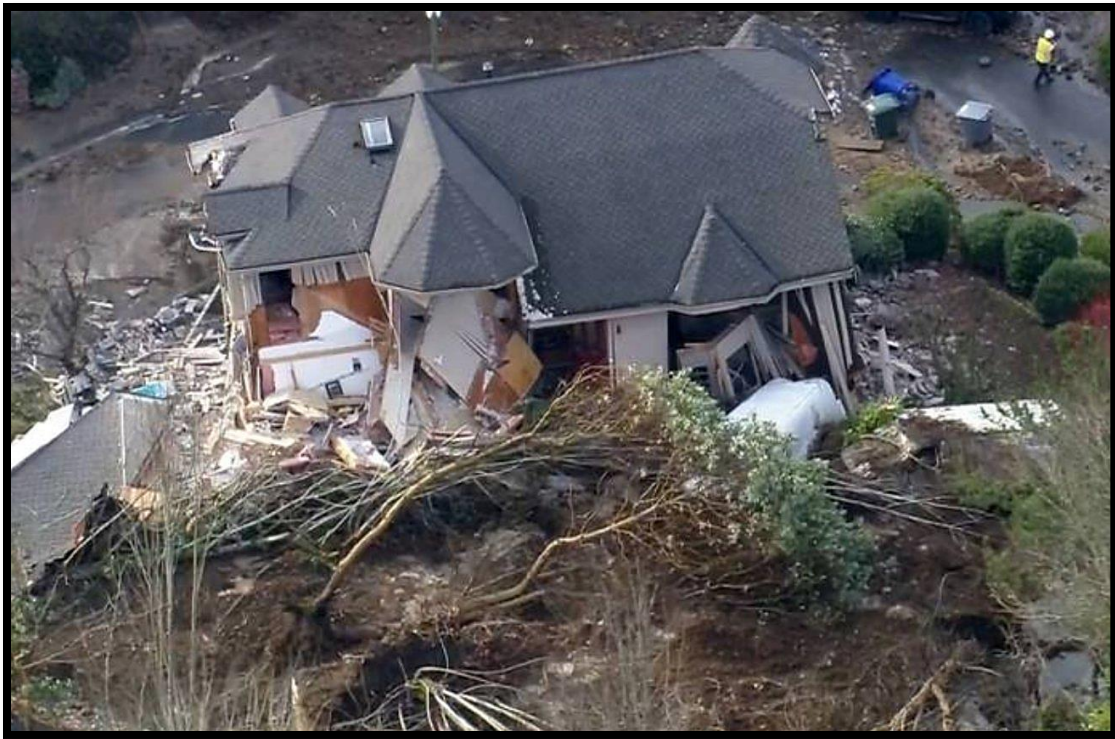
2. The north exterior wall of the home that previously supported the roof framing has broken into pieces (Photograph Nos. 5 & 7). The west wall is breaking apart where a chimney had been located adjacent to a two-story tall, vaulted section of the home (Photograph No. 8). Portions of the east wall are buckling along the floor line (Photograph No. 9). Only the south wall is relatively intact.

5. The north elevation of the Surdi Residence after the January 17, 2022 landslide (aerial image courtesy of KIRO 7).

Due to the instability of the subject wood structure and the ongoing risk that the home poses to the adjacent street and structures, we recommend that the home be demolished as soon as possible. It is our opinion that the safety risks are too great to allow construction personnel to work in close proximity to the home, and therefore, we are unable to recommend the installation of bracing near/for the home prior to demolition. There does not appear to be any portions of the wood-framed sections of the home that are salvageable. After demolition and debris removal, the home's concrete foundation may be evaluated for reuse.

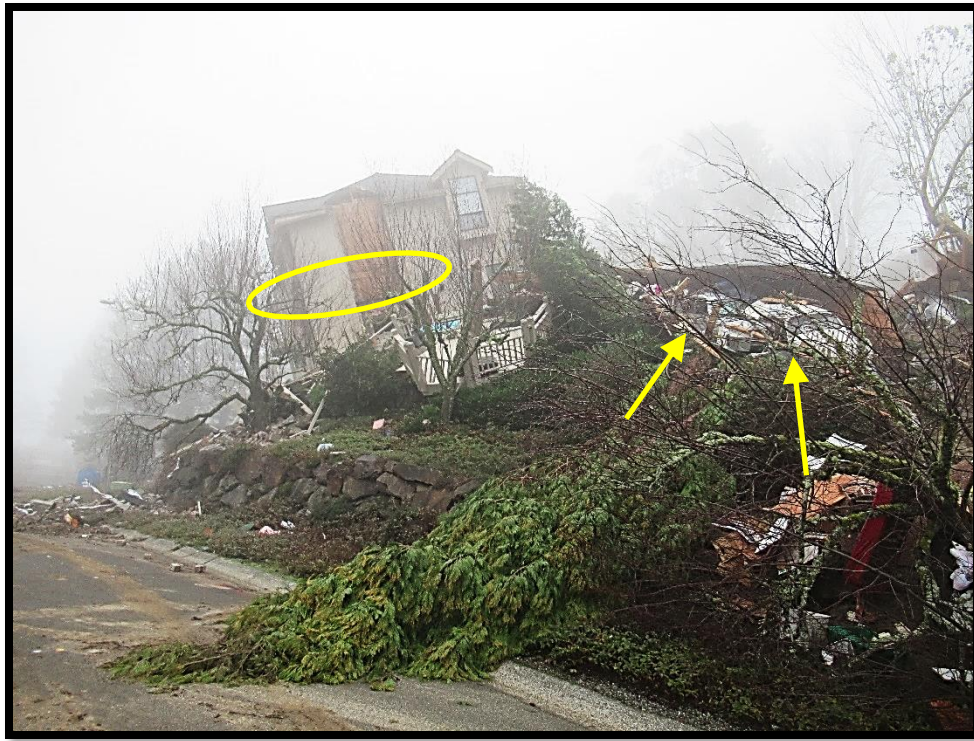
3. The south and east decks have been pulled down the hill along with the home. Most of the east side deck has broken to pieces and the debris is resting on trees in places (Photographs Nos. 9 & 10).

5. Landslide debris (loose and wet soil/mud/rock and vegetation) has filled portions of the basement as observed from the north side of the home. Two cars and two vans have been pushed into the north walls of the home and are located either up against the home or in the basement of the home (Photograph Nos. 12 & 13). Two additional cars are facing downhill in the middle of the debris at the east end of the home (Photograph No. 9).

9. Portions of the east wall are buckling along the floor line (oval). Two cars are facing downhill to the east of the home (arrows). A portion of the deck has also collapsed and is resting upon a tree.

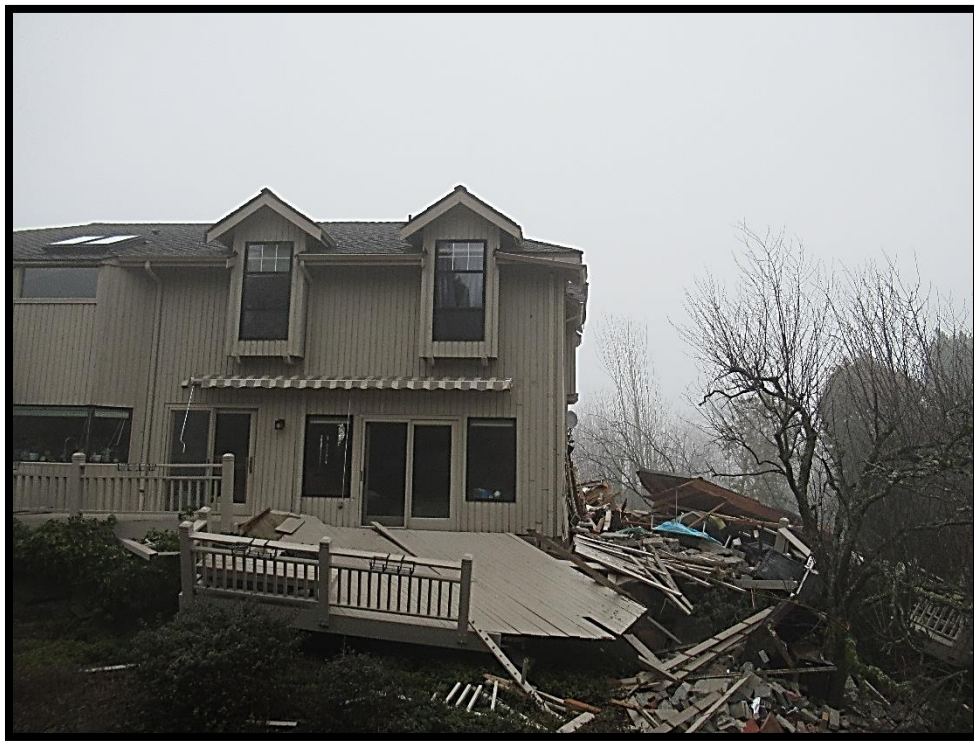
10. Portions of the east side deck have collapsed and are leaning downslope and, in places, are resting upon trees.
