Level Two Investigation

Region 3 Area 16 Mercedes Bronto Skylift F32RLX
Event Type: Cage Levelling System Failure
Event Date: 19 June 2017

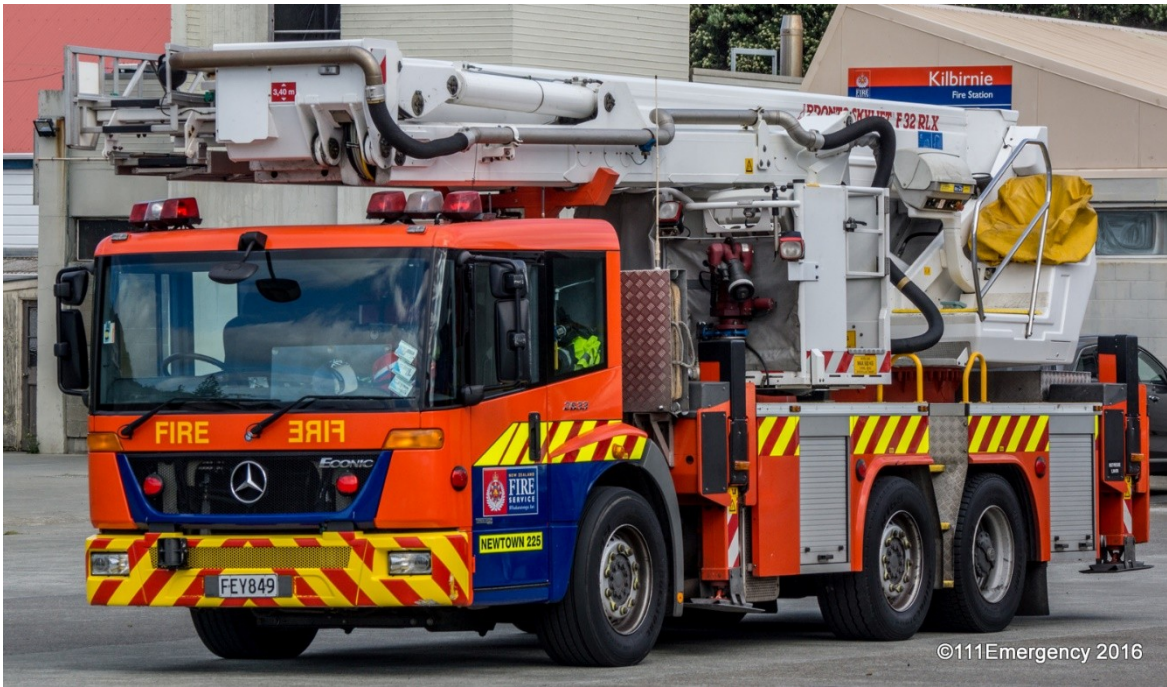
(Fig 1) Bronto Skylift F32 RLX Newtown 225

On Monday 19 June 2017, whilst carrying out the Weekly Checks on the Mercedes Bronto Skylift F32RLX (FEY 849/ Newtown 225)[Fig 1] at Newtown Fire Station, the crew experienced a catastrophic failure of the cage levelling system.

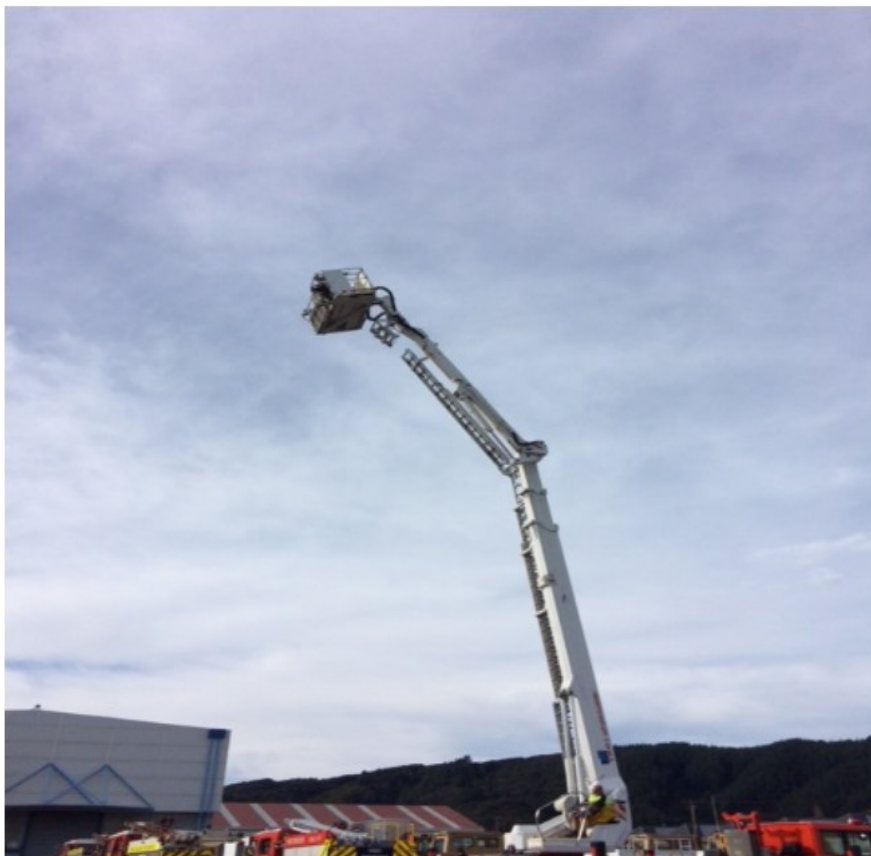
On Friday 21 July the Level 2 Investigation Team requested a recreation of the event and assembled at Lockheed Martin. The original OIC was available and performed similar movements resulting in the same fault occurring but not as violently. [Fig 2&3] also [Fig 5]

(Fig 2) Lockheed Martin Workshops 21/7/17 Cage Tilt Fault Replicated

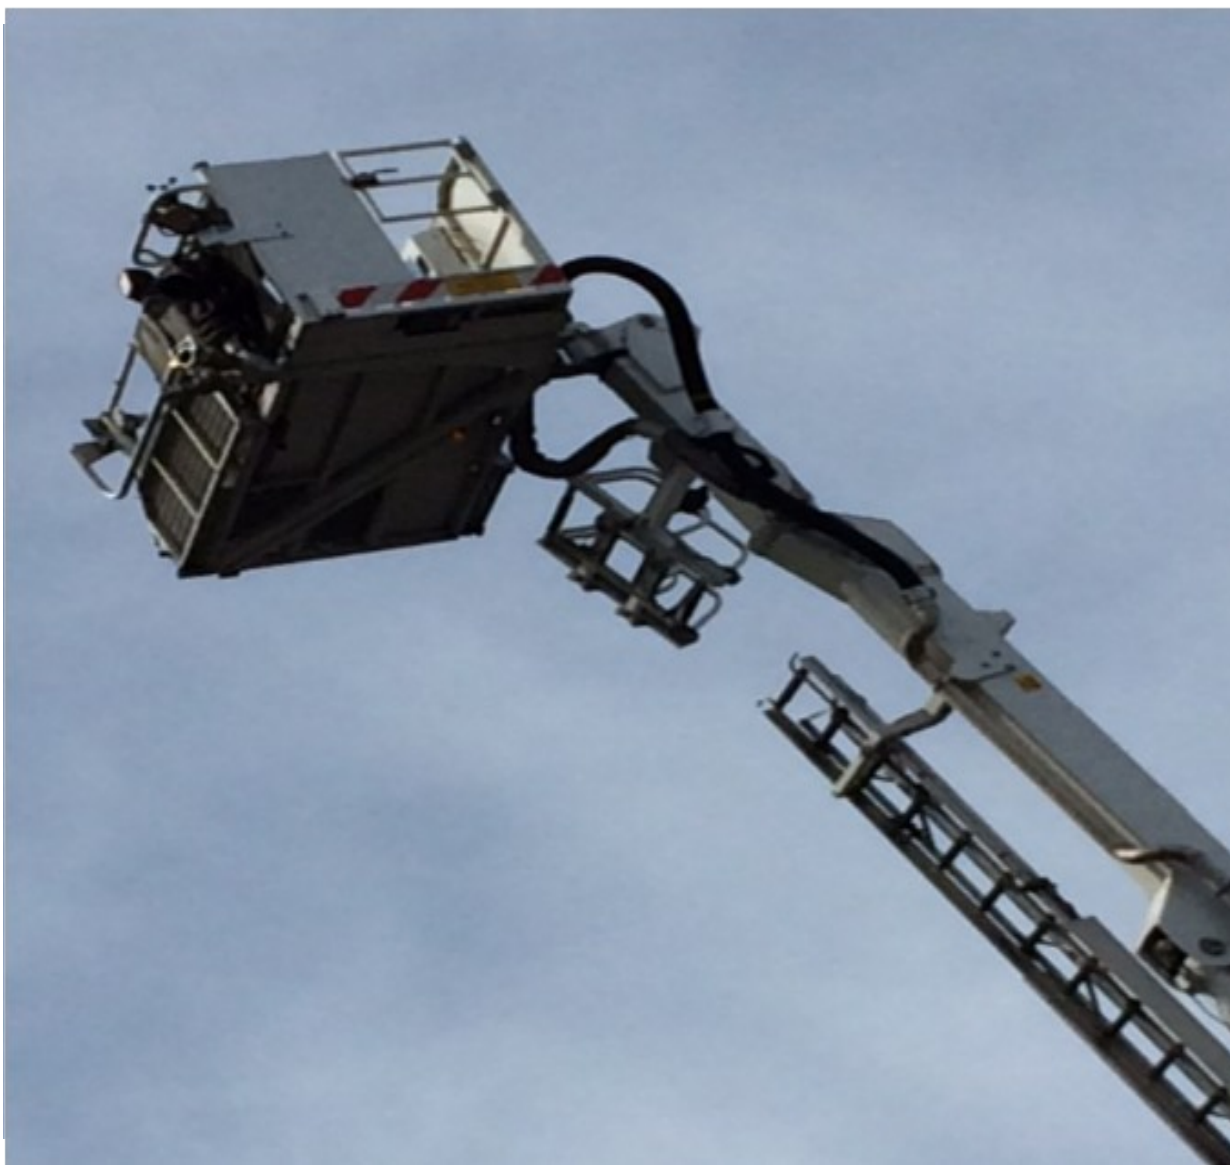
On Friday 21 July the Level 2 Investigation Team requested a recreation of the event and assembled at Lockheed Martin. The original OIC was available and performed similar movements resulting in the same fault occurring but not as violently. The Fleet Coordinator then attended and the fault recreated a second time for his benefit. There were several unusual computer fault readings that could not be interpreted by the group in attendance. The cage angle was showing -23.5deg when the normal reading should maintain at 0deg (but with a minor tolerance either side of 0deg) [Refer Fig 5]

The NZ Bronto service agents – Access Specialties from Auckland, attended on 25 July and effected adjustments to the cage tilt minimum bias and stated “ it was over-correcting due to normal wear and tear over time” and the Cage Down function which was “set too fast”. They also noted play in the Cage Slew sensor shaft connection.

(Fig 3) Lockheed Martin Workshops 21/7/17 Cage Tilt Fault Replicated

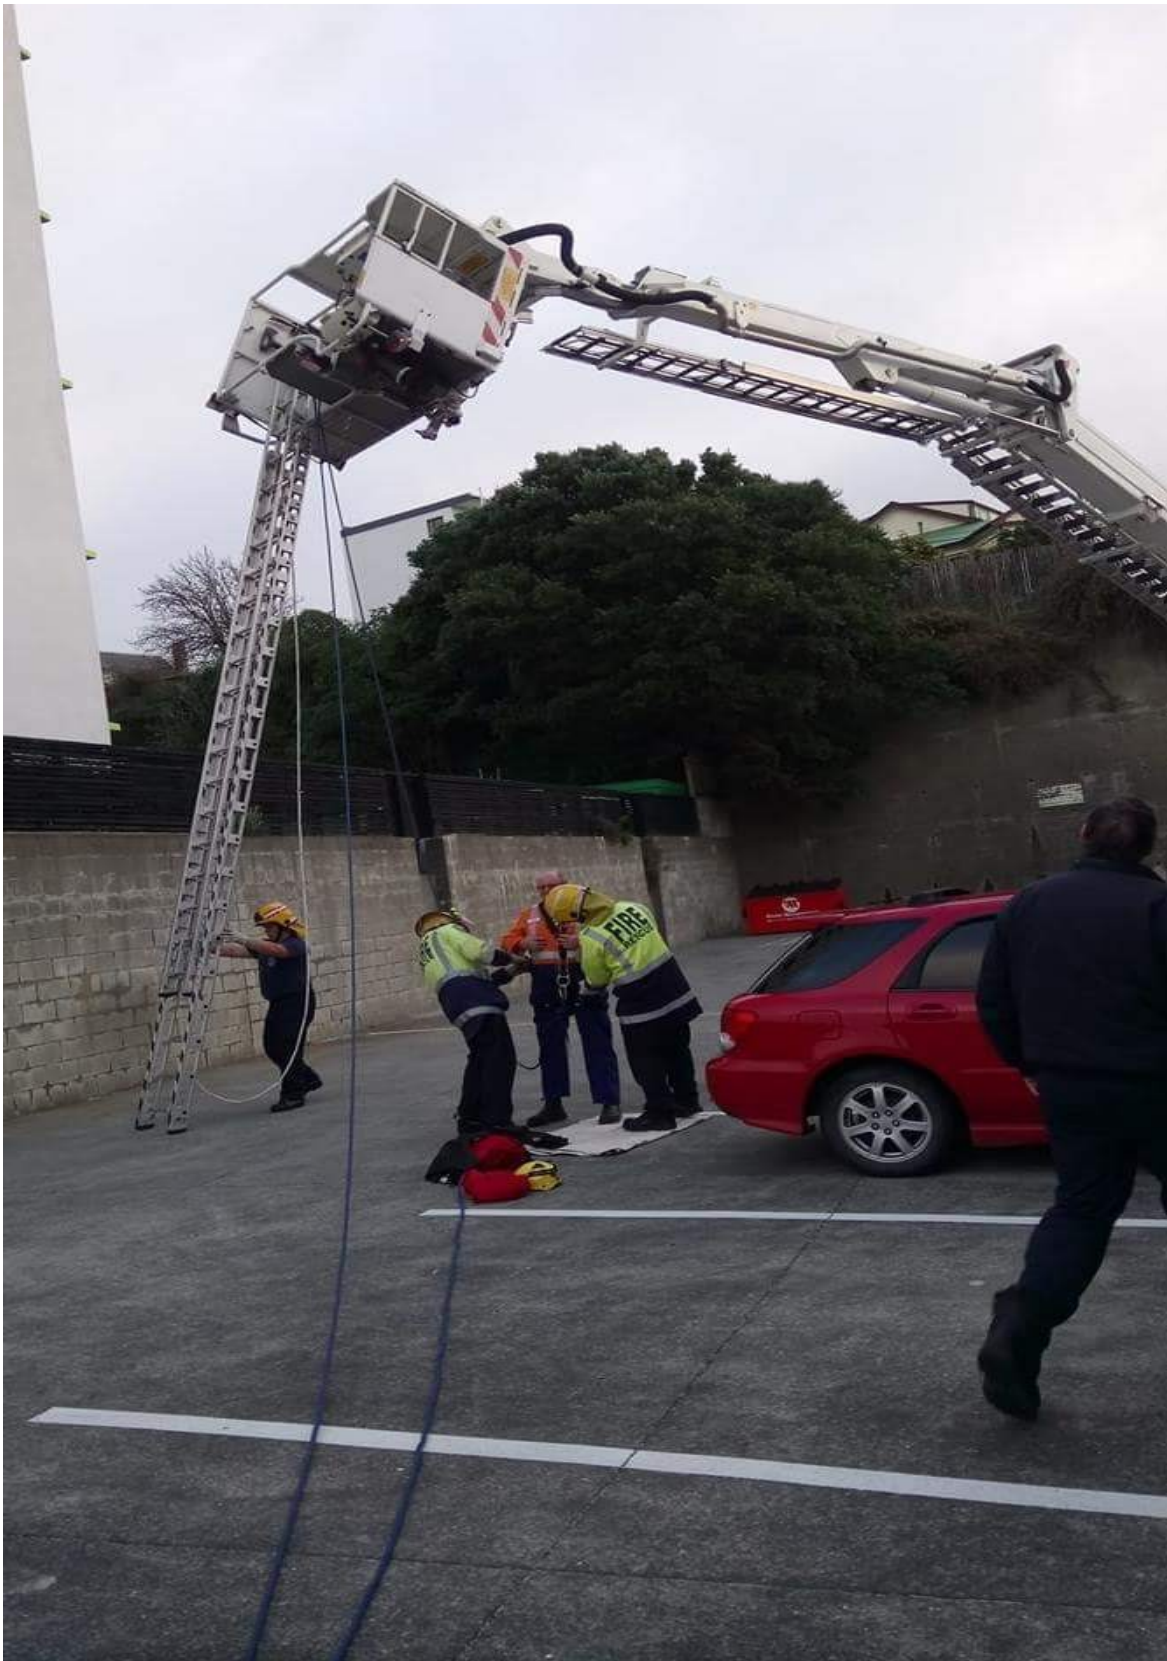
On Monday 19 June 2017, whilst carrying out the Weekly Checks on the Mercedes Bronto Skylift F32RLX (FEY 849/ Newtown 225) at Newtown Fire Station, the crew experienced a catastrophic failure of the cage leveling system.[refer Fig 4]

The OIC tried to re-house the aerial but the controls were frozen. He attempted the emergency re-house procedures utilizing the Electric over Hydraulic Motor and the HATZ Motor. Both of these were inoperable.

The Bronto was immediately booked out of service and the Brigade Mechanical Service Provider (Lockheed Martin) notified. They responded to Newtown Station within an hour, bled down the hydraulics to house the Bronto and it was taken to their workshops at Trentham for assessment.

(Fig 4) Newtown Station 19/6/17 – Partially lowered by Mechanic having bled down hydraulics

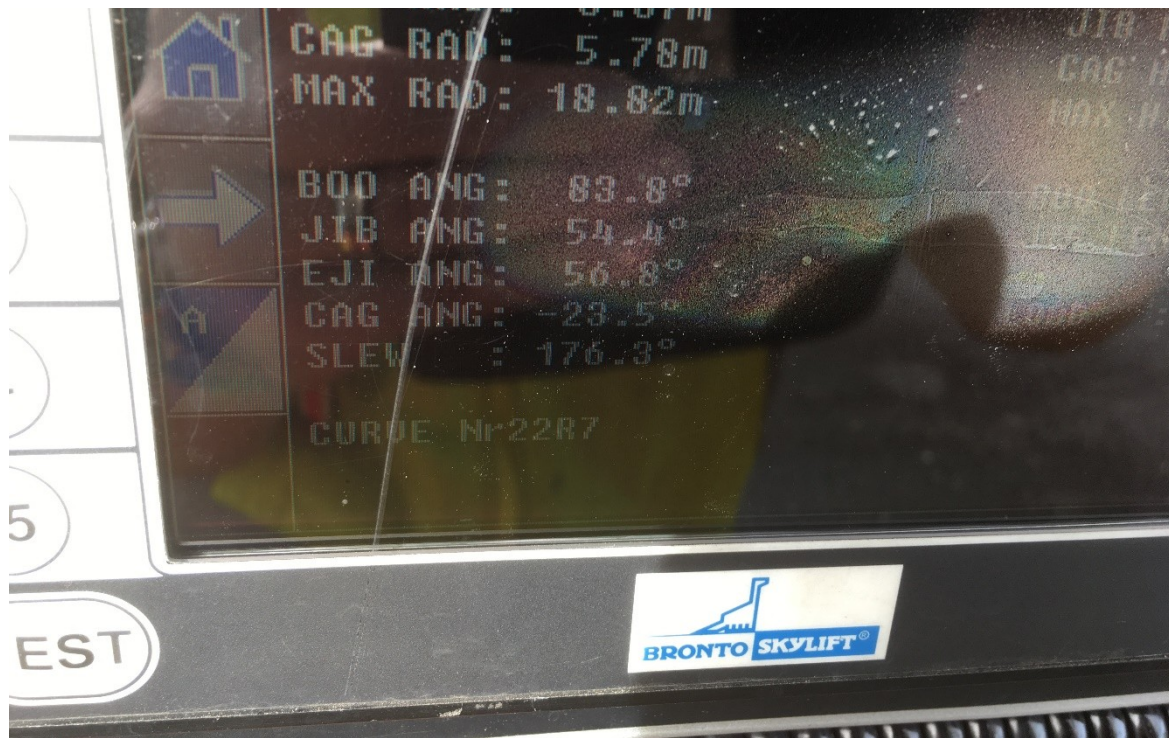
(Fig 5) Lockheed Martin Workshops 21/7/17 – Bronto computer showing Cage Angle of -23.5deg
