National Transportation Safety Board Aviation Accident Preliminary Report

Location:	Salem, OR	Accident Number:	WPR22FA087
Date & Time:	January 29, 2022, 15:03 Local	Registration:	N9530R
Aircraft:	Beech K35	Injuries:	2 Fatal
Flight Conducted Under:	Part 91: General aviation - Personal

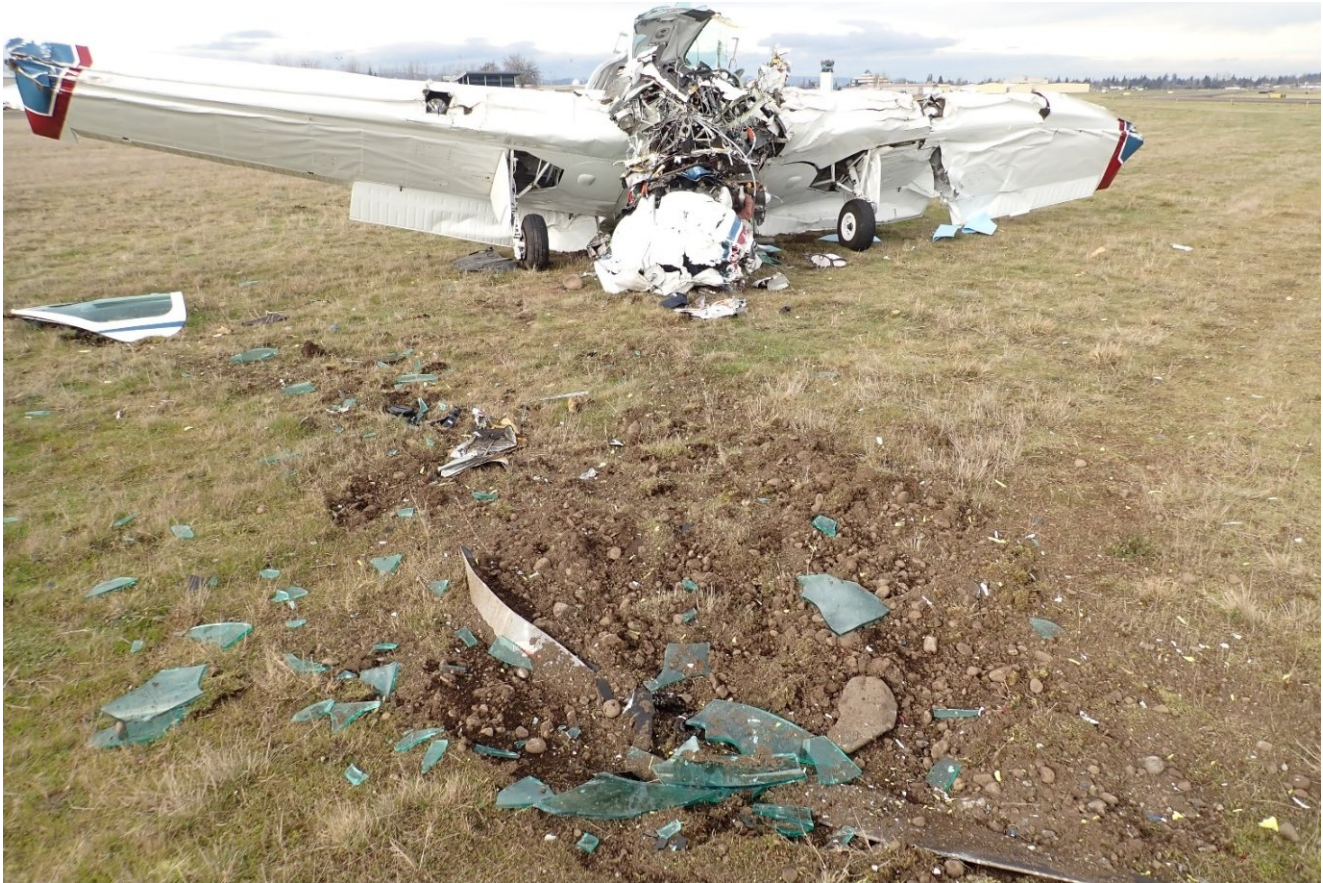
The engine compartment and the instrument panel remained attached to the airplane by the lower fuselage skin just aft of the firewall, and by avionics wires and flight control cables. The left side of the empennage revealed impact compression signatures emanating from top to bottom, just aft of the rear window. Both wings sustained substantial damage from wingtip to wing root.

Figure 1: View of the post-impact damage to N9530R
