STAFF REPORT

PROCEEDING NO. 20I-0437E

IN THE MATTER OF THE INVESTIGATION INTO THE HISTORY AND CONTINUING OPERATIONS OF THE PUBLIC SERVICE COMPANY OF COLORADO COMANCHE UNIT 3 GENERATING STATION PURSUANT TO DECISION NO. C20-0505.

March 1, 2021

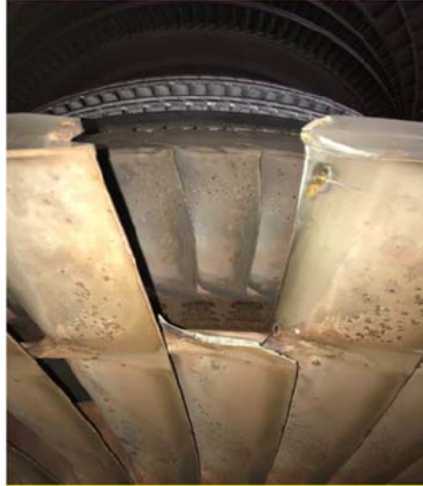
Figure 6. Missing turbine blade of L-1 section of LH.²⁰

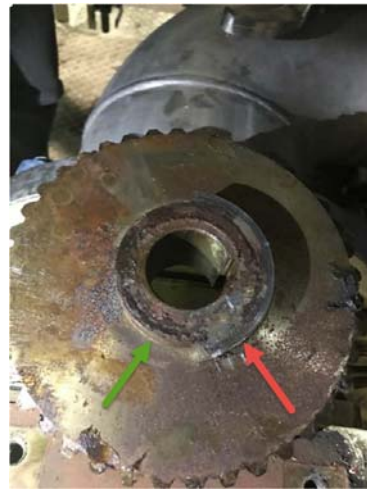
Figure 10(b) Underside of gear.⁴²

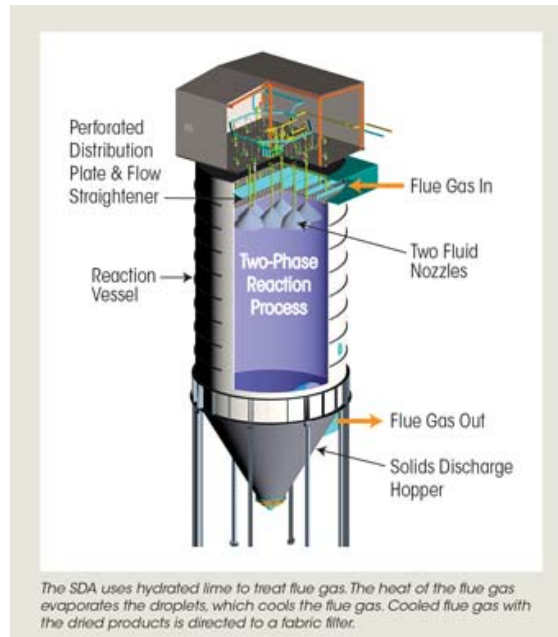
This outage was caused by debris which plugged the gas dispersion. The debris was cleared from the gas disperser and bottom of the vessel during the outage.⁹⁴ Comanche 3 was in an outage state for 8 days returning to service on December 7, 2018. Replacement power costs for this outage were estimated at \$1.4M.
