INCIDENT INVESTIGATION REPORT

INCIDENT NAME: Alpine CD1 Gas Release

May 3, 2022

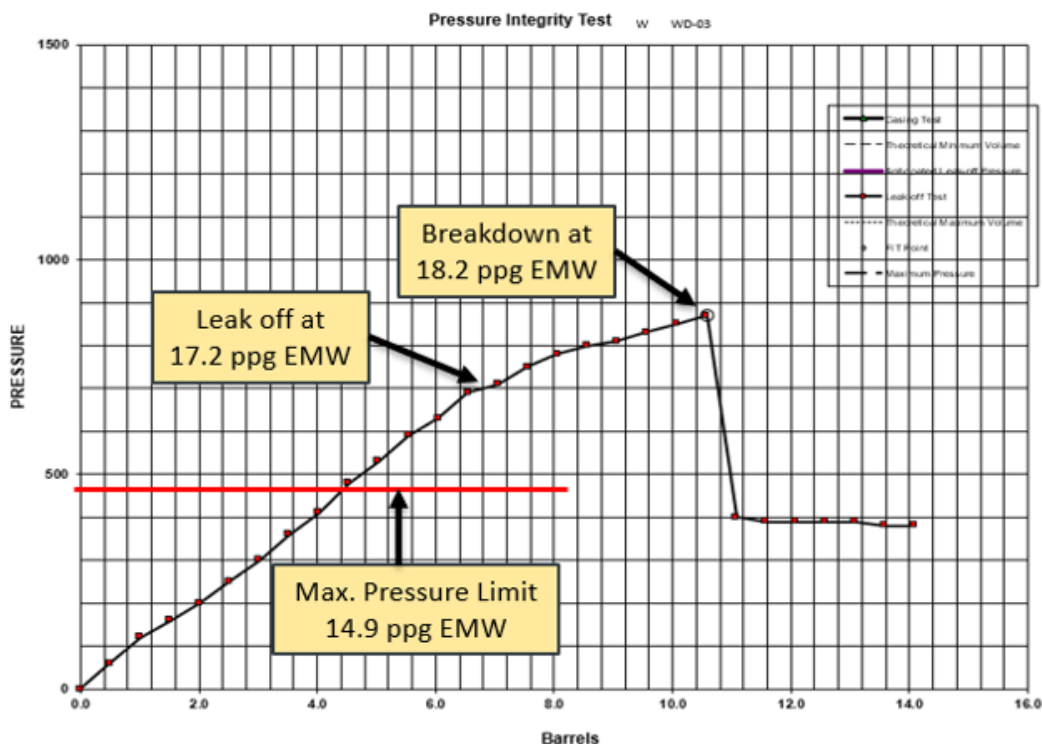
Figure 1.

The Section Plan 03 Annular LOT and Freeze Protect procedure stated on Page 10, section 1.b. "Max. test pressure of 14.9 ppg EMW which was LOT at surface casing shoe." The actual WD-03 Annular LOT results were 17.2 ppg, with the pressure breaking over at 18.2 ppg as injectivity was established. See Figure 1 below.

Exceeding the surface casing shoe LOT of 14.9 ppg EMW by up to 3.3 ppg during the Annular Leak-Off Test and Freeze Protect operations on February 27 most likely broke down the casing shoe and provided an initial pathway for gas migration around the outside of the WD-03 surface casing. Subsequent injection of approximately 300 bbls of water to displace the mud in the OA as part of the freeze protection procedure likely expanded this pathway.

WD-03 Annular LOT Injection #1 – 2/27/2022

Recommended Remedial Action	Responsible Party/Internet Address @conocophillips.com	Due Date
Develop a Freeze Protect SOP document for the North Slope with procedures, pressure limits, and contingent solutions when pumping operations reach limits.	[REDACTED]	July 1, 2022
Develop OA maximum pressure limits in the drilling program, communication protocols to the Wells Support Center, and consider drilling rig OA pressure sensors to allow for alarms/trending.	[REDACTED] [REDACTED]	July 1, 2022
Recognizing that Section Plan execution can occur across multiple personnel shift patterns, critical section plan operations should be reviewed with the personnel performing the work prior to execution.	[REDACTED]	June 1, 2022
Conduct a review of the overburden and adjust the associated log models as necessary to improve identification of drilling risks, flowability assessments, and zones requiring cement isolation.	[REDACTED]	August 1, 2022

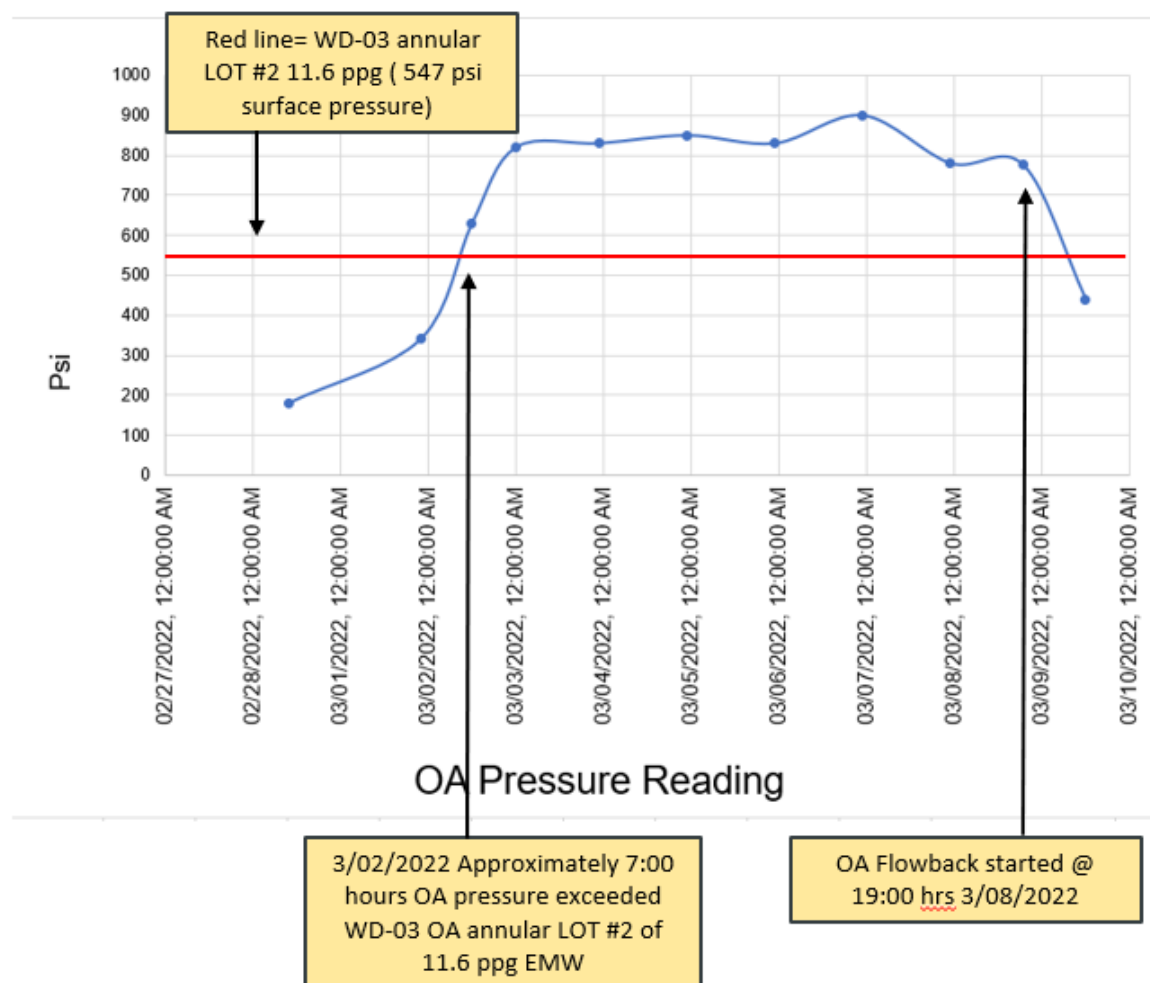
Figure 2.

The pressure increases in WD-03's OA from March 1 to March 3 were not recognized and/or addressed and, accordingly, did not lead to investigation or remedial action during that period. The volume of gas released from the C10/Halo in WD-03 could have been reduced if actions to address the elevated OA pressures had been taken earlier. See Figure 2 below.

WD-03 OA Pressure Trend

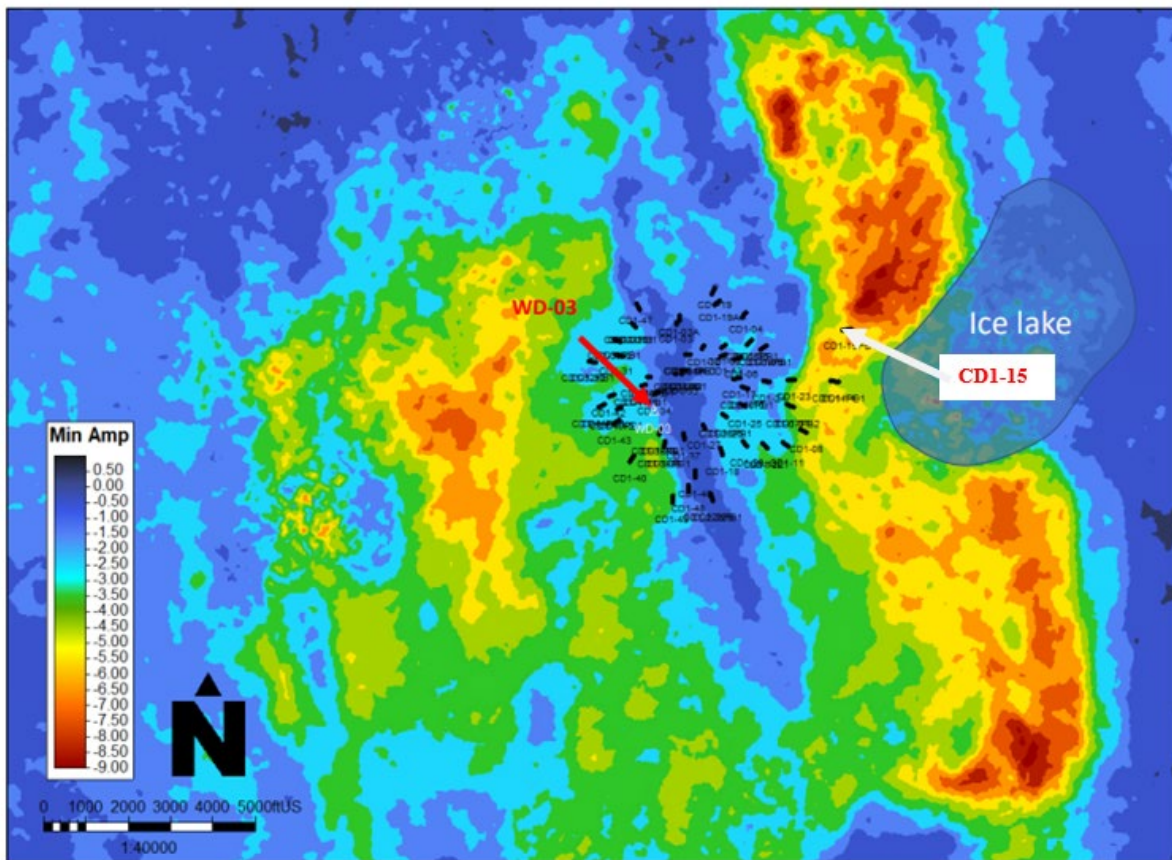
Note #1: The CD1-15 well produces gas intermittently from the C10/Halo as necessary to restart the Alpine facility following shutdowns. Thus, in contrast to the C10/Halo formation interval at the WD-03 well path, the C10/Halo formation interval at the CD1-15 well path was determined to be a “significant hydrocarbon zone” and was accordingly isolated with cement as per AOGCC regulations. The CD1-15 C10/Halo interval is located in a seismic bright spot/amplitude approximately 4922 ft NE of the WD-03 C10/Halo location. See Figures 3 and 4 below.

Figure 3. WD-03, CD1-15, and offset CD1 well locations at the C10/Halo interval

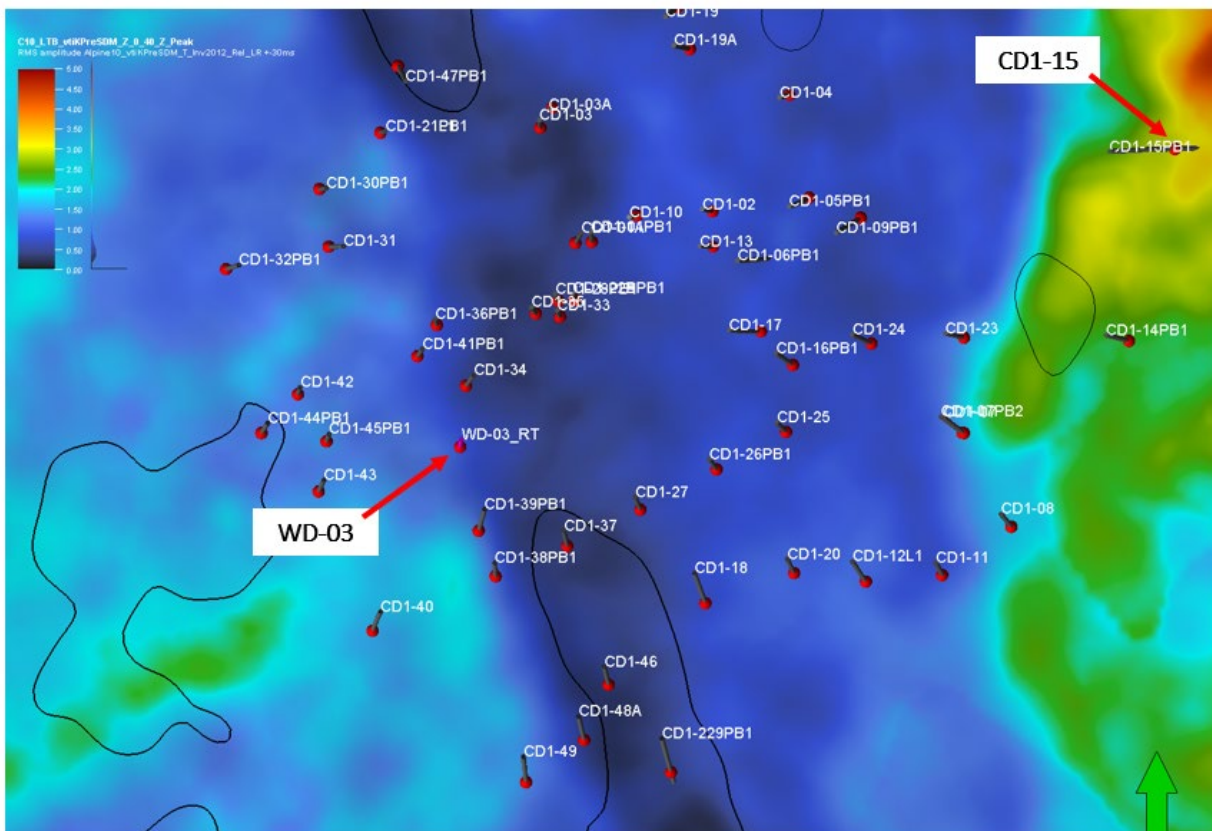
Figure 4. Zoomed in view showing WD-03, CD1-15, and offset CD1 well locations at the C10/Halo interval

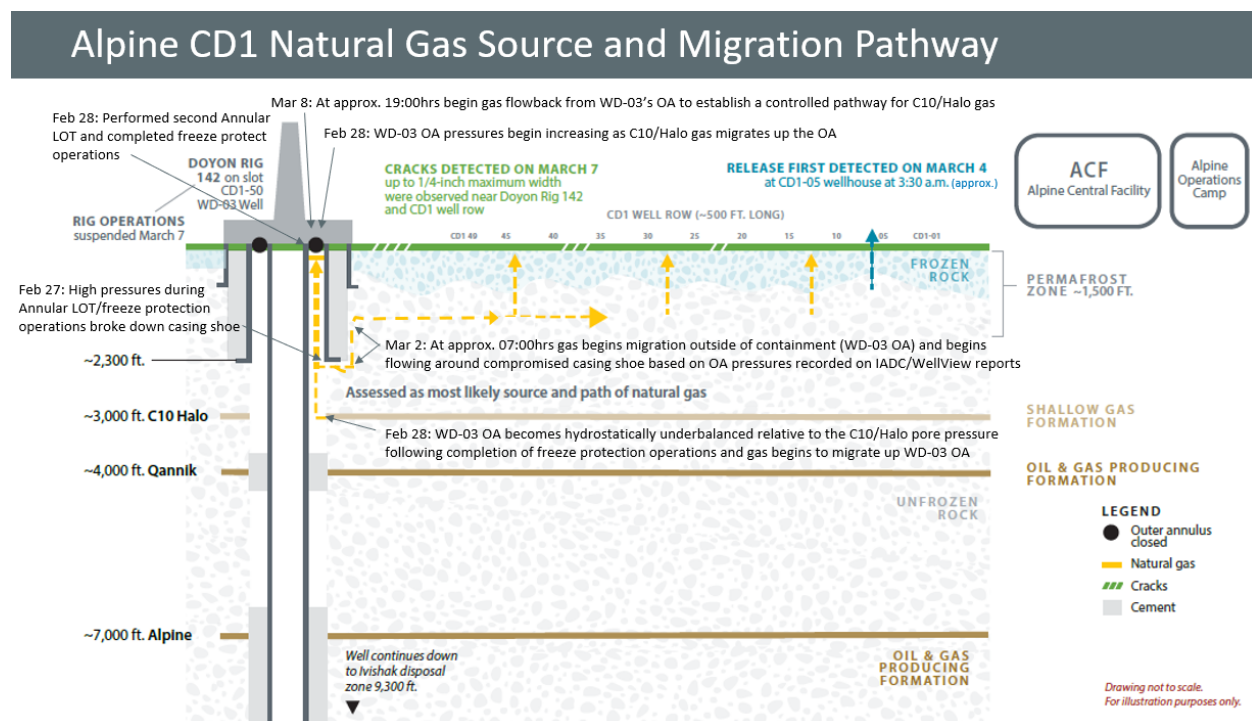
Figure 5.

CONDITION NO. 3: Displacing water with diesel in WD-03's OA for freeze protection purposes reduced the hydrostatic pressure in the OA, causing it to become hydrostatically underbalanced relative to the C10/Halo pore pressure.

Displacing water with diesel in WD-03's OA for freeze protection purposes was necessary to prevent casing damage from the forces that would be exerted by the expansion of fluids (e.g., water or water-based fluids) that would freeze across the permafrost interval. Displacing the water with diesel for freeze protection purposes also reduced the hydrostatic pressure in the WD-03 OA. This put the WD-03 OA into a hydrostatically underbalanced pressure condition relative to the C10/Halo pore pressure, thereby allowing gas to flow out of the C10/Halo and into the WD-03 OA. See Figure 5 below.
