**UNITED STATES AIR FORCE**  
**AIRCRAFT ACCIDENT INVESTIGATION**  
**BOARD REPORT**

**T-38C, T/N 68-8121 & T/N 70-1586**

**LOCATION: LAUGHLIN AIR FORCE BASE, TEXAS**

**DATE OF ACCIDENT: 19 NOVEMBER 2021**

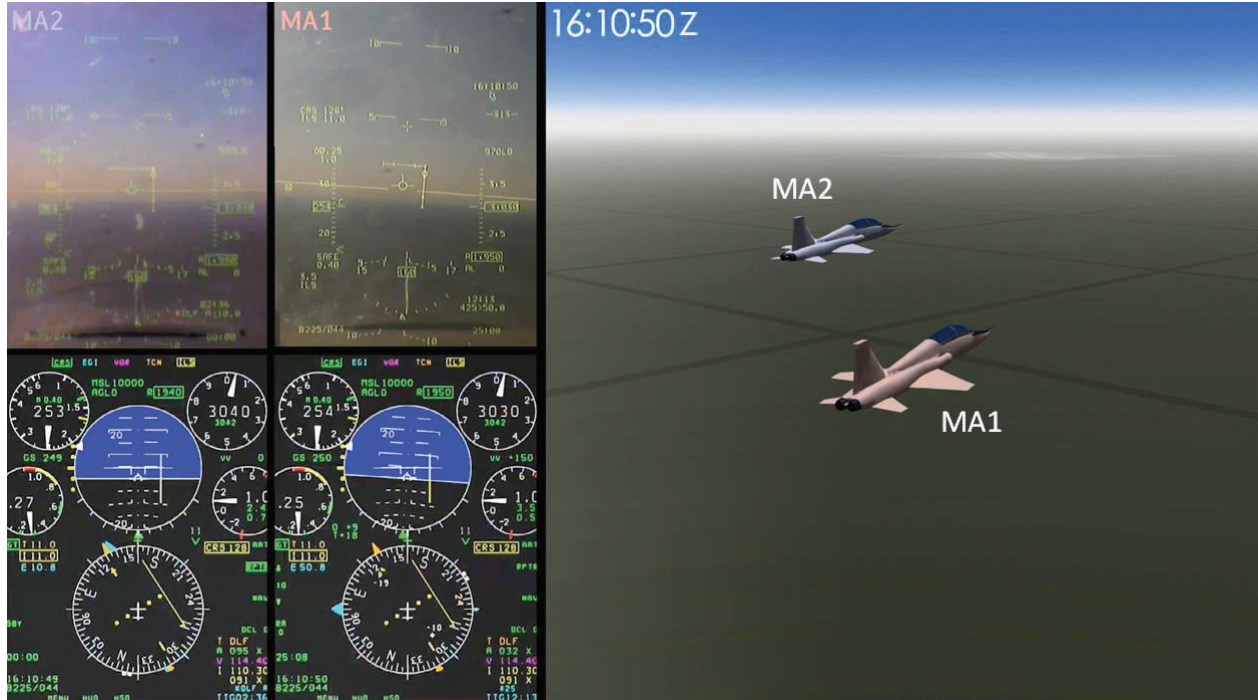
Figure 1 - (Tabs Z-2 and AA-9)

At 10:10:07L, when realizing that MA1 is on the right side of the formation, MSP states, "*Oh, excuse me, I need to put him on the left side, he's going to Lariat*" (Tab AA-8 and AA-23). MIP2 responded to MSP with a technique of keeping MA1 on the right side, saying, "*Say we have to go around and he's, like both of us? We actually want to be on the left so we can pull...*" at which

point MSP interrupts MIP2 and says “*But he’s still going into Lariat?*” (Tab AA-8 and AA-23). MIP2 then states, “*Ya it’s fine*” (Tab AA-8 and AA-23). See Figure 1 showing MA2 and MA1’s relative positions at this point during the MS.

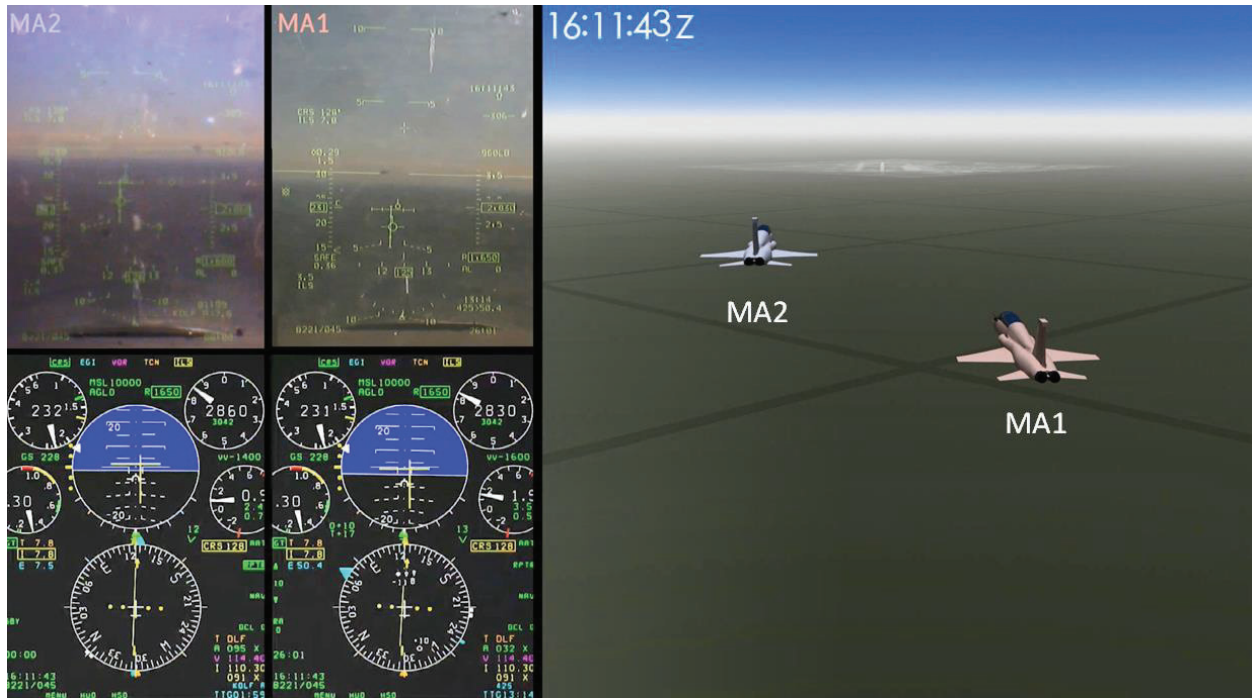
Figure 3 - (Tabs Z-4 and AA-9)

At 10:11:40L, after the turn to align to the 13C localizer, MSP rocked MA2’s wings as a visual signal for MA1 to move to the fingertip position (right side) (Tab AA-8 and AA-24). There was also some instruction from MIP2 to MSP over MA2 intercom about being a stable lead, use of throttle settings, and lowering the landing gear (Tab AA-8 and AA-24).

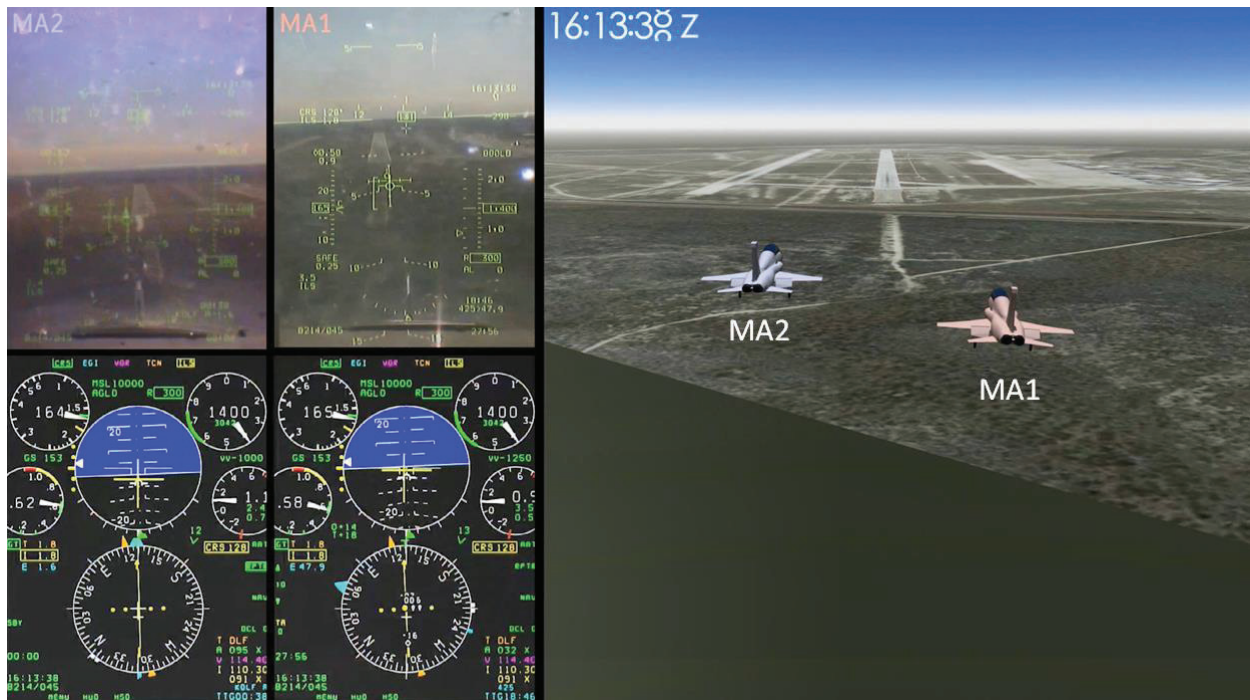
Figure 6 - (Tabs Z-5 and AA-9)

At 10:13:39L (250 feet AGL) MIP2 started a series of prompts to MSP regarding glide path correction and airspeed corrections (Tab AA-9). MSP had let MA2 get slower than final approach speed by two knots calibrated airspeed (KCAS) (Tab AA-9 and AA-25). It is unknown what visual cues, if any, MIP2 or MSP saw after the “cleared off” call because neither pilot was, or could be, interviewed; however, based on other unit pilot interviews and the board’s simulator replications, MIP2 would have seen MA1 descend after the “cleared off” call, which would have been an immediate indication that there was confusion between the aircraft (Tabs V-2.17, V-10.17, V-14.22, V-14.34, and AA-14). At this time, MIP2’s communications were focused on instructing MSP on landing the aircraft (glide path and airspeed). Based on the positions of the aircraft, MIP2 would have been able to see MA1 descending and preparing for landing, which would have been alarming and prompted immediate action. Therefore, evidence indicates that MIP2 was not looking at MA1 after the “cleared off call” (Tab AA-9 and AA-14).

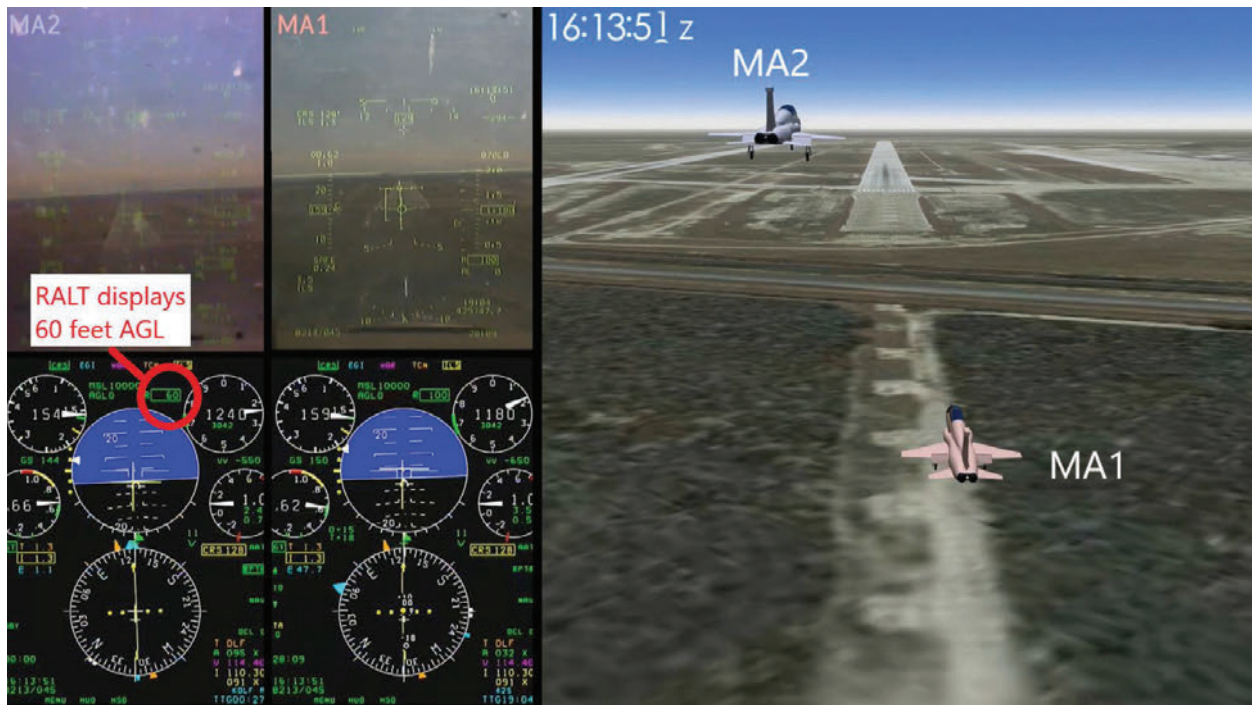
Figure 10 - (Tabs Z-8 and AA-9)

Also at 10:13:50L, MA2’s Radar Altimeter (RALT) indicated 150 feet AGL, then shortly (10:13:51L) showed 60 feet AGL, prior to switching back to 150 feet AGL (Tab AA-9 and AA-25). MA1’s RALT at this moment read 90 feet AGL. The board determined the momentary RALT deviation of MA2 was due to MA1 being 60 feet under MA2 (Tab AA-9 and AA-25).

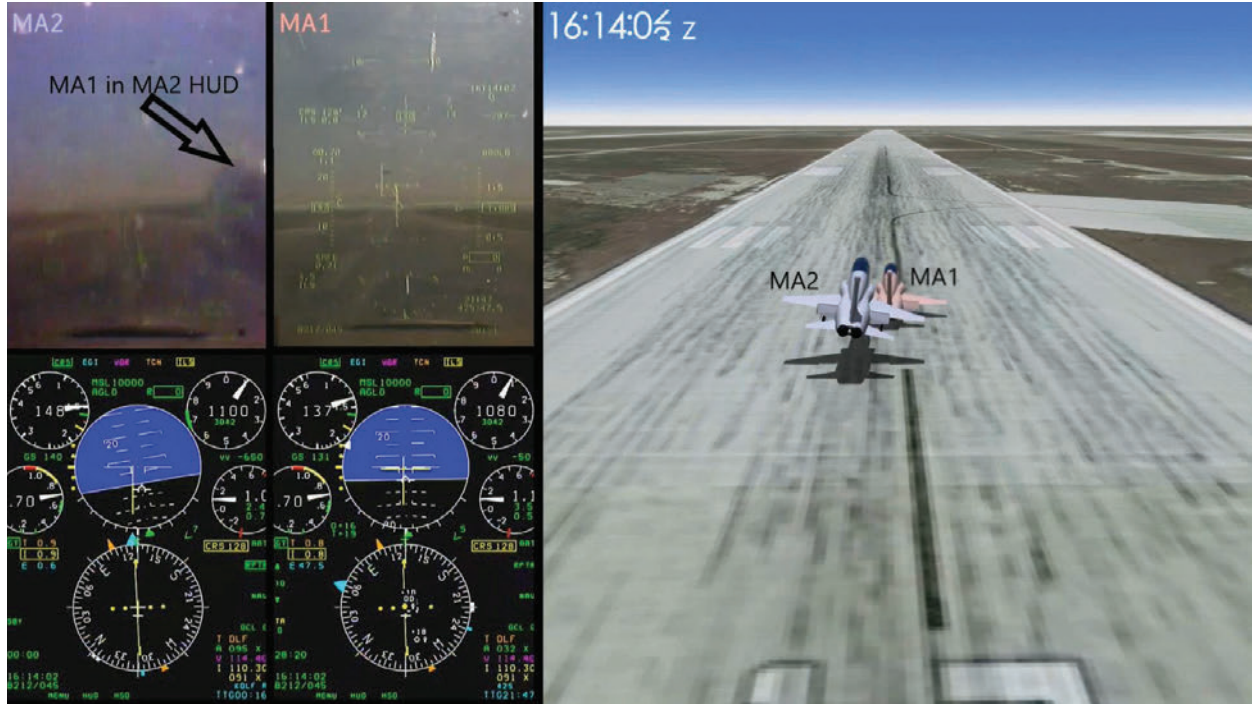
Figure 21 - (Tab Z-13 and AA-9)

At 10:14:02L, MA2's nose landing gear impacted MA1's left horizontal stabilizer at 148 Knots Calibrated Air Speed (KCAS), approximately 10 KCAS faster than MA1 (Tab AA-9).

The impact caused MA1 to abruptly pitch up (Tab J-3 and J-6). MA2's RCP canopy scraped the left side of MA1's vertical stabilizer followed by MA1's rudder and aft portion of its vertical stabilizer being wedged between MA2's #2 (right) engine inlet and fuselage (Tab J-3 and J-6). The forces on MA1's tail section caused MA1 to abruptly turn to the right (Tab AA-9).
