# MaxiTrans, Refrigerated Rear Trailer - Body Separation

## Report

# Engineering Report

## Maxi-CUBE Body Separation January 2020

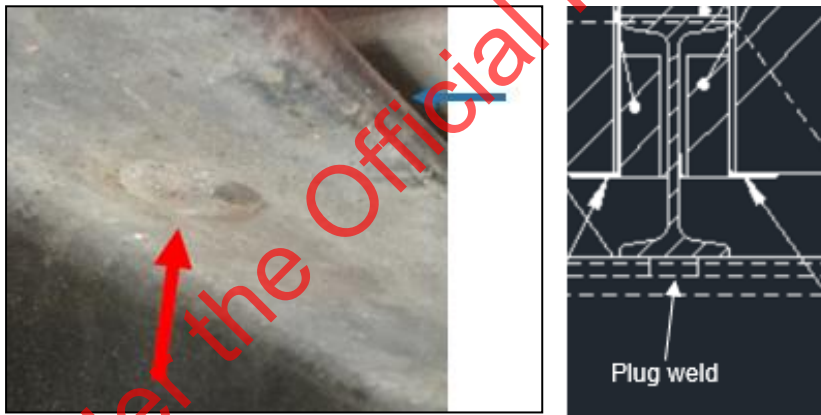
Image 1:

The red arrow in image 1 indicates the finished face of the plug weld which is visible for inspection. The blue arrow in image 1 indicates a space between the two profiles which should be connected by the plug weld.

The weld in image 1 is broken; this was demonstrated for the purposes of the photo by inserting a jack (out of the image) which lifted the body away from the mounting angle. Without the jack in place gravity causes the space to close and the weld visibly appears sound.

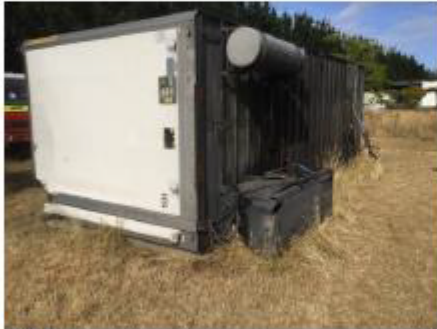
Body

The body is largely intact having separated from its mounting angles. These mounting angles are still bolted to the chassis.

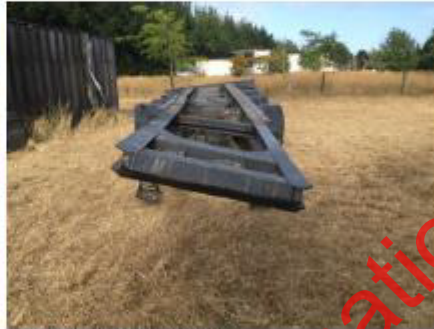
Chassis- twisted

The chassis is twisted and the outside wall of the right side forward tyre and its rim have been in hard contact with the road. It is believed that after the body started to roll off, the chassis was then forced to roll after it, but finally the chassis was able to spring back once the body was clear.

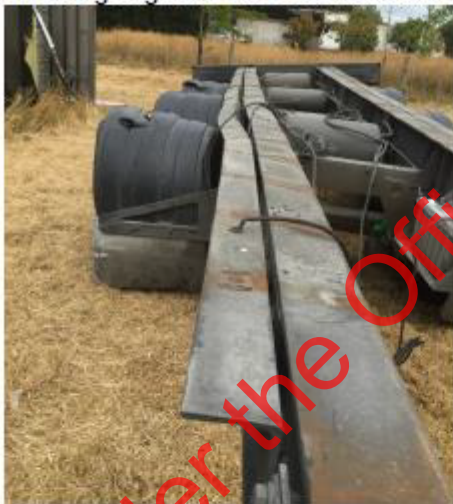
Right rail- only the angle at the rear has resisted the body falling off

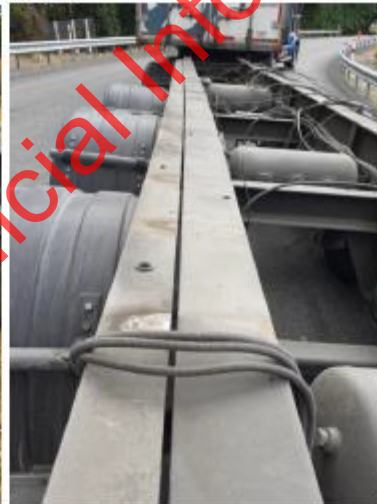
Left rail- the angle did not resist the body falling off

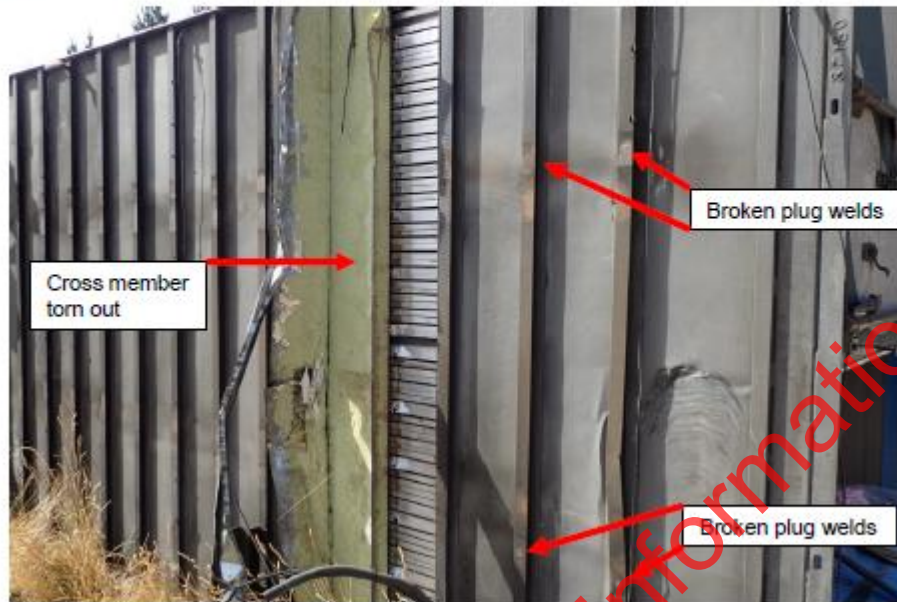
All but one of the body cross members remained with the body and separated cleanly from the chassis. This one cross member was near the second axle and was torn out of the floor.

There are 21 body floor cross members at 300 mm spacing. They are I-beams 100 x 45.

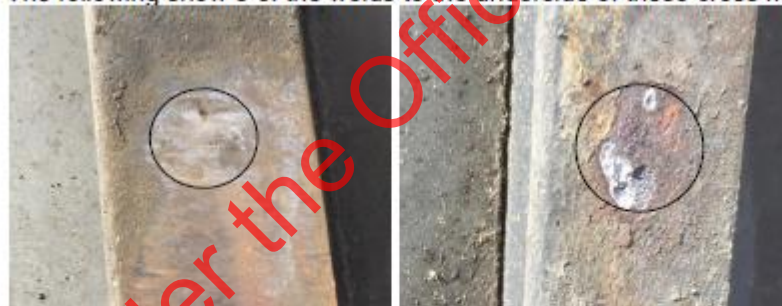
There has been little fusion of the plug welds to the body floor cross members. The following show 3 of the welds to the underside of these cross members.

No fusion

Very little fusion

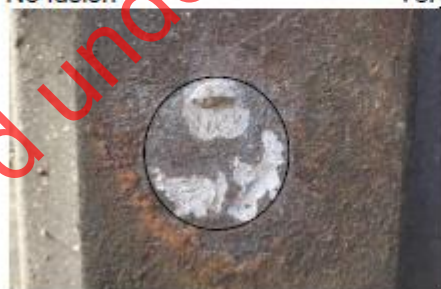
Little fusion

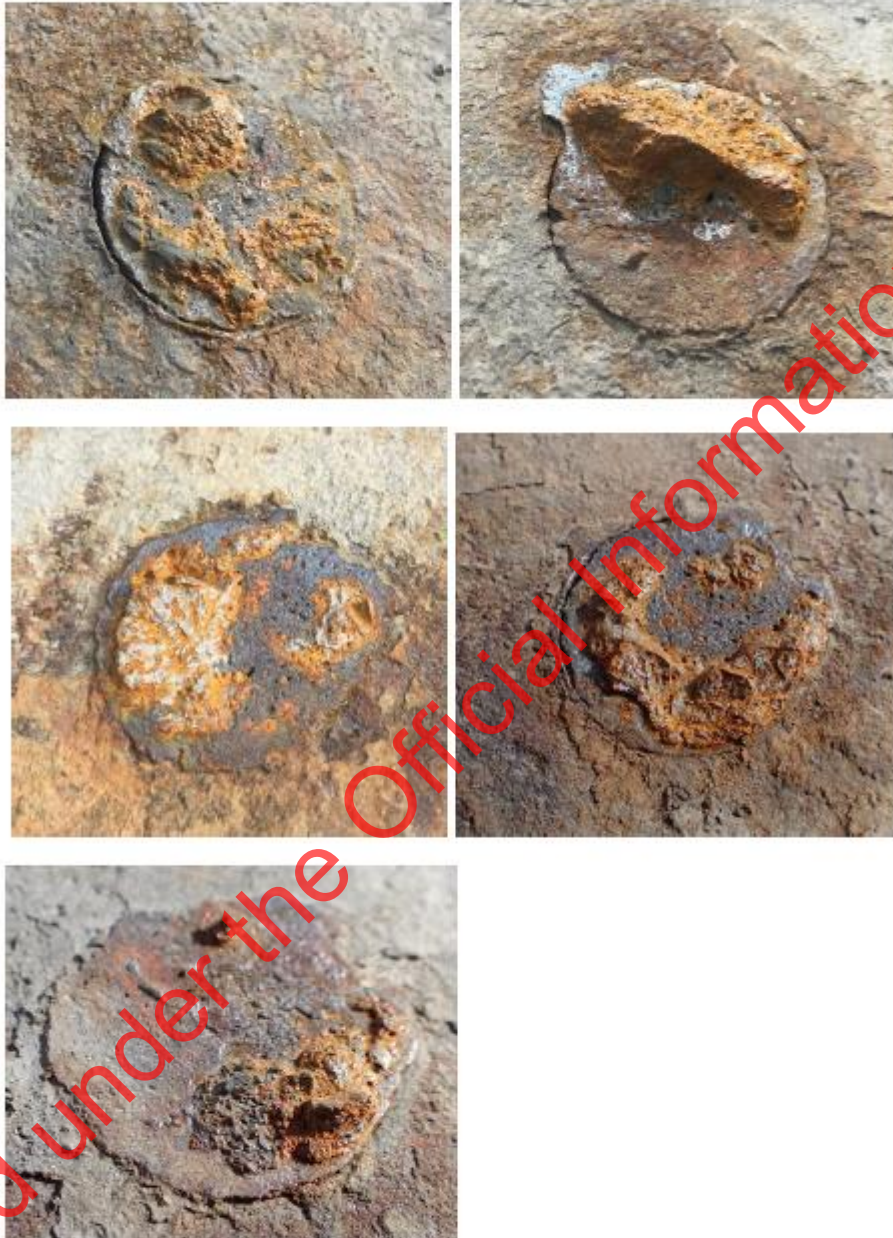
The following five photos show the lack of fusion of the plug welds that are visible on the top of the attachment angle. Note that these probably show the better of the welds as those with even less fusion would have broken earlier and been rubbed smooth by wear.

This was the best of the welds, but it still has about half of its area that is not fused.

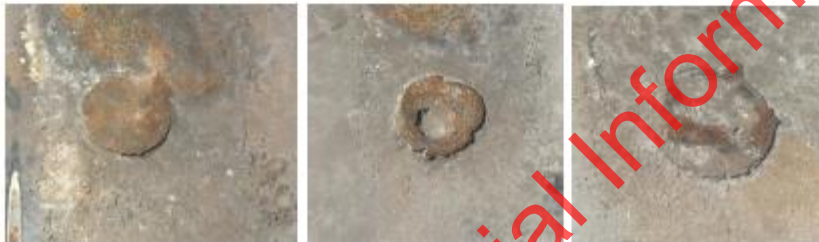
The following three photos show the top of plug welds that have been broken for some time and have been rubbed smooth by wear.

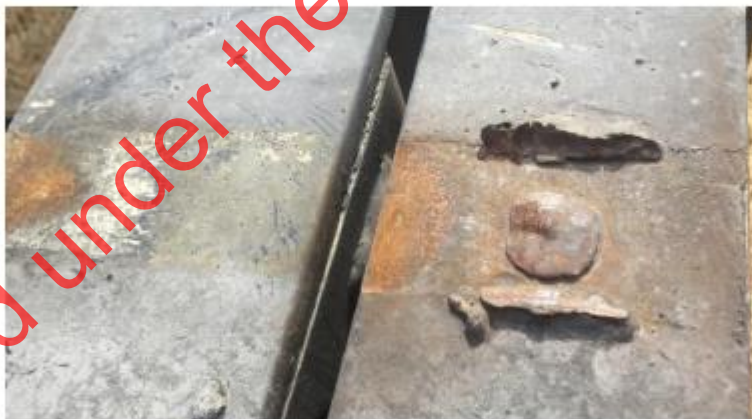
It is notable that someone was aware of some part of this problem as they had in the past fillet welded the front right floor cross member lower flange to the attachment angle. This was insufficient and these welds had also broken some time ago.

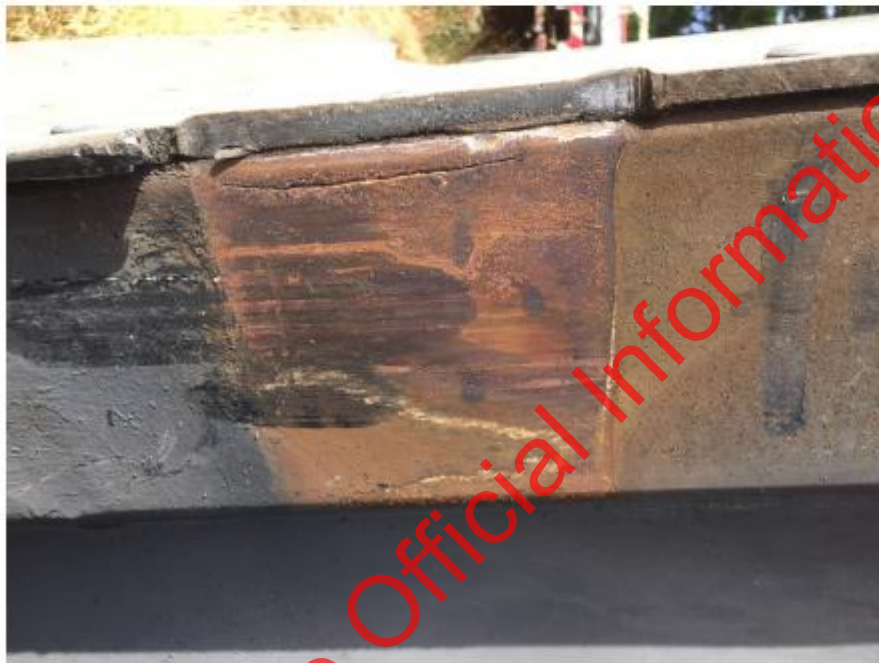
From the appearance of the welds and the wear on the chassis and on the body floor cross members it appears as if all twenty one of the welds on the left side and the front six on the right side were fully broken prior to the final incident. With so many of the attachment welds broken, there was considerable movement taking place between the front of the body and the chassis member that it rests on. The chassis at this point is 130 mm wide and the wear is 145 mm wide or more, so that has been a total of at least 15 mm side movement.

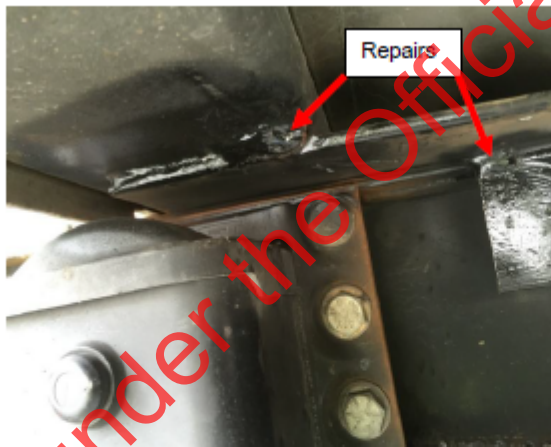
Photo of an older unit where the top flange of the support angle has been taken forward and welded to the front wall cross member. This has cracked and has needed repair as Maxitrans say is not uncommon. Yet the Fruehauf modified units are different in that it is the complete angle that is taken forward and the welding is to the front and rear only of the large wall cross member.

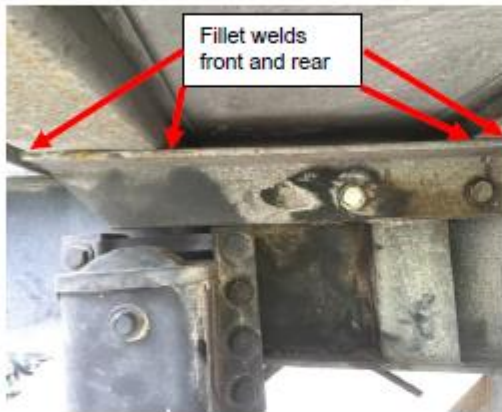
Fruehauf modified unit showing the angle that is taken forward to the front wall cross member and the welded to it at this members front and rear only.

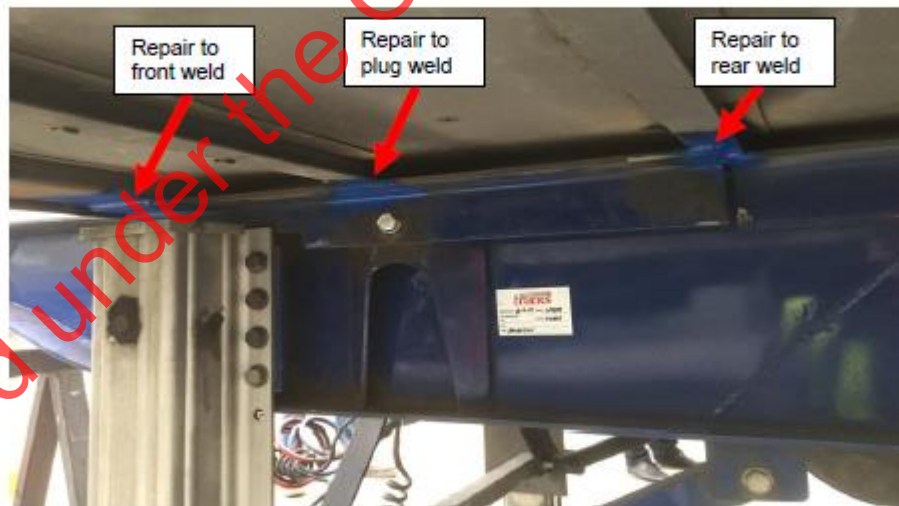
C) One of the units is purpose built to carry mushrooms and is lighter. Some of its floor cross member to chassis securing details are different. It has a support angle that attaches to the body wall front cross member, but inspection has shown cracks in this attachment and in one plug weld.

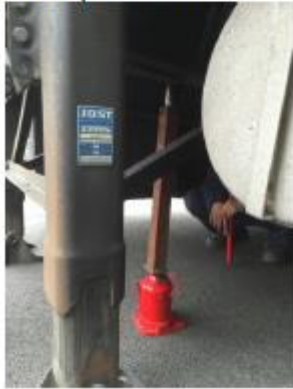
Maxitrans have found that the only effective way to inspect for insecure floor cross members is to jack them upwards. The following photo shows the technique used.

On some failed joints it is possible to see light through the gap (on an unloaded empty trailer), and sometimes cross members with failed welds show some degree of rust bleed. A pry bar proved to be ineffective, or the locations inaccessible, and the force required was too great to safely apply. In practice a man with a jack is the way to check these parts.

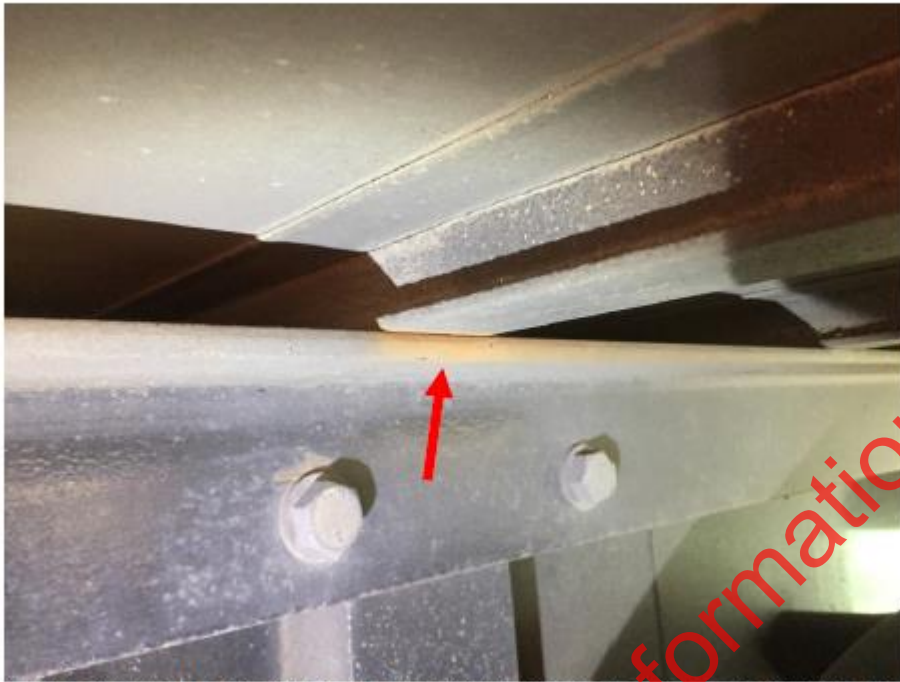
A hint of rust bleed is visible at some joints where the welds are broken, but this is not a reliable method of identifying this problem.

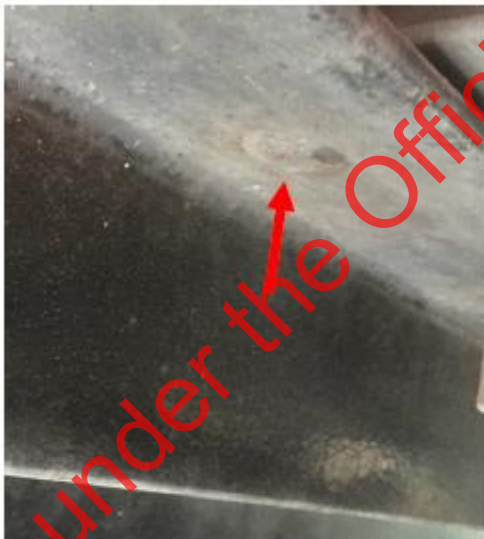
From below a failed plug weld still looks sound.

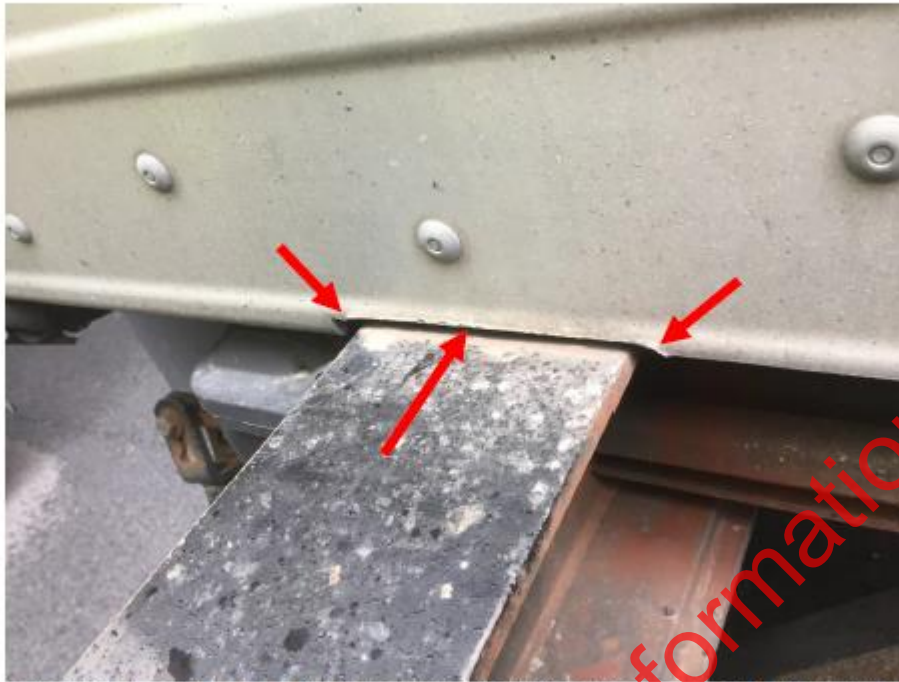
Failed welds on the floor front cross members lead to movement between the chassis and the front of the body and with experience this can provide an indication of broken welds.

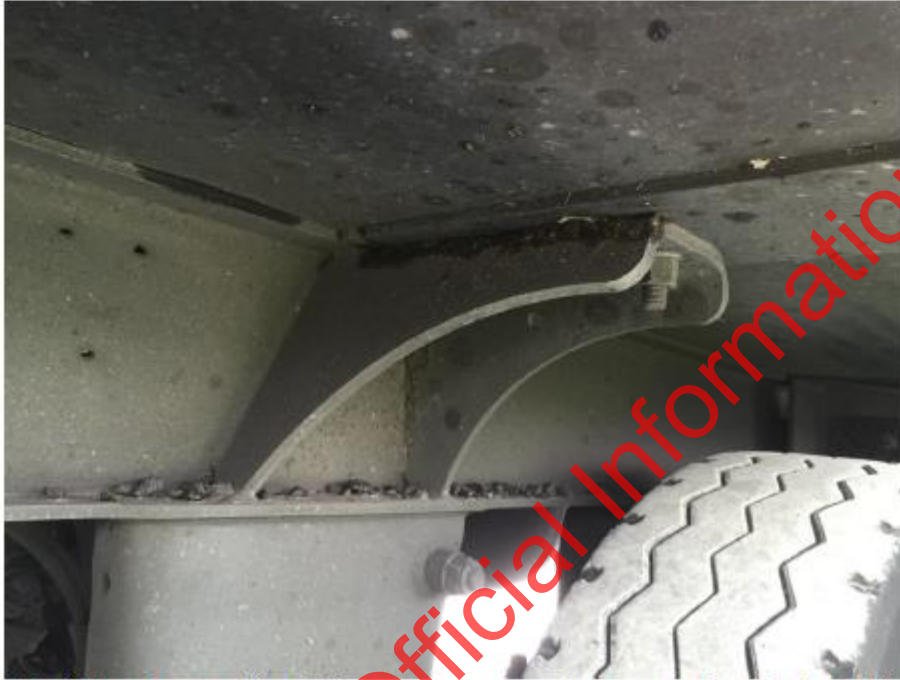
Schmitz body connection to the chassis appears to be very robust, but what is under the insulation is unknown.

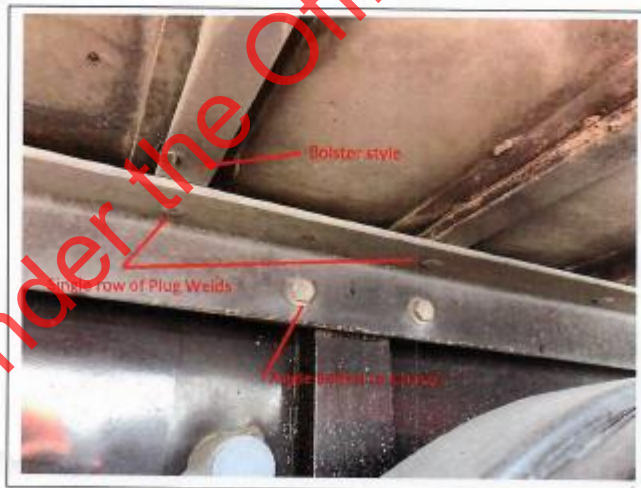
Below is example of mounting style that is at risk:
