DEPARTMENT OF THE NAVY
VICE CHIEF OF NAVAL OPERATIONS
2000 NAVY PENTAGON
WASHINGTON DC 20350-2000

FINAL ENDORSEMENT on RDML Christopher J. Cavanaugh, USN ltr 5830 of 14 Jan 22

Subj: COMMAND INVESTIGATION INTO THE 6 MAY 2021 AND 20 NOVEMBER 2021
INCIDENTS AT RED HILL BULK FUEL STORAGE FACILITY

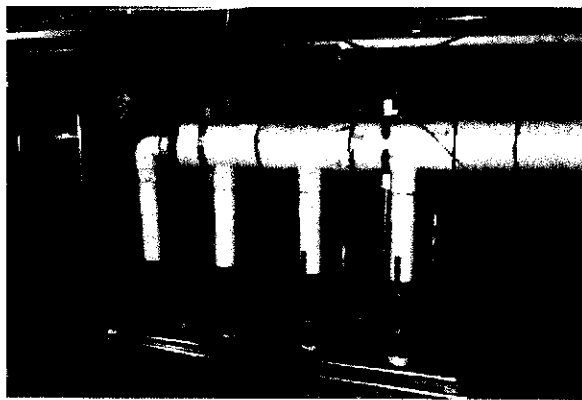
383. On 13 Mar 17, the construction contractor formally notified NAVFAC PAC, in writing, that they constructed the entire AFFF retention line with PVC vice Steel pipe. [Encl (353)]

Original AFFF Retention Line Piping in Immediate Area of an AFFF Sump
