Race Rock Lighthouse
Long Island Sound, New York
Report of Investigation
30 August 2019

**REPORT OF INVESTIGATION
Race Rock Lighthouse**

Race Rock Reef, Long Island Sound, SW of Fishers Island, Suffolk County, New York
WSA Ref No 1909.01

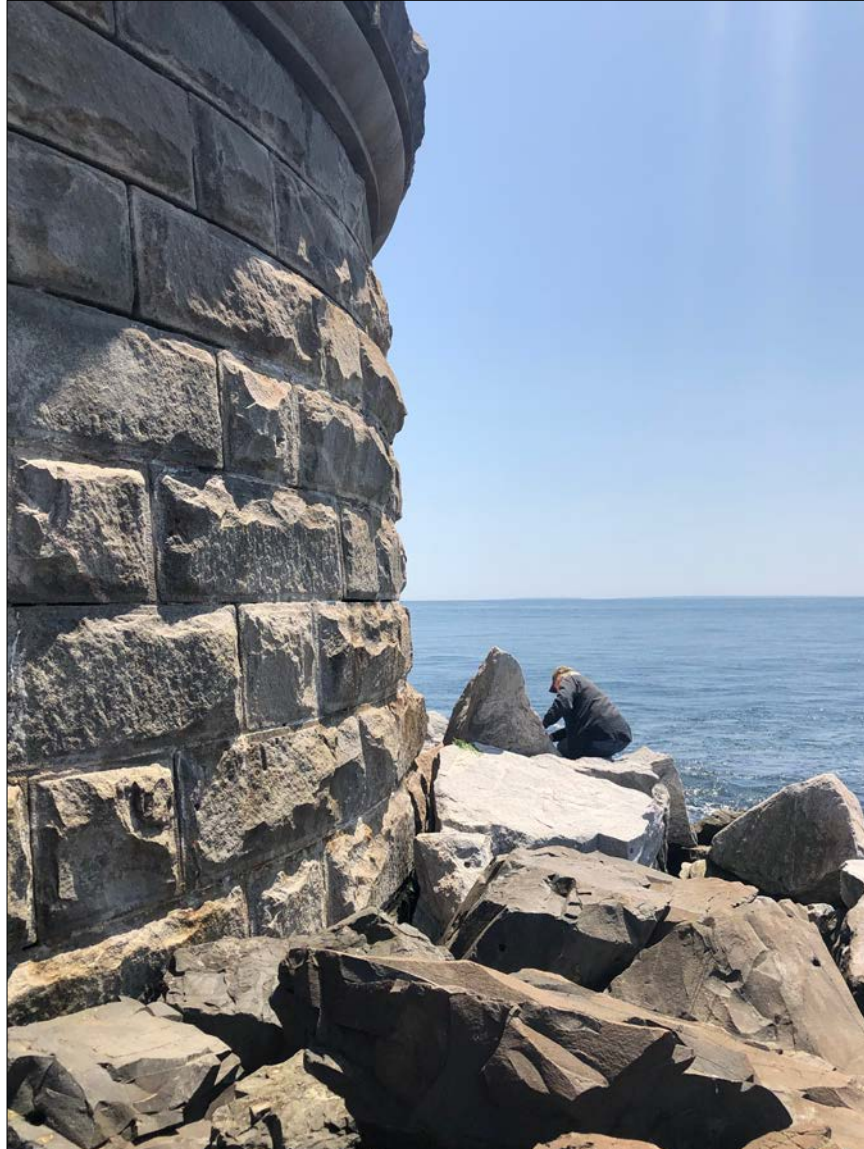
Photo 5. Years in the making, the granite sheathed concrete drum is an inherently rugged core, yet there are locations of distress rendered from lack of continual maintenance that would have occurred with a Keeper.

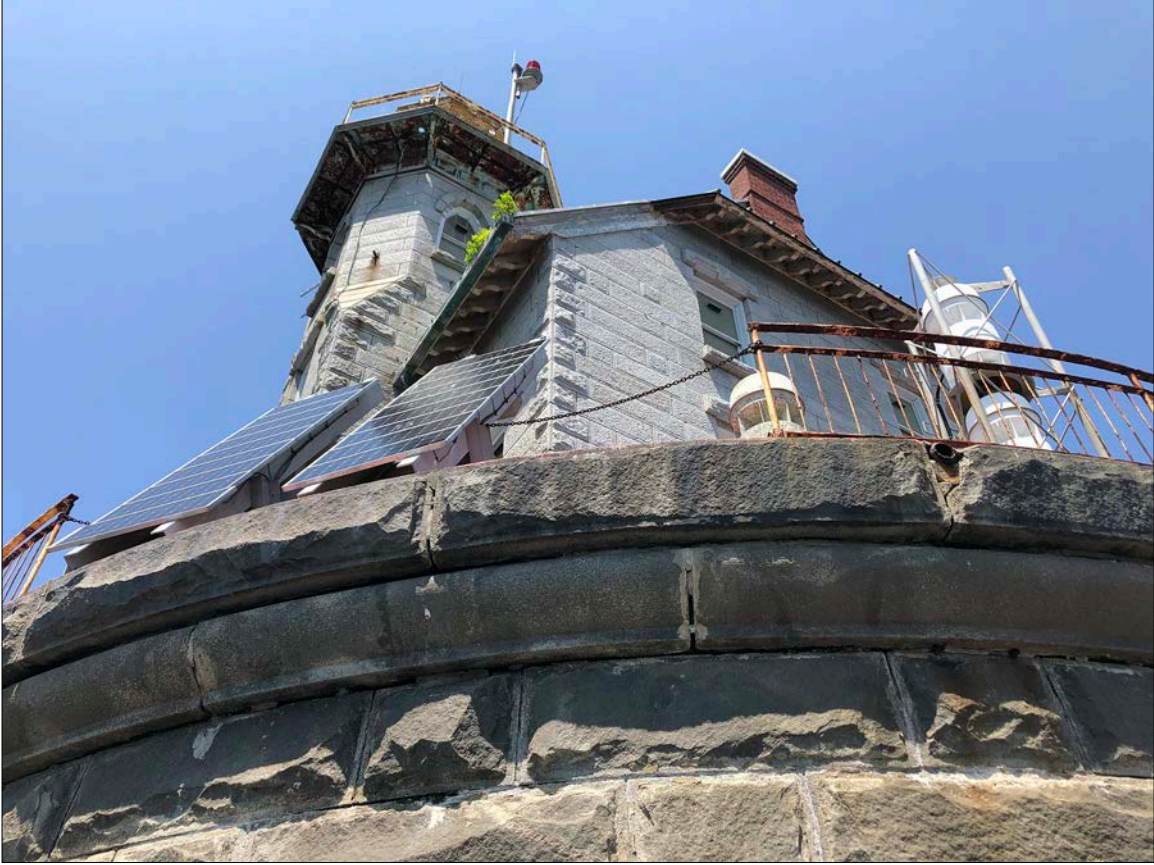
Photo 6. Missing rails, open masonry joints, gutters filled with organic matter, and similar myriad but addressable issues combine to undermine stability, even of structures built to last hundreds of years or more.

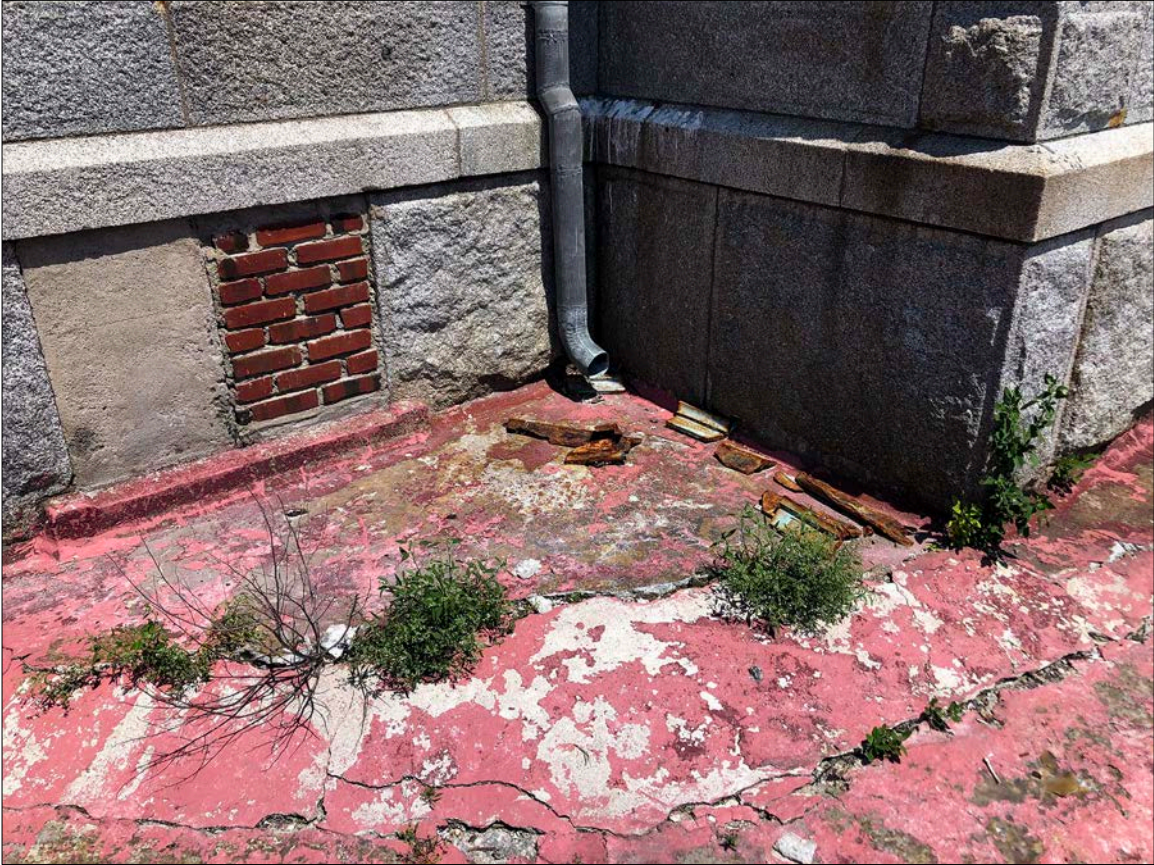
Photo 8. The Drum's deck surface is a crucial first line of defense, protecting the foundation and stores below. Cracks and breaching allow infiltration of vegetation and other organic matter, exacerbating the condition. Rainwater, left to spill adjacent to foundation walls, compounds deterioration. Note shards of cast iron that have fallen from the Lantern above.

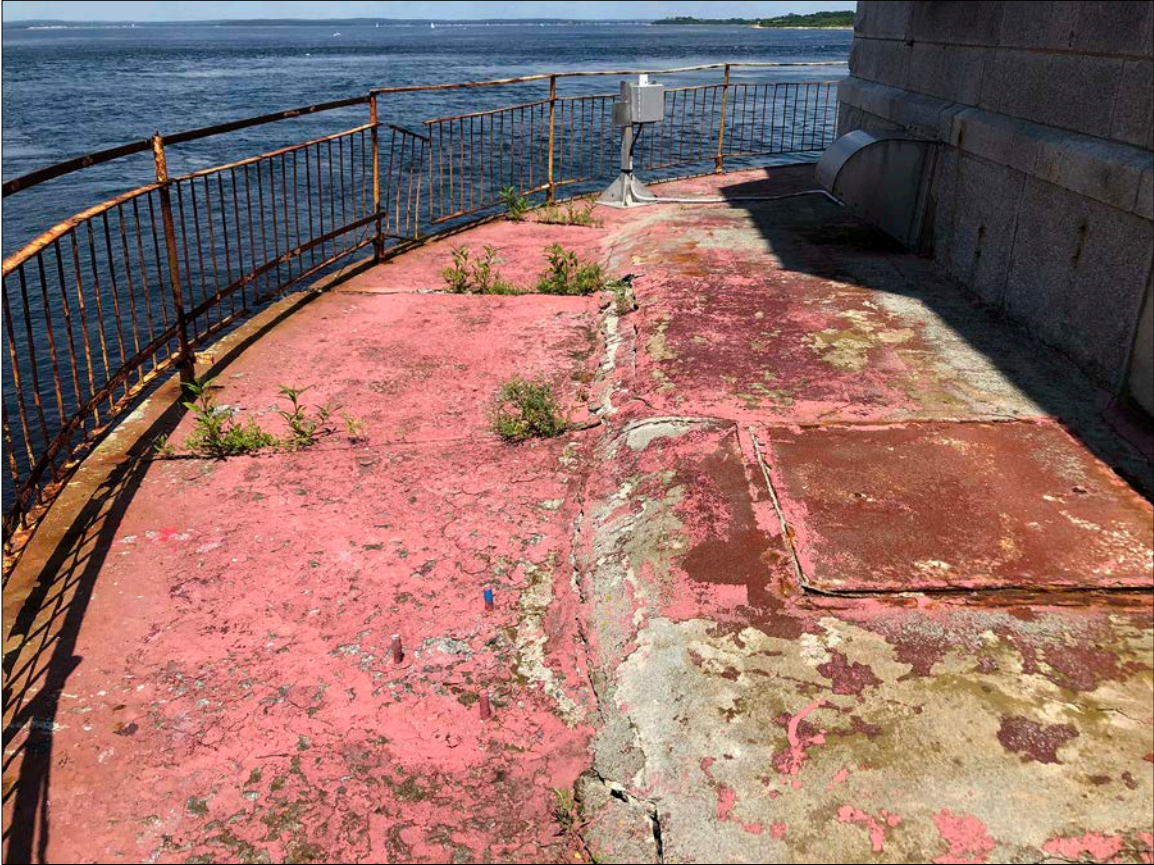
Photo 9. General view of the Drum deck and perimeter railing, both of which are currently in an unsafe condition. Bulkheads to the right provide access to the cellar and stores; in their deteriorated state, and without being safely cordoned, they harbor potential for a serious fall to nearly one story below.

- 2.2. A temporary perimeter rail system needs to be employed that does not limit the ability of the original to be eventually restored. In its present condition, the original railing is not a proper fall arrest device.

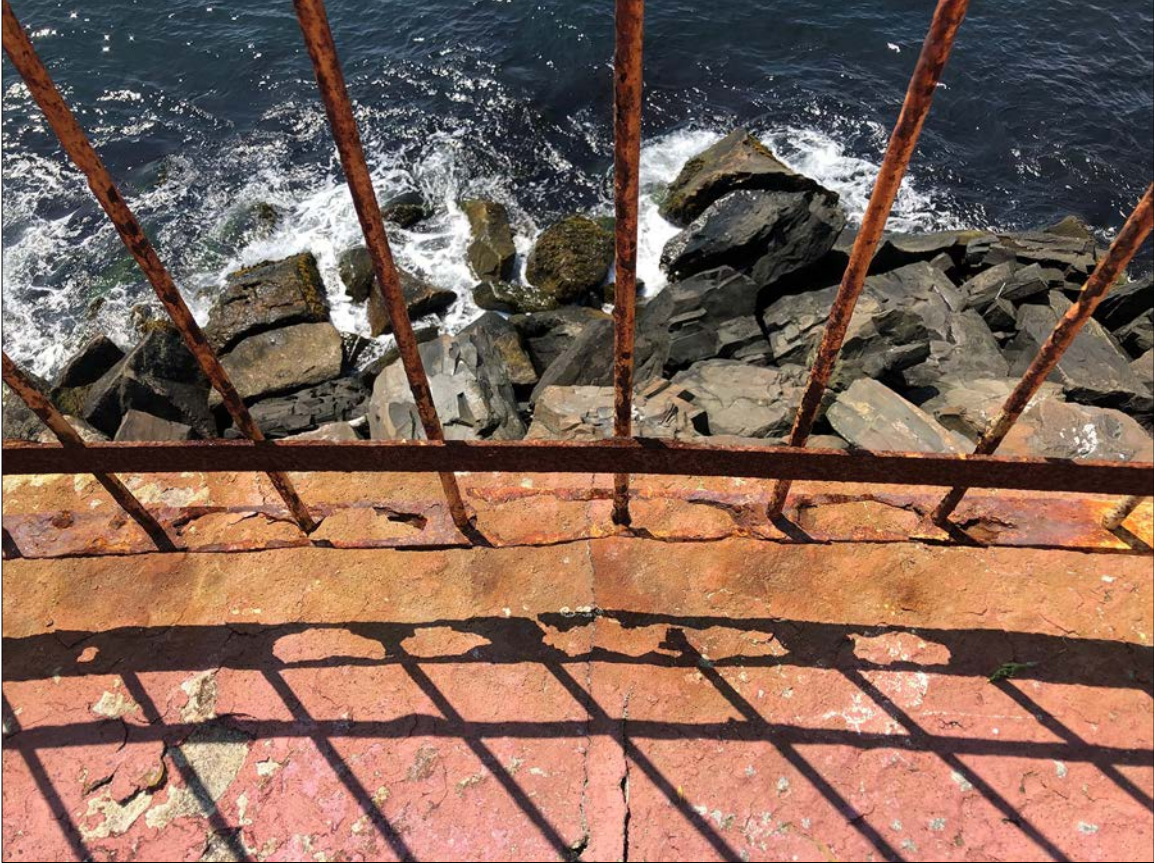
Photo 10. Perimeter iron railing, embedded into concrete Drum deck, is strong but corroded. It also is discontinuous. Despite these conditions, this early railing remains restorable and may be refined to meet current building safety standards.

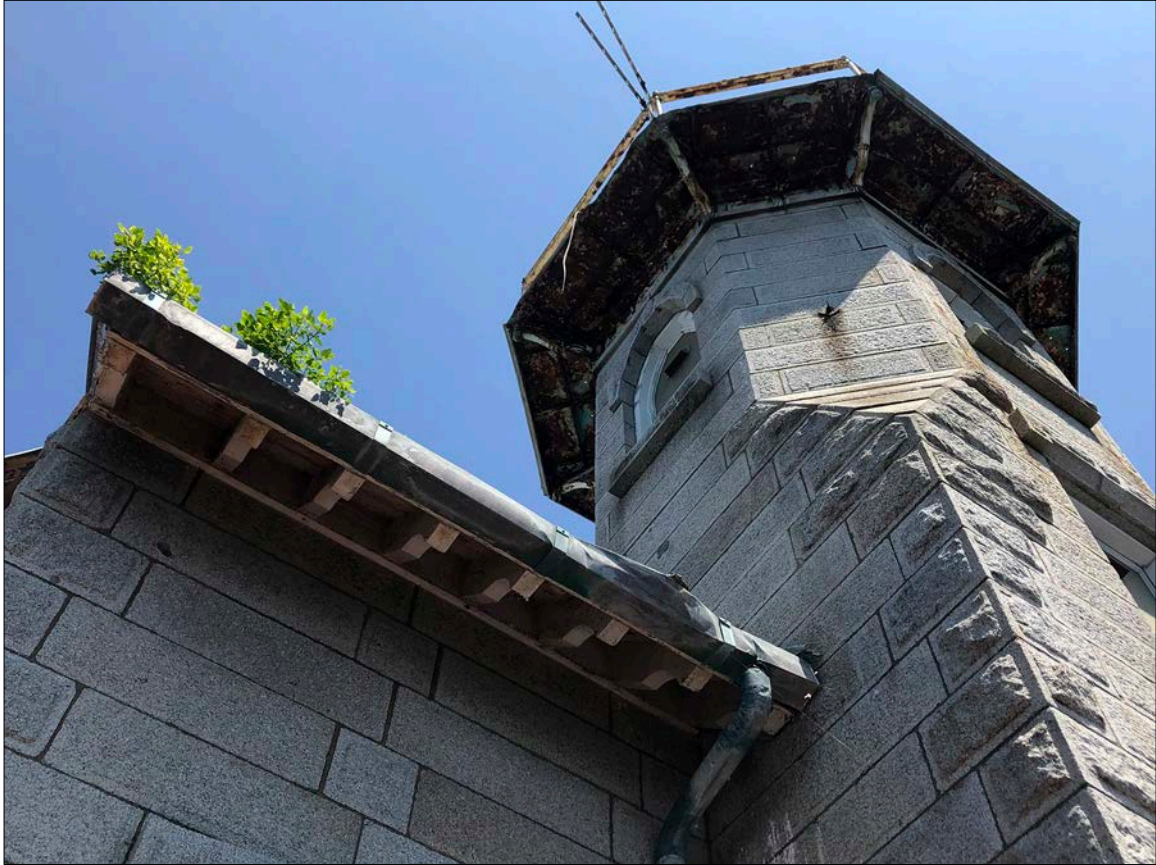
Photo 11. View up the west wall of the Tower and adjoining west eave. Coursed ashlar granite walls remain in extraordinary condition – a testament to their underlying technology – though the assembly possesses several Achilles’ heels: gutters, unpainted cast iron and marginally maintained windows.

- 5.1. Granite walls require selective repointing, as well as the extraction of embedded iron elements: rives, clamps, fasteners, et al. that have led to staining and cracking.

- 5.2. Embedded iron elements may be safely replaced with non-ferrous alternatives.
- 5.3. Original windows – or new windows more closely emulating the originals – need to be reinstalled throughout the Light Station.
- 5.4. Exterior paint finishes are important architectonic considerations, and vary significantly from the non-historic white finishes now present. Original hues also are more closely aligned with the stylistic elements of the resource as a whole, rendering its appearance more pleasing and unified.

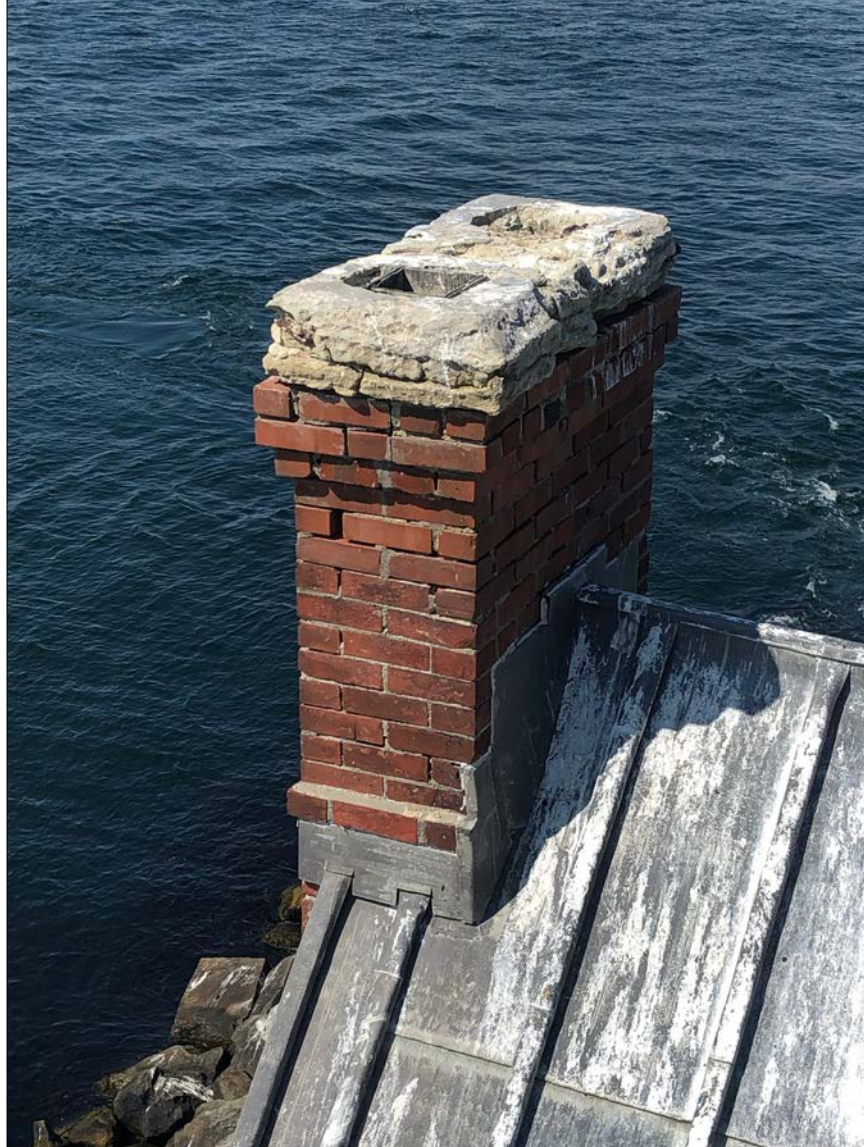
Photo 16. Despite the high quality of the present roofing installation, original chimney and other penetrations require special attention. Damage to the copings is not unusual, and eminently repairable.

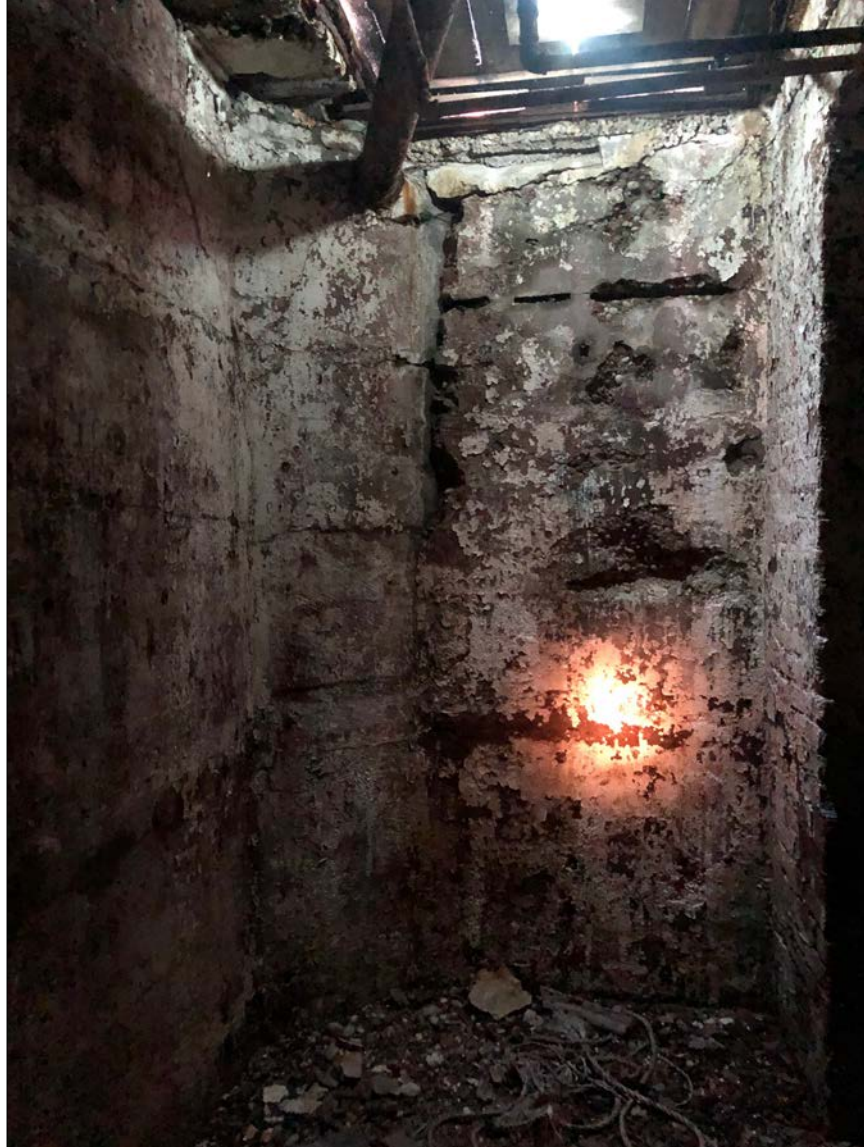
Photo 17. Beneath the Drum deck bulkheads are vertical access shafts for coal, food & ice. At present, these pose a severe potential safety hazard for anyone standing on or near the bulkhead plates, or below.

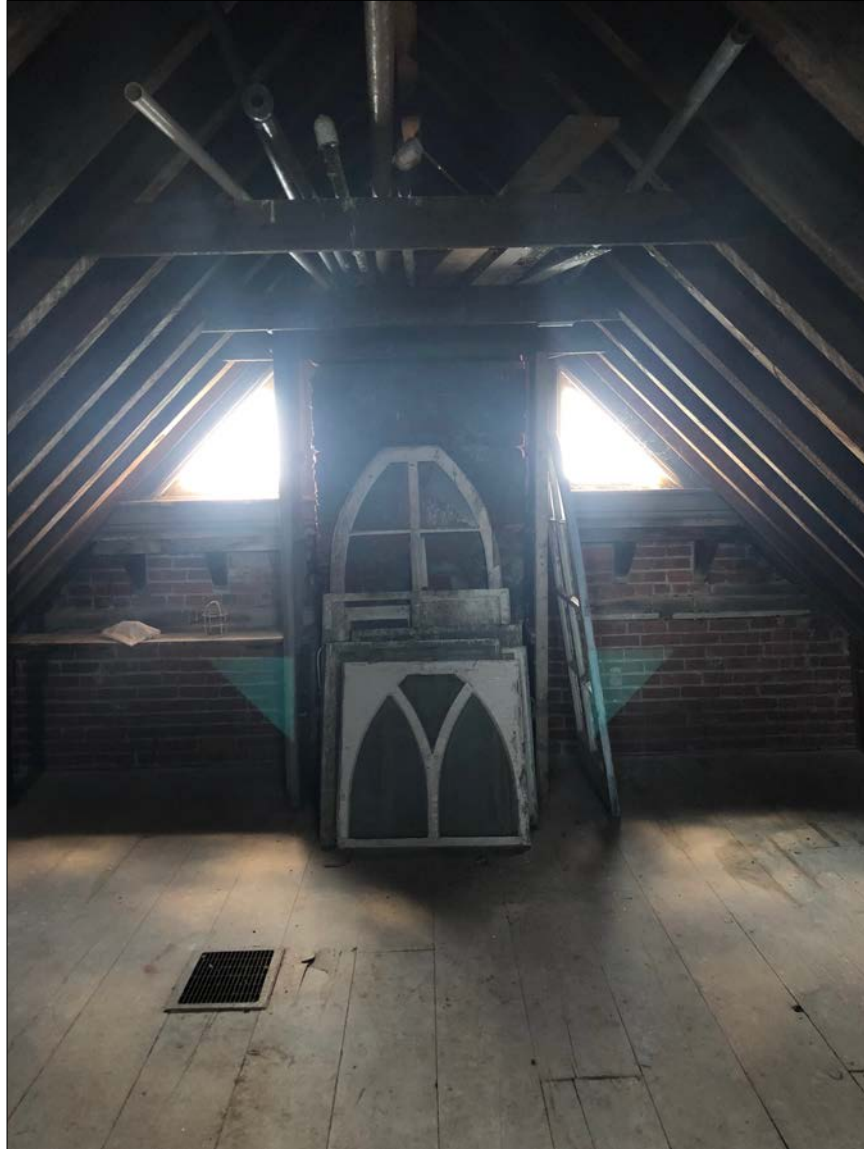
Photo 20. The attic space is clear and pristine, with few issues of concern relating to condition, structural integrity or usefulness. Remarkably, many of the original wood windows – swapped for utilitarian versions by USGC – have been stored for safekeeping; these should be re-integrated during the Lighthouse restoration, where they can exceed new energy standards.

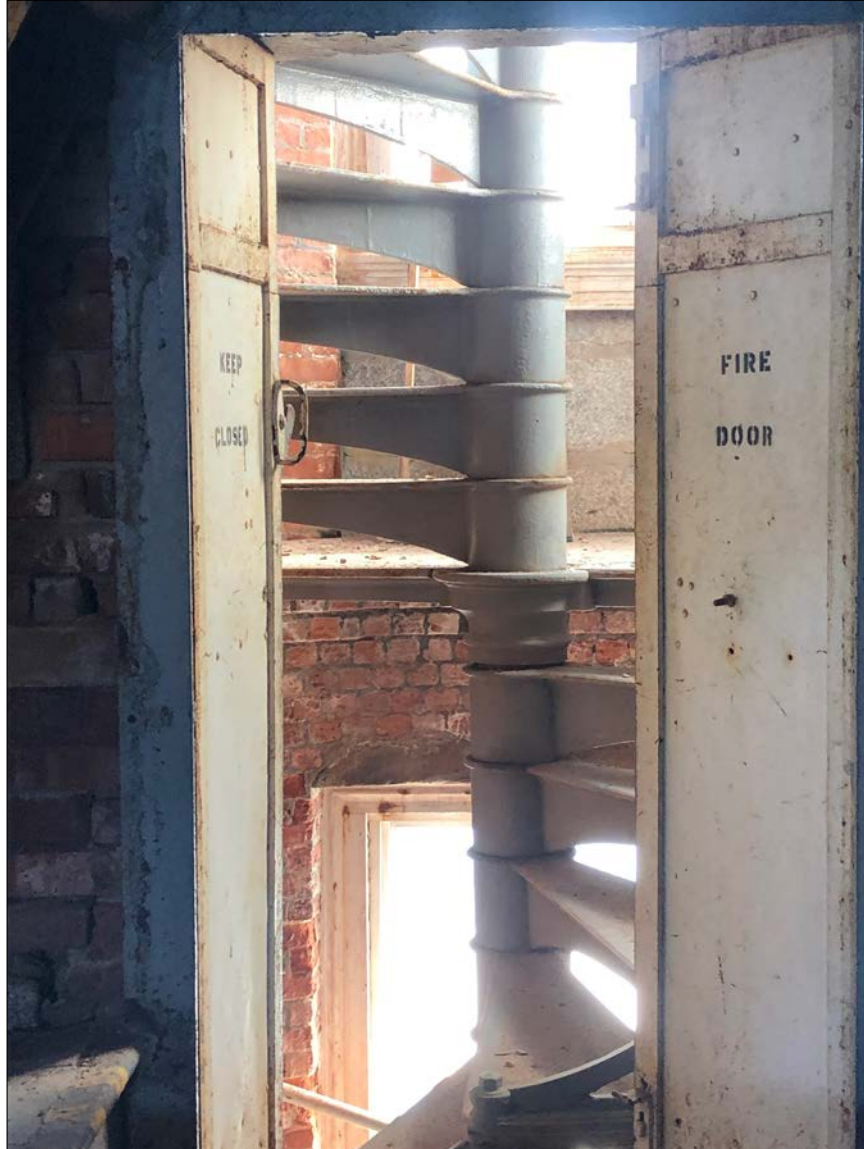
Photo 22. Cast iron spiral stairs continue directly to the Lantern, via the attic and Service Level of the Lighthouse. Water seeping through the Lantern's cast iron elements is evident throughout.

- 2.1. DO NOT apply any coatings or other products to the interior surfaces of the brick!
- 2.2. Provide a secure weatherproofing system that encompasses the entirety of the Lantern gallery decking, down to the base of the octagonal portion of the stone tower below (approximately 8'-10' vertically). Allow the masonry materials within this enclosure to dry out naturally before next steps are taken; this will require at least 3-4 months, and may readily be monitored with field meters as desired. Once excessive moisture levels have stabilized, durable corrective measures may begin.

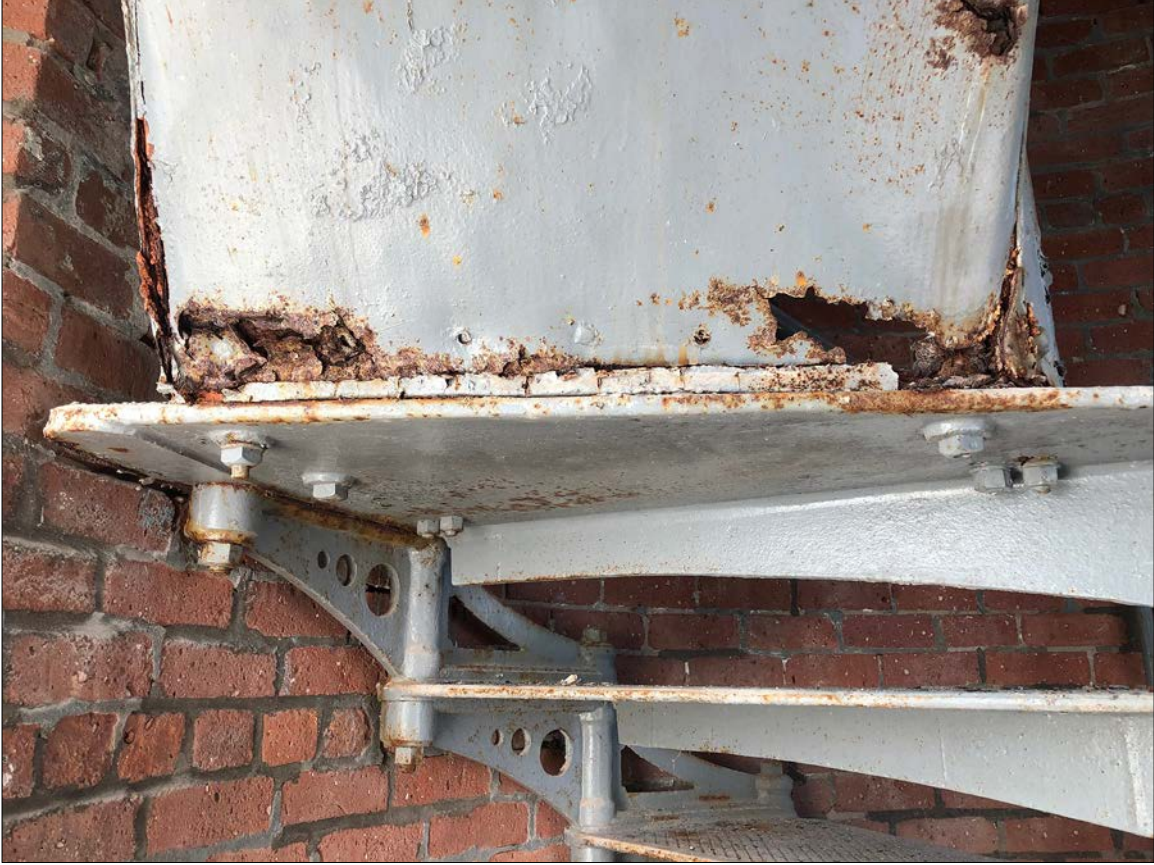
Photo 23. Just beneath the Lantern Level, the final stair run is permeated with rust resulting from water ingress above as well as deposition of condensation from being closed for long periods. Despite its appearance, damage such as this remains very restorable.

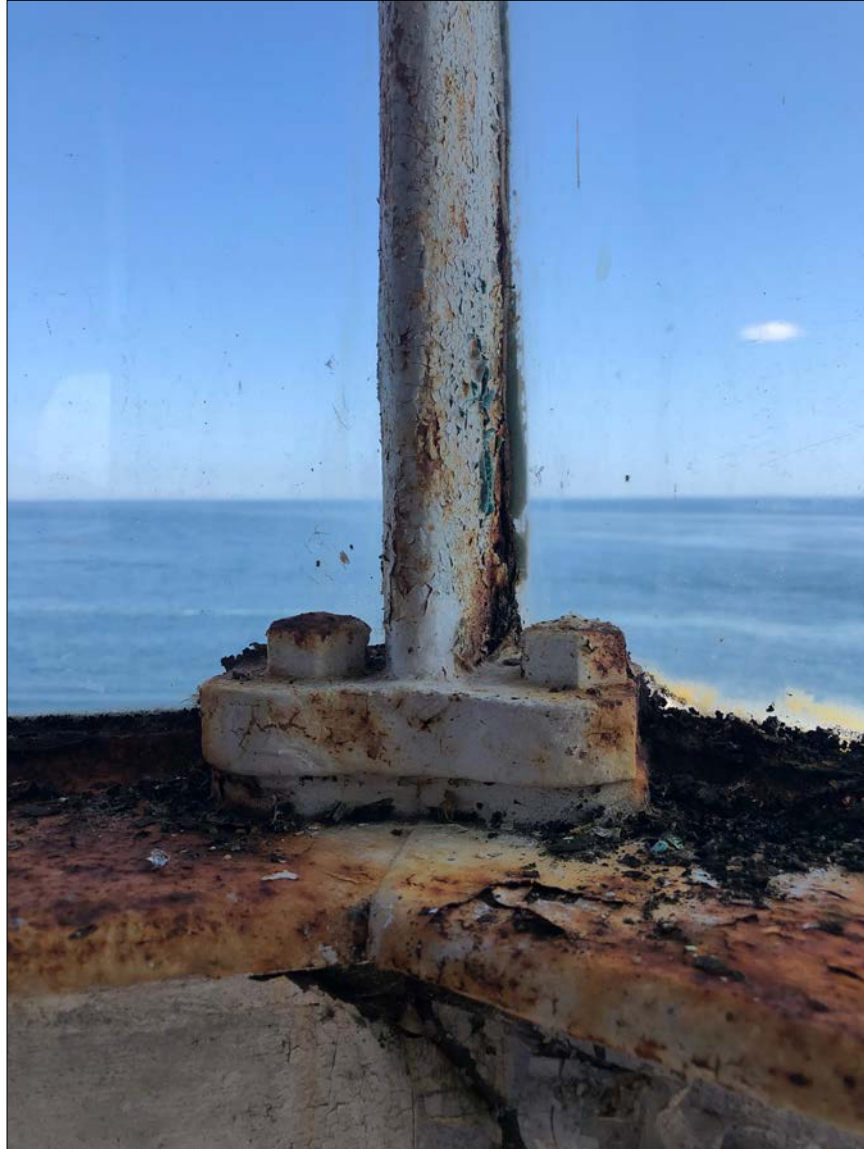
Photo 24. Within the Lantern, the vertical bars, sills, vents, spider frame and various related elements all suffer from lack of a Keeper who could attend to small coating & repair issues before they became large. Most elements are intact, which speaks well for the success of the planned restoration.
