National Transportation Safety Board Aviation Accident Factual Report

| Location: | Ketchikan, Alaska | Accident Number: | ANC21FA069 |
| Date & Time: | August 5, 2021, 10:50 Local | Registration: | N1249K |
| Aircraft: | DEHAVILLAND DHC-2 MK.I | Aircraft Damage: | Destroyed |

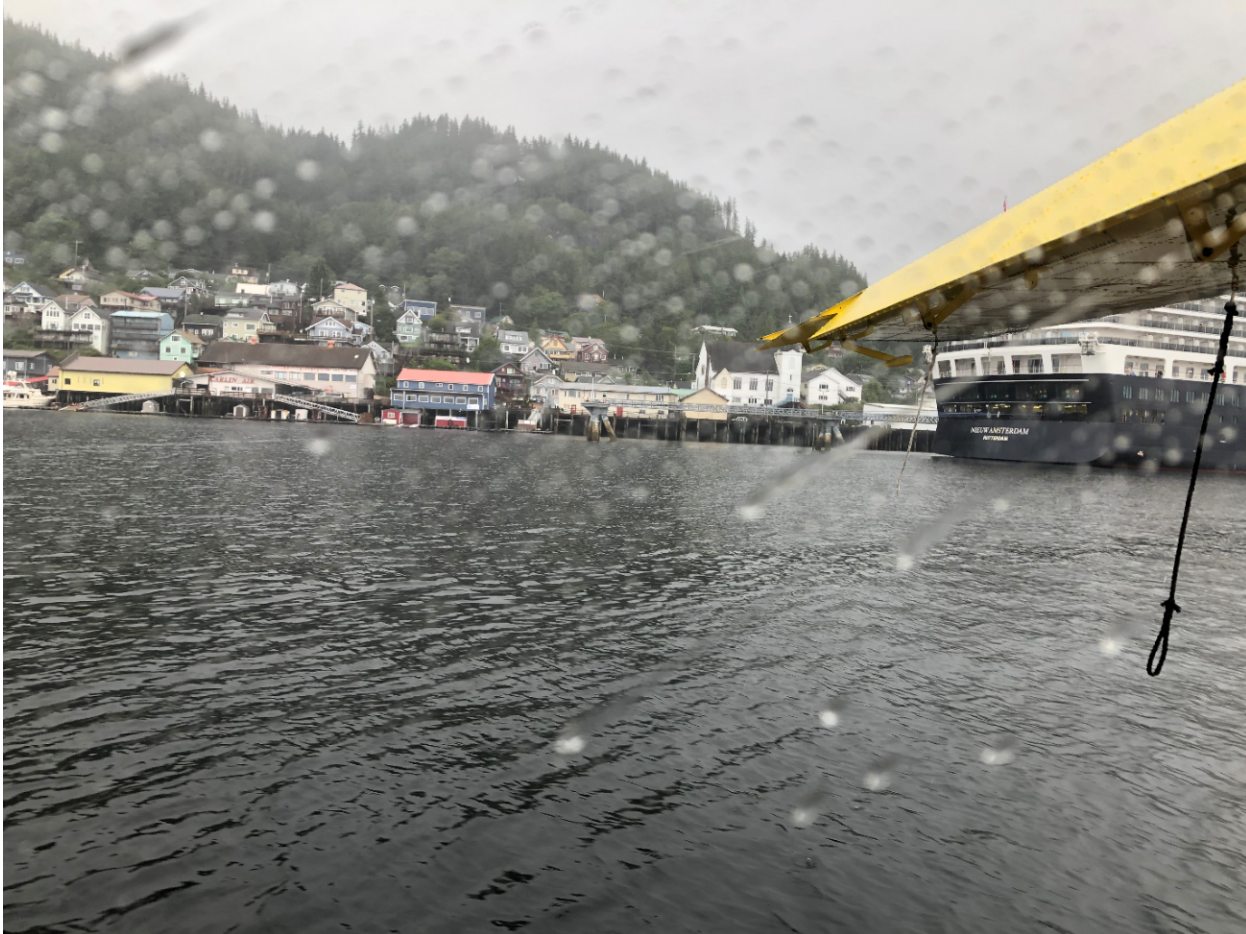
Figure 1. Photograph taken by a passenger on the accident flight prior to departure. Image depicts the left side view from the accident airplane and shows rain on the passenger window.

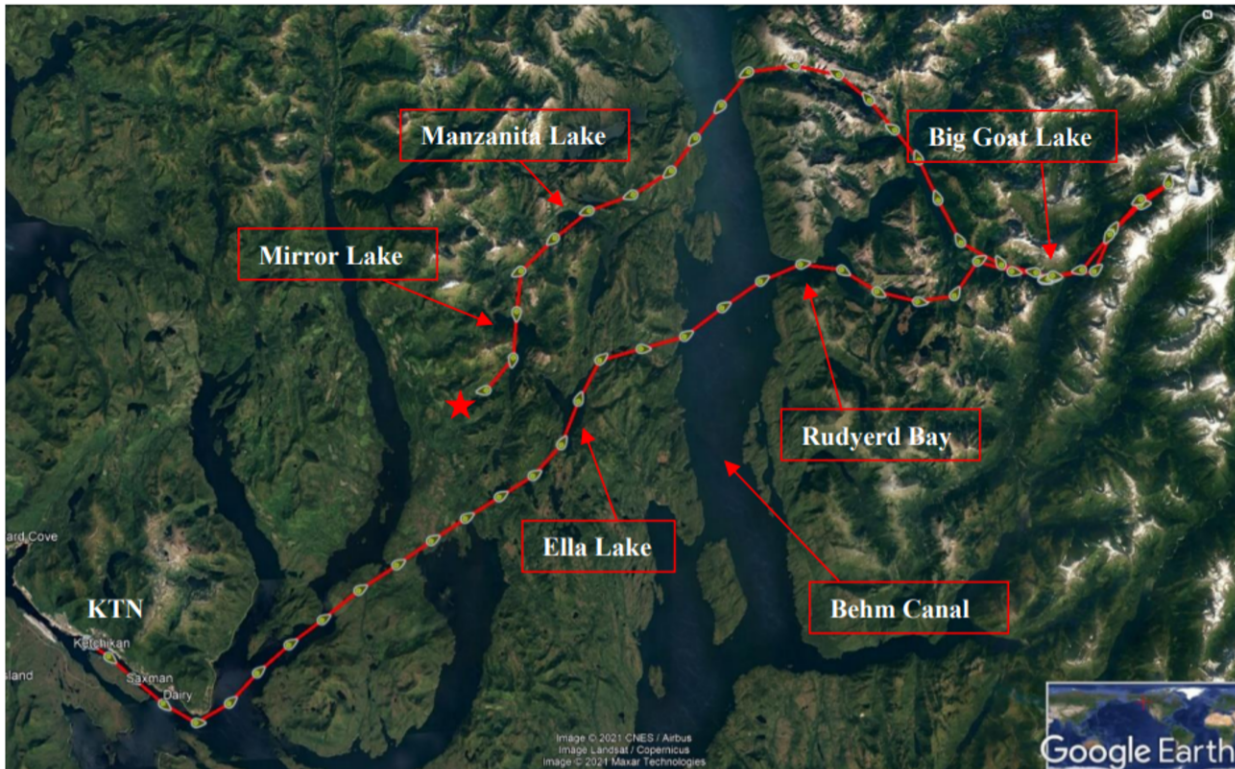
The last two Spidertracks returns indicated that the airplane was flying alongside the northern (right) side of the valley. The final satellite tracking system transmission from the airplane was at 1048, at an altitude of 1,730 ft msl and a ground track of 261° true. Figure 3 depicts the Spidertracks data from throughout the accident flight.

Figure 3. Spidertracks image of accident flight. Arrows denote direction of travel and red star indicates approximate location where accident occurred.

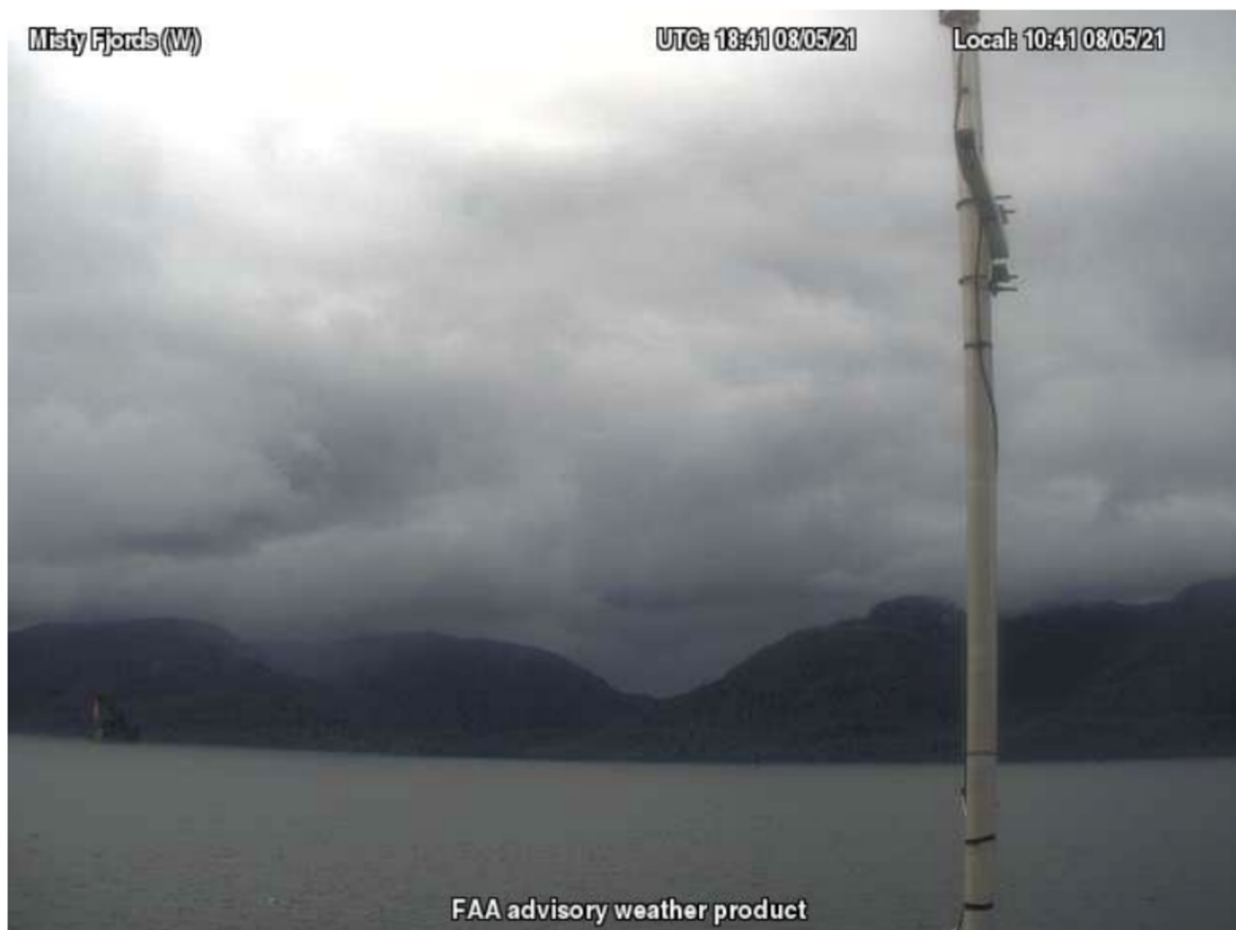
Figure 5. FAA weather camera from Misty Fjords west view from 1041, which was just after the airplane crossed Behm Canal on the return portion of the accident flight.
