# NUCLEAR SAFETY, SECURITY AND SAFEGUARDS IN UKRAINE

## 2<sup>nd</sup> Summary Report by the Director General

28 April – 5 September 2022

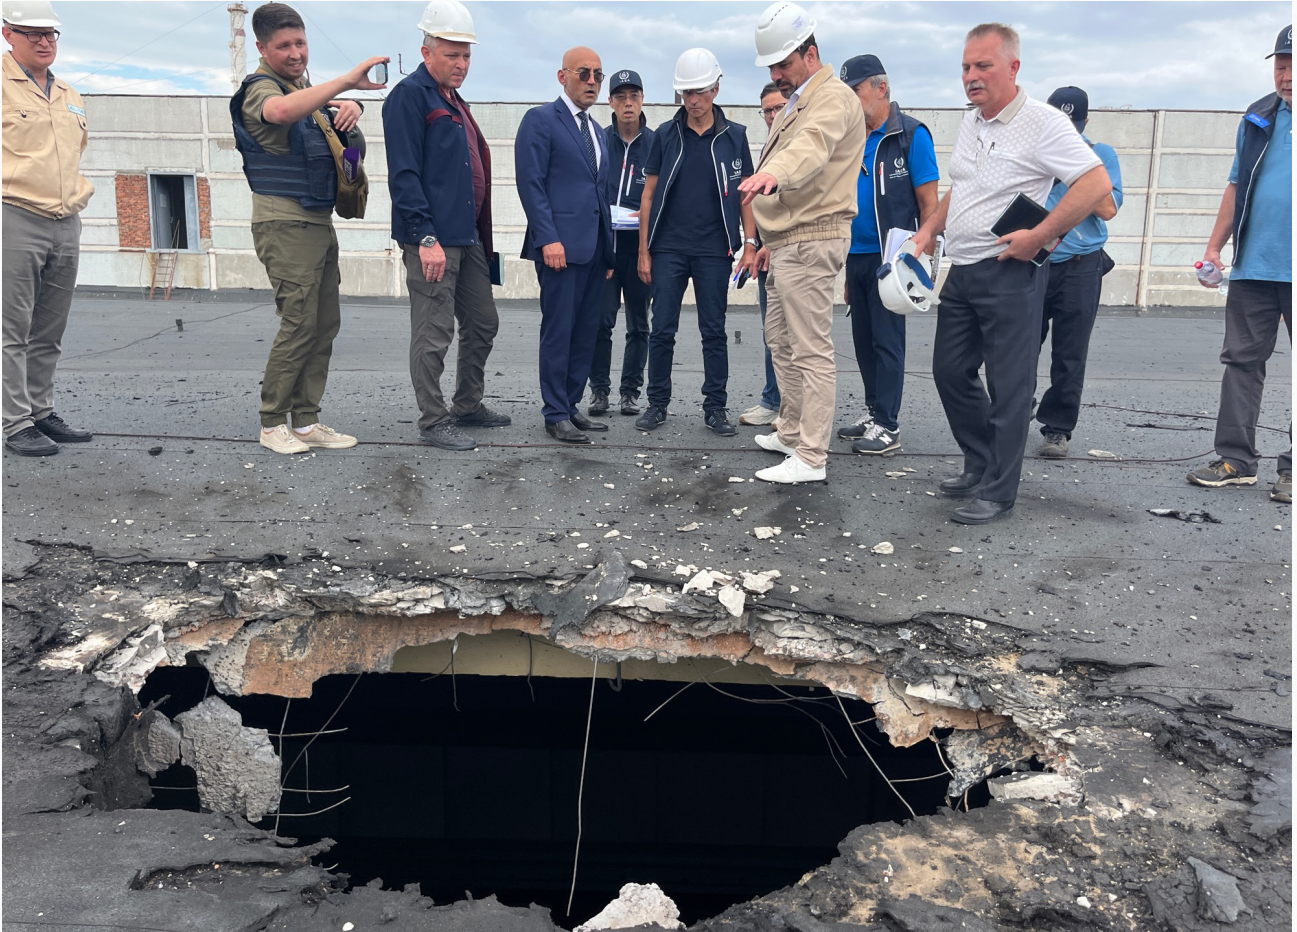
The IAEA team observes the damage caused by shelling on the roof of the special building at the ZNPP that houses, among other items, the fresh nuclear fuel and the solid radioactive waste storage facility. (Photo: IAEA)

**Recommendation 1:** The IAEA recommends that shelling on site and in its vicinity should be stopped immediately to avoid any further damages to the plant and associated facilities, for the safety of the operating staff and to maintain the physical integrity to support safe and secure operation. This requires agreement by all relevant parties to the establishment of a nuclear safety and security protection zone around the ZNPP.

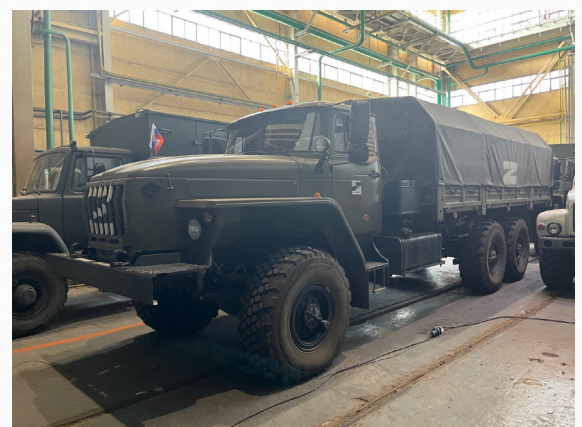
39. The team observed the presence of Russian military personnel, vehicles and equipment at various places at the ZNPP, including several military trucks on the ground floor of the Unit 1 and Unit 2 turbine halls

Military vehicles on the ground floor of the turbine hall of Unit 2 of ZNPP (Photo: IAEA)

and military vehicles stationed under the overpass connecting the reactor units. The team also observed the presence of an expert group from Rosenergoatom. It was explained to the team by the Ukrainian plant staff and managers that the role of this expert group was to provide advice on nuclear safety, security, and operations to the management of the ZNPP.

**Recommendation 2:** The IAEA recommends that the physical protection system should be operated as designed and licensed, and that the continued functioning of safety and security systems and operability of the systems and equipment at ZNPP be ensured. This requires the removal of vehicles from areas that could interfere with the operation of safety and security systems and equipment.
