Level 2 Investigation Report

Event title: Newtown 225 Aerial Failure V1.0

Event ID: 9107
Event date: 02 February 2022

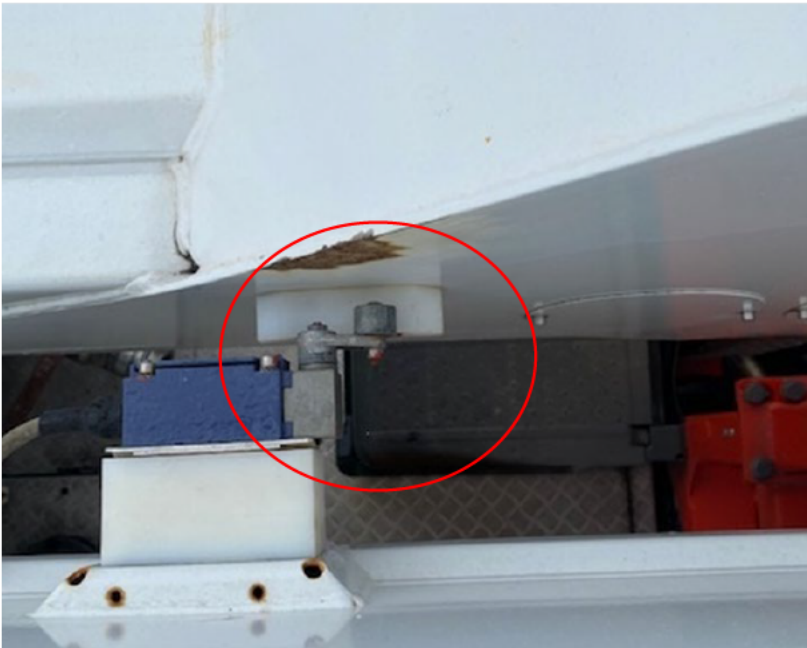
Figure 3 While examining the aerial unit, the cage auto-housing feature 'failed' and the fault was traced to a small sensor on the boom, designed to give the computer system position status information. The photograph shows the sensor, which had likely gone outside of its tolerance range because of 1-2mm wear on the nylon sensor pick-up plate.

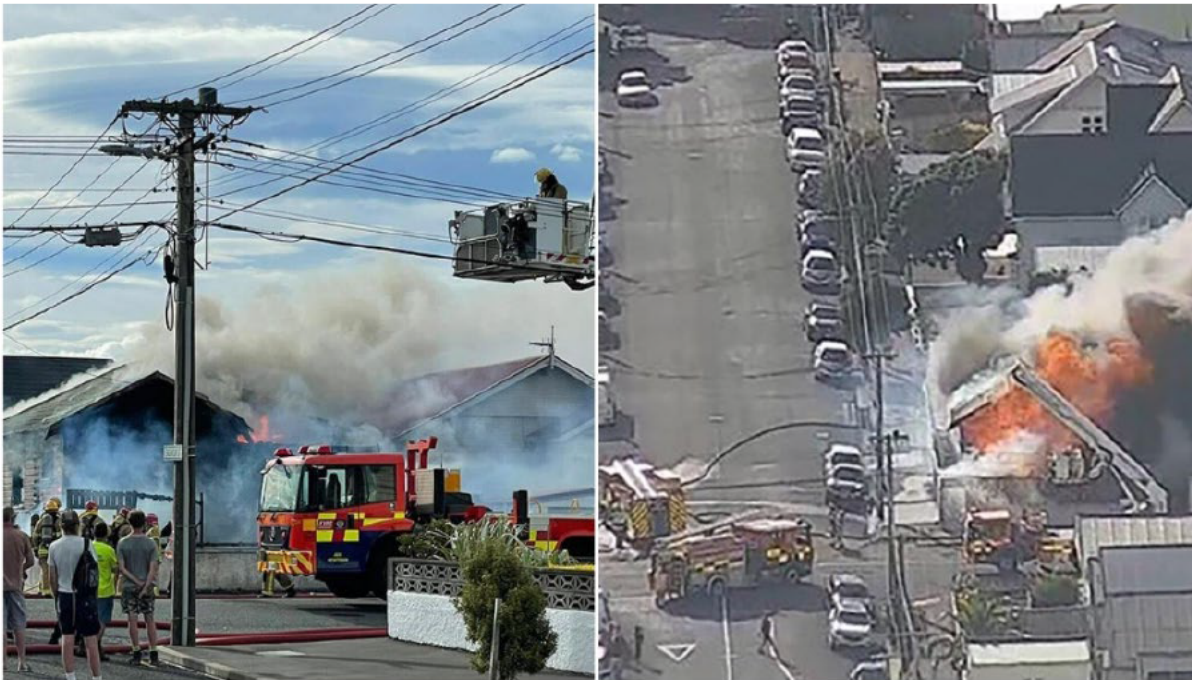
Figure 5 Images published by Newshub showing the extent of the fire and FEY849 while it was in a fault condition.

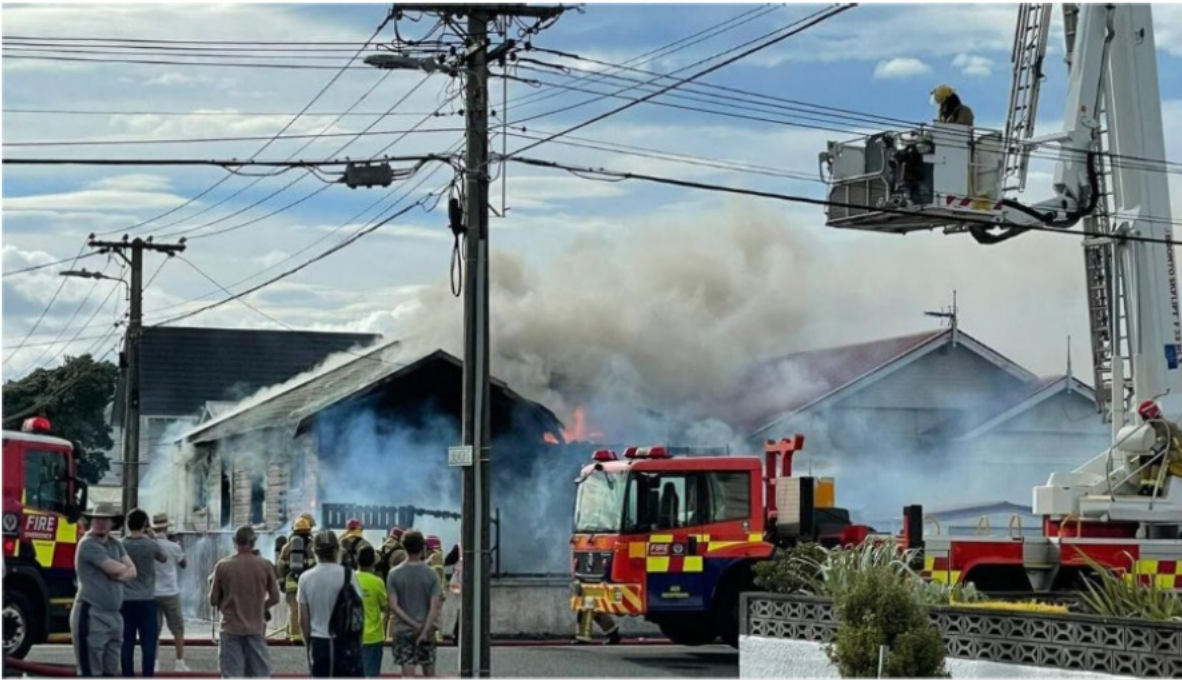
Figure 7 Image published online by NZPFU showing FEY849 in fault condition.
