City of Kodiak
Kodiak Historical Society

RUSSIAN-AMERICAN COMPANY MAGAZIN
KODIAK, ALASKA
Historic Structure Report

MARCH 22, 2022

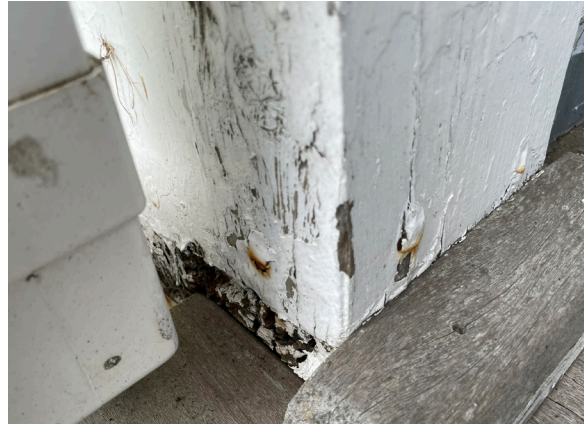
Figure 1-150. Deteriorated column base. (KAC, 08/24/2021)

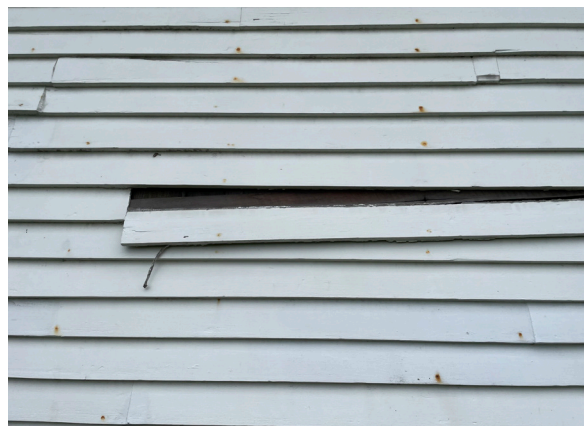
Figure 1-157. Loose siding board on the north facade. (KAC, 08/24/2021)

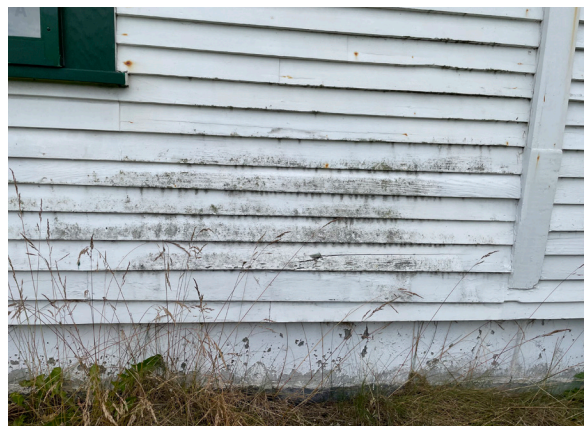
Figure 1-158. Deteriorated siding on the north facade, below the missing downspout. (KAC, 08/24/2021)

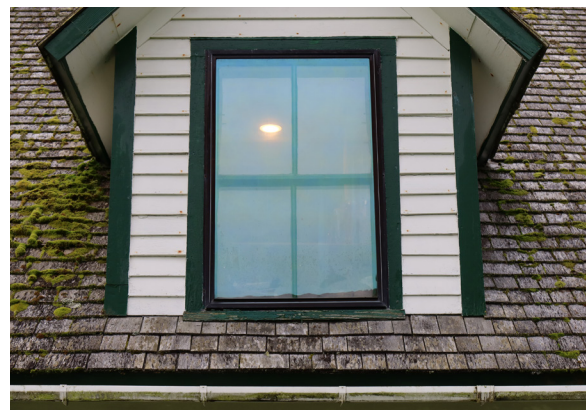
The sill at Window 30 is significantly deteriorated and in poor condition. Casing

Figure 1-163. Deteriorated sill at Window 30, Type C. (EAV, 08/24/2021)

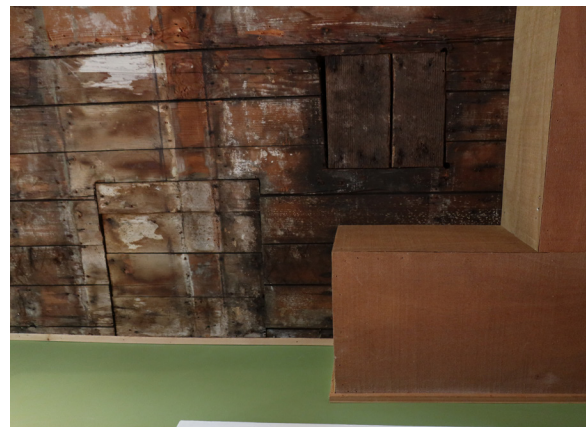
Figure 1-290. Patched and stained ceiling boards in Museum II 104. (EAV, 08/24/2021)

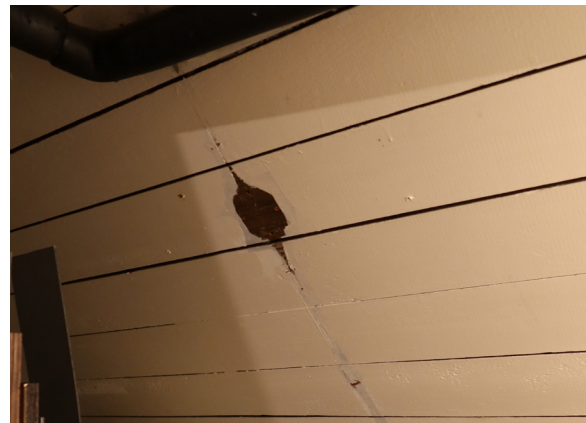
Figure 1-329. Missing paint from previous attachments in Eunice 201A. (EAV, 08/24/2021)

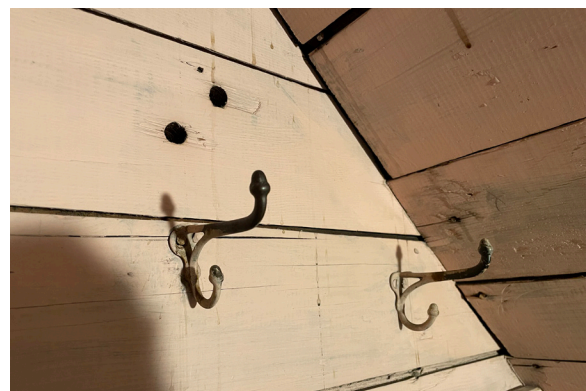
Figure 1-332. Scratched paint and holes from previous attachments in Storage 205A. (EAV, 08/24/2021)

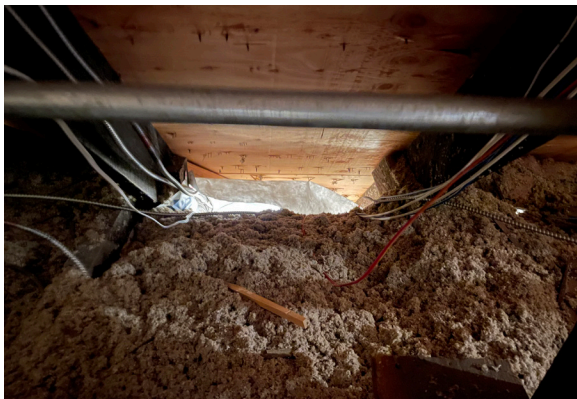
Figure 1-340. Loose insulation at perimeter of Attic I 300. Light is visible from Storage 205B below. (EAV, 08/24/2021)

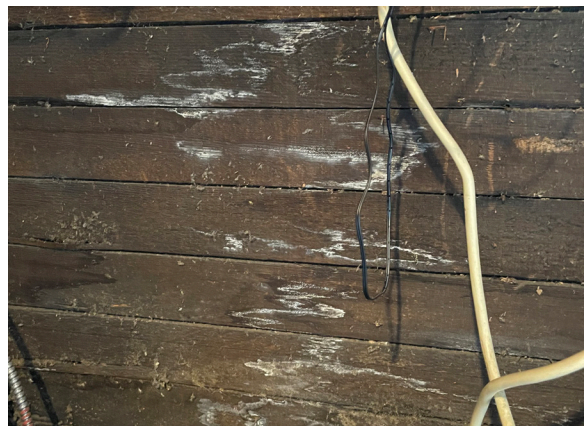
Figure 1-343. Smoke stain and efflorescence on exposed sheathing at the east wall of Attic I 300. (EAV, 08/24/2021)

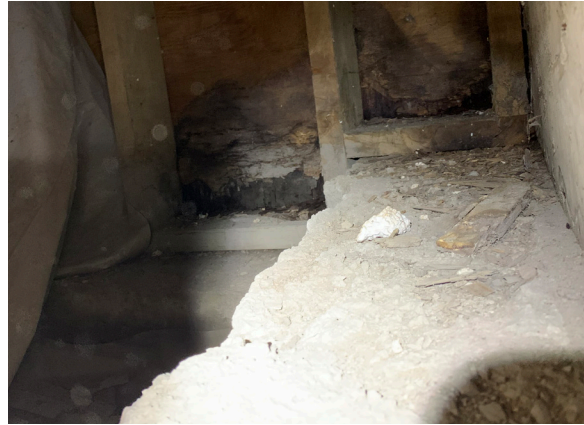
Figure 1-346. Interior face of the north wood stud foundation wall of the Alcove. Note the water staining and deterioration at the base of the wall (CBB, 08/25/2021)

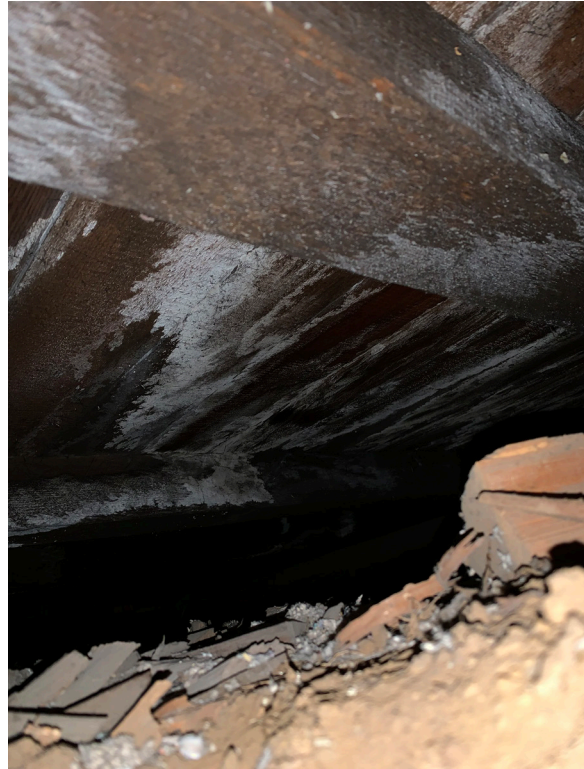
Figure 1-353. Second floor framing cavity of the Magazin on the east half of the structure. Note the 4x4 joists at the top of the cavity and the mold or water staining visible on the wood members (CBB, 08/25/2021)

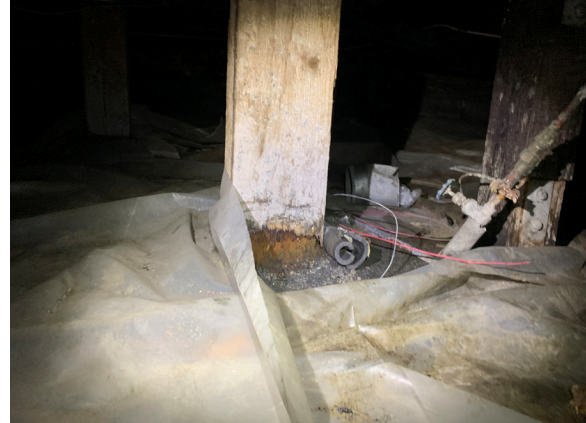
Figure 1-355. Deteriorating base of a post supporting the first floor of the Magazin (CBB, 08/25/2021)

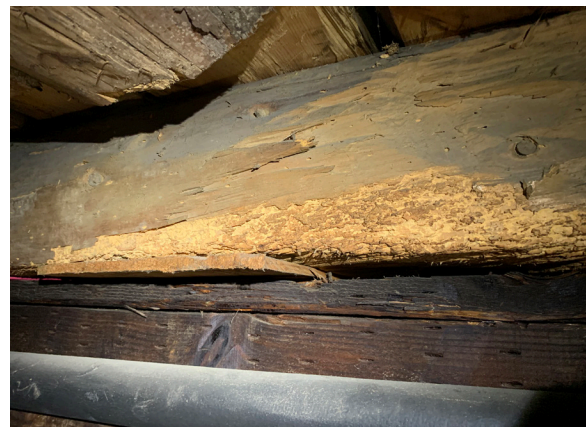
Figure 1-357. Insect damage visible on a first floor dropped log beam (CBB, 08/26/2021)

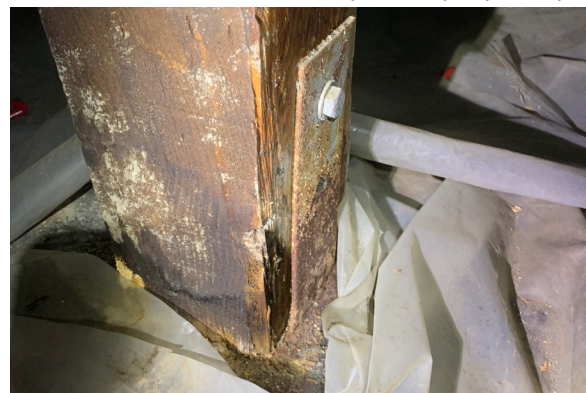
Figure 1-360. Deteriorating base of first floor post in the crawlspace. Note the corrosion of the steel angle that was intended to connect the post to the foundation (CBB, 08/25/2021)

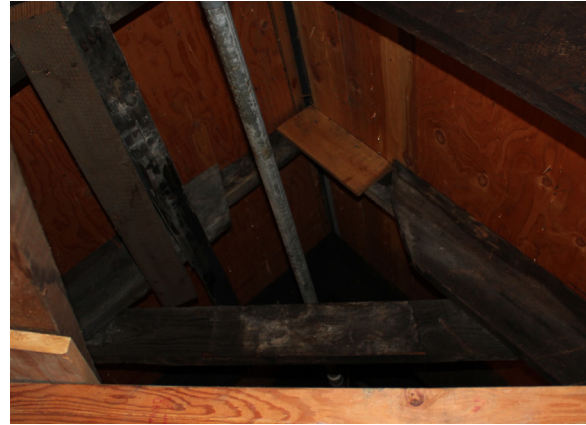
Figure 1-367. In one location, the rafters have been cutback from the peak of the roof and sistered (CBB, 08/26/2021)

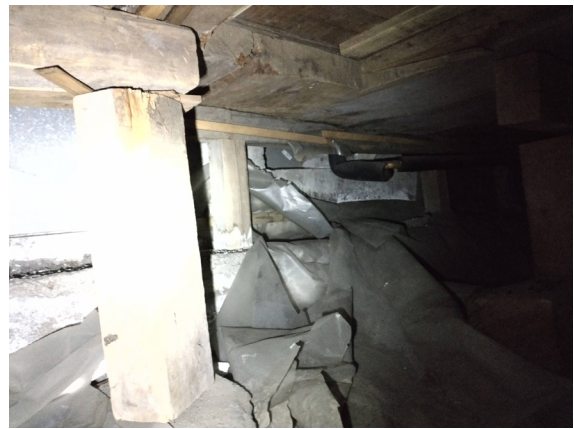
Figure 1-387. Damaged Cast-Iron Waste Pipe (JSW 8/24/2021)
