San Francisco Bay Regional Water Quality Control Board

CONFINED ANIMAL FACILITY COMPLIANCE INSPECTION

General Waste Discharge Requirements for Confined Animal facilities within SF Bay Region; Order No. R2-2016-0031

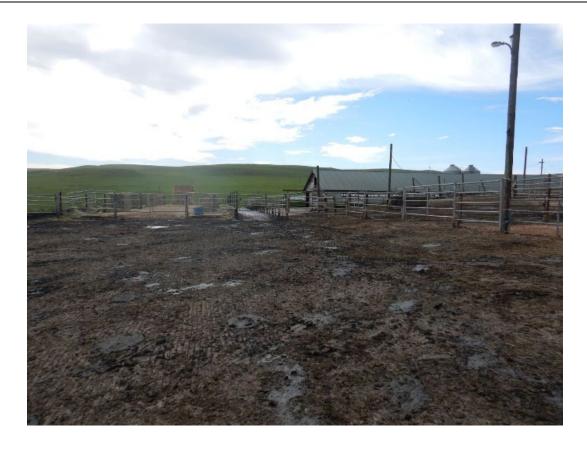
Photo 1: The main concrete-lined corral scraped into the primary waste pond.

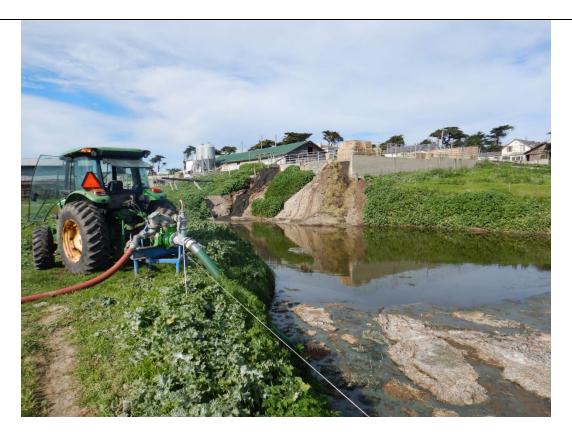
Photo 2: The primary waste pond. The tractor and pump system are used to transfer manure from this primary pond to the third waste pond, below the loafing barn. The pond's inlet, the area where waste is scraped from the corrals into the storage area, is visible in the background.

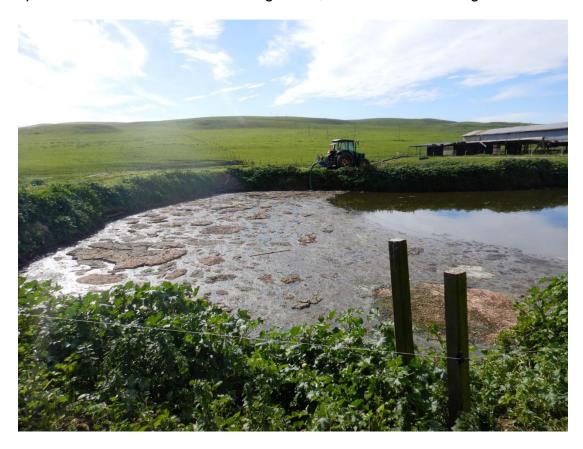
Photo 3: The primary waste pond, facing west.

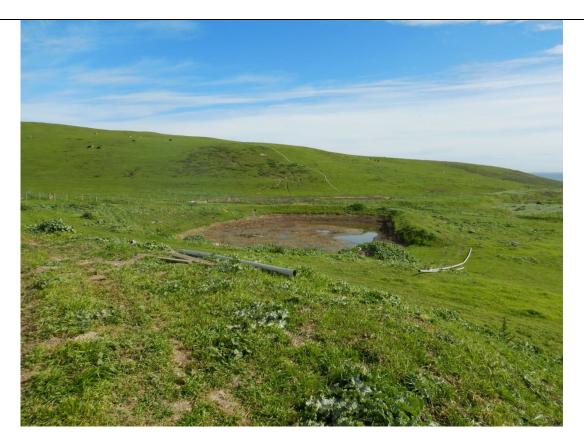
See "Retention Pond Management" comments for the initial discussion. The pond system is dysfunctional, and operators must determine what their current storage capacity needs are, and how the pond system must be upgraded to meet the needs of the operation and the minimum requirements of the General WDR.

Photo 4: The secondary waste pond, empty with an incomplete berm.

In the short term, active management practices are necessary to ensure the complete containment of manure and stormwater contacting manure, especially within the second pond. These measures may include spray irrigating during extended dry weather and implementing an emergency contingency plan for extreme weather events (pump truck contracts or other actions to gain capacity before storm events). A written description of updated management practices and/or photos of pollution prevention measures must be submitted in the 2022 Annual Report.

To address a long-term solution, we request that a detailed Corrective Action Plan for addressing the pond systems capacity be developed and submitted to the SF Bay Water Board by November 1st, 2022. This plan must include a timeline for updating all management plans and storage calculations, completing engineering designs to upgrade the pond system, and implementing the upgrade project. We suggest contacting the CA Dairy Quality Assurance

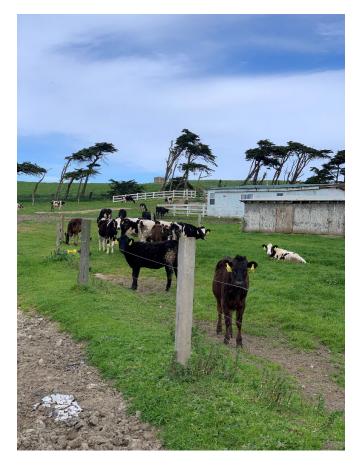
See "Confined Areas" comments for the initial discussion. The loafing barn gutters and stormwater run-on from an uphill corral are directed into the field where livestock are currently confined. These flows are directed across the field, across the adject livestock pathway and into the creek. With two sources of clean stormwater being diverted into a manured area, and no BMPs to prevent contaminated flows from entering the creek, we concluded that the present design and animal management in this field pose a risk to water quality.

Photo 5: Cows in the field adjacent to the dilapidated loafing barn.

When this field is used as a confined area, it must be managed like a corral. The operator must identify and implement BMPs to prevent the discharge of manure and wastewater during storm events and to divert clean stormwater away from this area. At a minimum, before all storms, operators must scrape/remove waste from the confined area and install erosion and sediment controls. For example, straw cover. Before and during a rain event, operators must relocate animals to confined spaces that drain into a wastewater pond.

We recommend adjusting the stormwater diversion system to stop the southern corral and barn gutters from discharging stormwater into the field. With the stream being relatively close, an option to consider is extending the gutter system to release the clean stormwater into the stream, but BMPs are up to the discretion of owners and operators. A written description of updated management practices and photos of pre-rainy season pollution prevention measures in this field must be submitted in the 2022 Annual Report.

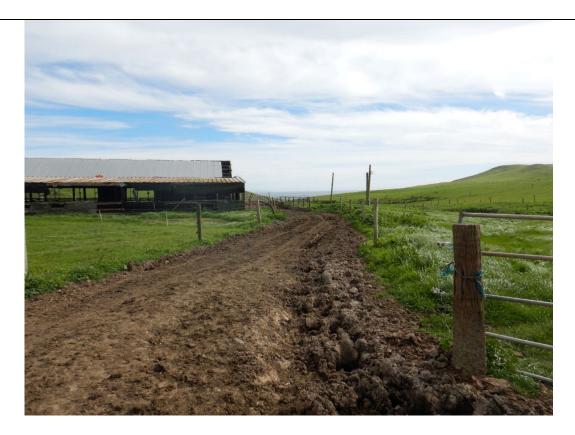
Photo 6: From left to right of the photo, the loafing barn, visible in the background, with its adjacent field, a dirt livestock pathway, and a vegetated filter strip separating the pathway and the creek, which is to the right of this photo.

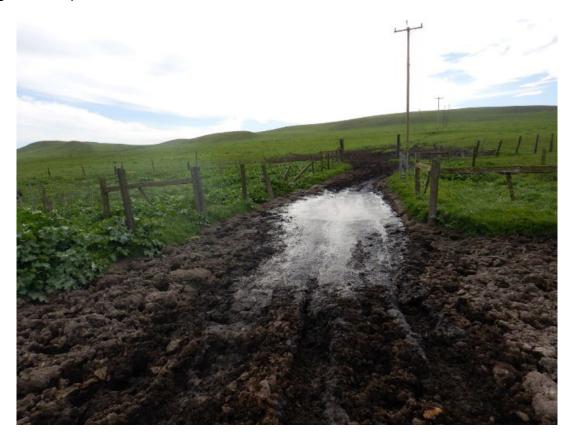
See "Animal Management and Clean Water Diversion" comments for initial discussion. At the stream crossing/livestock pathway, we observed heavily disturbed soils and pooled water with no measures to prevent soil and manure from discharging into the creek (see Photo 7).

From the operator, we know that the water comes from Field 9 which develops springs each winter. Being at the bottom of Field 9's hills, the water naturally flows down and collects at the flat stream crossing.

Photo 7: The flooded livestock pathway and stream crossing. See Facility Map for the location of the creek.

In the short term, a written description of updated management practices and photos of implemented pollution prevention measures must be submitted in the 2022 Annual Report. We recommend installing sandbags along the inside eastern fence bordering the crossing to prevent soil and manure from entering the stream below. These are our recommendations though the best management practices used to prevent soil and manure discharge from this crossing is up to the discretion of the owners and operators.

To address a long-term solution, we request a detailed Corrective Action Plan, including an implementation timeline, be developed and submitted to the SF Bay Water Board by November 1st, 2022. To develop a long-term solution, we recommend the facility reach out to NRCS and discuss adding or altering the existing improvement project to include lining the stream crossing and entire livestock crossing in concrete, which would minimize soil disturbance, and incorporating a berm along the stream crossing to block potential discharge. A project like this would reduce erosion and make this confined stream crossing easier to manage for manure (i.e., making the path and crossing scrapable). Funding options can be sought with 319(h) grants, NRCS, and NPS.

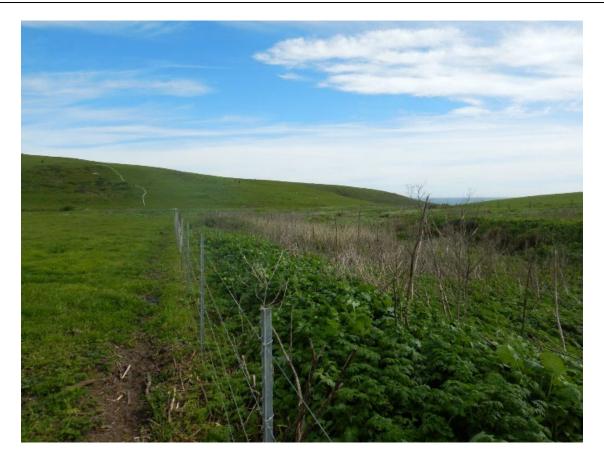
Photo 8: Fencing and vegetated buffer by the creek.
