DEPARTMENT OF THE NAVY
COMMANDER NAVAL AIR FORCE
UNITED STATES PACIFIC FLEET
BOX 357051
SAN DIEGO CALIFORNIA 92135-7051

Subj: COMMAND INVESTIGATION INTO THE FACTS AND CIRCUMSTANCES
SURROUNDING THE F-35C CLASS A AVIATION MISHAP OF 24 JAN 22

15 Apr 22

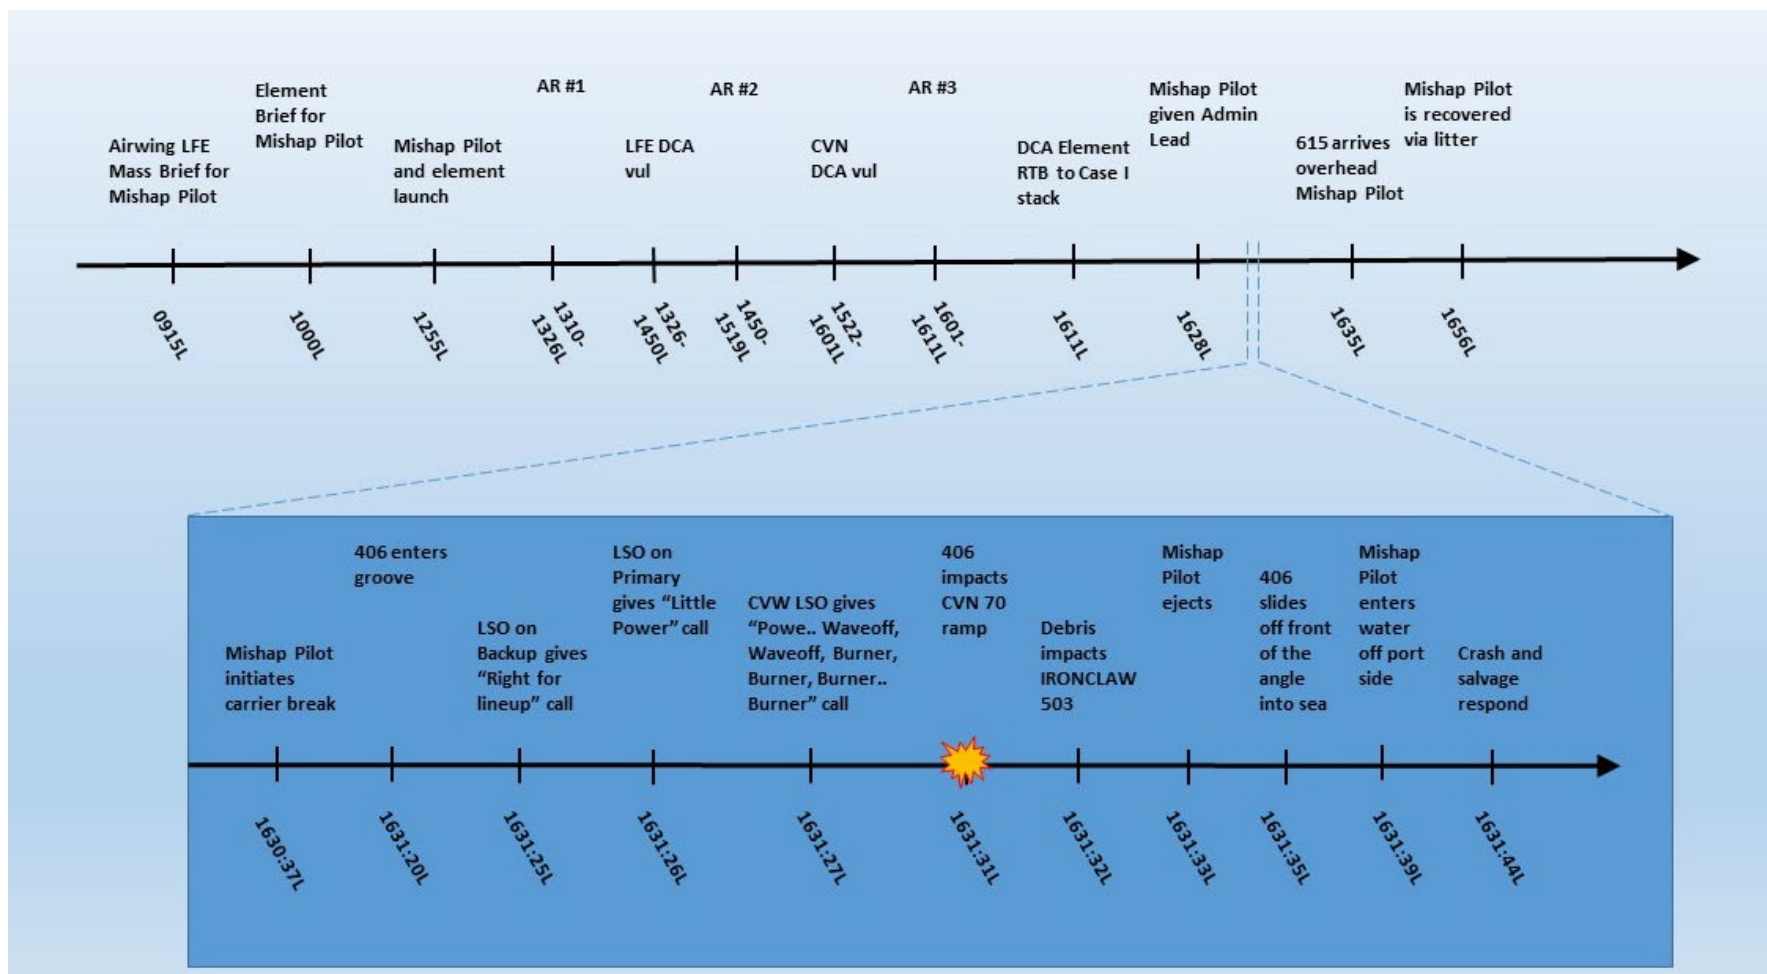
Mishap Aircraft Sequence of Events

8. The investigation determined the cause of the mishap to be pilot error. The pilot entered the carrier break, bringing the throttle to Flight IDLE, allowing the aircraft to slow to approach speed. Once approach speed was achieved, the F-35C landing checklist was not fully completed by selecting Approach Power Compensation Mode (APC)/Delta Flight Path (DFP), leaving the aircraft operating in Manual Powered Approach (PA) Control Laws (CLAW).

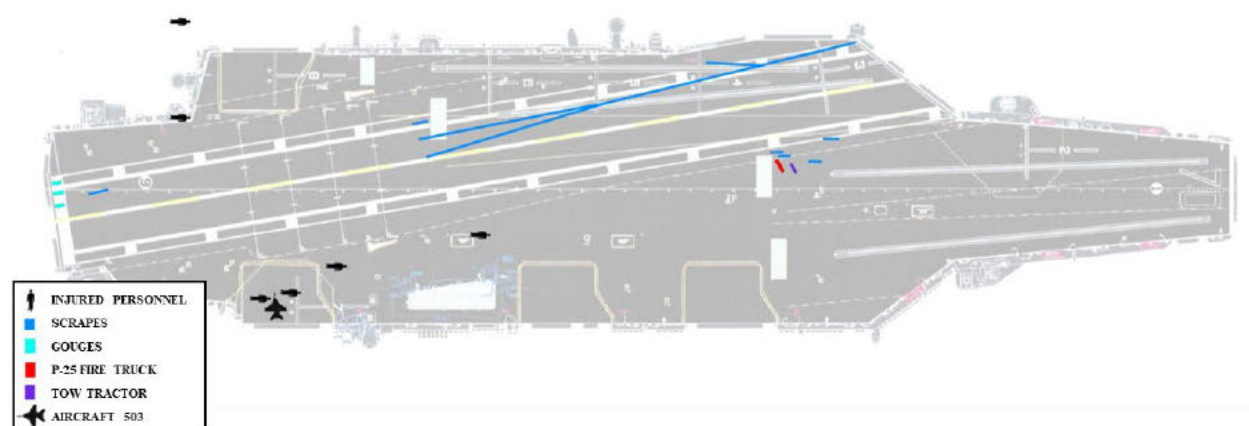
Figure 6 depicts the Location of Injured Personnel and Damages

148. The mishap resulted in the destruction of BUNO 169304, significant damage to EA-18G BUNO 169211 (IRONCLAW 503), and minor damage to the CVN 70 flight deck and ground support equipment. [Encl 4-6, 69, 70-72, 84]

150. Aircraft BUNO 169211 (IRONCLAW 503) was parked on aircraft elevator 3 of CVN 70 and struck by debris from MA impacting the flight deck. The following monetary costs are for replacement of IRONCLAW 503's respective component, which is the expected course of action at the organizational level. [Encl 4-6, 69]

(3) To ensure survivability of the upwind Mobile Firefighting Vehicle (MFFV) and its ability to help respond to a crash in the landing area, position upwind MFFV away from the foul line.
