Targeted Asbestos Refurbishment Survey

Address:
Central Fire Station
40 Pitt Street
Auckland
1010

Project Reference: M-00235.003

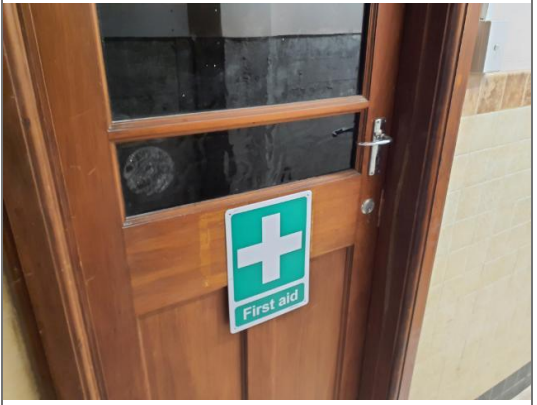
Central Fire Station		
Location / Location Number - Room	Access/Notes	Photo
2nd Floor First Aid (Room 022)	No Access The room could not be accessed because the door was locked. Sampling of dust and debris in the corridor outside the room was negative for the presence of asbestos. Should future refurbishment works be required inside the room then an inspection of the room is required.

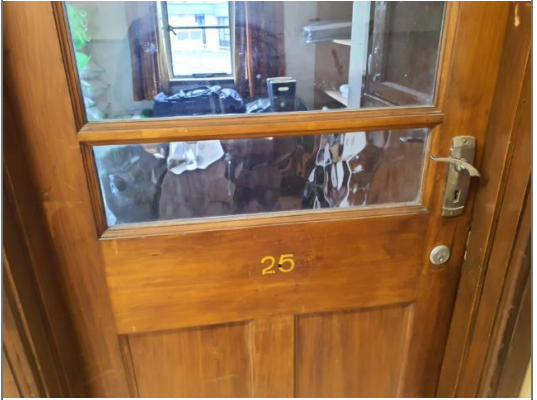
2nd Floor Room 25 (Room 023)	No Access The room could not be accessed because the door was locked. Sampling of dust and debris in the corridor outside the room was negative for the presence of asbestos. Should future refurbishment works be required inside the room then an inspection of the room is required.

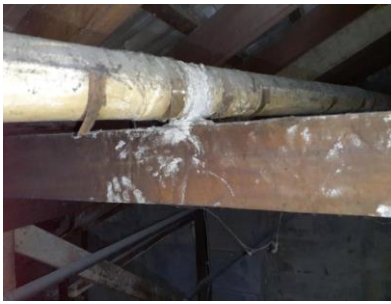
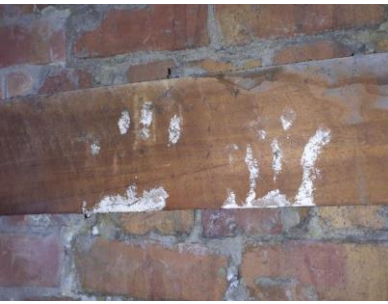
Material and Sample Details						Material Risk Assessment							Additional		
Location / Location Number – Room / Item Description	Material	Sample ID	Sample Status	Quantity	Ease of Access	Product Type	Material Condition	Surface Treatment	Fibre Type	Material Risk Score	Friable / Non Friable	Risk Rating	Comments and Recommendation	Photo (Location)	Photo (Detailed)
044 - Roof Void Insulation Residues to timbers	Insulation	S051	Sampled Amosite	Unable to Quantify	Medium	3	3	3	2	11	Friable	High	Restrict access to void from below. Remove material to allow contractor/maintenance access using an appropriately licenced asbestos removal contractor. Review and update Asbestos Management Plan accordingly.

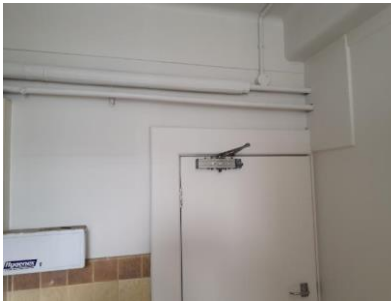
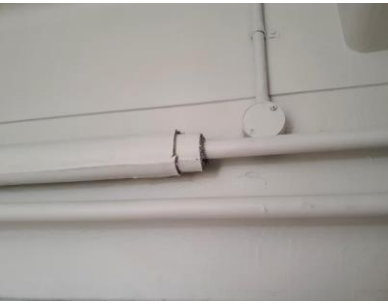
2nd Floor 025 - Male Toilet Insulation to Pipework	Insulation	As-X032	Cross Reference Chrysotile	3m sq	Medium	3	2	2	1	8	Friable	Medium	Fully seal or encapsulate damaged section above door or remove material using an appropriately licensed asbestos removal contractor. Review and update Asbestos Management Plan accordingly.

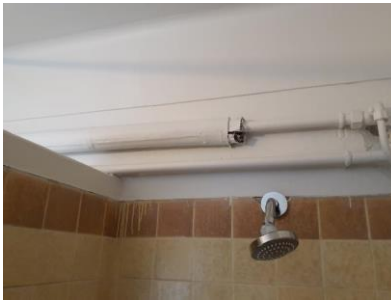
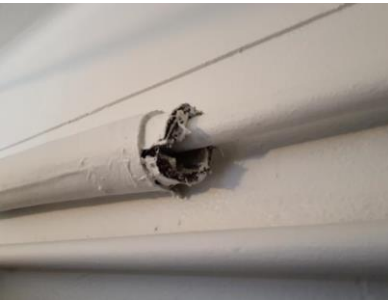
2nd Floor 024 - Female Toilet Insulation to Pipework	Insulation	S032	Sampled Chrysotile	3m	Medium	3	2	1	1	7	Friable	Medium	Restrict access to shower. Fully seal or encapsulate damaged section above shower head or remove material using an appropriately licensed asbestos removal contractor. Review and update Asbestos Management Plan accordingly.

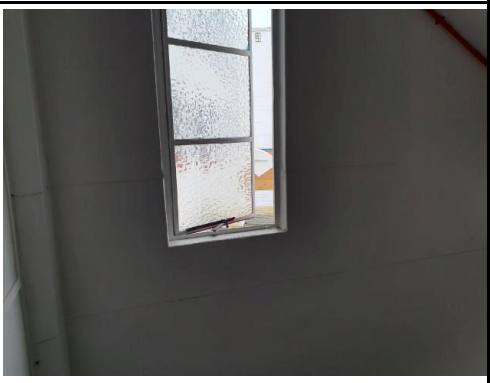
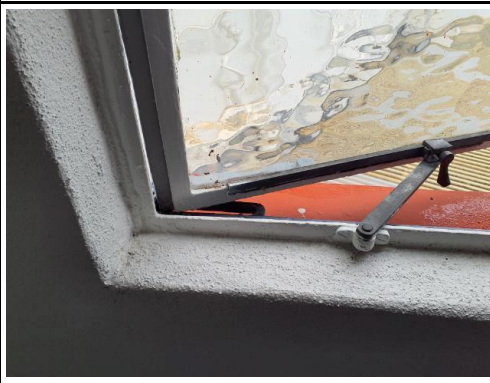
1st Floor 001 - Stairwell Window Putty	Composite Product	Sampled	S023	NAD	No asbestos was detected, no further action is required.

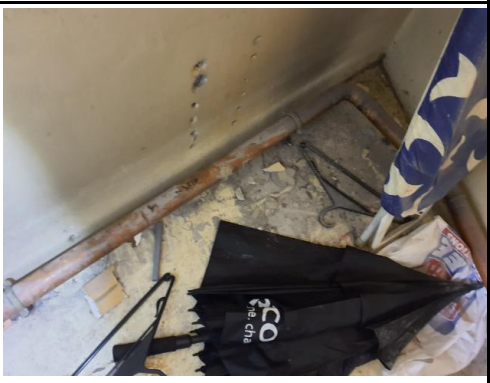
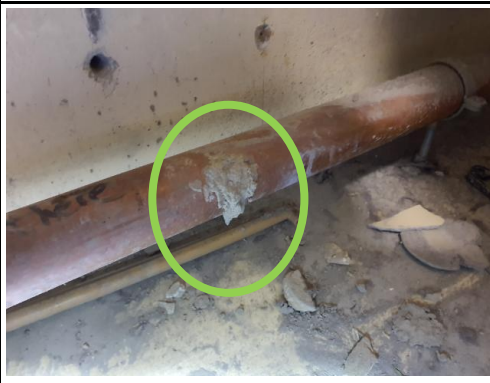
1st Floor 002 - Laundry and Cupboard Insulation 'snot' to pipe	Insulation	Sampled	S012	NAD	No asbestos was detected, no further action is required.

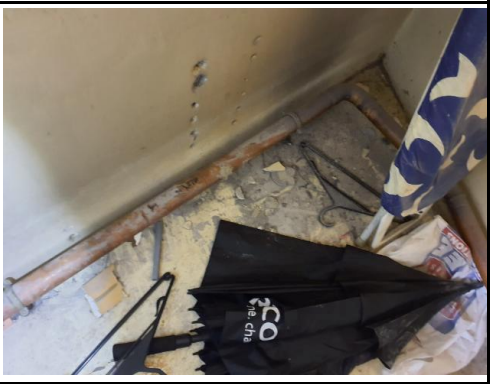
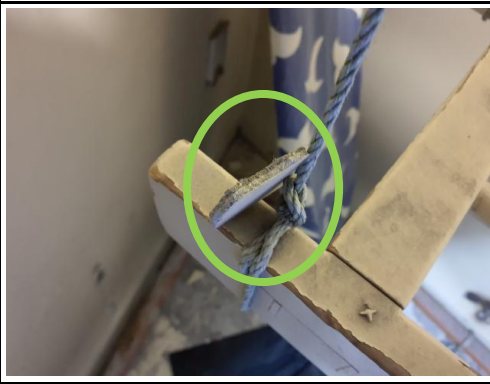
1st Floor 002 - Laundry and Cupboard Textured coating wall debris	Textured Coating	Sampled	S011	NAD	Composite sample taken. No asbestos was detected, no further action is required.

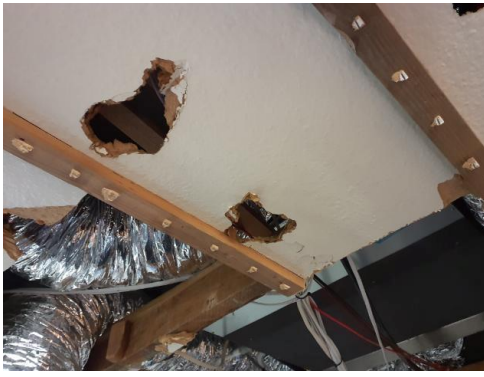
1st Floor 004 - Main Corridor Textured coating to ceiling	Textured Coating	Sampled	S007	NAD	Composite sample taken. No asbestos was detected, no further action is required.

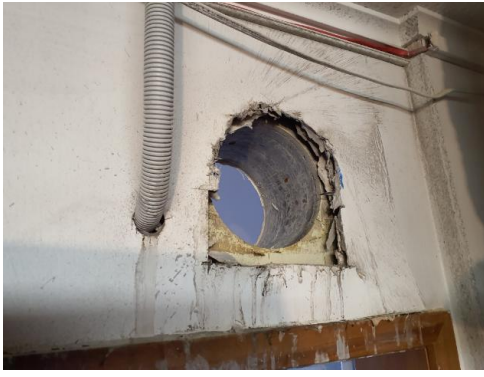
1st Floor 004 - Main Corridor Textured coating to wall	Textured Coating	Sampled	S002	NAD	Composite sample taken. No asbestos was detected, no further action is required.

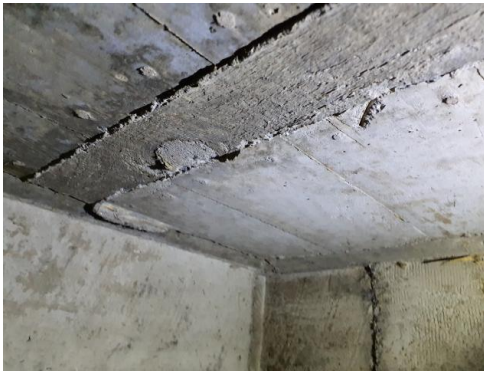
1st Floor 004 - Main Corridor Concrete filling compound to ceiling voids	Composite Product	Sampled	S013	NAD	No asbestos was detected, no further action is required.

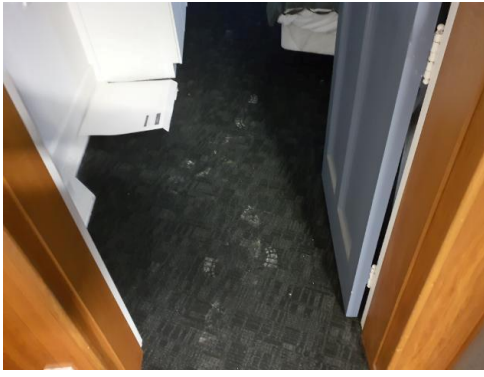
1st Floor 004 - Main Corridor Dust to floor	Debris / Dust Deposits	Sampled	S024	NAD	Composite sample taken. No asbestos was detected, no further action is required.

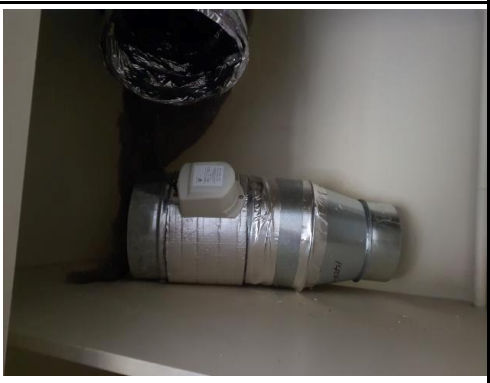
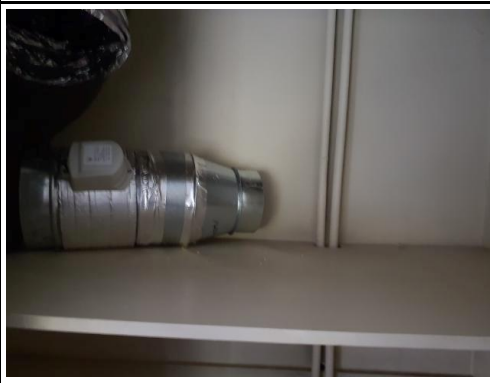
1st Floor 008 - Bedroom 4 Cupboard debris	Debris / Dust Deposits	Sampled	S018	NAD	Composite sample taken. No asbestos was detected, no further action is required.

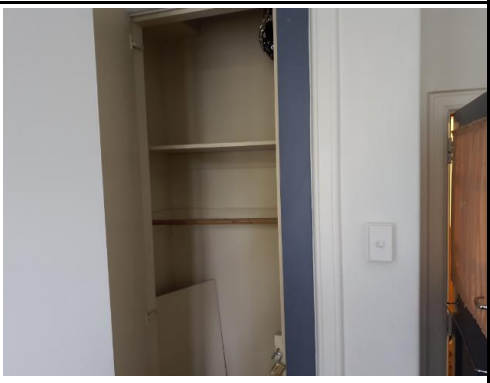
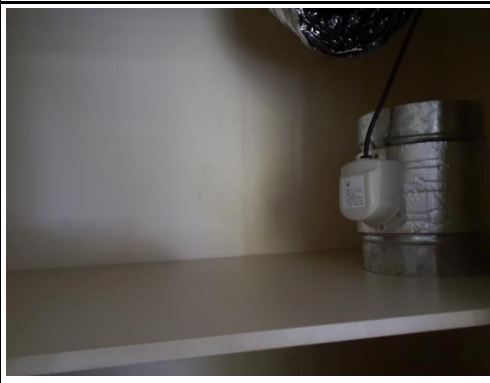
1st Floor 009 - Bedroom 5 Cupboard debris	Debris / Dust Deposits	Sampled	S017	NAD	Composite sample taken. No asbestos was detected, no further action is required.

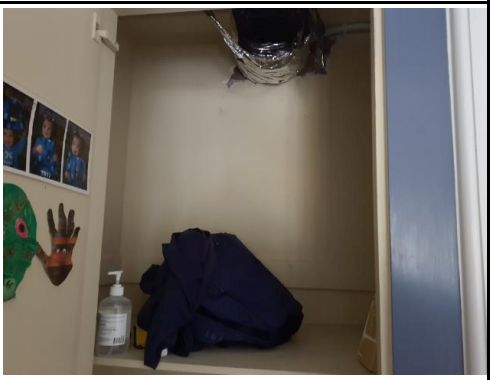
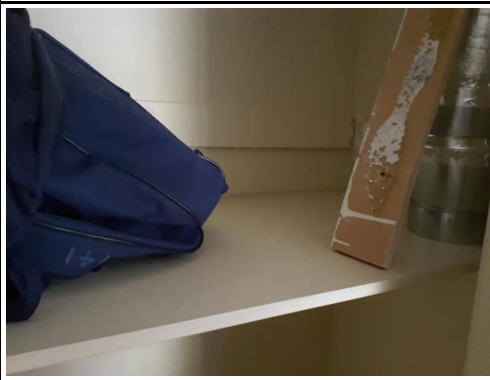
1st Floor 010 - Bedroom 6 Debris in Cupboard	Debris / Dust Deposits	Sampled	S016	NAD	Composite sample taken. No asbestos was detected, no further action is required.

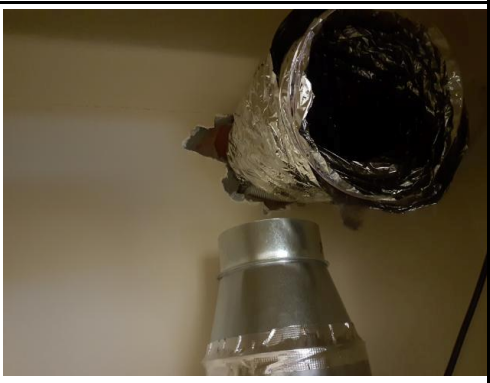
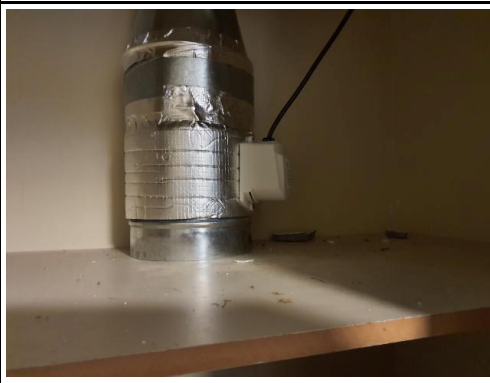
1st Floor 012 - Bedroom 8 Debris in Cupboard	Debris / Dust Deposits	Sampled	S014	NAD	Composite sample taken. No asbestos was detected, no further action is required.

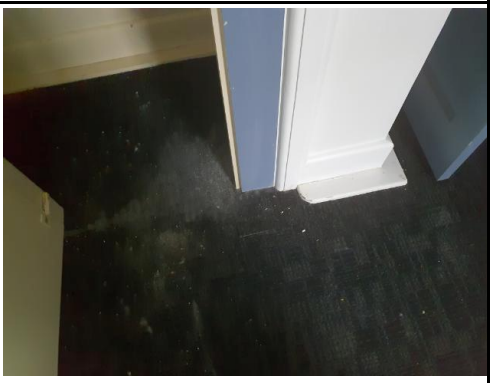
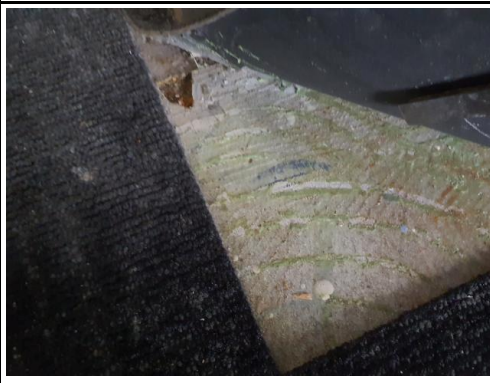
1st Floor 013 - Bedroom 9 Floor Coverings Composite	Vinyl Products	Sampled	S009	NAD	Composite sample taken. No asbestos was detected, no further action is required.

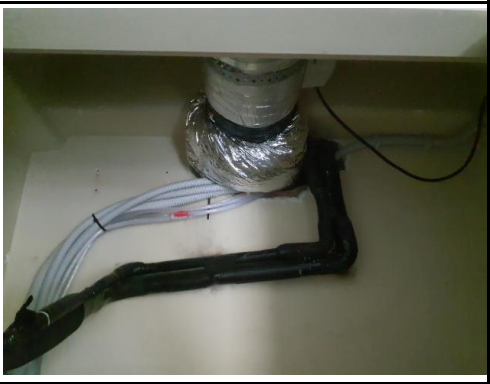
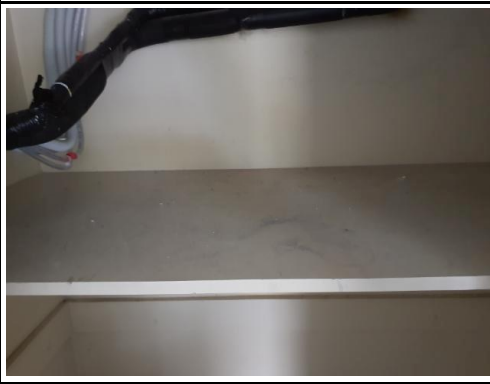
1st Floor 013 - Bedroom 9 Settled Dust to Surfaces	Debris / Dust Deposits	Sampled	S010	NAD	Composite sample taken. No asbestos was detected, no further action is required.

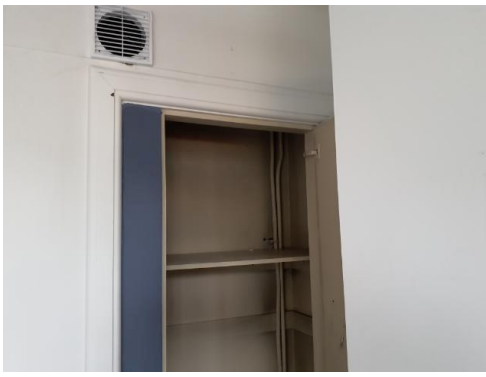
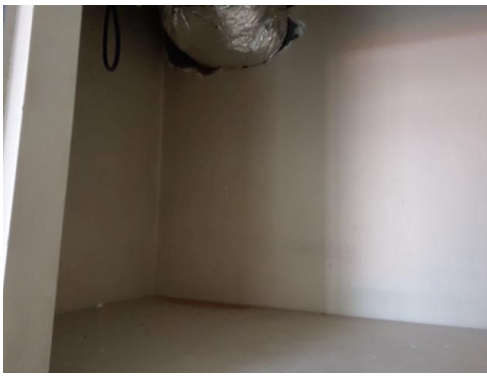
1st Floor 015 - Bedroom 11 Debris in Cupboard	Debris / Dust Deposits	Sampled	S021	NAD	Composite sample taken. No asbestos was detected, no further action is required.

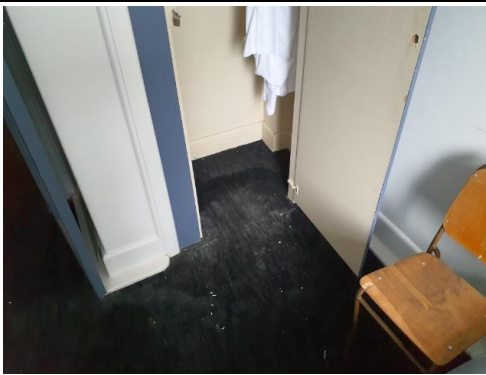
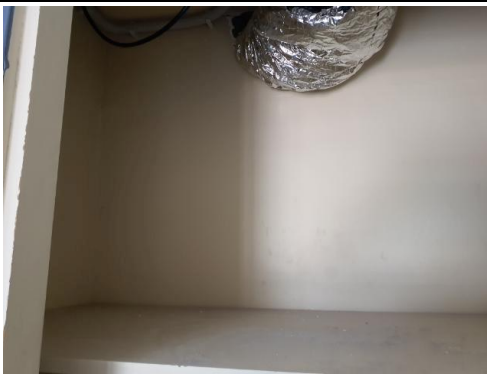
1st Floor 016 - Bedroom 12 Debris in Cupboard	Debris / Dust Deposits	Sampled	S022	NAD	Composite sample taken. No asbestos was detected, no further action is required.

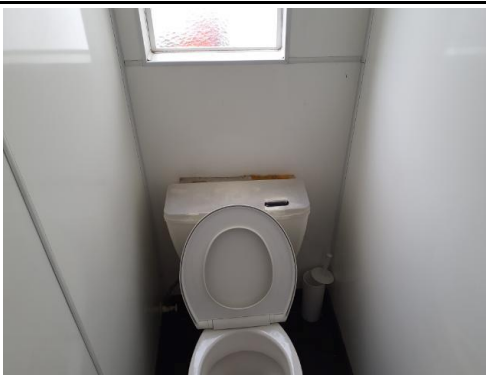
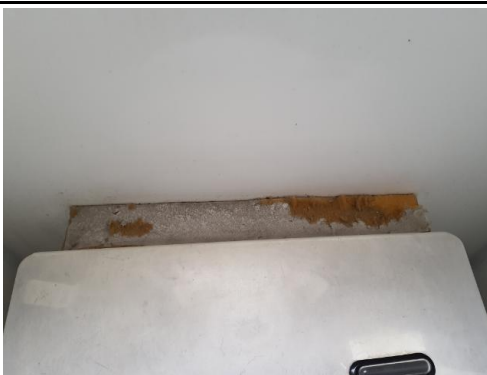
1st Floor 017 - Bathrooms and showers Insulation	Insulation	Sampled	S005	NAD	No asbestos was detected, no further action is required.

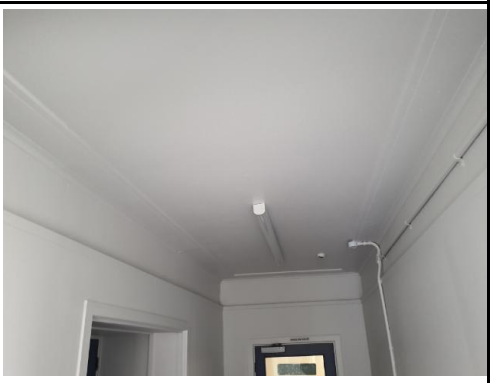
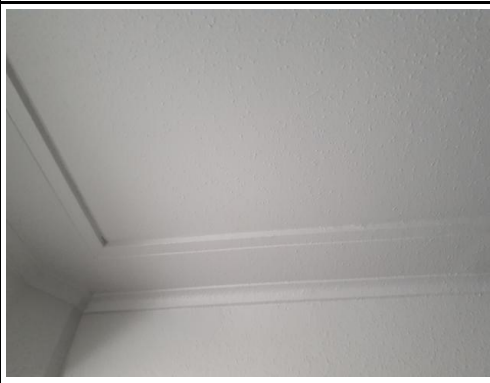
2nd Floor 019 - Entrance foyer Textured coating to ceiling	Textured Coating	Cross Reference	As-X004	NAD	No asbestos was detected, no further action is required.

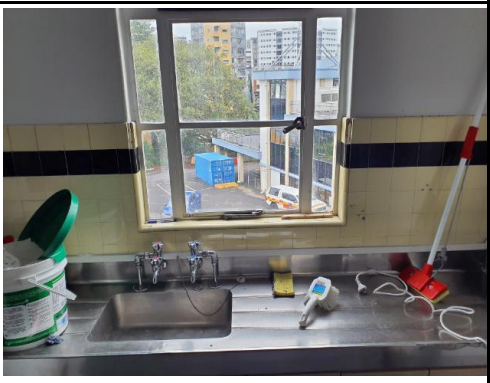
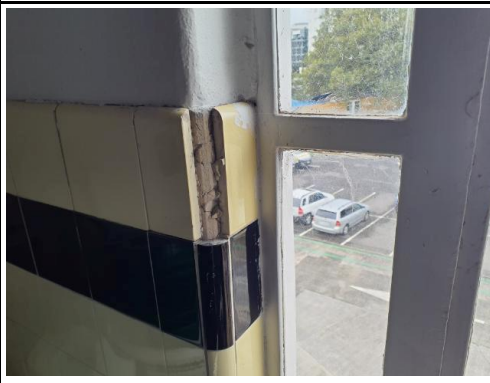
2nd Floor 020 - Laundry Adhesive to underside of screed	Bituminous Product	Sampled	S026	NAD	No asbestos was detected, no further action is required.

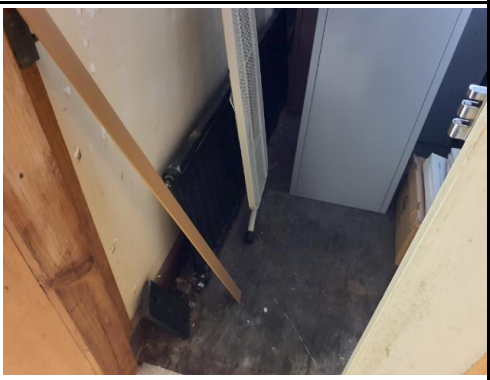
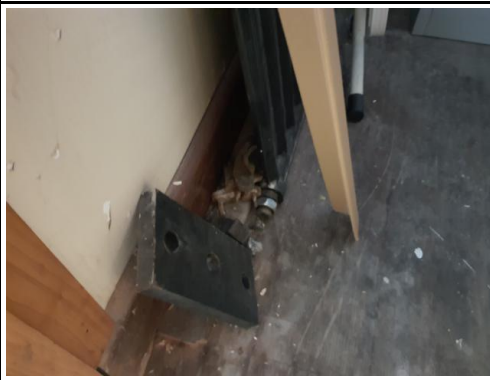
2nd Floor 021 - Store Debris	Debris / Dust Deposits	Sampled	S030	NAD	Composite sample taken. No asbestos was detected, no further action is required.

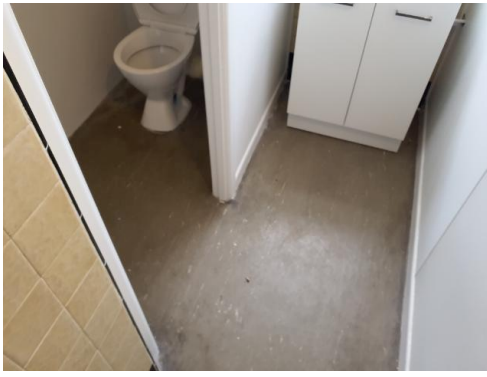
2nd Floor 024 - Female Toilet Floor Vinyl	Vinyl Products	Sampled	S033	NAD	No asbestos was detected, no further action is required.

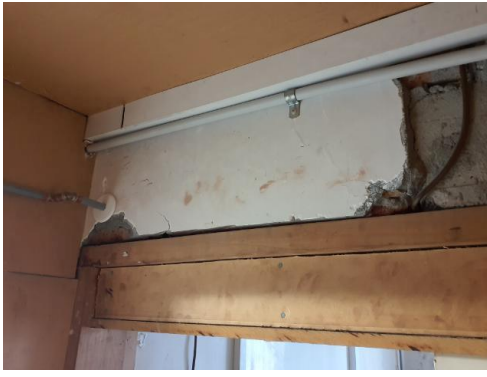
2nd Floor 026 - Corridor Textured coating to wall	Textured Coating	Sampled	S027	NAD	Composite sample taken. No asbestos was detected, no further action is required.

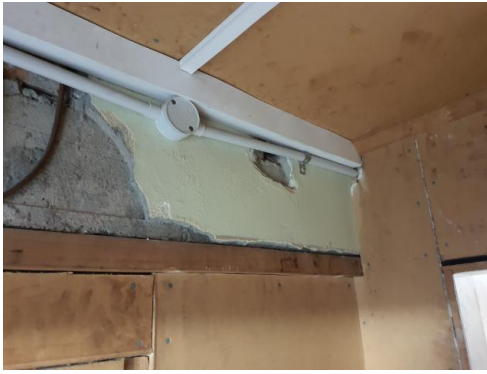
2nd Floor 026 - Corridor Textured coating to wall	Textured Coating	Sampled	S028	NAD	Composite sample taken. No asbestos was detected, no further action is required.

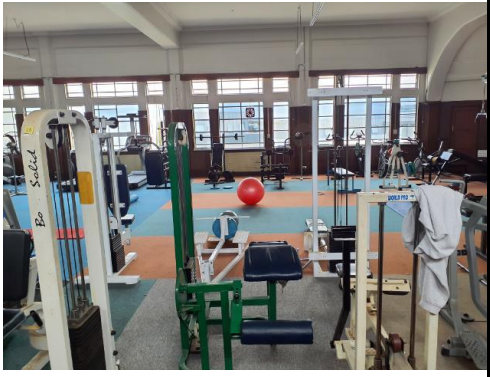
2nd Floor 027 - Gym Settled Dust and Debris to Surfaces	Debris / Dust Deposits	Sampled	S035	NAD	Composite sample taken. No asbestos was detected, no further action is required.

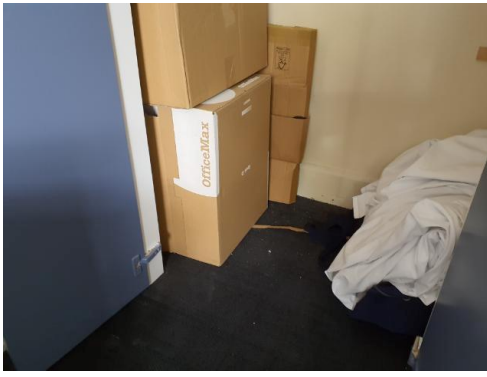
2nd Floor 032 - Bedroom 03 Settled Dust to Surfaces	Debris / Dust Deposits	Sampled	S042	NAD	Composite sample taken. No asbestos was detected, no further action is required.

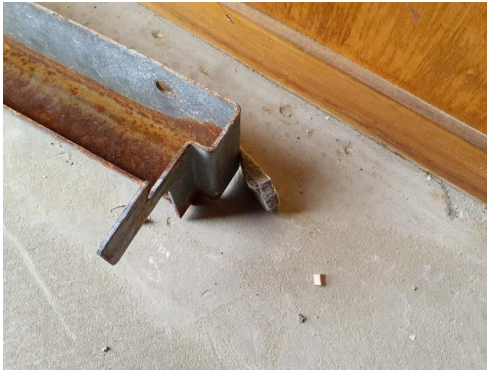
2nd Floor 035 - Bedroom 06 Settled Dust and Debris to Surfaces	Debris / Dust Deposits	Sampled	S041	NAD	No asbestos was detected, no further action is required.

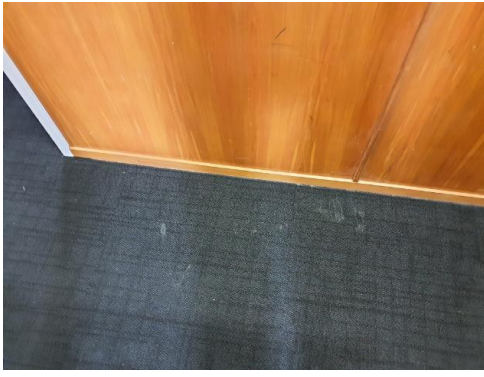
2nd Floor 041 - Bedroom 08 Settled Dust and Debris to Surfaces	Debris / Dust Deposits	Sampled	S043	NAD	Composite sample taken. No asbestos was detected, no further action is required.

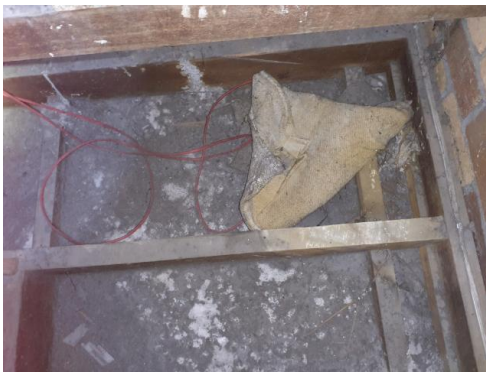
044 - Roof Void Fire blanket	Woven Product	Sampled	S048	NAD	No asbestos was detected, no further action is required.
