14 October 2021

Report

Ngauranga Gorge Fatal Incident Investigation

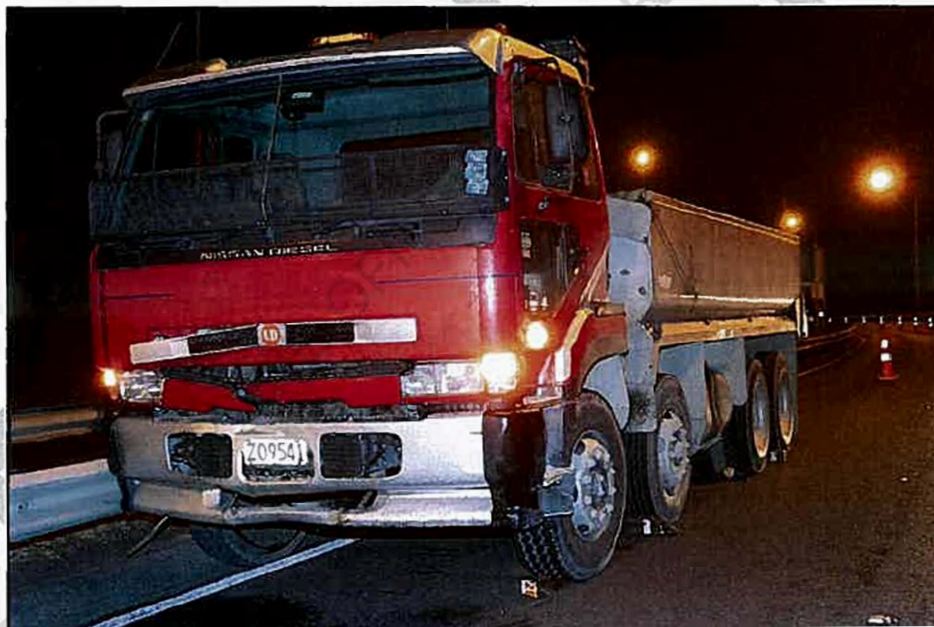
The vehicle involved in incident was a Nissan Diesel CG400, with registration ZO9541 and VIN # JNBCGB45000T00252 (**Figure 1**). The truck is understood to be powered by a 6-cylinder (12503cc) turbo diesel engine with a manual Road Ranger transmission [60000]. The truck has twin steer front axles and tandem drive rear axles (i.e. 8x4).

Figure 1 – Nissan Diesel CG400 Truck involved in incident [60000]

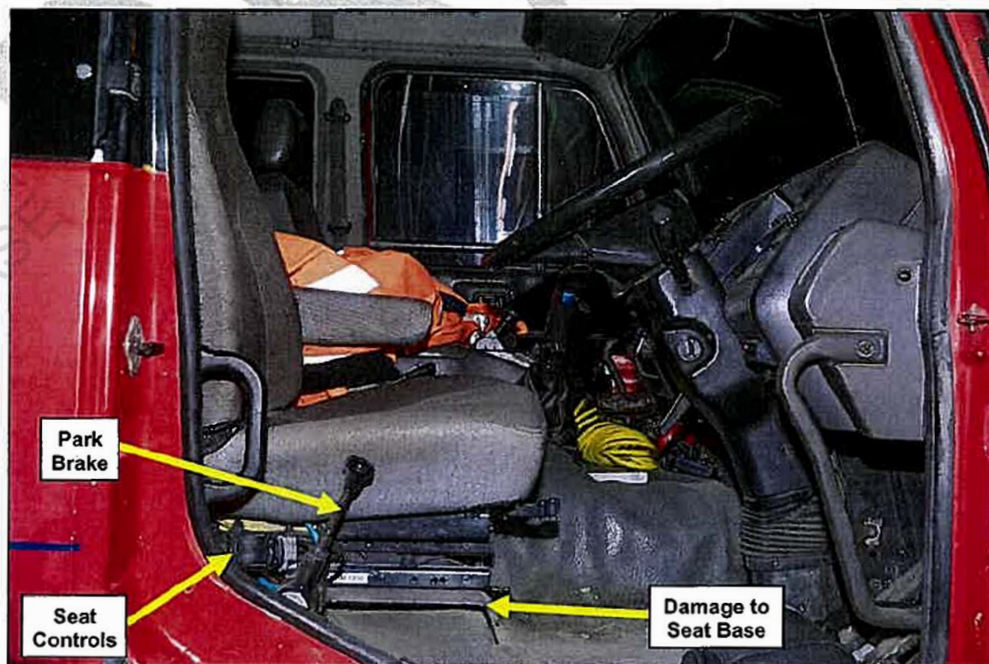
- 5.22 The controls for the seat were loosely secured to the seat base behind the park brake area (**Figure 2**).
- 5.23 When checked, the adjustment system worked correctly and lifted the seat up off the floor.

- 5.28 The Nissan is fitted with a 'Sanwa Seiki Ltd' brand park brake, which is located on the right side floor next to the driver's seat base (**Figure 2**).

Figure 2 – Nissan Diesel truck interior [60000]

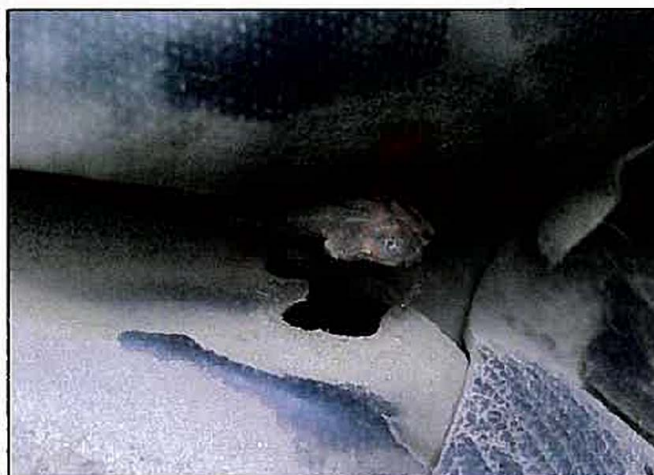
- 5.26 The area around the weld had oxidised (rusty) indicating it had been in this condition for some time (**Figure 3**).
- 5.27 The movement in the seat should not pass a Certificate of Fitness inspection. The corresponding hole in the floor is visible from underneath the truck.

Figure 3 – Torn weld and subsequent hole on right front corner of driver's seat [60000]

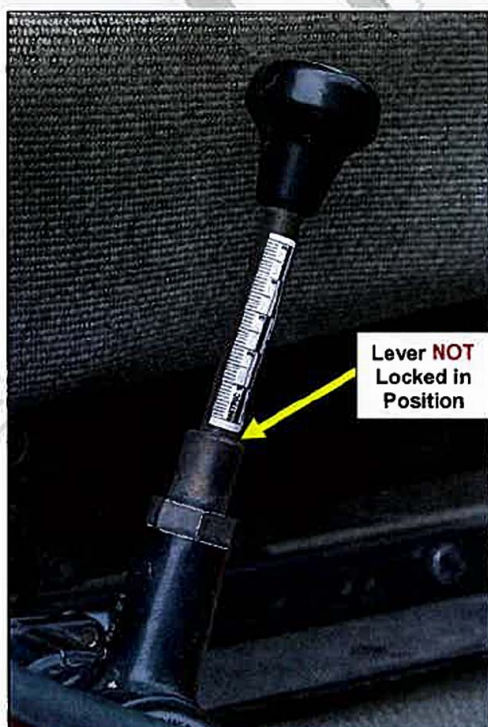
Figure 4 – Park brake engaged and lever not locked [60000]

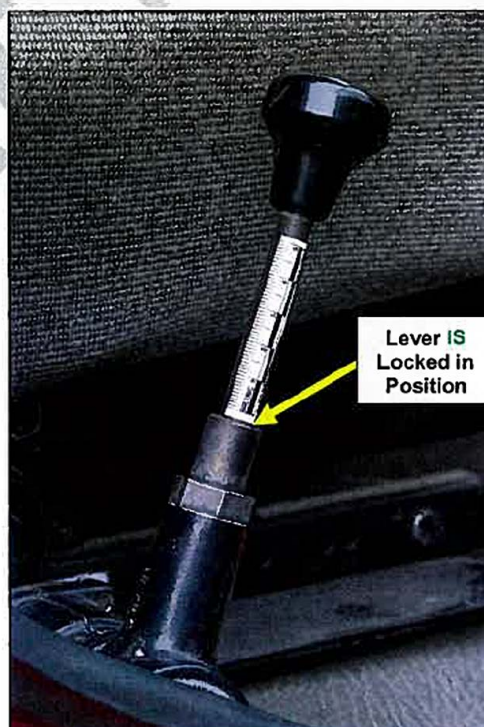
Figure 5 – Park brake engaged and lever locked [60000]

The author understands that contact with the park brake when exiting the truck (**Figure 7**) would likely result in the park brake disengaging (i.e. dropping to the floor) if the lever was not locked in as shown in **Figure 4**. However, if the lever was locked in position (**Figure 5**), the park brake should remain engaged.

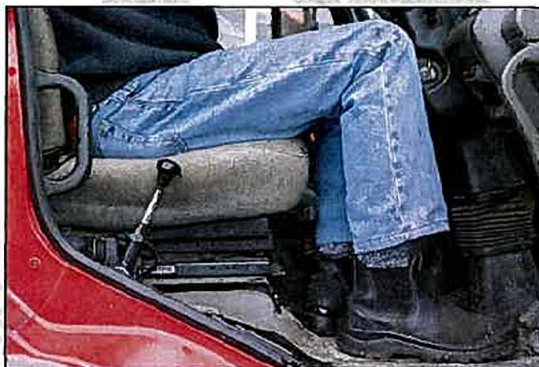
5.43 *It was noted that when someone was sitting in the truck and with the engine running, the seat was sitting on the floor as had not been adjusted or inflated with air. This meant that right side of the foam base squashed down to a position that exposed the top of the brake lever (**Figure 6**).*

Figure 6 – Location of engaged park brake with driver seated [60000]

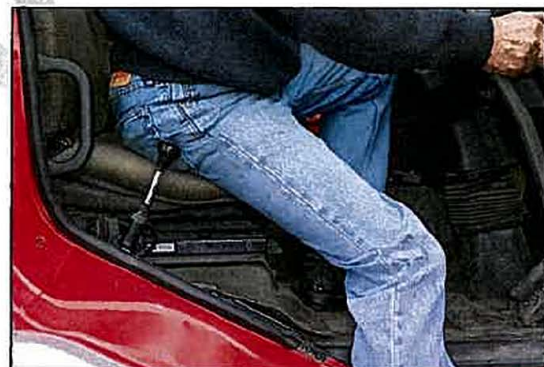
25 5.44 *When the driver of the truck got out of the cab, the right thigh and trouser pocket could come into contact with the lever (**Figure 7**).*

Figure 7 – Contact with the park brake when exiting the truck [60000]

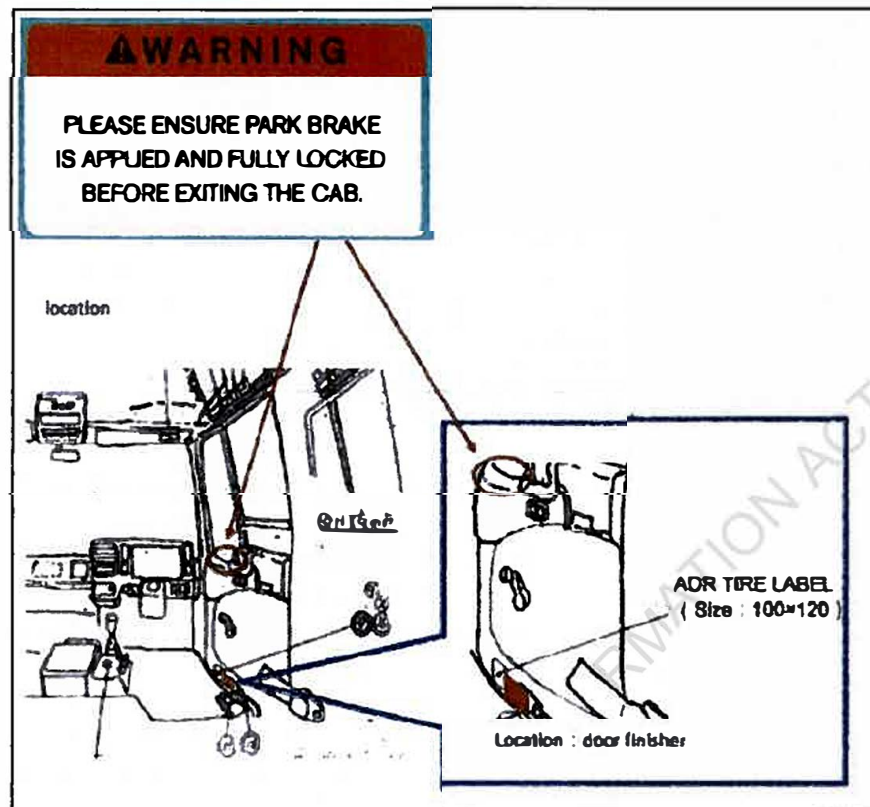
Figure 8 – UD Trucks Warning Label and affixing location diagram [50010]

5.41 When the truck was examined it was noted that there was no warning label on the inside of the driver's door.

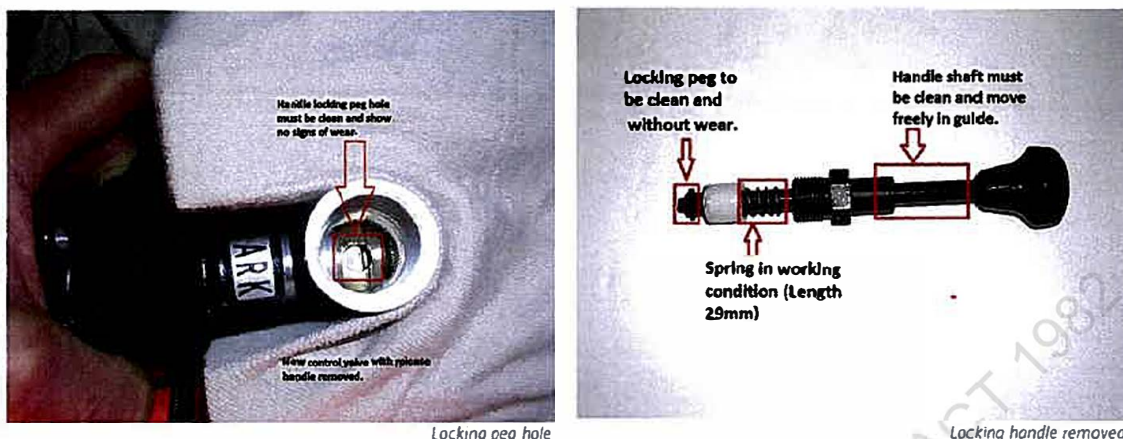
In May 2017, the New Zealand Transport Agency (NZTA) published a Safety Alert relating to Heavy Vehicle Servicing Information [50006(1) and **Attachment 4**] to avoid park brake failures. The Safety Alert described the maintenance and operational requirements for the park brake control valve for Nissan CK330, CW330, CW380, CW400, CG380 & CG400 vehicles manufactured between 1993 and 2005. The mechanism and areas required for inspection were described in **Figure 9**.

Figure 9 – Sanwa Seiki park brake control valve issues described by NZTA [50006(1)]

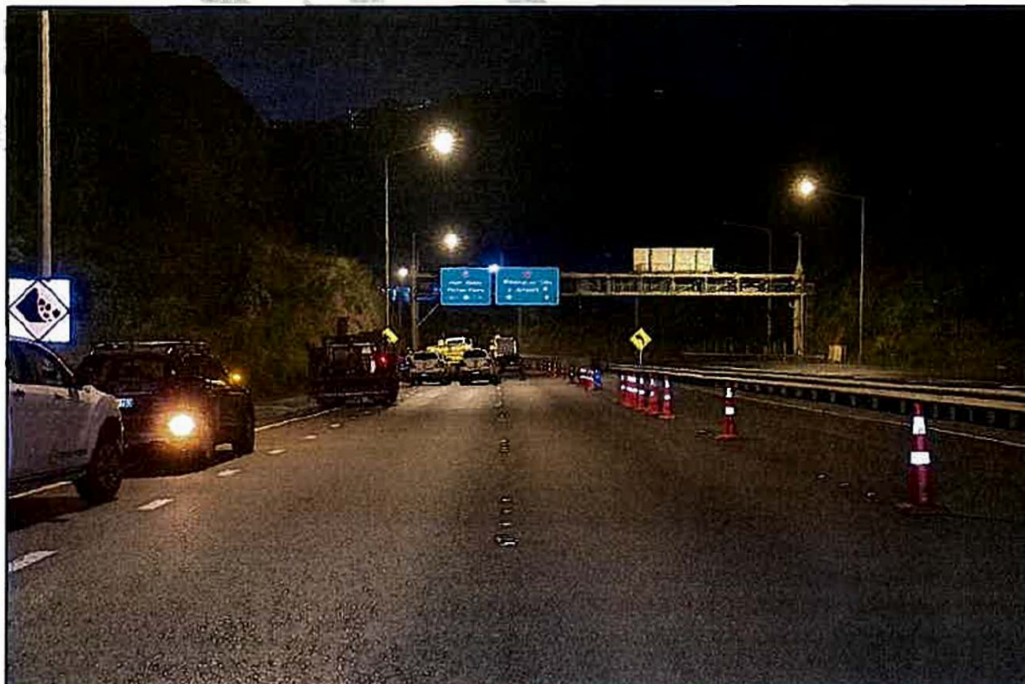
Figure 12 – Work area on night of the incident (60000)

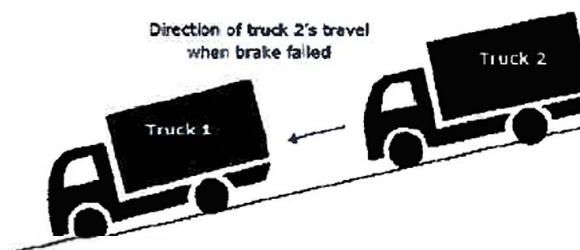
1

The driver engaged the park brake control valve, but the operating lever failed to fully engage the locking dowel. The driver exited the truck with the park brake engaged but not correctly locked. Factors such as engine vibration, the bump of the closing door, and the return spring pressure on the operating lever would have been enough to release the brake, with fatal consequences.

Figure 1: Diagram showing how the trucks were parked and the direction truck 2 travelled when the park brake failed.

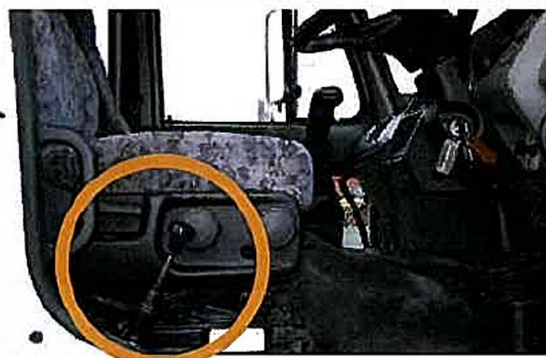
2

Figure 2: shows the interior of a truck cab with a park brake control valve positioned at the base of the driver's seat. The park brake is in the "engaged" position.

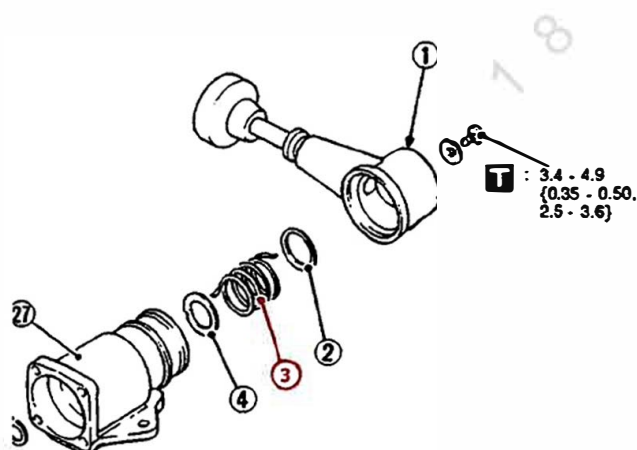
Figure 1. Handle lift to release (spring loaded to lock down)

If there are faults found with the above checks the valve must be inspected/replaced before the vehicle is put into service.
