DEPARTMENT OF THE NAVY
COMMANDER NAVAL AIR FORCE
UNITED STATES PACIFIC FLEET
BOX 357051
SAN DIEGO CALIFORNIA 92135-7051

Subj: COMMAND INVESTIGATION INTO THE INCIDENT INVOLVING BACTERIA AND OTHER CONTAMINANTS WITHIN THE POTABLE WATER SYSTEM ABOARD USS ABRAHAM LINCOLN (CVN 72) ON OR ABOUT 21 SEPTEMBER 2022

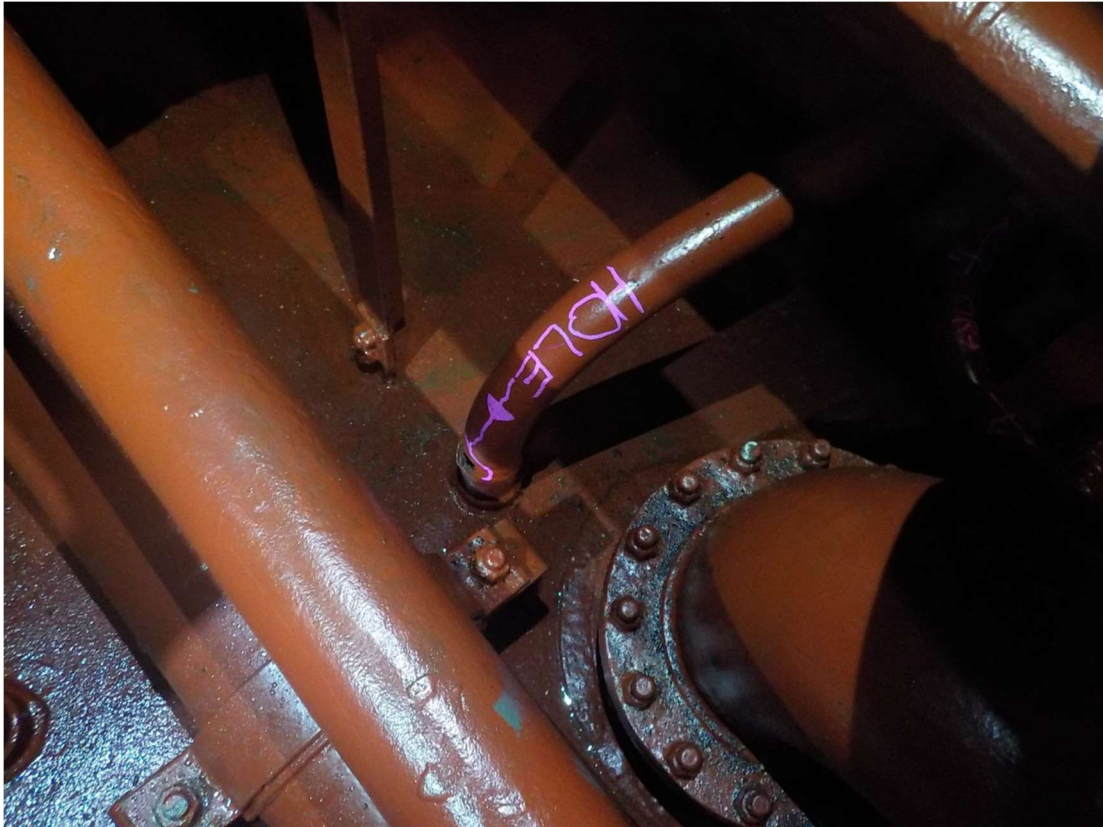
1. Sometime in spring 2022, corrosion produced a hole in a vent header of Potable Water (PW) Tank (b) (3) (A) onboard USS ABRAHAM LINCOLN (CVN 72), hereinafter "LINCOLN." This hole was about 6 inches off the low point in the bilge in Main Machinery Room (b) (3) (A) MMR) and allowed bilge water to flow into PW Tank (b) (3) (A) whenever bilge levels were high enough.

40. The vent header hole is approximately 1 inch x 3 inches and about 6 inches above the low point of the bilge in █ MMR. The hole was covered with rotten material and was about 1-inch wide before the final excavation of the pipe. [Encls (9), (25)]

Figure 1: Hole in Vent Header to Tank (b) (3) (A)

1. The primary root cause of LINCOLN's PW system contamination was material. Specifically, bilge water in [REDACTED] MMR was introduced into PW Tank (b) (3) (A) through a hole in its vent header located a few inches above the bilge deck. When bilge levels were high there was a free flow of bilge water into the tank. The regularly occurring seawater, contaminated with oils and greases that collect in the bilge after normal ship operation resulted in the positive bacteriological results and visual indications observed when PW Tank (b) (3) (A) was opened and inspected by PSNS. Once PW Tank (b) (3) (A) was put online, contamination was then able to spread to other parts of the PW System. [FF (1)-(50)]

[REDACTED]
[REDACTED]
[REDACTED] Located in the bilge, the (b) (3) (A) vent header was susceptible to corrosion, leading to premature failure in an operational environment with higher

3. The Bilge Inspector for MMR performed a satisfactory inspection of the Bilge Zone that contains the vent header. PW Tank (b) (3) (A) was reported to be in acceptable condition. Current condition of the tank indicates that the leak into the tank is likely a recent event. Though a nascent through-pipe leak may have existed in early 2022, it is unlikely that it was large enough to be discovered in the standard ship’s force inspection. [FF (37)-(45)]
