INDEPENDENT OPERATIONAL REVIEW

**New Zealand International Convention
Centre fire**

Prepared for Fire and Emergency New Zealand

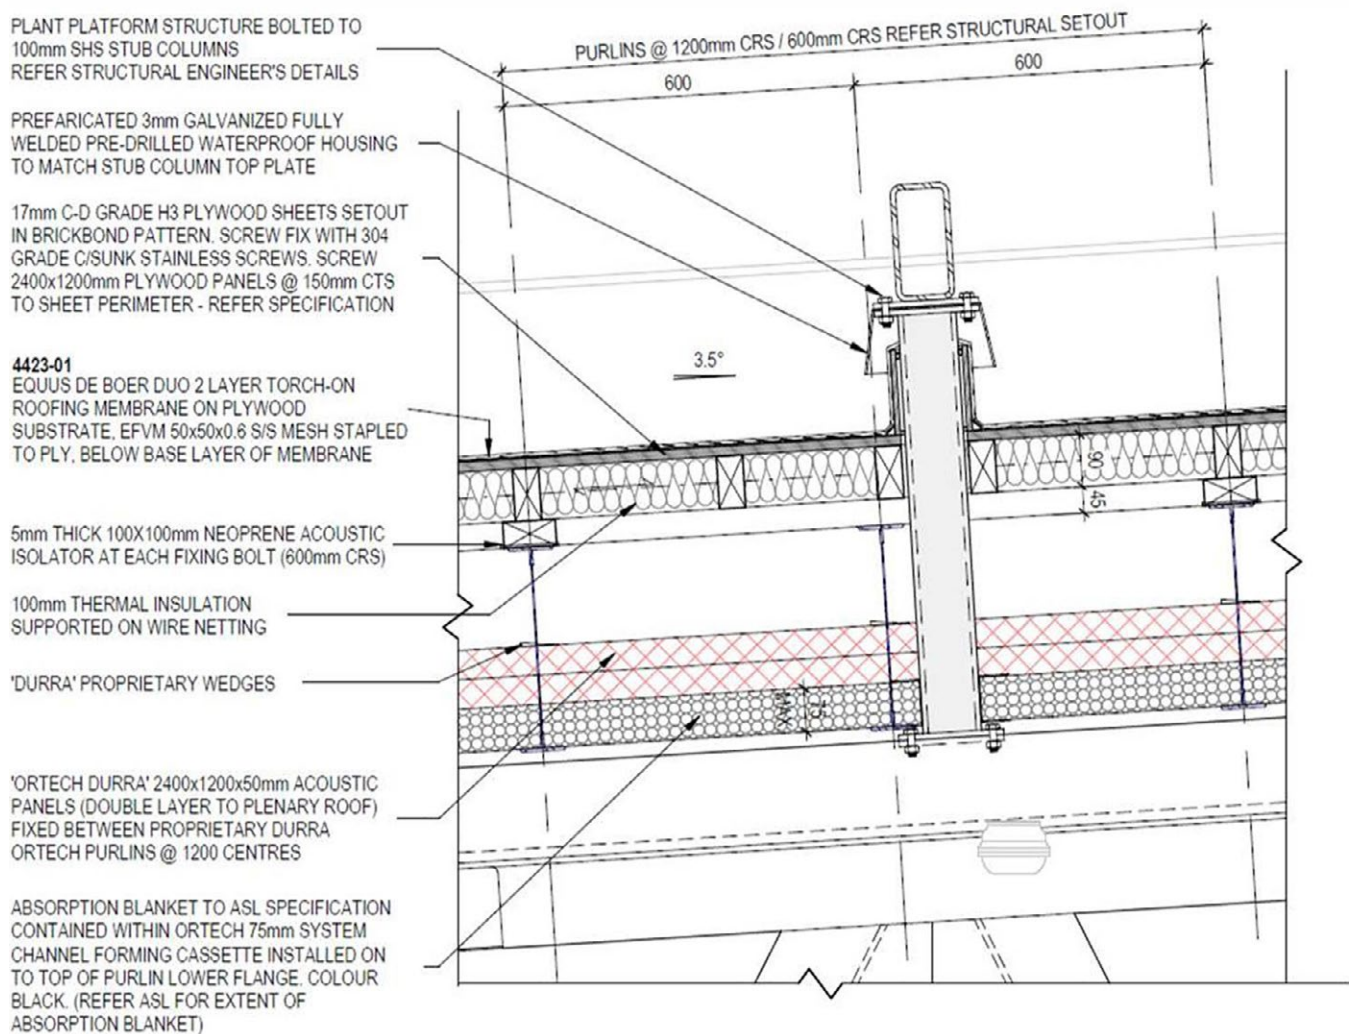
Figure 2: Side elevation of building materials and construction method of roof. Credit: Fletcher Construction.

- 3.38** The fuels burning in the fire were all products used in the construction of the roof. The skeleton of the roof had thousands of metres of high-grade timber to support the top layer of the roof. The roof was termed a 'non-walk on roof' that was engineered to carry a load not exceeding 75 kilograms per square metre.

- 3.39** The weather seal was a two-layer rubber membrane on plywood substrate. The plywood had a 50mm by 50mm stainless steel mesh stapled to it that the membrane lay on. Under this lay 100mm of thermal insulation supported on wire netting. This lay on hundreds of large joists packed with a compressed straw-like product to add further insulation properties. Below this again were acoustic panels on top of an absorption blanket.
