# Collier Gorge Swingbridge Visitor Fall Accident, June 2020

**Issued To:** Darryl Lew, Director Operations Planning

**Author:** Jonathan Calder  
DOC Engineering Manager

**Date:** 7 June 2020

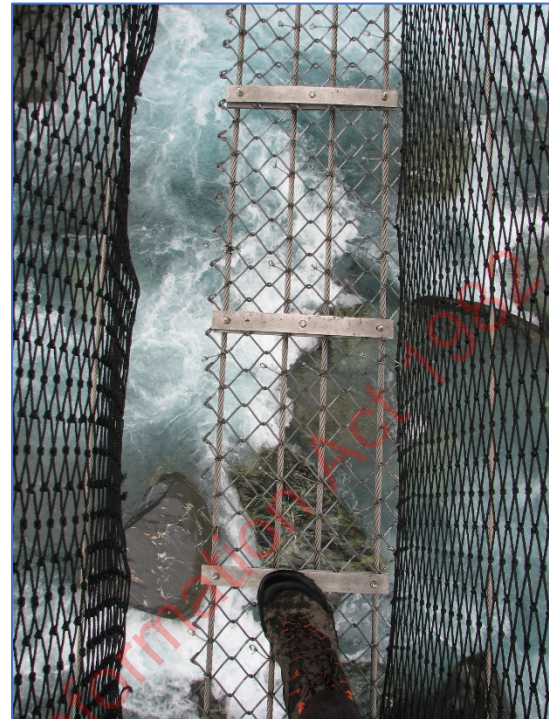
The accident progressed from what should have been a minor slip to a serious fall, because the bridge's polyethylene barrier-infill netting had detached, leaving a 450mm high opening between the lower barrier-infill cable and the deck. The netting had deteriorated between structure inspections and so was not picked up in the normal course of the Department of Conservation's (DOC) asset inspection regime.

Fig. 1 Detached barrier-infill netting where the fall occurred

1. *Replace polyethylene barrier-infill netting on Collier Gorge Swingbridge with stainless steel chain-link netting.*
2. *All NZFS Swingbridges should have barrier-infill netting. Install stainless steel chain-link netting on 31 NZFS Swingbridges that currently have no barrier-infill netting.*

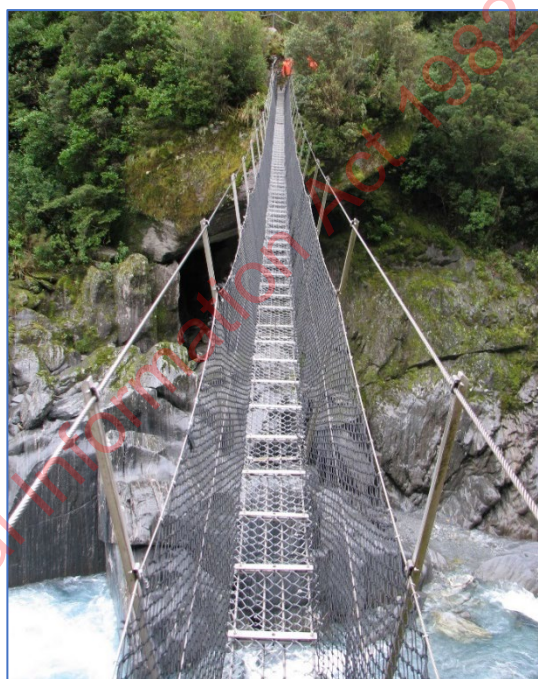
Fig. 2 Colliers Gorge NZFS Swingbridge, 2020

On the day of the accident, Collier Gorge Swingbridge had polyethylene barrier-infill netting fixed with ring staples (Fig. 2), but the bridge has had intermittent periods in its history with no barrier-infill netting (Fig. 3).

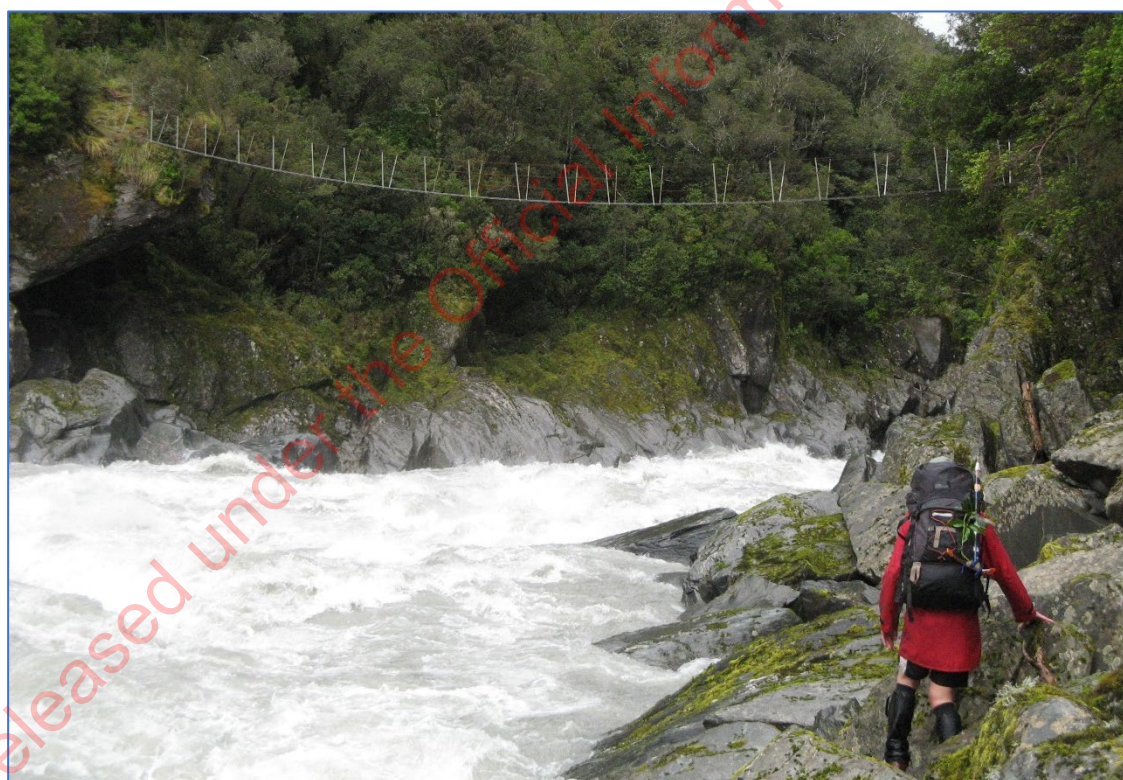
Fig. 3 Colliers Gorge NZFS Swingbridge, 2014 (no barrier-infill netting)

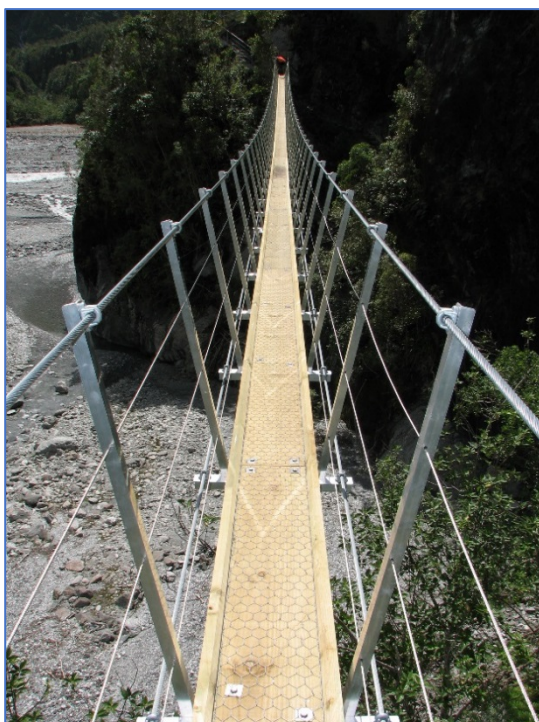
Fig. 4 Roberts Point Swingbridge, 2015

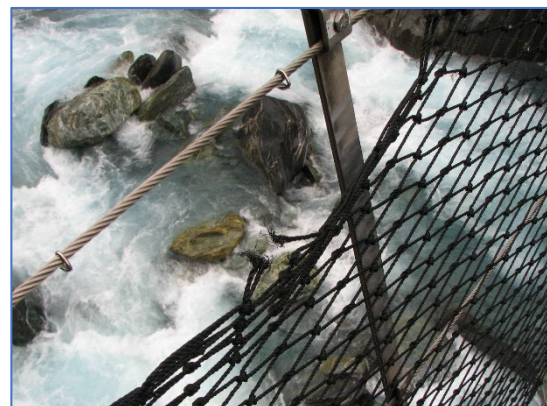
1. The bridge's polyethylene barrier infill netting had worn through at the ring staple fixings, detaching from the deck netting and the top barrier infill cable in several places along the bridge (Fig. 5). Near mid-span, where the accident occurred, a 5.0m length of netting had detached from the deck on the downstream side (Fig. 6).
2. The netting wear didn't seem to be related to excessive vertical tension in the netting.

Fig. 5 Barrier-infill netting worn through at ring staples

***Replace existing netting with 75mm diamond x 2.5mm diameter grade 316 stainless steel wire x 850mm wide (overall width outside diamonds) plain knuckle chain-link netting\* with 1.6mm x 150mm grade 316 stainless steel wire loop ties to deck netting and top infill cable, every second diamond. Recommend completing within 4 months.***

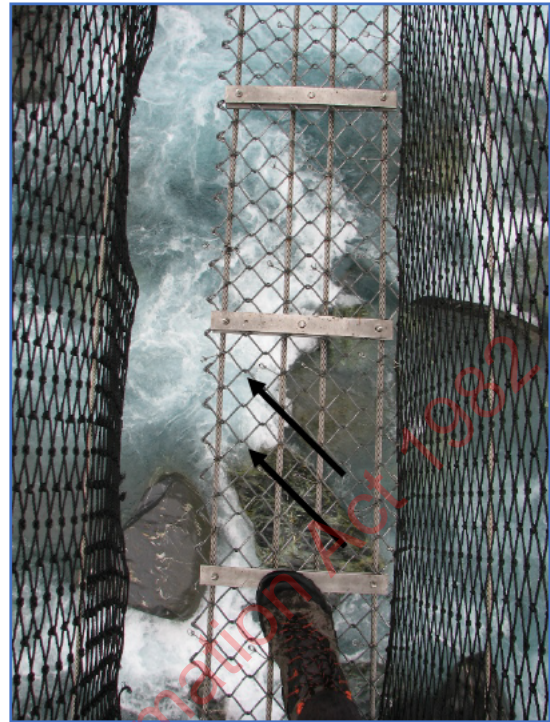
5. Stainless steel chain-link deck netting has been used on this bridge, unlike the more common galvanised steel chain-link netting. The stainless steel netting is anecdotally more slippery than galvanised steel, but this wasn't noticeable on the day of the inspection. It was noted on site, and has been mentioned by members of the CTC group, that chain link netting has a right-to-left diagonal high-point (Fig. 6). This could direct a sliding boot off the left-hand edge of the deck.

Fig. 6 Detached barrier-infill netting where the fall occurred. Arrows show 'slip-direction' of chain link netting.

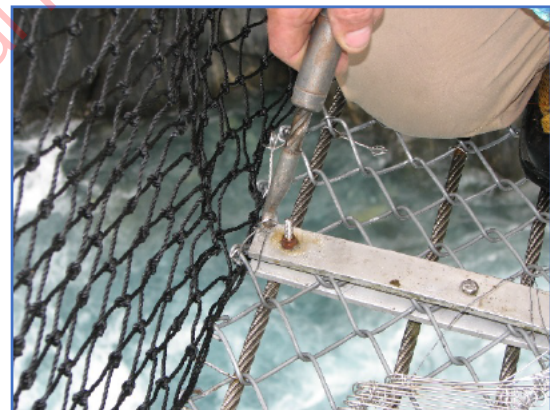
6. M8 treadplate 'j-bolts' protrude approximately 15mm at each end of each treadplate (Refer Fig. 7) and would probably stop a boot sliding sideways off the end of a treadplate.

Fig. 7 Re-fixing barrier in-fill netting with wire loop ties.

The bridge was inspected, and the barrier infill netting re-fixed where it had detached from the barrier-infill cable and deck netting. 1.2mm stainless steel wire loop ties were installed every two-to-three netting 'diamonds'.

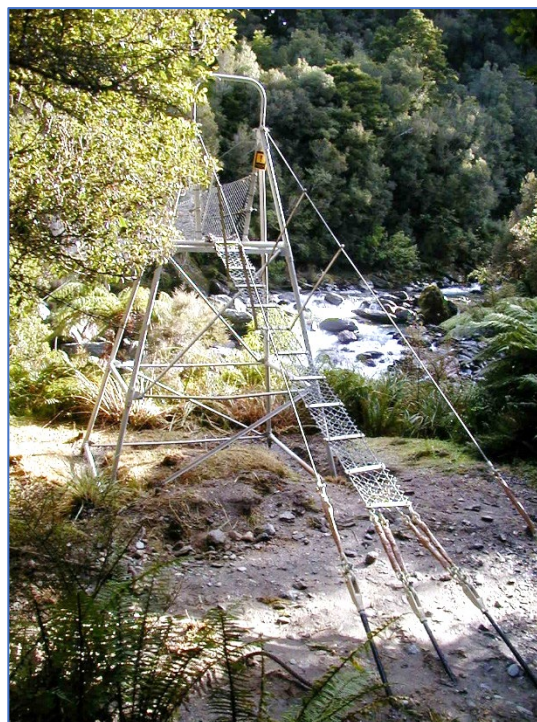
Fig. 8 Architects CK Swingbridge, 2006

*Improve the slip resistance of tread plates on steep NZFS Swingbridge ramps (method and ramp gradient to be determined). Five years is suggested as a reasonable timeframe to complete this work.*
