Request for advice under S121[1][b] of the Building Act 2004

Address of Property:  
Four Canoes Motel, 273 Fenton Glenholme, Rotorua

Report completed by:  
Lynda McHugh, Persons deemed competent  
Fire and Emergency New Zealand, Nga tai ki te Puku

**Section 121(a) Building Act 2004 advice on: Four Canoes Hotel - 273 Fenton Street, Rotorua**

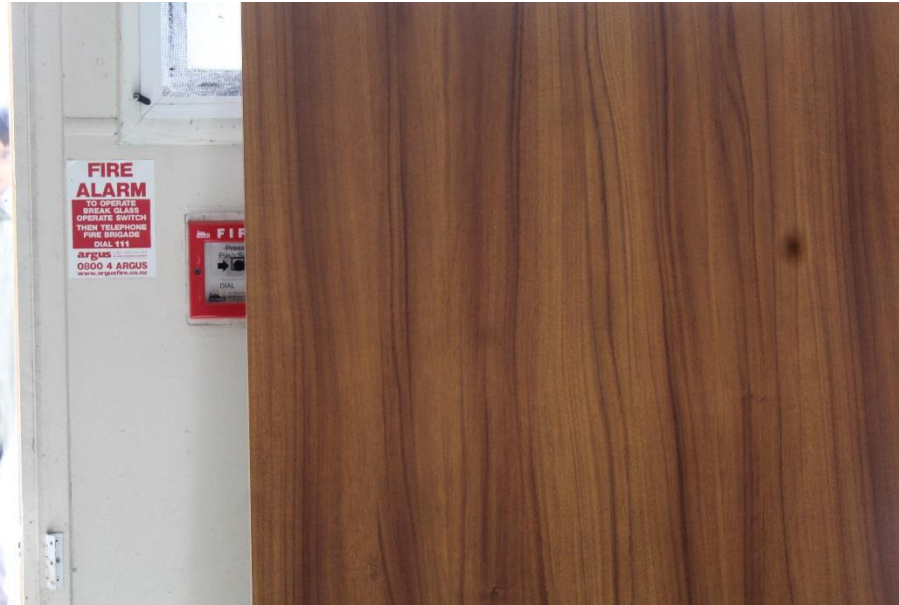
*Photo 4: A Block – Manual call point [MCP]*

In A Block, I observed that combustibles obstructed an MCP.

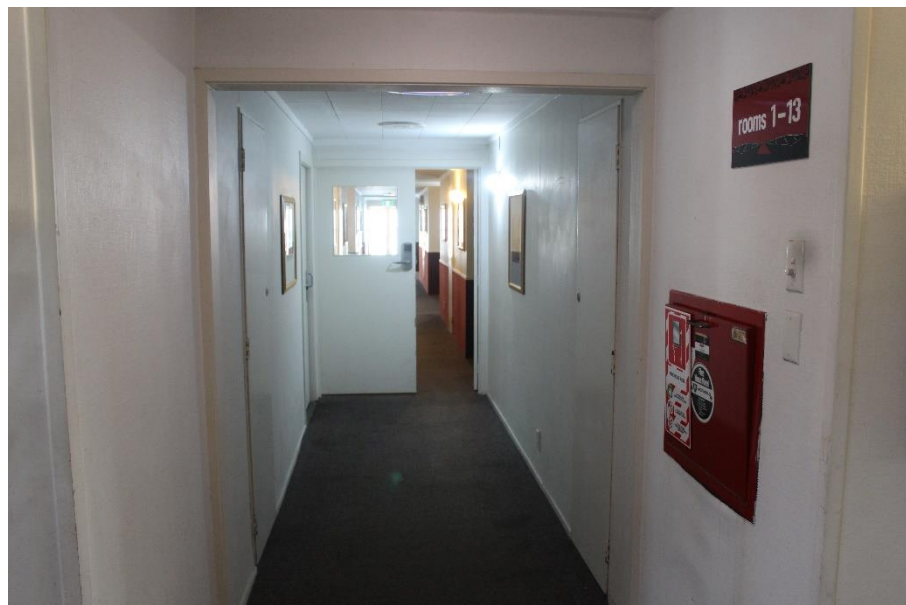
*Photo 5: A Block - Firehose reel*

I observed fire extinguishers and firehoses throughout the Building. Records indicated that these are tested and maintained. However, the door of the above firehose showed some signs of rust and failed at the hinges as I opened the door.

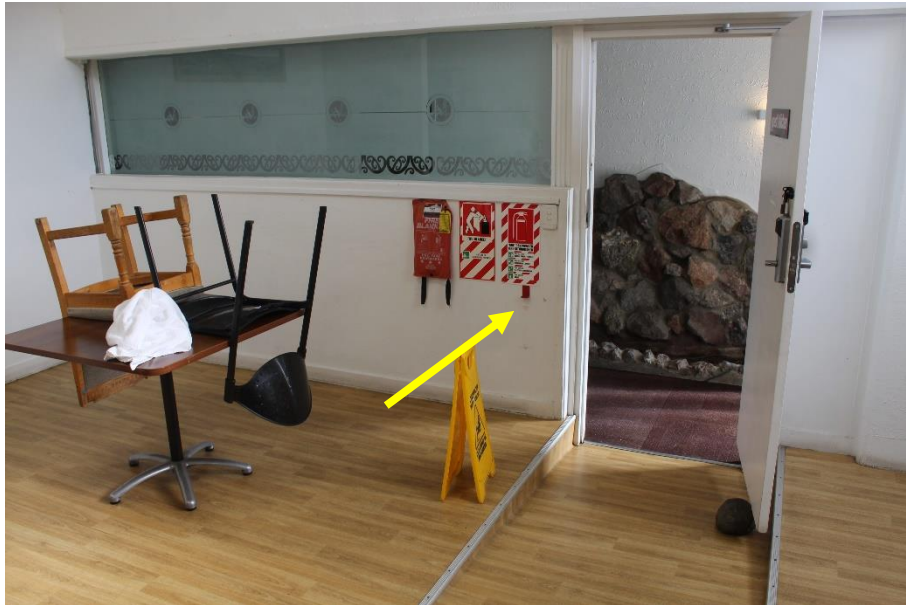
*Photo 6: A Block – Communal Kitchen*

I observed several missing fire extinguishers. In the communal kitchen, where all the residents cook their meals, the fire extinguisher had been removed from its bracket on the wall.

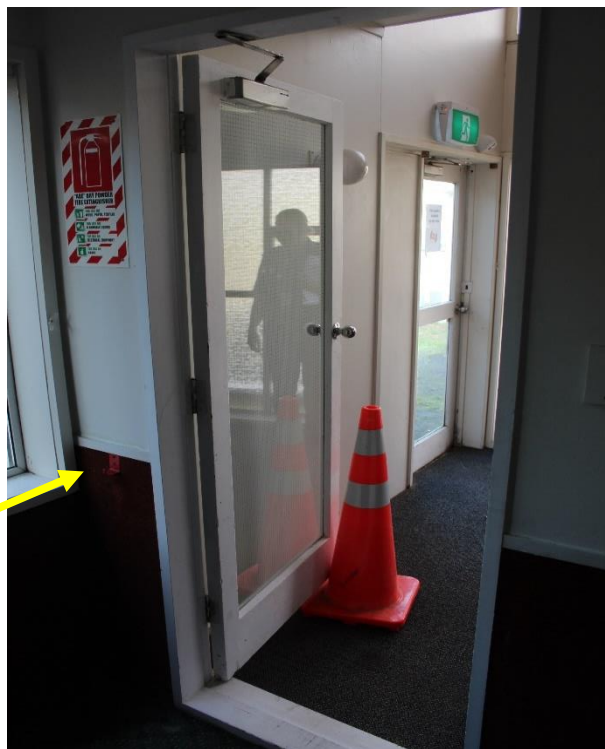
*Photo 7: B Block, Ground level rear*

At the rear of the Building on the ground level in B block, a fire extinguisher was missing from its bracket on the wall.

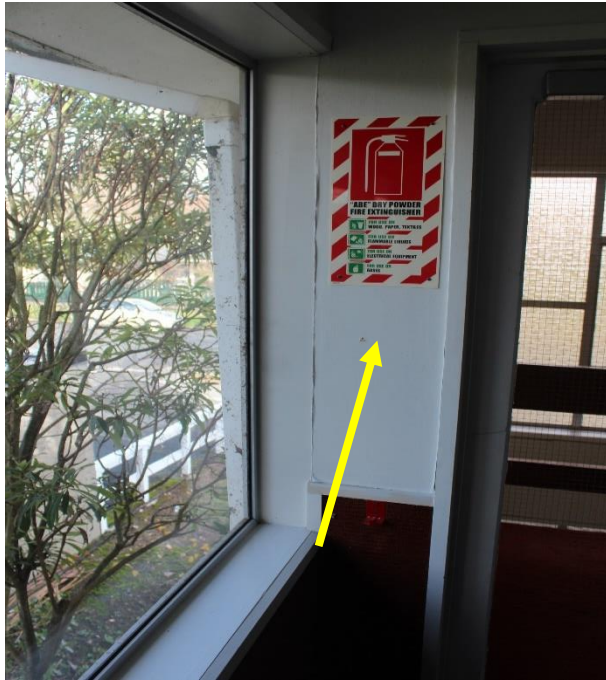
*Photo 8: B Block, upper level*

On the upper level in B block a fire extinguisher was missing from its bracket on the wall.

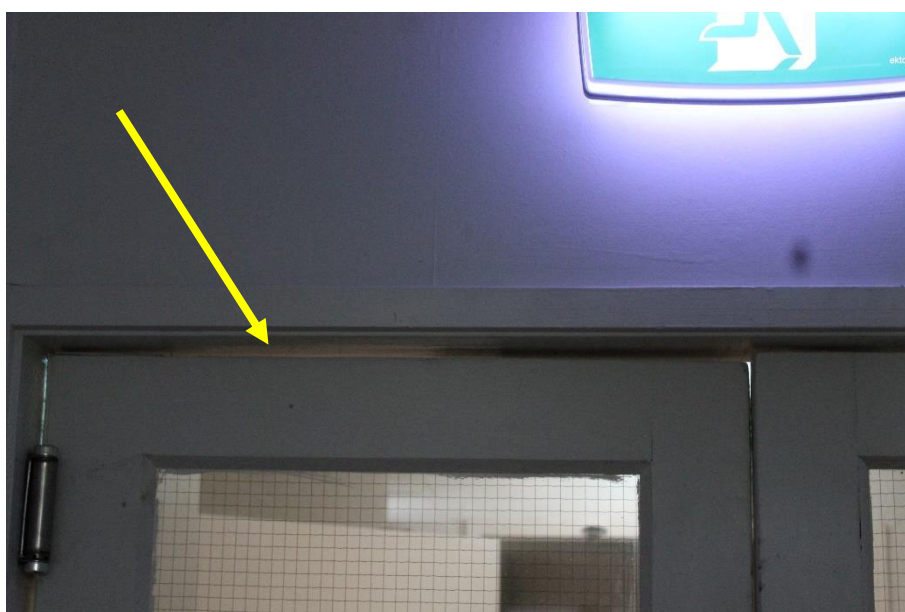
*Photo 10: Close-up smoke-stop doors, A Block, upper level*

I observed a number of the smoke-stop doors with horizontal and vertical gaps in them when they were closed. There are no smoke seals in place on any of the smoke-stop doors. These issues compromise the effectiveness of the means of escape from this Building and place occupants at risk in the event of a fire, allowing smoke to spread through the Building faster.

It is recommended that all of the smoke-stop doors be assessed for suitability and consider installing hold-open devices that release upon activation of the fire alarm system. Mr Hoffman explained to everyone that this would require Council consent.

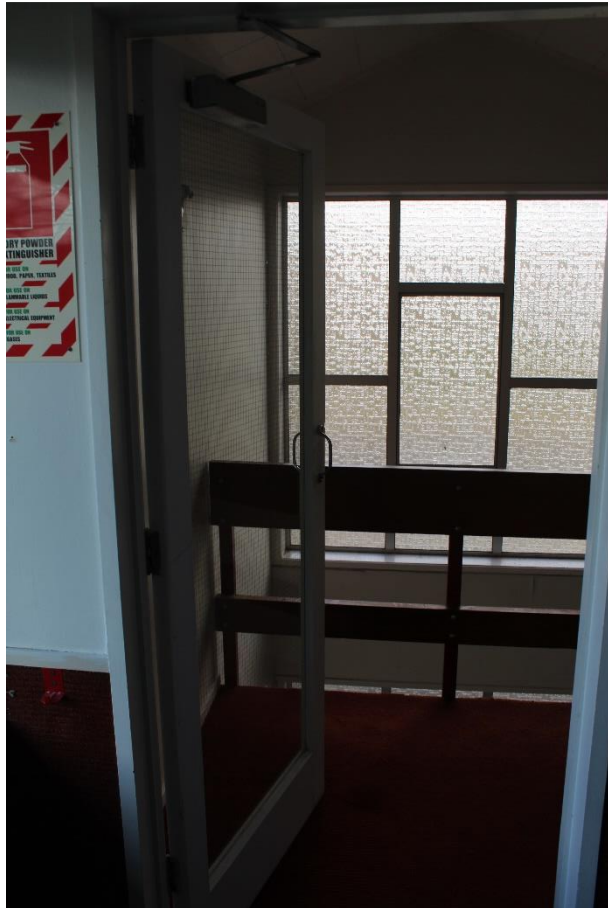
*Photo 11: Smoke-stop doors, upper level*

A number of smoke-stop doors were wedged or jammed open.

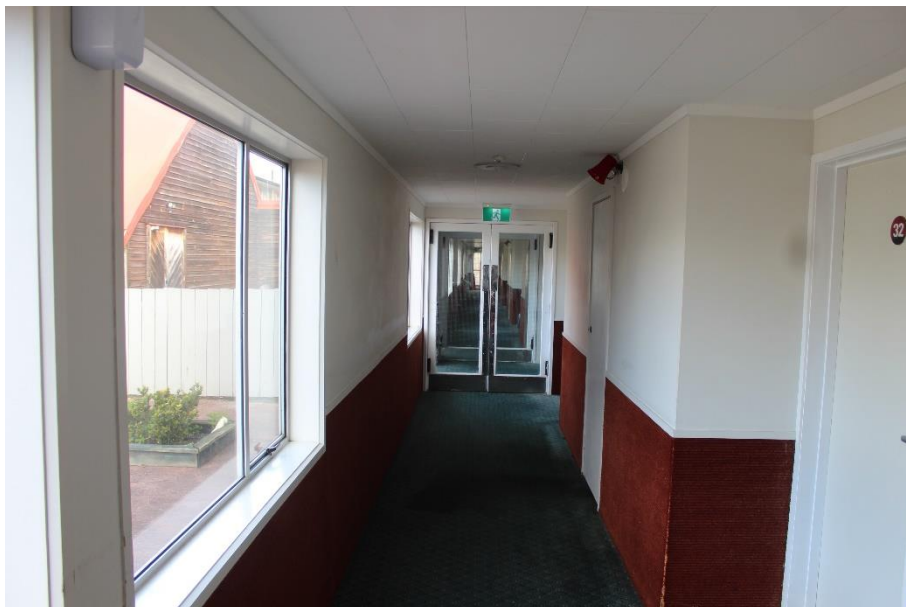
*Photo 12: B Block, ground level*

The above photo shows a set of smoke-stop doors located on the ground floor of B Block.

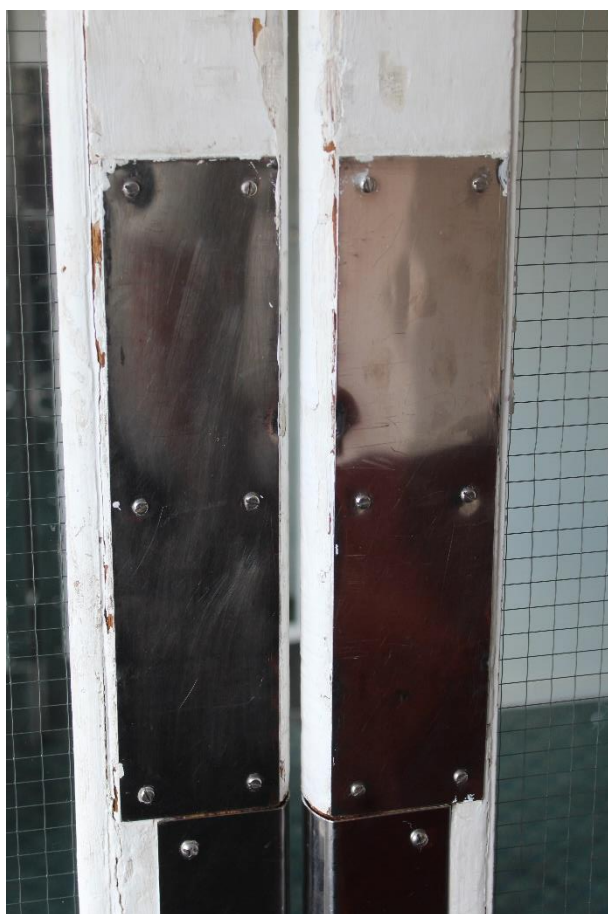
*Photo 13: Close-up of smoke-stop doors*

The above photo is a close-up of photo 12. When the doors are closed, they remain ajar with a gap between the two doors.

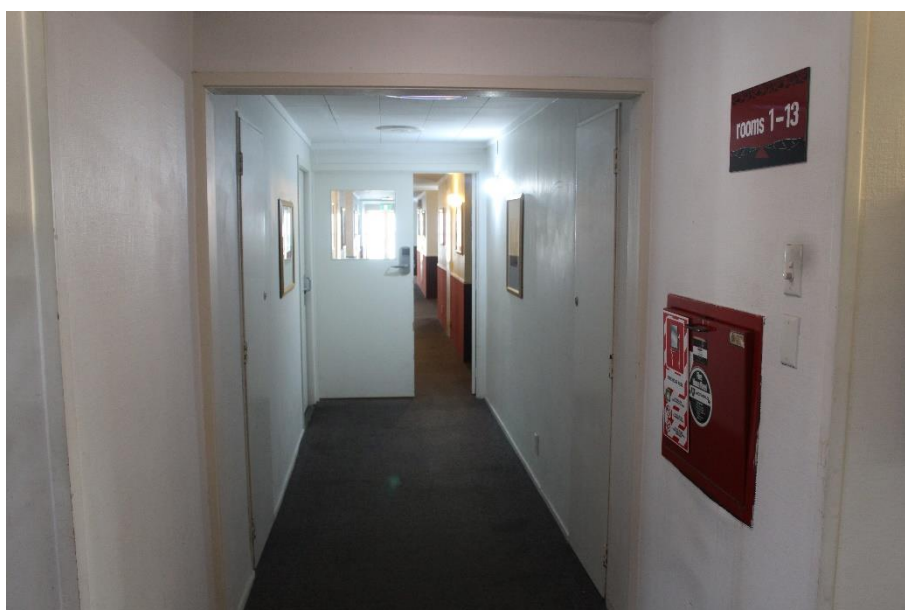
*Photo 14: A Block, ground level*

On the ground floor in A Block, I observed a set of doors that, at some stage, may have been designed to be smoke-stop doors. One side of the door had a self-closer installed on it. However, the other side that was open and [in the above photo] did not have a self-closer installed. The doors appear to be of solid construction like a smoke-stop door. However, there was no fire-rated glass installed in the window, which may have been replaced at some stage of its life.

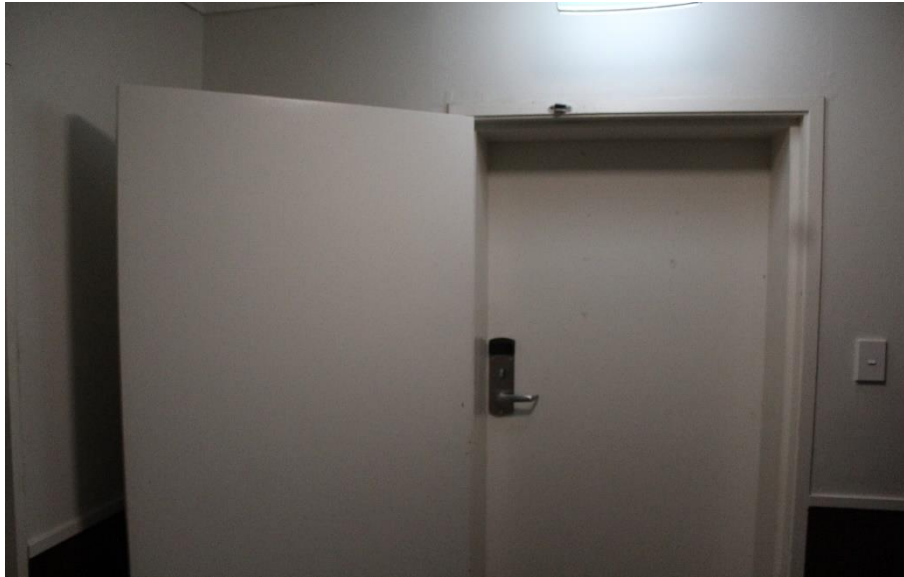
*Photo 15: A Block, upper level, escape route*

On A Block's upper level, I observed two solid constructed doors, one after the other. The first door opened inwards, directly followed by the second door that opened outwards. Given the thickness and construction of the doors, it was presumed that they were fire or smoke stop doors. However, opening doors different directions could easily lead to confusion in a smoke or fire-filled room.

Having these doors in a means of escape is generally not permissible under the relevant acceptable solutions. It is recommended that the owner engage a Fire Engineer who can assess these doors' suitability and make recommendations per the Building Act 2004.

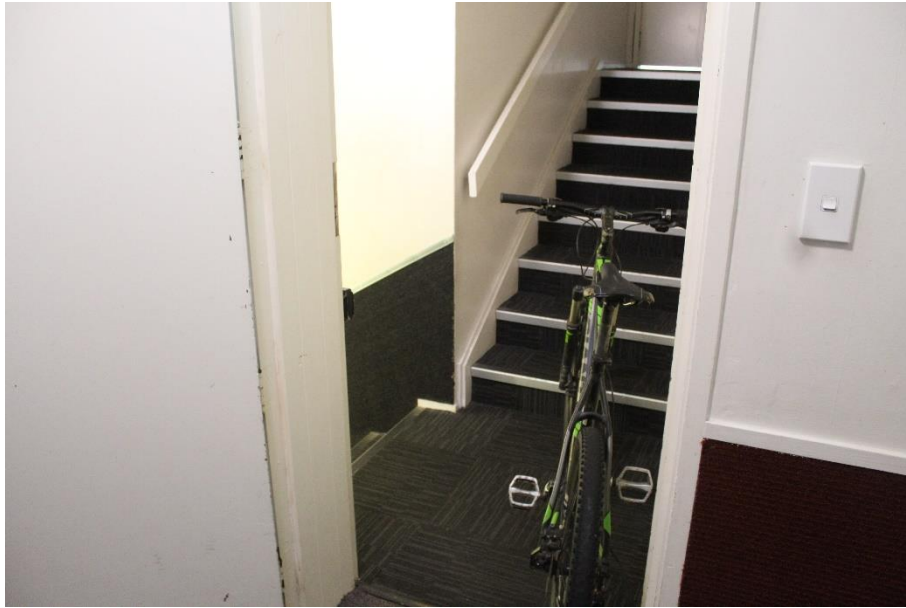
*Photo 16: A Block, upper level, leading to upstairs accommodation and office.*

Once through the double doors in photo 15, I observed a bicycle stored in the escape route. The bike was also used to hold open one of the fire/smoke stop doors. All other escape routes were relatively clear from the storage of combustible items.

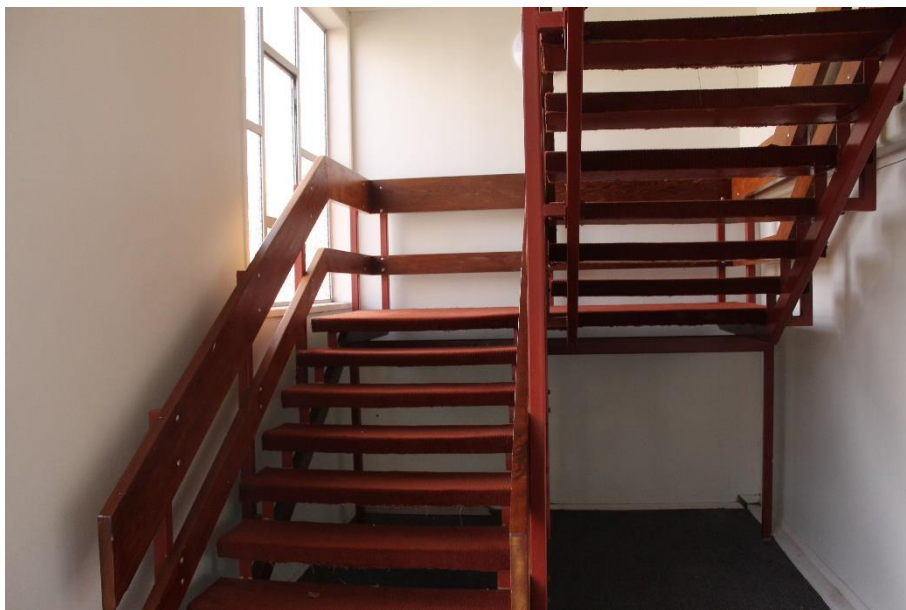
The 21 units in B Block have a concrete horizontal deck (Spandrel) which provides two different escape route directions; however, the stairs are not fire-rated underneath and should be upgraded if the change of the Building's use is determined to have been made.

*Photo 17: B Block stairs on the southwest side of the Building.*

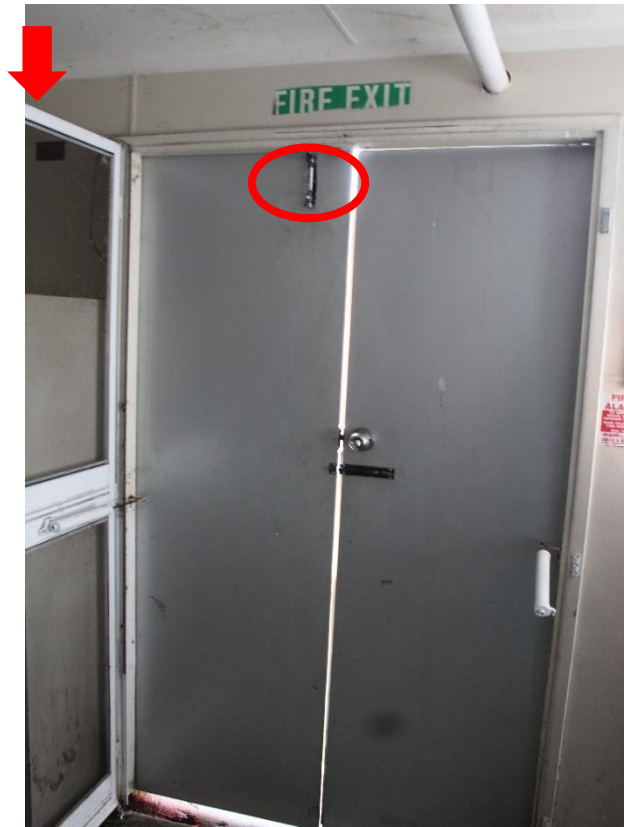
*Photo 18: A Block – Fire exit door, ground level*

The red arrow in the above photo indicates a screen door that has been installed in front of the fire exit door. When closed, the screen door does not open in the direction of flow and may impede the residents from evacuating.

The red circle in the above photo indicates a locking mechanism that is not located in a convenient position. It is recommended that "Crash Bars" are installed on Fire Exits.

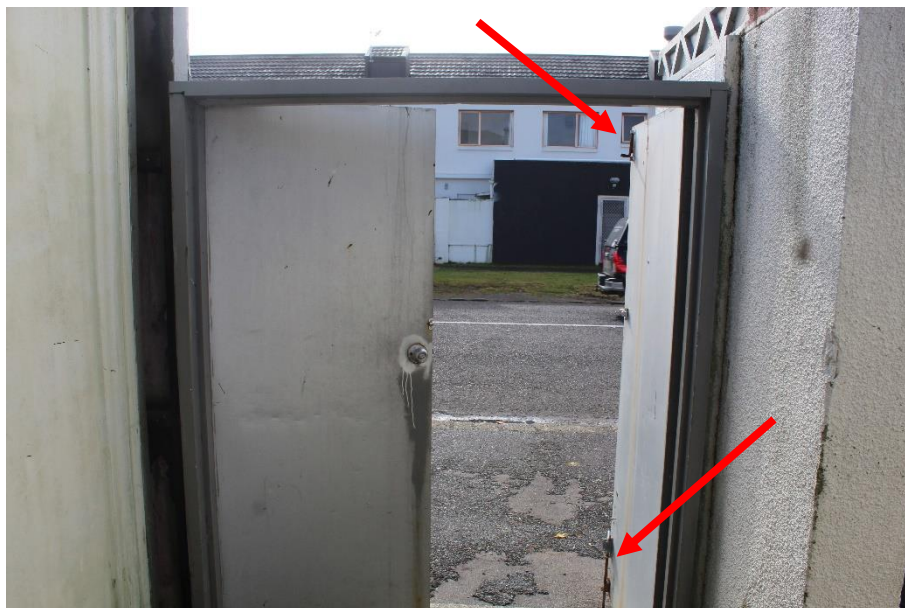
*Photo 19: A Block – Fire exit door, ground level*

The fire exit in the above photo had two locking hardware that was not located in a convenient position, one at the bottom of the door and the other at the top of the door. I recommended that the current locking hardware be removed, and a crash bar be installed on these doors. This will ensure all occupants unfamiliar with the layout of the lock can easily operate the locking hardware and safely escape from fire.

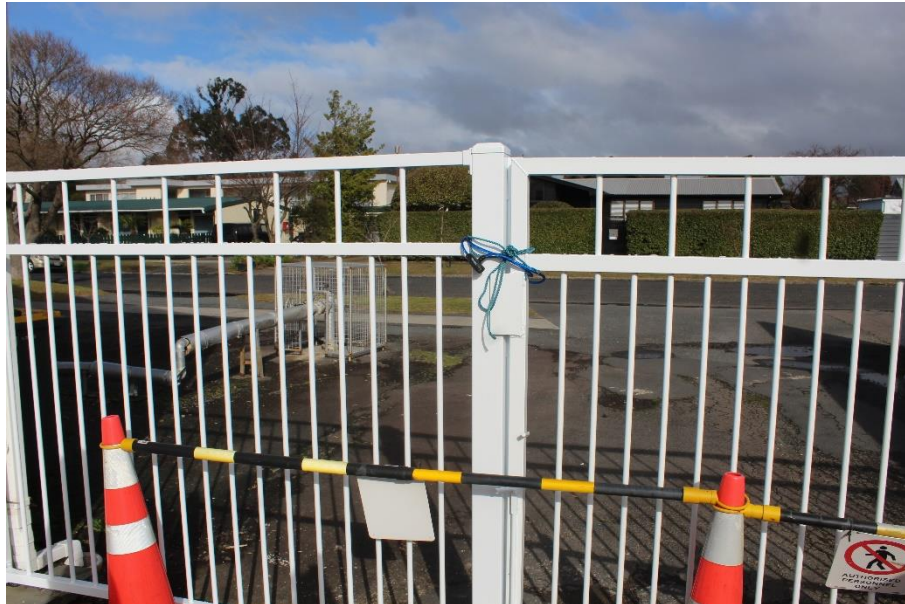
*Photo 20: Gates on the south side of the property*

I observed the double metal gates padlocked and locked on the south side of the property. This is not an acceptable practice as it prevents the occupants from moving to a place of safety.
