## FIRE CASE STUDY

An example of the challenges of emergency response in Tāmaki Makaurau

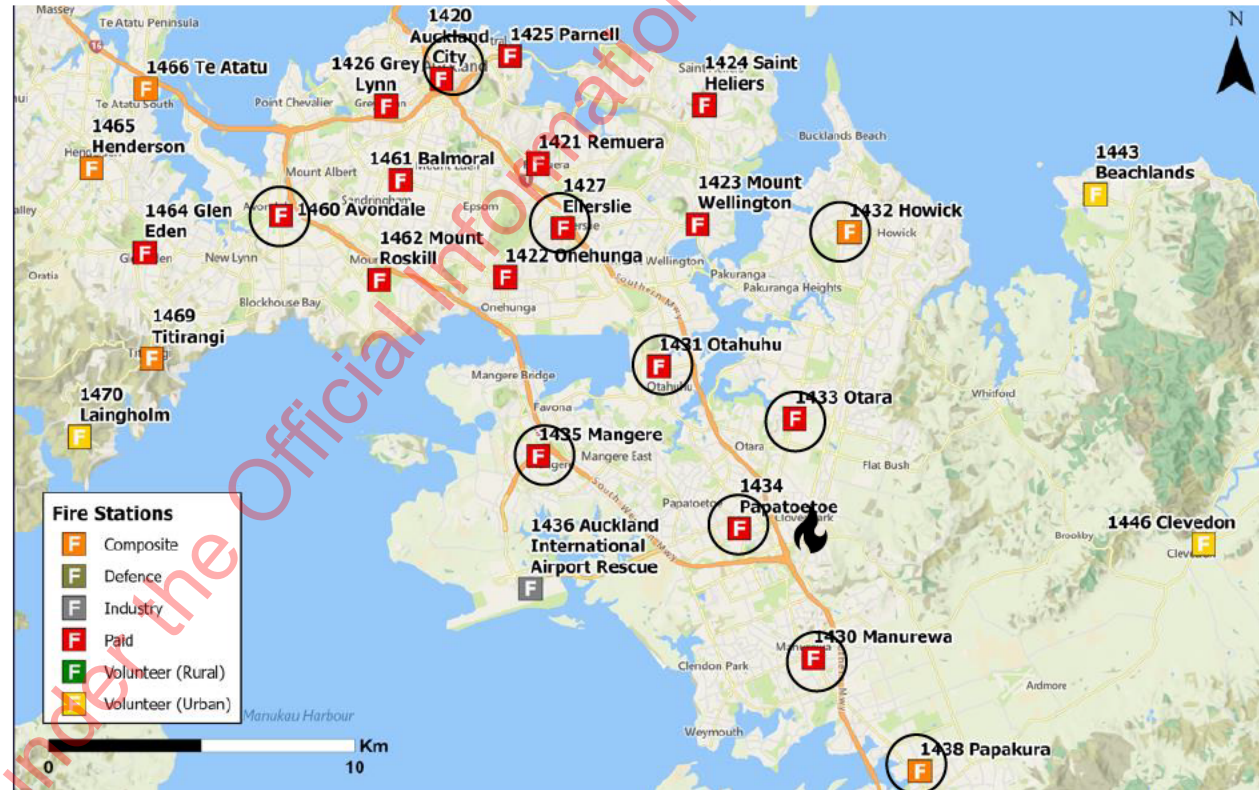
- 9(2)a is a residential area zoned Residential Mixed Housing Suburban.
- The fire was located at a building site for residential infill housing
- The cause of the fire is suspected arson
- There were no residents in the property, and no injuries to the public
- A firefighter received minor burns
- It was a 3rd Alarm fire, 15 appliances attended from 10 stations across 2 fire districts
- The property (a stand alone house) was completely destroyed, 3 other properties were severely damaged due to the heat of the fire.

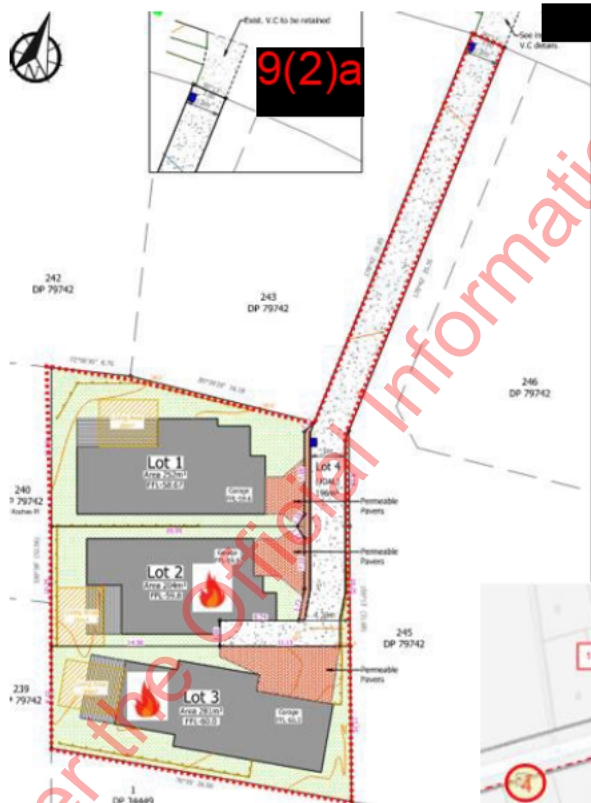
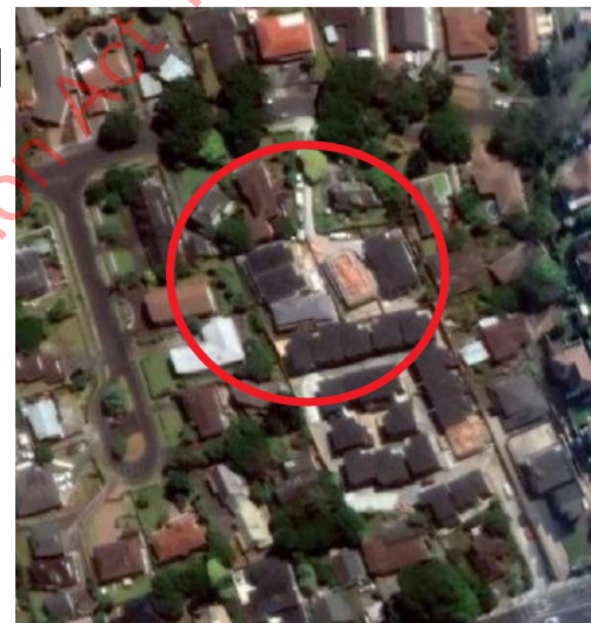
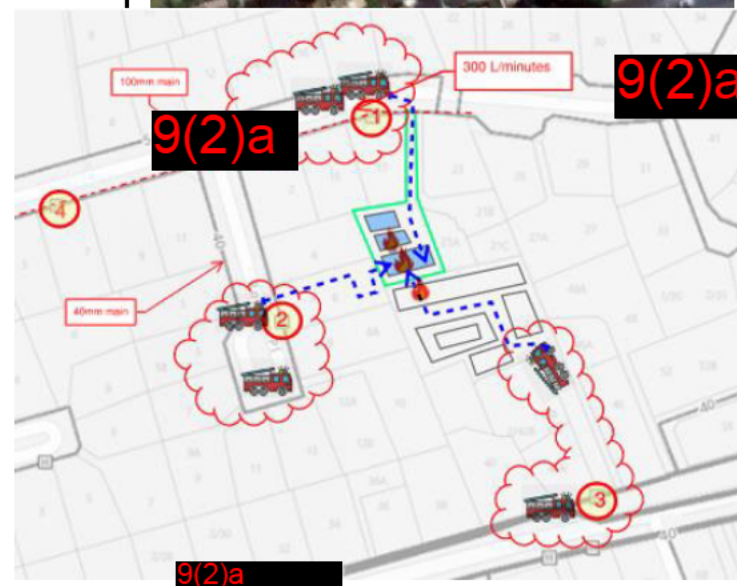
- Neither developments at 9(2)a [redacted] have adequate access for fire appliances, both have driveways that exceed 20m
- The driveway to access the property is over 40m in length, and 2.9m wide.
- The driveway for properties which back on to the house, 9(2)a [redacted] is 45m in length and too narrow for an appliance
- During the consent application it was determined that sufficient provision had been made for legal and physical access to the proposed allotments.
- While the Joint Owned Access Lot did not meet the 3.5m standard it met most requirements and could utilise the access way from 9(2)a [redacted]
- Firefighters accessed the fire by foot at 9(2)a [redacted], 9(2)a [redacted] and by breaking down a fence of a neighbouring property on 9(2)a [redacted]

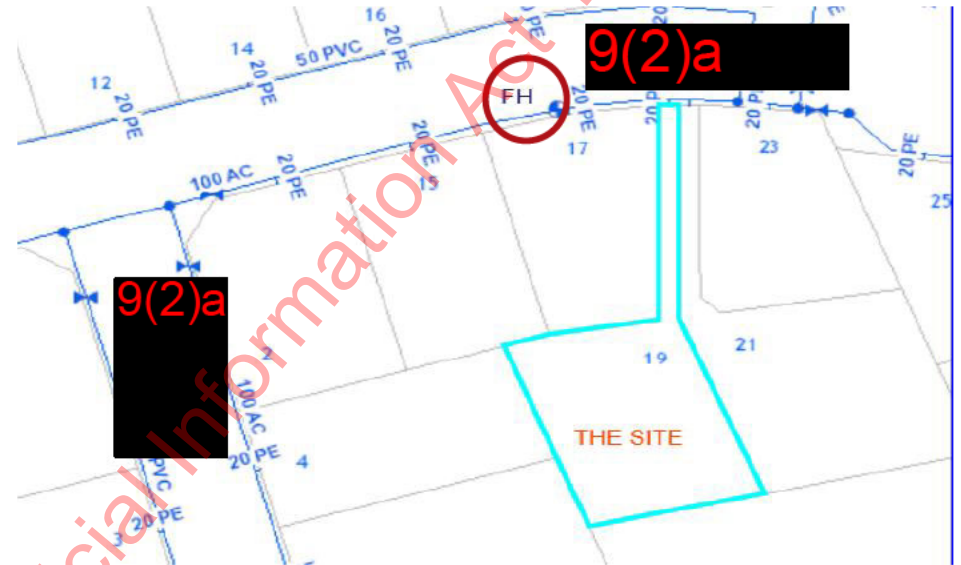
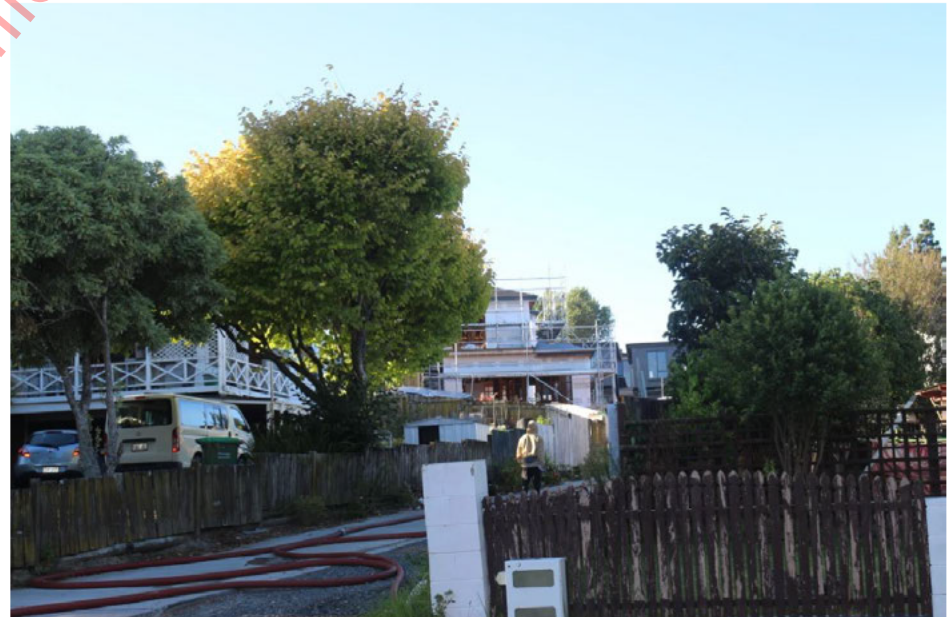
- Development connection was approved by Watercare. It assessed that there was network capacity to service the new properties and would achieve FW2 risk classification with 1500L/m flow total (750L/m from two hydrants)

- Engineering reports identifying that water for firefighting was ideally located at 9(2)a [REDACTED] and another at Rochas Place, 135m distance to the site measured in a straight line. Actual distance exceeded 270m.

- During the fire water flowing from the hydrant at 9(2)a [REDACTED] was insufficient for firefighting estimated to flow at only 300 L/m
- Firefighters connected to 3 hydrants creating a flow rate at best of 900L/m (in reality likely to be less due to the number of hydrants open)

- Minimum requirement for firefighting at this incident was 2000L/m due to the multiple exposure and fire spread to multiple buildings
- The engineer application to Watercare did not include evidence to support that the water supply would be adequate.

- Following the incident Watercare completed an audit of the main supply to 9(2)a [REDACTED]. Two valves were found to be nearly closed.

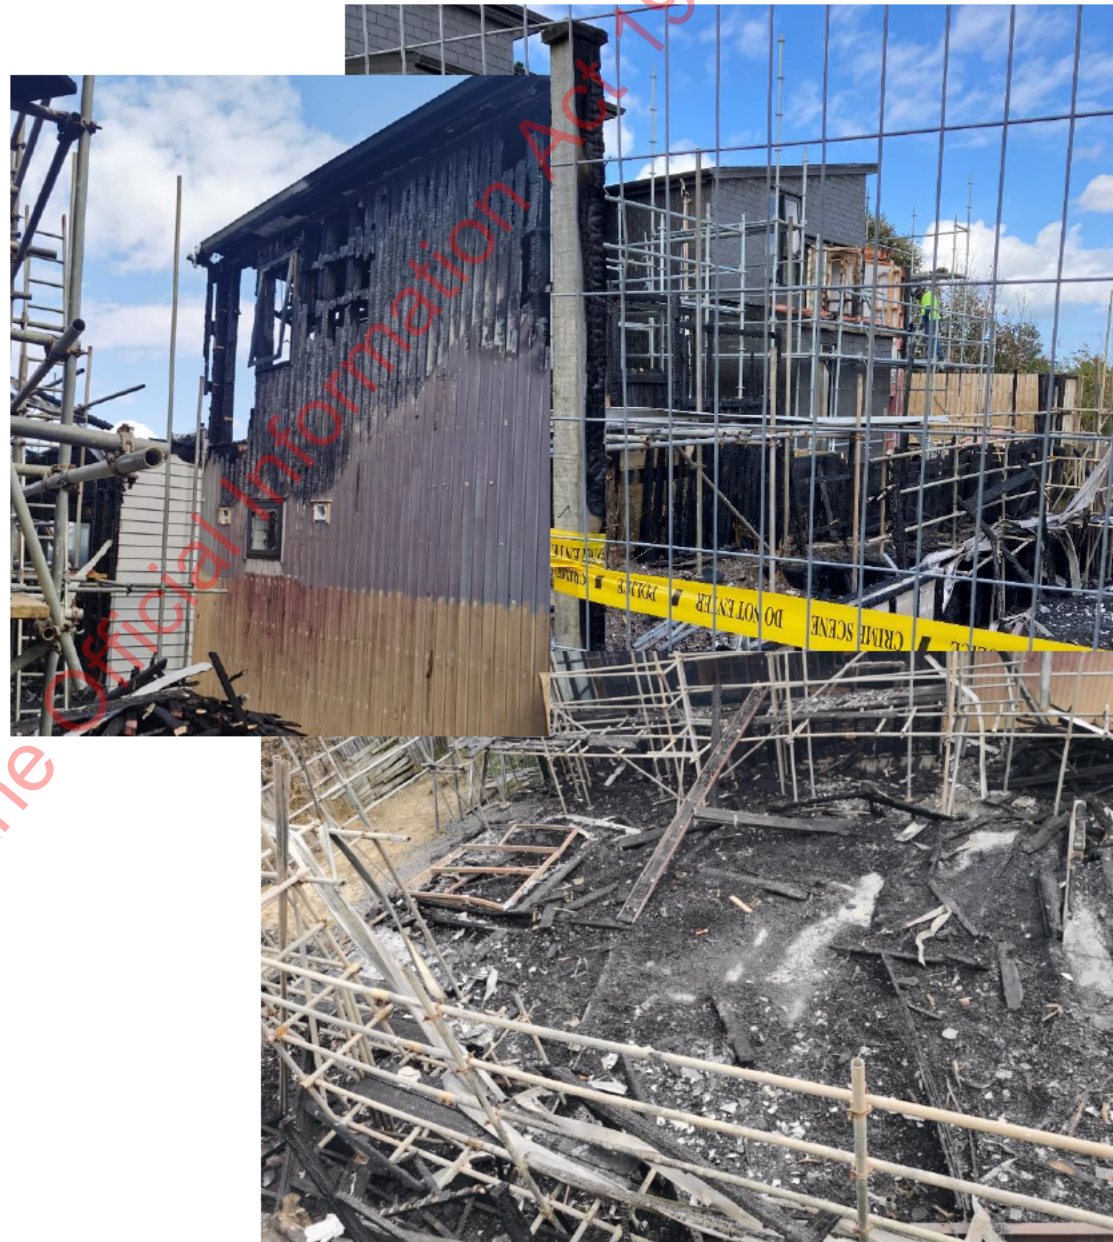
- One dwelling was entirely consumed. The top floor of a second dwelling was extensively damaged
- Dwellings on the neighbouring property at Redoubt Road were also effected and the boundary fence severely damaged

- The level of destruction was due to wind direction, and short separation distance (1-3m between dwellings)
- The design complies with relevant boundary requirements for a single family unit dwelling (1m between building and boundary, 2m between any two buildings)

- It is fully compliant the Building Code – Acceptable Solution C/AS1. However a more thorough assessment would have not demonstrated compliance with Building Code cl. C3.6 – *in event of a fire received radiation at the relevant boundary does not exceed 30kW/m<sup>2</sup> or exceed 16kW/m<sup>2</sup> at 1m beyond the boundary*

- Incident radiation was estimated 57.858kW/m<sup>2</sup> at the boundary and 46.708kW/m<sup>2</sup> at 1m beyond the boundary
- Small separation distance on all sides of the building increase the risk of fire spreading. The difficult of access increases the time for fire to burn increasing the head radiation in a confined area.
