# Passenger Fatality

## Massachusetts Bay Transportation Authority

Boston, Massachusetts  
April 10, 2022

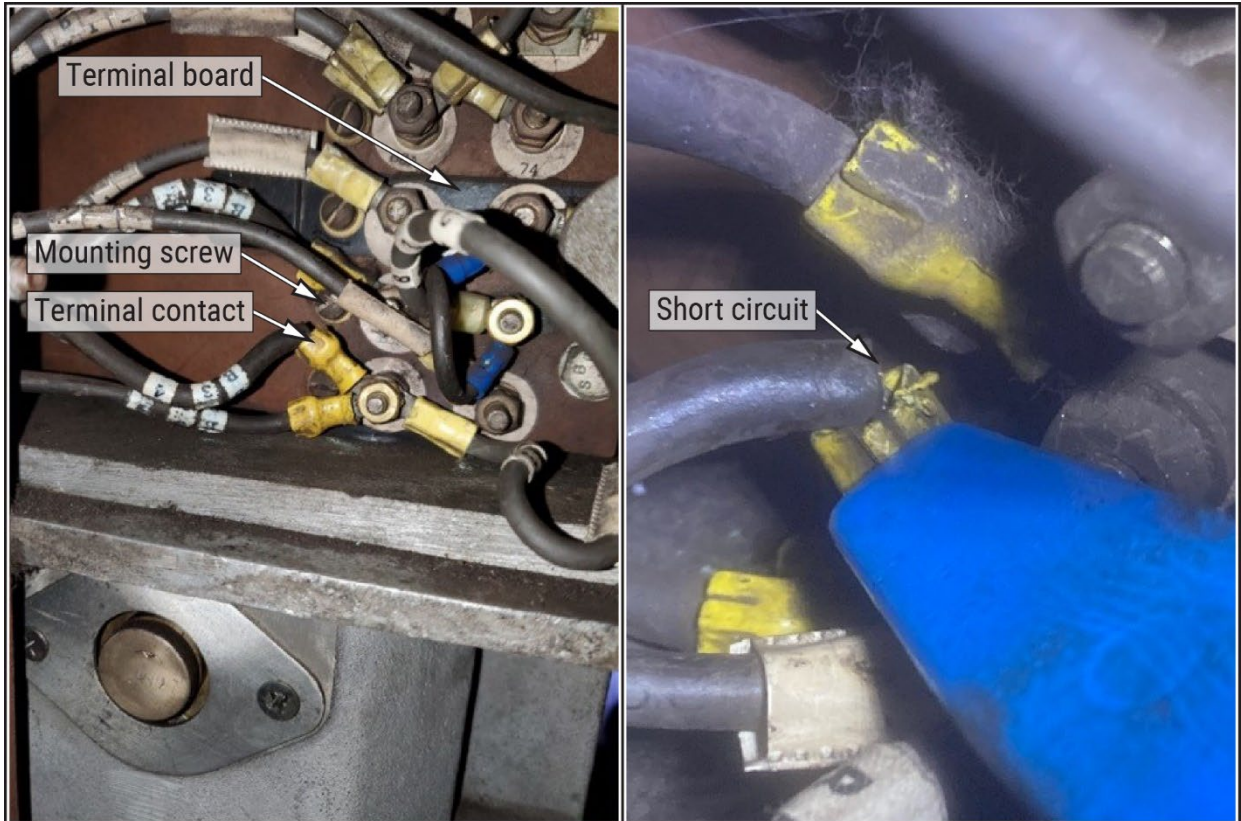
On April 11, 2022, on MBTA property, NTSB investigators tested the propulsion system on train 1034 and observed that trainline propulsion was enabled even if the passenger door interlock circuit was open (that is, if there was an open door). Further testing of each railcar in train 1034 showed that a short circuit in railcar 1511 bypassed the functionality of the passenger door interlock circuit.<sup>7</sup> A review of the passenger door interlock circuit schematics indicated the short circuit was located in the electromechanical contact connections, specifically the terminal contacts and finger contacts located on the wire terminal board under the Cineston master controller in railcar 1511.<sup>8</sup>

NTSB investigators then examined the Cineston master controller and observed wire strands protruding from the terminal contact of one of the wires. These protruding wire strands were touching a mounting screw close to the contact, completing the short circuit. (See figure 2.)

**Figure 2.** View (*left*) and close-up (*right*) of the short circuit.

In this accident, an MBTA passenger was dragged and killed when the passenger doors of railcar 1510 of MBTA Red Line train 1034 closed on his upper body and the train departed Boston's Broadway Station. Postaccident examinations and testing found a short circuit in the electromechanical contact connections under the Cineston master controller in the lead railcar.

The National Transportation Safety Board determines that the probable cause of the April 10, 2022, passenger fatality was a short circuit in the passenger door interlock circuit on the accident railcar that enabled propulsion on train 1034 with the door obstructed by a passenger, causing the passenger to be dragged along the platform.

MBTA implemented a method of electrical isolation between wire terminal contacts and mounting screws on the Cineston terminal board so that protruding wires do not unintentionally complete a short circuit.
