# Aviation Investigation Preliminary Report

<b>Location:</b>	Shaktoolik, AK	<b>Accident Number:</b>	ANC23FA042
<b>Date &amp; Time:</b>	June 16, 2023, 11:35 Local	<b>Registration:</b>	N91361
<b>Aircraft:</b>	Cessna 180	<b>Injuries:</b>	2 Fatal
<b>Flight Conducted Under:</b>	Part 135: Air taxi & commuter - Non-scheduled

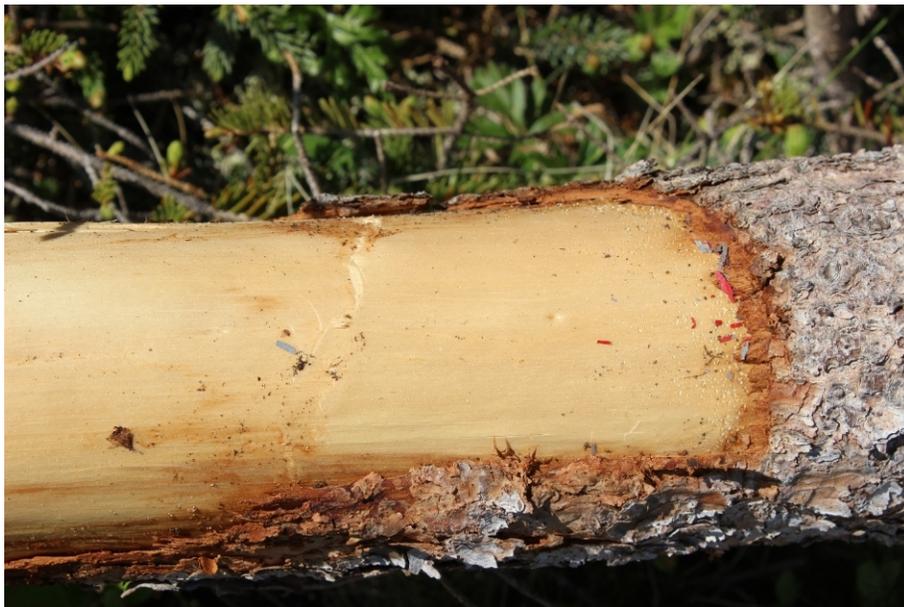
Examination of the airstrip revealed a small cluster of trees about 2/3 of the distance from the departure end on the runway’s left side, and downslope. One 12 ft tree, about 4 inches in diameter, was fractured about 4 ft from its base. The separated portion of the tree was found next to its trunk and displayed fragments of red paint that matched the accident airplane’s paint color.

Figure 1 View of the fractured tree with fragments of red paint.

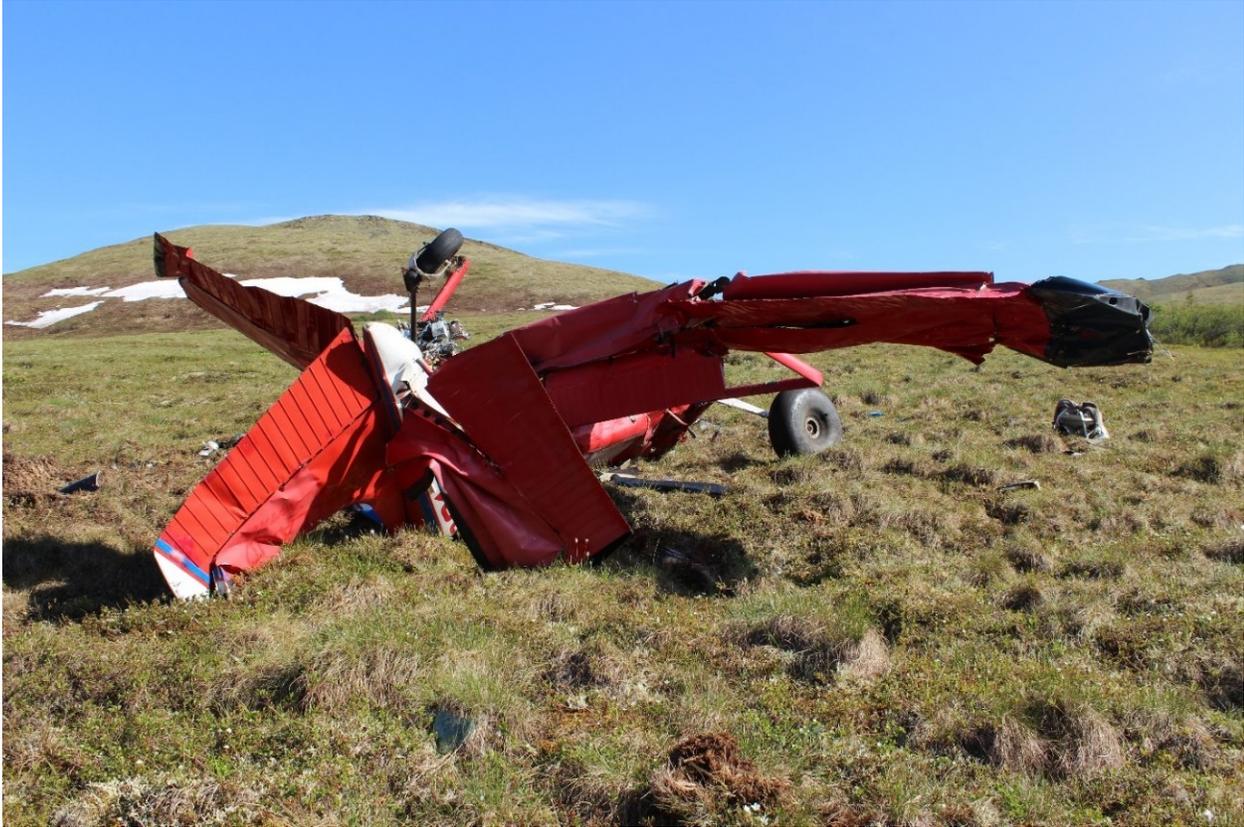
Examination of the wreckage revealed it impacted tundra in a steep nose-down wings level attitude about 1,200 ft. from the broken tree. The wings were displaced by impact, the right wing leading edge was uniformly crushed aft along its span. The upper and lower wing skins were crushed aft in compression. Flight control continuity was established through several breaks to the flight control surfaces. All breaks and separations were consistent with impact and overstress failure. The engine was separated from the airframe and came to rest inverted behind the left wing. The propeller hub was fractured, and the propeller blades were separated from the hub.

Figure 2 View of the airplane where it came to rest.

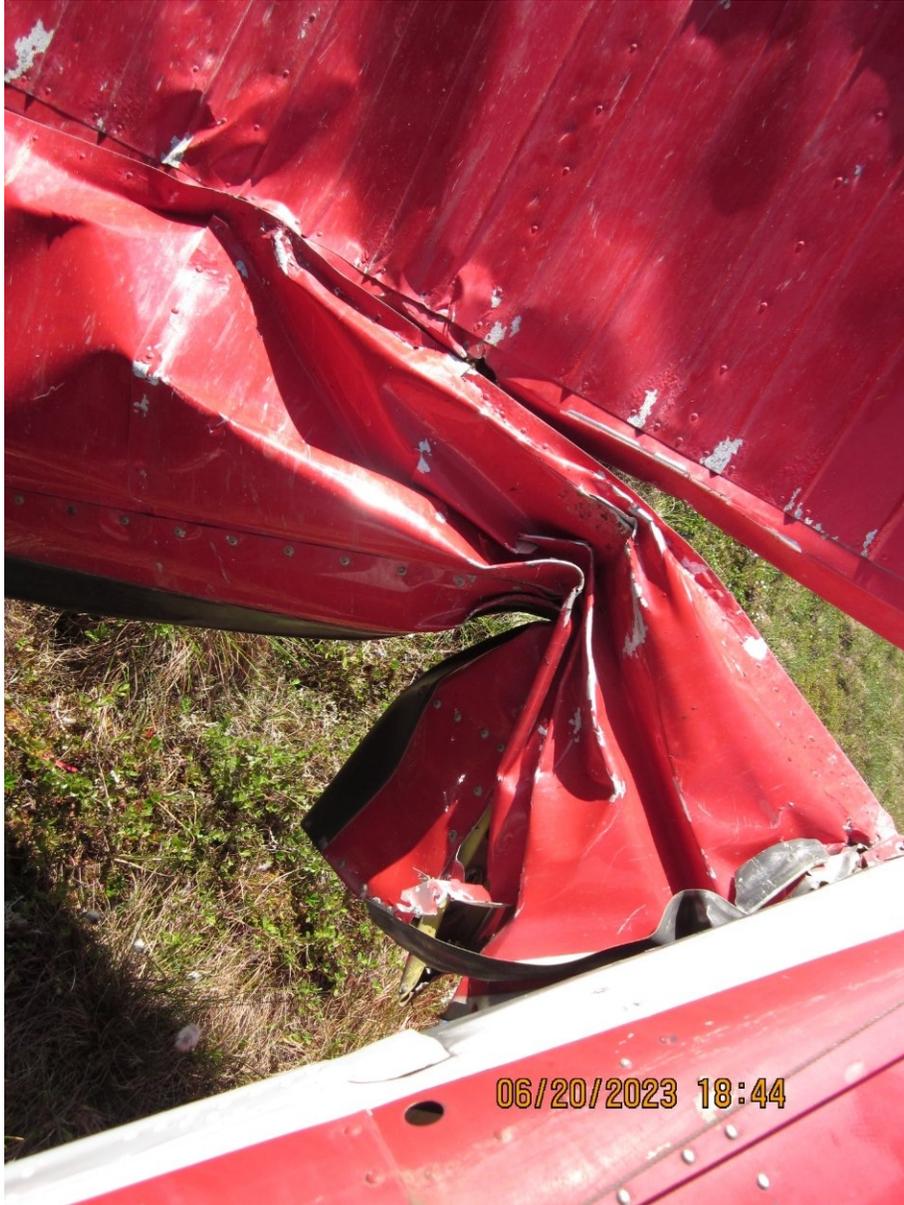
The left horizontal stabilizer displayed a concave dent perpendicular to the leading edge about 1 ft outboard of the stabilizer root. Tree sap and embedded tree fibers were observed in the leading edge of the horizontal stabilizer.

Figure 3 View of the aft crushing on the horizontal stabilizer.
