Aviation Investigation Preliminary Report

Location:	Old Harbor, AK	Accident Number:	ANC23FA045
Date & Time:	July 2, 2023, 15:10 Local	Registration:	N1132Q
Aircraft:	Piper PA-32-300	Injuries:	2 Fatal, 3 Serious
Flight Conducted Under:	Part 135: Air taxi & commuter - Non-scheduled

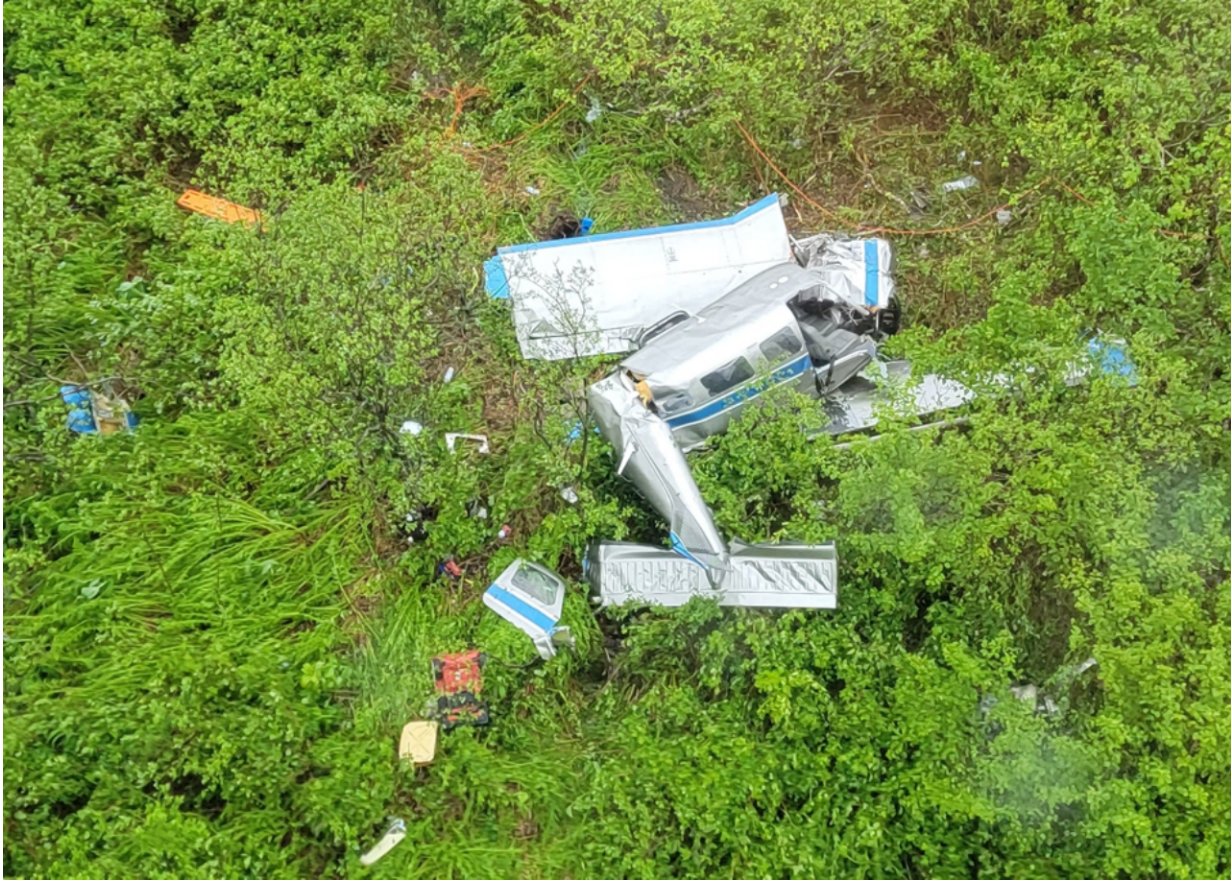
Figure 1 Aerial view of wreckage site. (NTSB Photo)

The NTSB IIC, along with an Alaska State Trooper, reached the accident site on the morning of July 3, and determined that all the airplane's major components were located at the main accident site. An initial on scene wreckage examination revealed no preaccident anomalies. However, a detailed post recovery airframe and engine examination are pending.

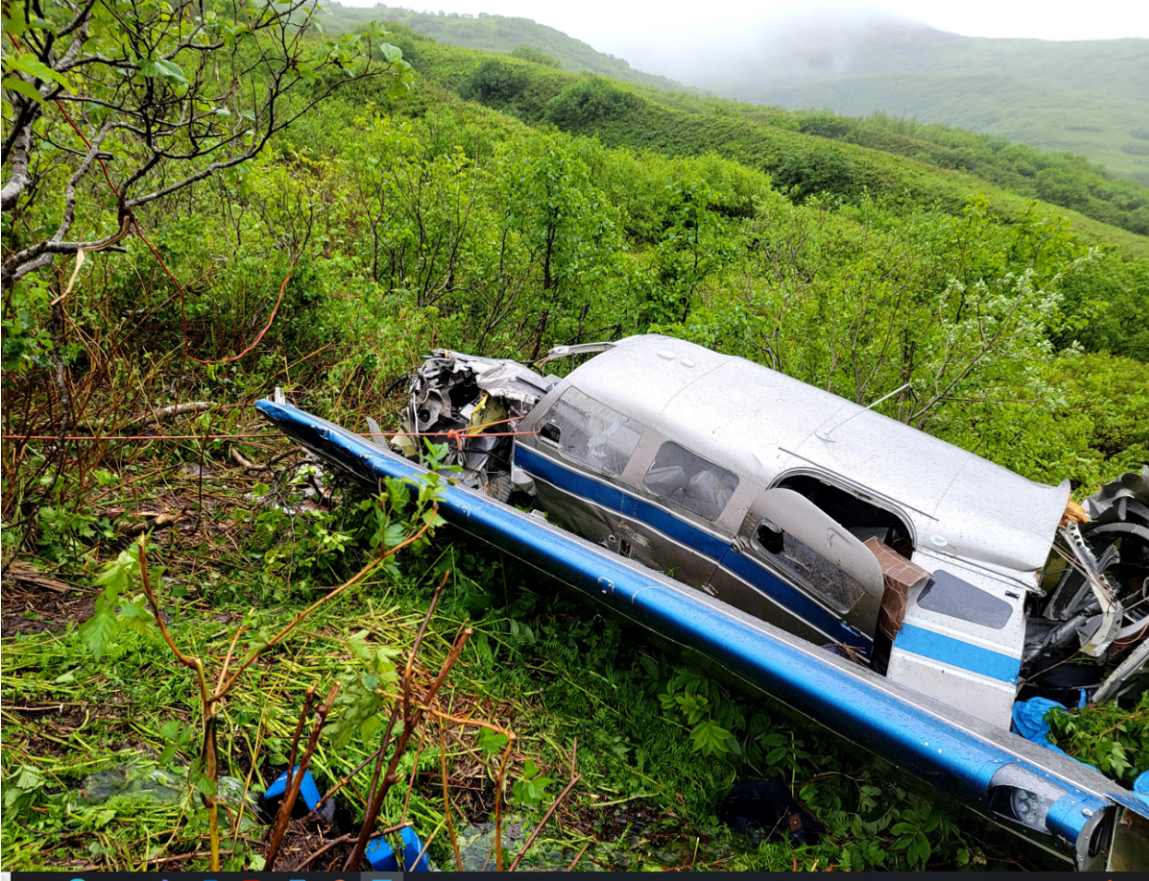
Figure 2 View looking south down valley from accident site. (NTSB Photo)
