Puhoi to Warkworth

Technical Memo

N1A Remediation Options - Technical Review Comments

P2WK-TAS-GE-TM-0010 | A

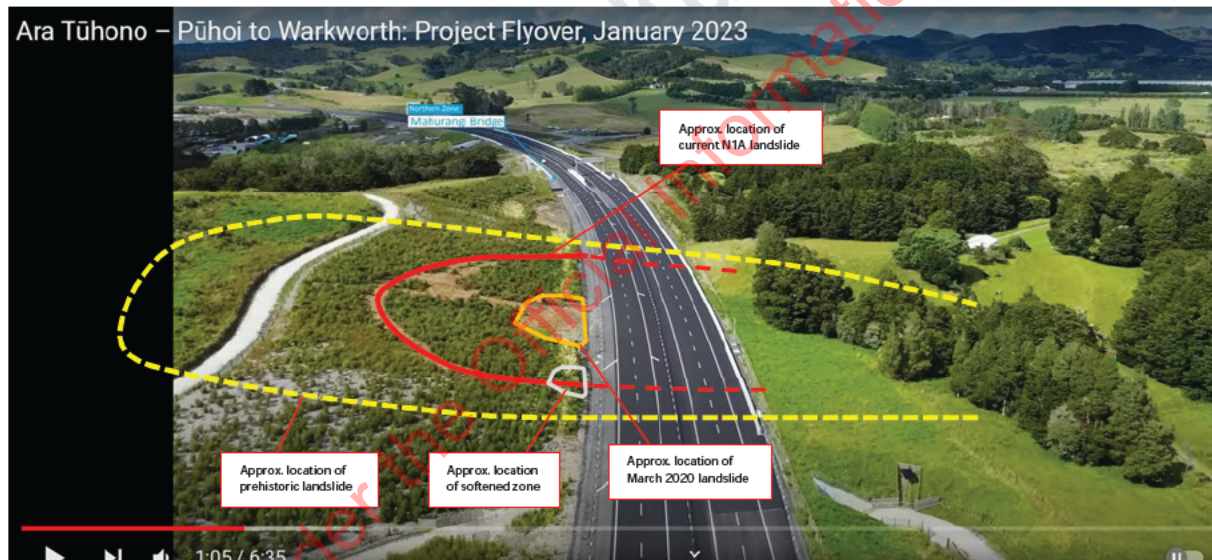
Figure 1 Screen capture of NX2's January 2023 drone flyover, with sketches of approximate locations of (a) March 2020 N1A landslide (b) current N1A landslide (c) prehistoric landslide. View towards the south-west.

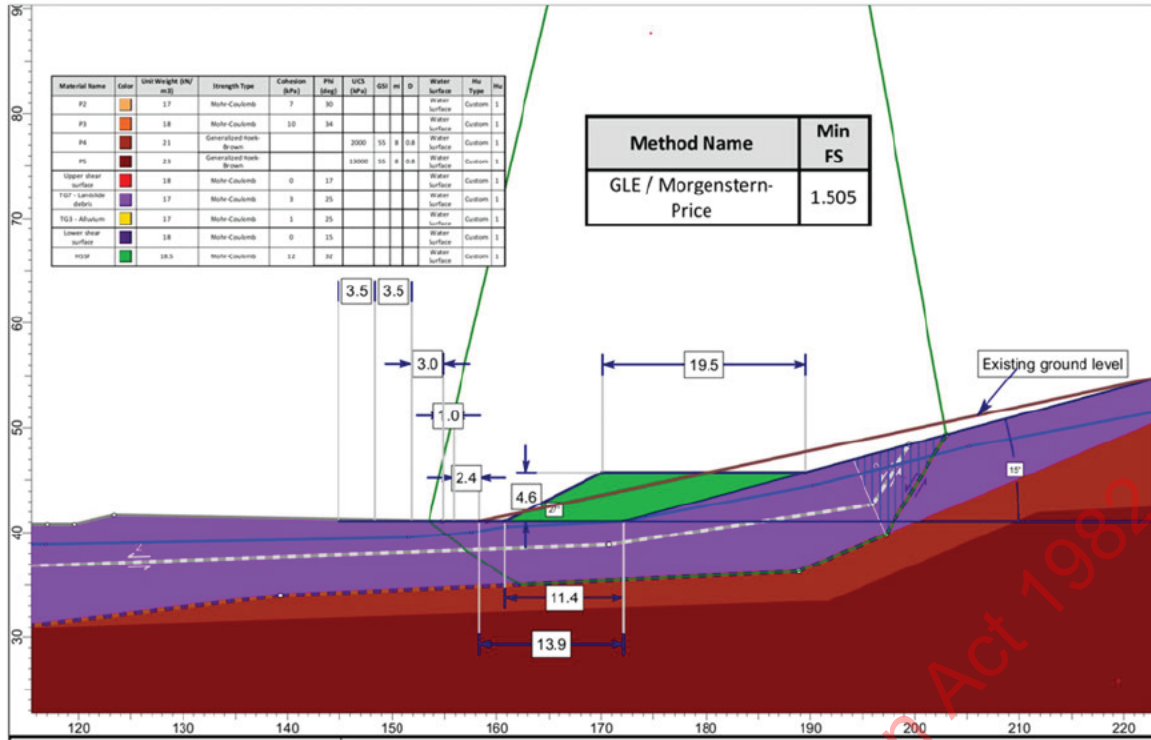
Figure 3 NX2's stability section for Option 1

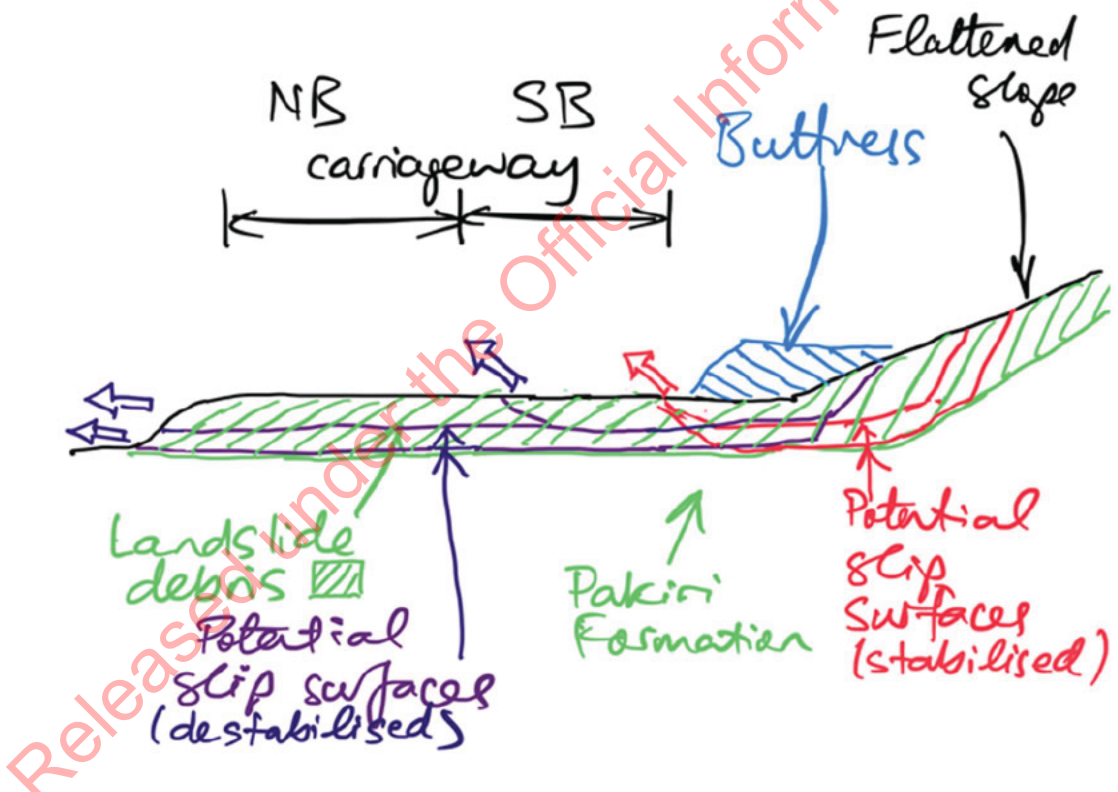
Figure 4 TAS's interpretation of stability for Option 1

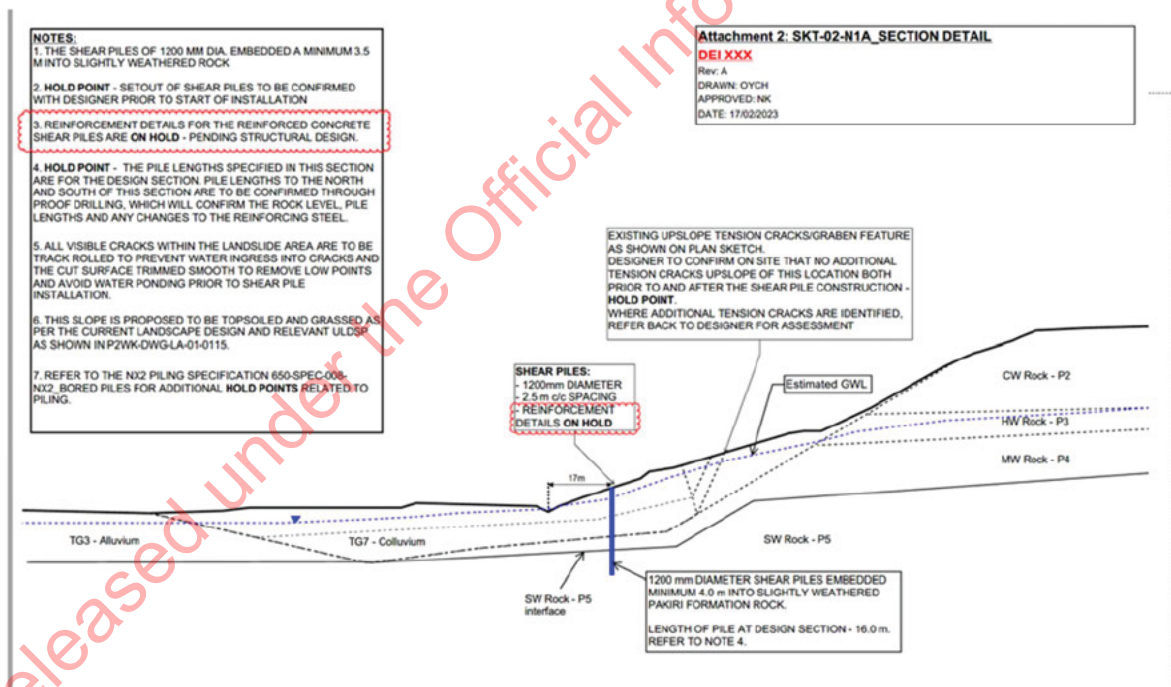
Figure 5 Options 2 and 3 section

- It is essential that the piles are embedded into underlying stable rock well below the lower slip surface. This would require a knowledge of the geometry of the lowermost slip surface in the direction along the row of piles. We note that the NX2 presentation shows a proposed hold point to confirm the pile lengths through proof drilling. TAS agrees with this approach and would recommend that adequate proof drilling is carried out in advance of the construction in order to adjust or confirm the design based on the drilling results.

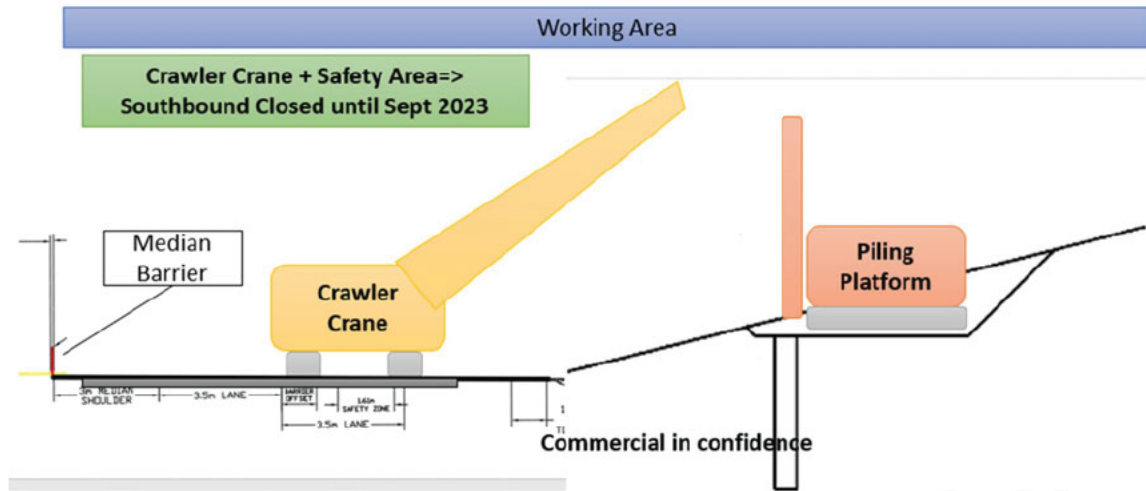
Figure 6 Option 2 (single platform)

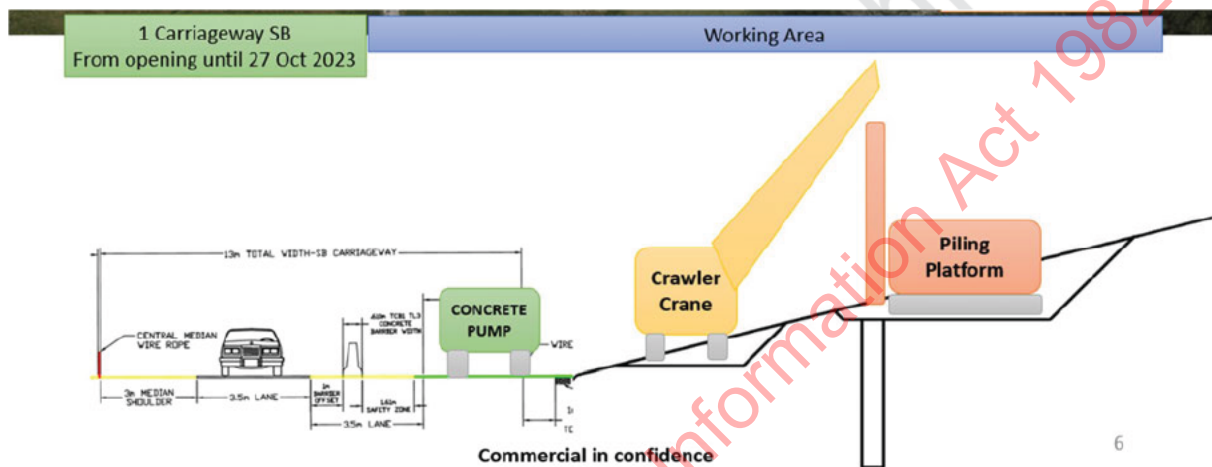
Figure 7 Option 3 (two platforms)

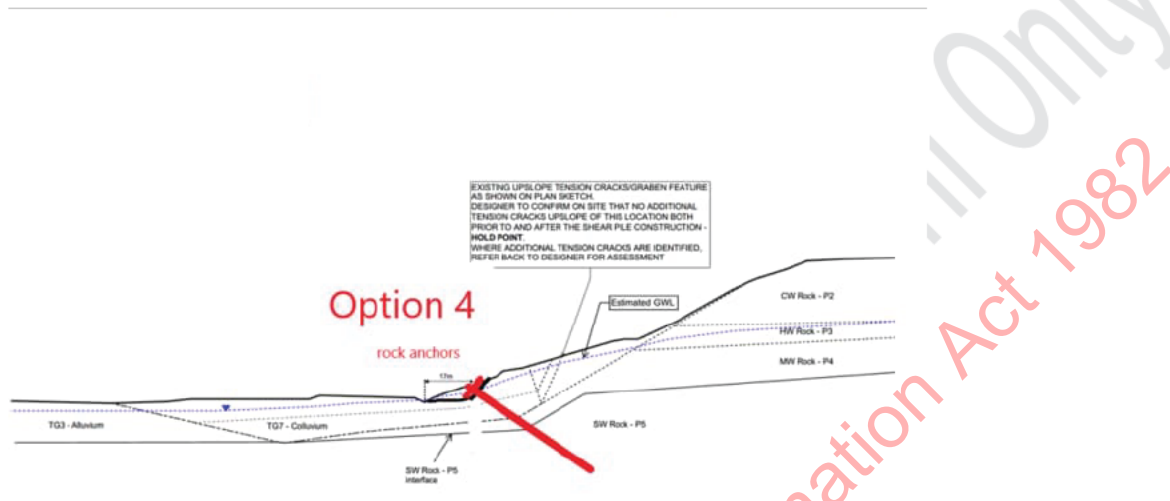
Figure 8 Modified NX2 sketch to show potential rock anchor option for consideration

A risk with Option 4 is that a better understanding of anchor founding conditions through further ground investigations would be required so that when installation of the anchors begin the risk of longer anchors being required is minimal. Trial anchors would need to be drilled and load tested to confirm anchor design prior to construction.

As an alternative deep rock anchors could be investigated as a possible solution requiring works to be performed along either one or two platforms on the slope face similar to Options 2 and 3. A second platform may be required if two rows of rock anchors are needed rather than a single row of rock anchors. The anchors would need large concrete pads to transfer anchor loads into the landslide mass. We expect that road closures for this option would be similar to that required for Option 3. Installation of rock anchors is likely to require smaller plant than that for Options 2 & 3.

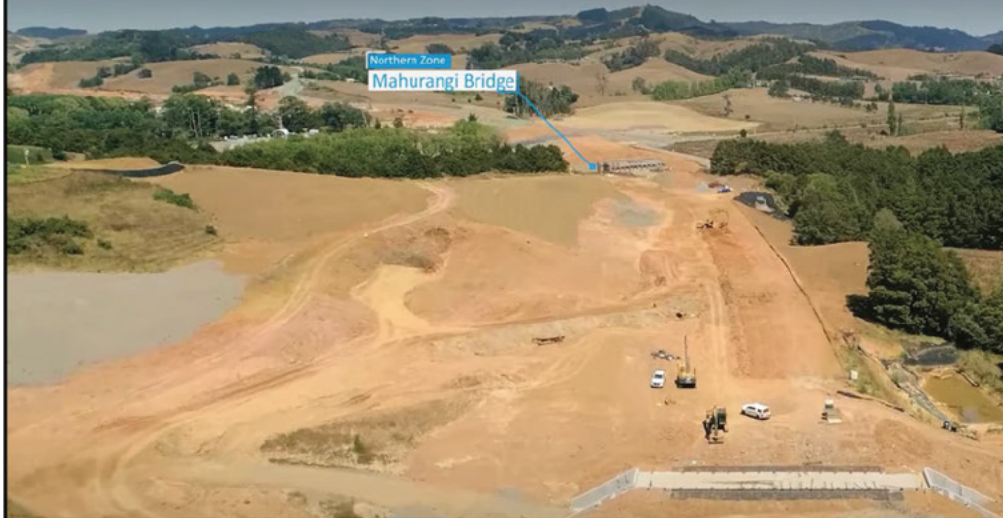
Figure 9 Screenshot of N1A cut (view southwards) from the February 2020 Drone Flyover

This measure may not be considered viable since the access road stability would have to be reviewed.

- reprofiling the slope below the farm access track to reduce the driving force on the upper portion of the slope. Originally fill was placed in this area prior to the 2020 landslides. See drone photo below.
