# 3.0 Existing Landslides

## 3.1 Overview

### 3.3 Typical Slope Failures Modes and Risks

Table 10: Typical Slip and Landslide Features

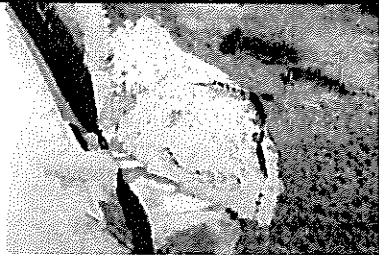
Risk Item	Example	Potential Causes	Locations
1. Soil slope failures, predominantly failing along/above the soil rock transition zone

CN1 North-west (September 2021, now repaired)	<ul style="list-style-type: none"> <li>• Cut slope too steep for geological conditions, i.e. conditions and inclination of soil-rock transition zone,</li> <li>• High groundwater levels or groundwater seepage,</li> <li>• Surface water runoff infiltration into slope,</li> </ul>	<ul style="list-style-type: none"> <li>• Transition into cut slopes from embankment fills,</li> <li>• Soil slope above rock cuts,</li> <li>• CN1 North-west,</li> </ul>

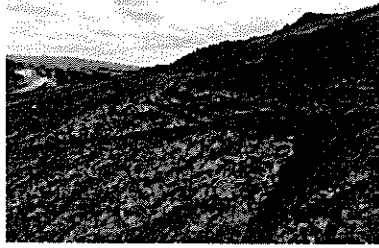
2. Slope failures within transitional rock or highly weathered rock at previous landslides

CN5B East (12 November 2021)	<ul style="list-style-type: none"> <li>• Surface water runoff infiltration into exposed fractured and highly weathered rock mass or zone of transitional rock,</li> <li>• Groundwater seepage,</li> </ul>	<ul style="list-style-type: none"> <li>• Exposed highly weathered and fractured transitional rock near cut slope surface, particularly where not protected by topsoil,</li> <li>• CN5B East,</li> </ul>

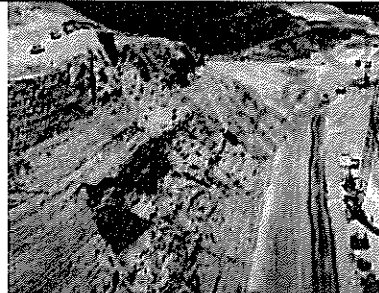
4. Wedge failures at rock slopes between rock bolts or at location without rock bolts Wedge failure may result in large scale failures.

CN5B East	<ul style="list-style-type: none"> <li>• Intersection defect sets,</li> <li>• Heavily faulted rock mass,</li> <li>• Too steep cut slopes for encountered geology,</li> <li>• Insufficient rock support (rock bolts),</li> <li>• As-built cuts are steeper than design,</li> </ul>	<ul style="list-style-type: none"> <li>• Refer to Table 11 for locations of 85°/64° steep rock cuts,</li> <li>• CN5B East &amp; West,</li> </ul>

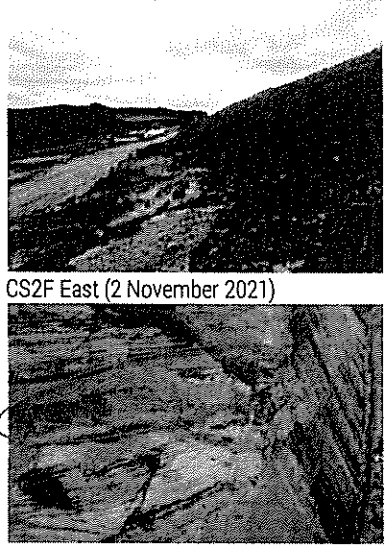
Risk Item	Example	Potential Causes	Locations
<p>6. Rockfall from debris above rock cuts, potentially rolling or dropping on the SH1.</p> <p>Refer to revised rockfall risk assessments in Section 4.2.</p>

<p>CS2F East (2 November 2021)</p> <p>CN5B East (buttress fill)</p>	<ul style="list-style-type: none"> <li>Exposed weathered and highly fractured rock,</li> <li>Steep slopes above rock cuts without sufficient rockfall catch area or protection,</li> <li>Rock lining fill from swale drains or buttress fill,</li> </ul>	<ul style="list-style-type: none"> <li>Refer to Table 11 for locations of 85° steep rock cuts,</li> <li>CN5B (buttress),</li> <li>CN5B East &amp; West,</li> <li>CS2F East,</li> <li>CS3 East,</li> </ul>
<p>7. Topsoil slumps and surficial erosion</p>

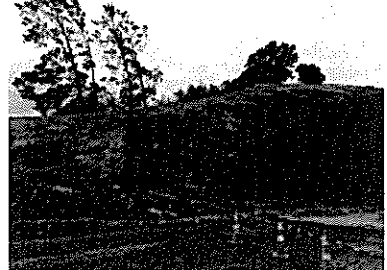
<p>CS16D</p>	<ul style="list-style-type: none"> <li>Soil slopes with smooth surfaces or topsoil placed on rock cuts,</li> <li>Too loosely placed or thick topsoil,</li> <li>Topsoil placed prior to winter (rainfall) season,</li> </ul>	<ul style="list-style-type: none"> <li>Soils slopes, particularly at transition into cut slopes from embankment fills, where batters could be steeper than 2H:1V,</li> <li>CS16D,</li> </ul>

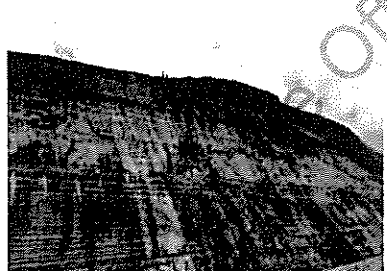
<p>8. Surficial rock dropouts and rockfall behind mesh draping without affecting rock cut integrity.</p>

<p>CN5B</p>	<ul style="list-style-type: none"> <li>Defect sets of rock mass,</li> <li>Ongoing weathering of exposed rock surface,</li> <li>Groundwater seepage,</li> </ul>	<p>All location of steep rock cuts. Refer to Table 11.</p>
