# National Transportation Safety Board

CEN22FA331

## **EXEMPLAR HELICOPTER AND IPAD EXAMINATION SUMMARY**

Location: North Fork, Idaho  
Date: July 21, 2022  
Time: 1644 mountain daylight time (MDT)  
2244 coordinated universal time (UTC)  
Helicopter: N388RA, Columbia Helicopters CH-47D

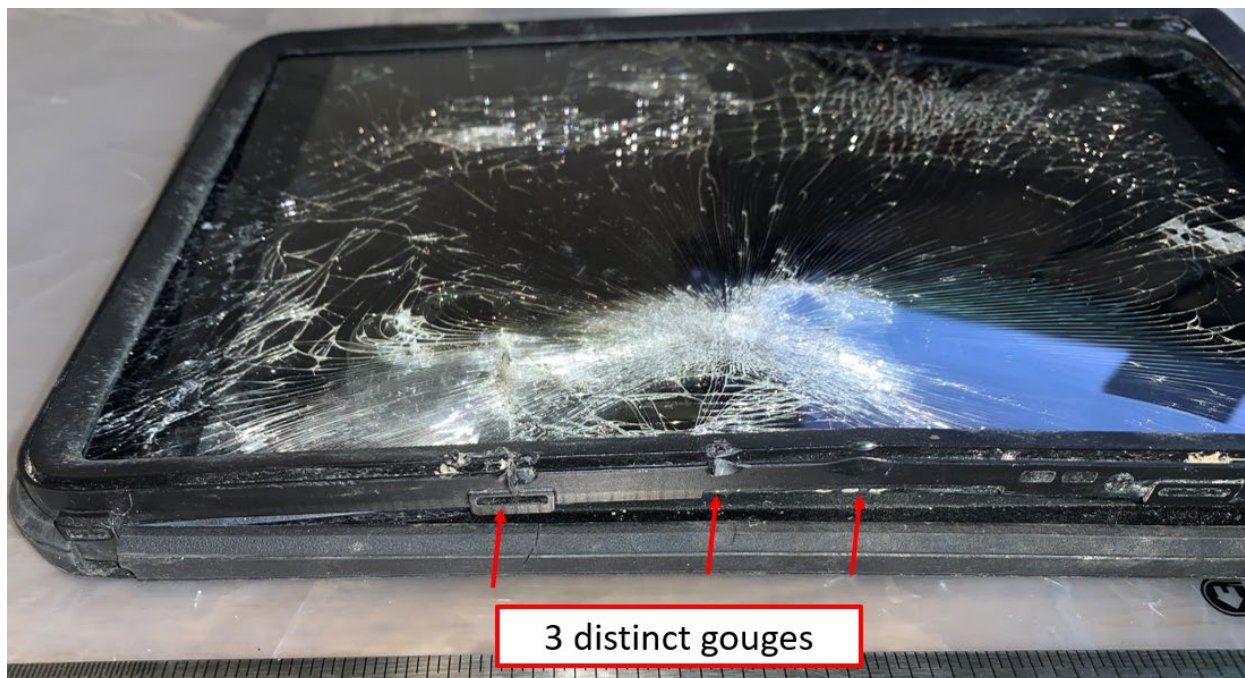
During recovery of the accident helicopter, the flight crew's Apple iPad was found in the river near the cockpit. Figure 1 shows the overall damage to the iPad as recovered. There were three distinct gouge marks on the left side of the iPad and its case, when viewed in portrait mode. The iPad exhibited abend from the back of the case toward the screen. The top two gouges extend from the edge of the case inward into the screen about 3 inches. The bottom gouge is shallower and does not extend into the screen.

Figure 1. Condition of iPad after the accident with 3 distinct gouges in the iPad and it's case. The gouges are on the left side of the iPad when viewed in portrait mode. In the image, the iPad is rotated left into landscape mode.

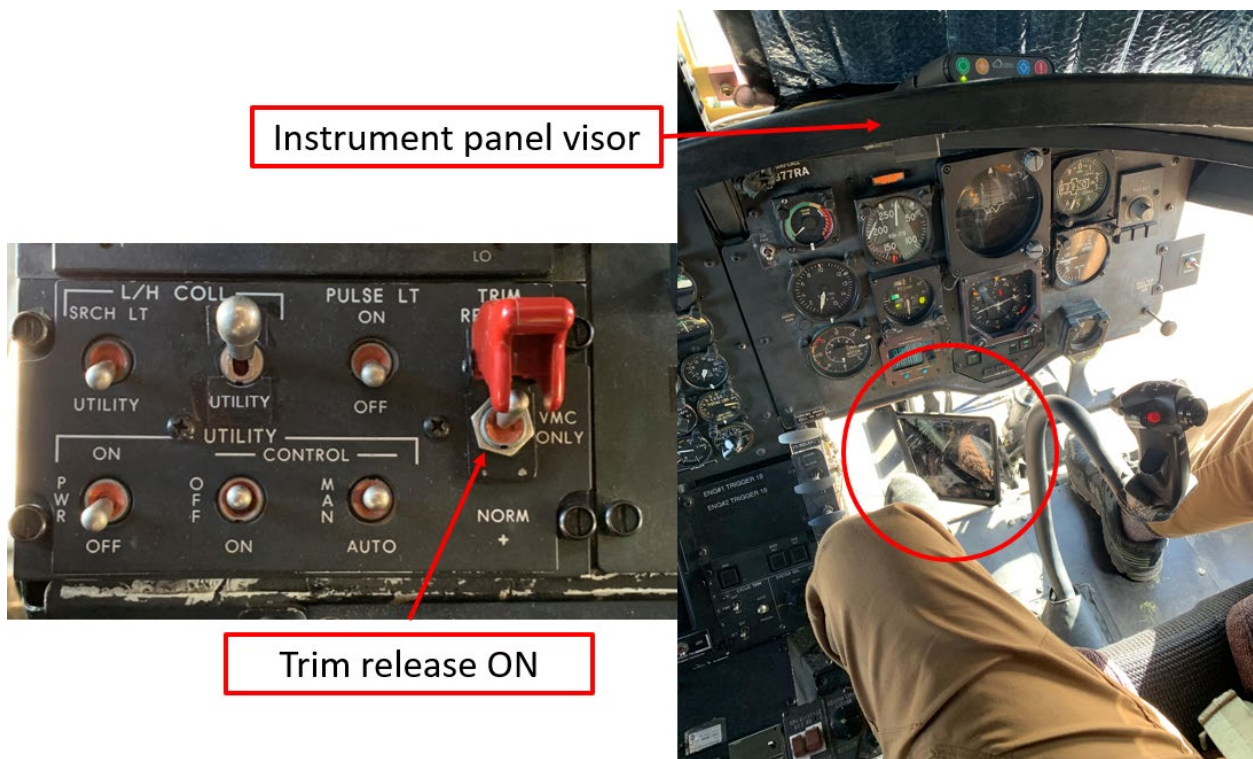
Figure 2. Trim release ON and iPad placed in co-pilot's left pedal area.

Once the iPad was placed in the co-pilot's left pedal area, the pilot's pedals were slowly manipulated in order to determine how the position of the iPad would change. Additional pressure was applied to the pilot's left pedal, which allowed the iPad to fall farther into the left pedal and jam between the heel slide support assembly. The jammed iPad prevented the pedals from recentering. The iPad also pushed against co-pilot's left pedal adjustment lever.

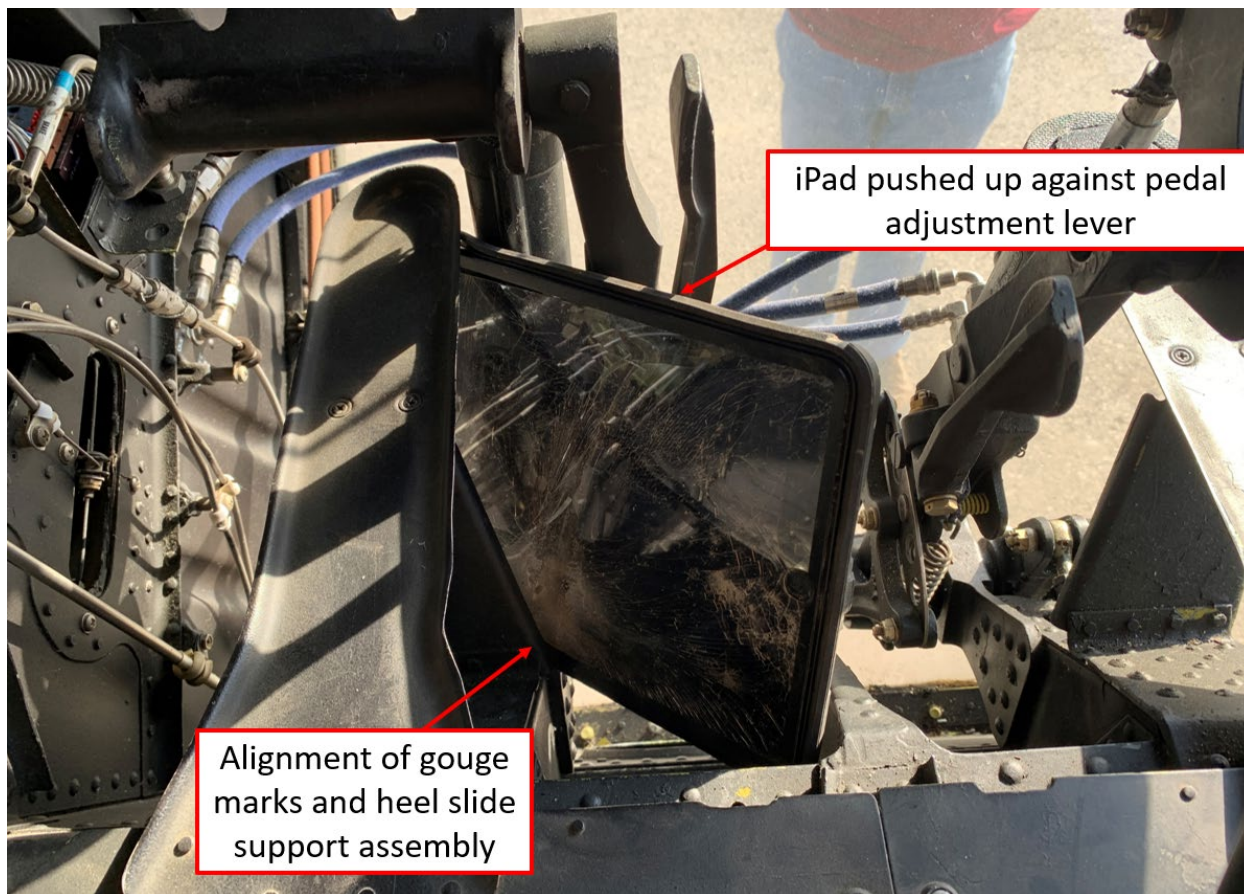
When pressure was applied to the pilot's right pedal, the iPad was squeezed in between the pedal and the heel slide support assembly, which was concentrated near the gouges. The gouges in the iPad aligned with a sharp, vertical metal piece of the heel slide support assembly underneath the heel slide, as seen in Figures 3, 4, and 5. Additional right pedal input forced the iPad to apply more pressure to the co-pilot's pedal adjustment lever.

Figure 3. The iPad impinged in between the co-pilot's left pedal and the airframe. The back side of the iPad is pushing against the left pedal adjustment lever. The lower left corner of the iPad is lodged into a small corner of the airframe. The gouges in the iPad aligned with a sharp, vertical metal piece of the heel slide support assembly.

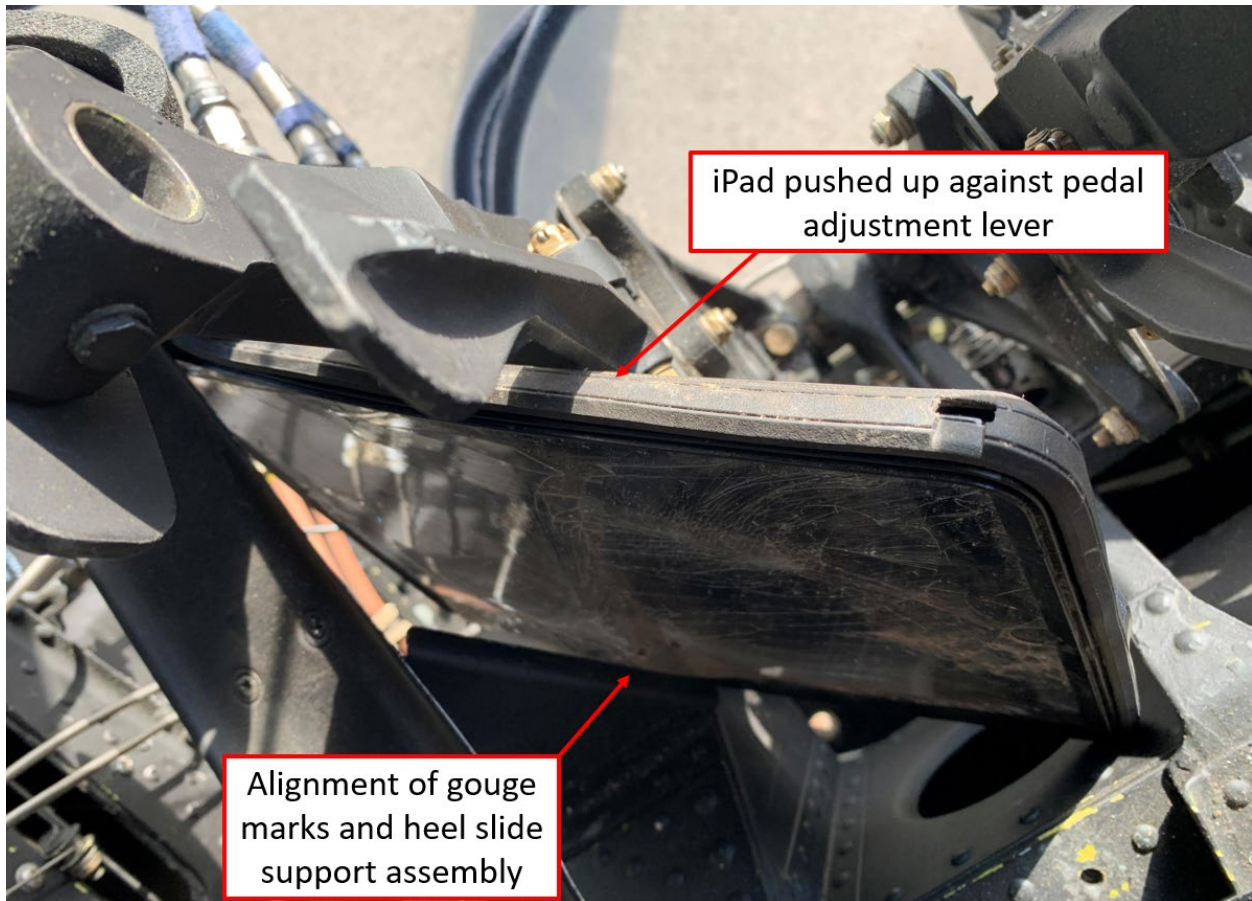
Figure 4. The iPad impinged in between the co-pilot's left pedal and the airframe. The back side of the iPad is pushing against the left pedal adjustment lever. The lower left corner of the iPad is lodged into a small corner of the airframe. The gouges in the iPad aligned with a sharp, vertical metal piece of the heel slide support assembly.

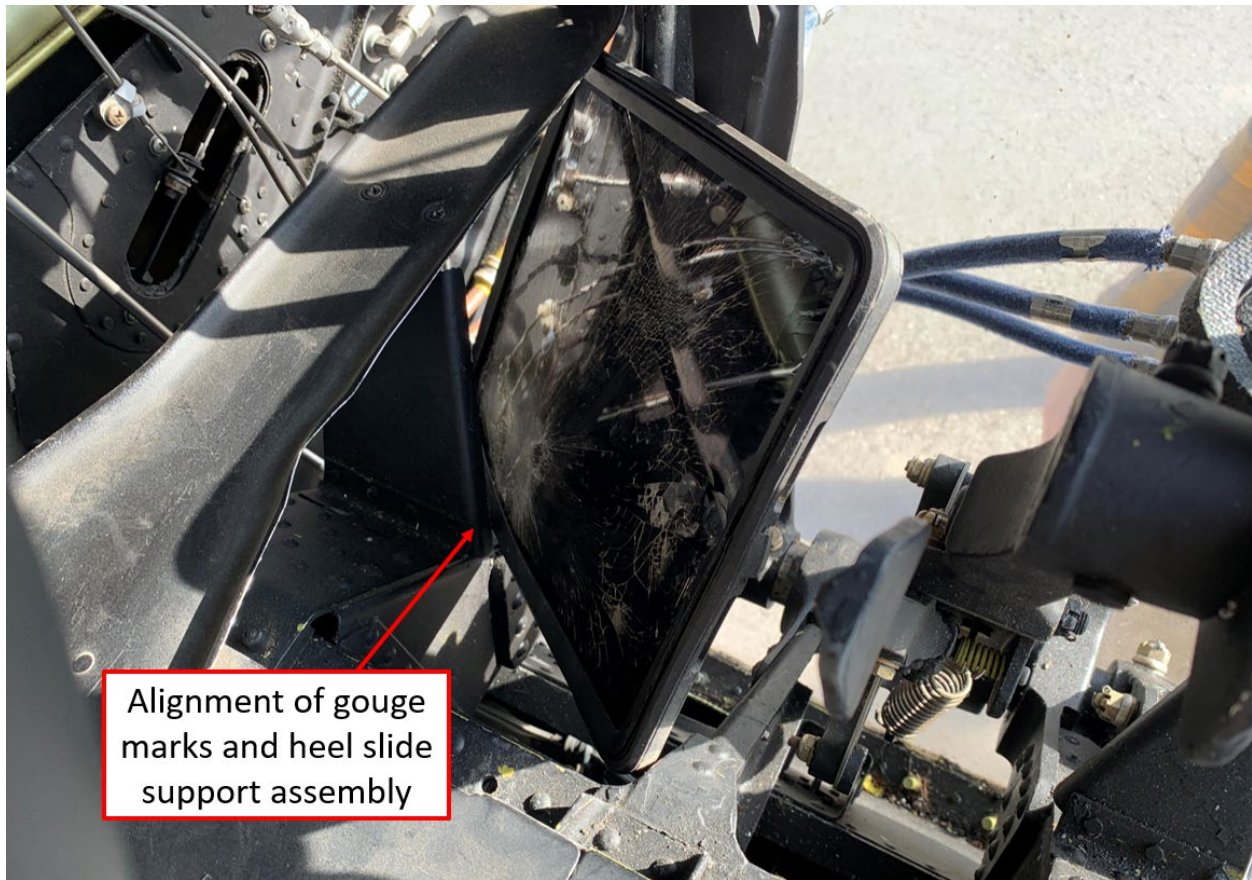
Figure 5. The iPad impinged in between the co-pilot's left pedal and the airframe. The lower left corner of the iPad is lodged into a small corner of the airframe. The gouges in the iPad aligned with a sharp, vertical metal piece of the heel slide support assembly.

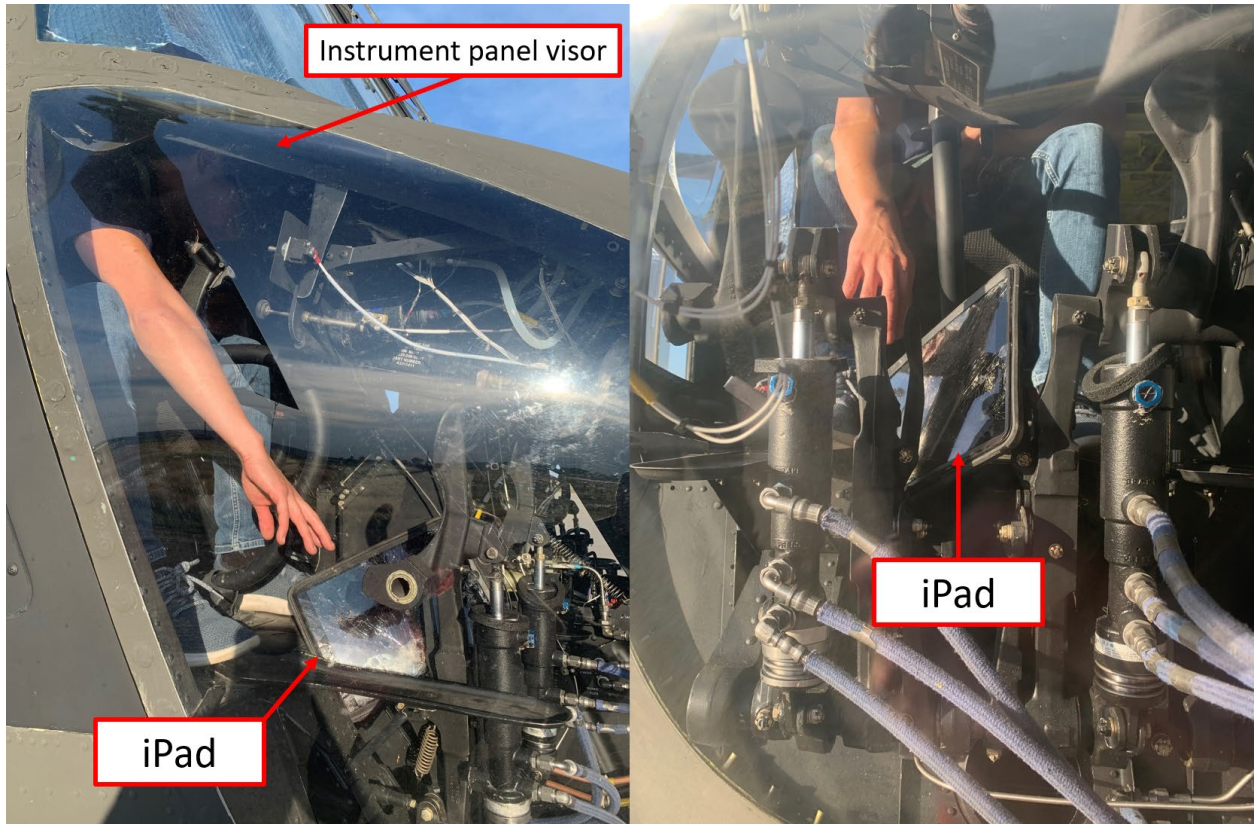
With the seat restraints on and seats adjusted for comfort, both a 5'7" male and 6'2" male could not reach the iPad in this position. The accident co-pilot's height was 5'10". Additionally, wearing a flight helmet would limit the ability to reach down as the flight helmet would contact the instrument panel visor as seen in Figure 2 and Figure 6.

Figure 6. Exemplar 5'7" male wearing seat restraints is reaching for the iPad. The restraints and instrument panel visor prevent the iPad from being accessible.
