# Aviation Investigation Preliminary Report

<b>Location:</b>	Wainwright, AK	<b>Accident Number:</b>	ANC23FA056
<b>Date &amp; Time:</b>	July 20, 2023, 11:05 Local	<b>Registration:</b>	N311MH
<b>Aircraft:</b>	Bell 206-L4	<b>Injuries:</b>	4 Fatal
<b>Flight Conducted Under:</b>	Part 135: Air taxi & commuter - Non-scheduled

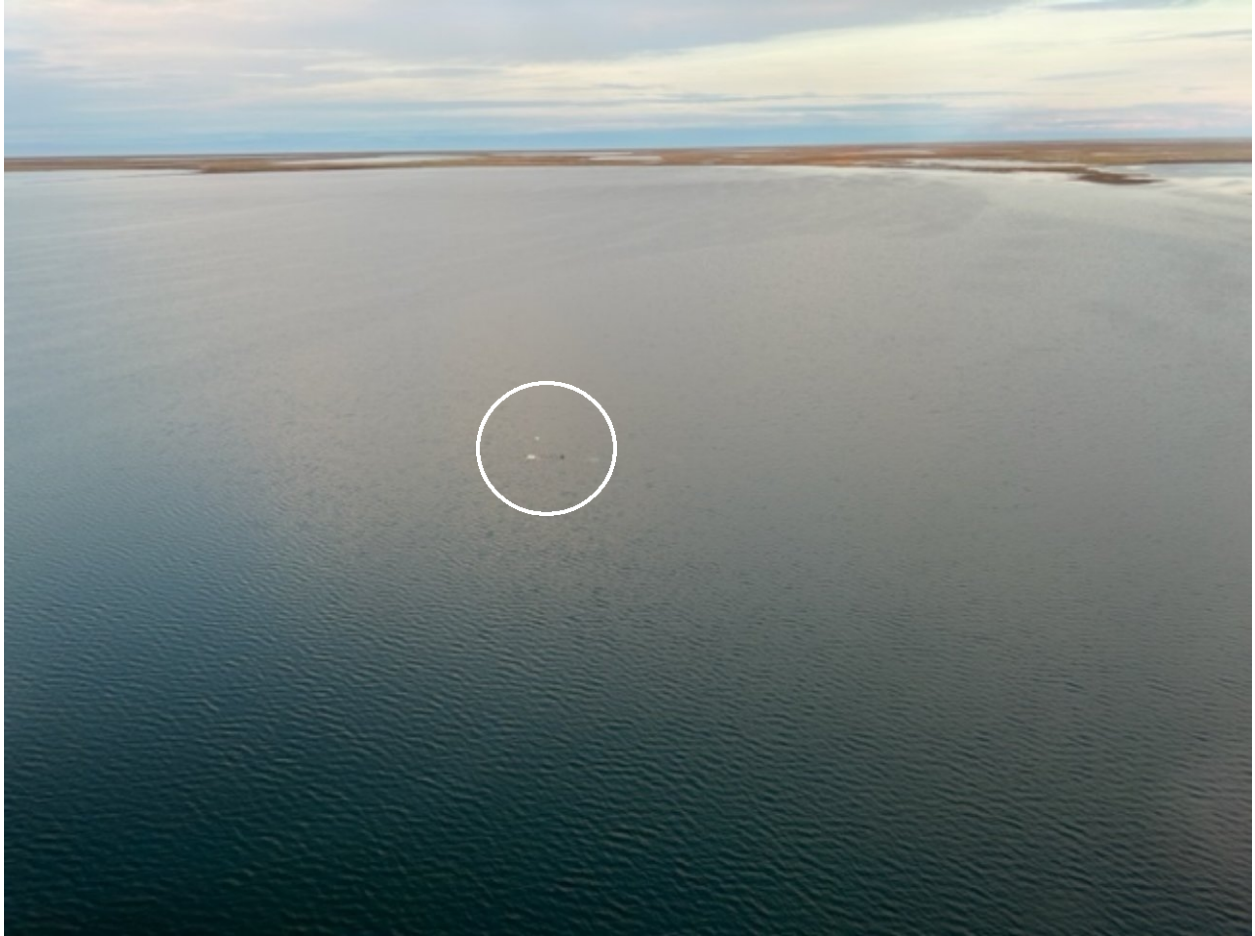
On July 21, about 0315, NSB search and rescue crews found the partially submerged, fragmented helicopter wreckage in the shallow waters of Lake Itinik located about 30 miles east of Wainwright. See figures 1 and 2.

*Figure 1 Aerial view Lake Ttinik with wreckage noted in circle (North Slope Borough Search and Rescue photo).*

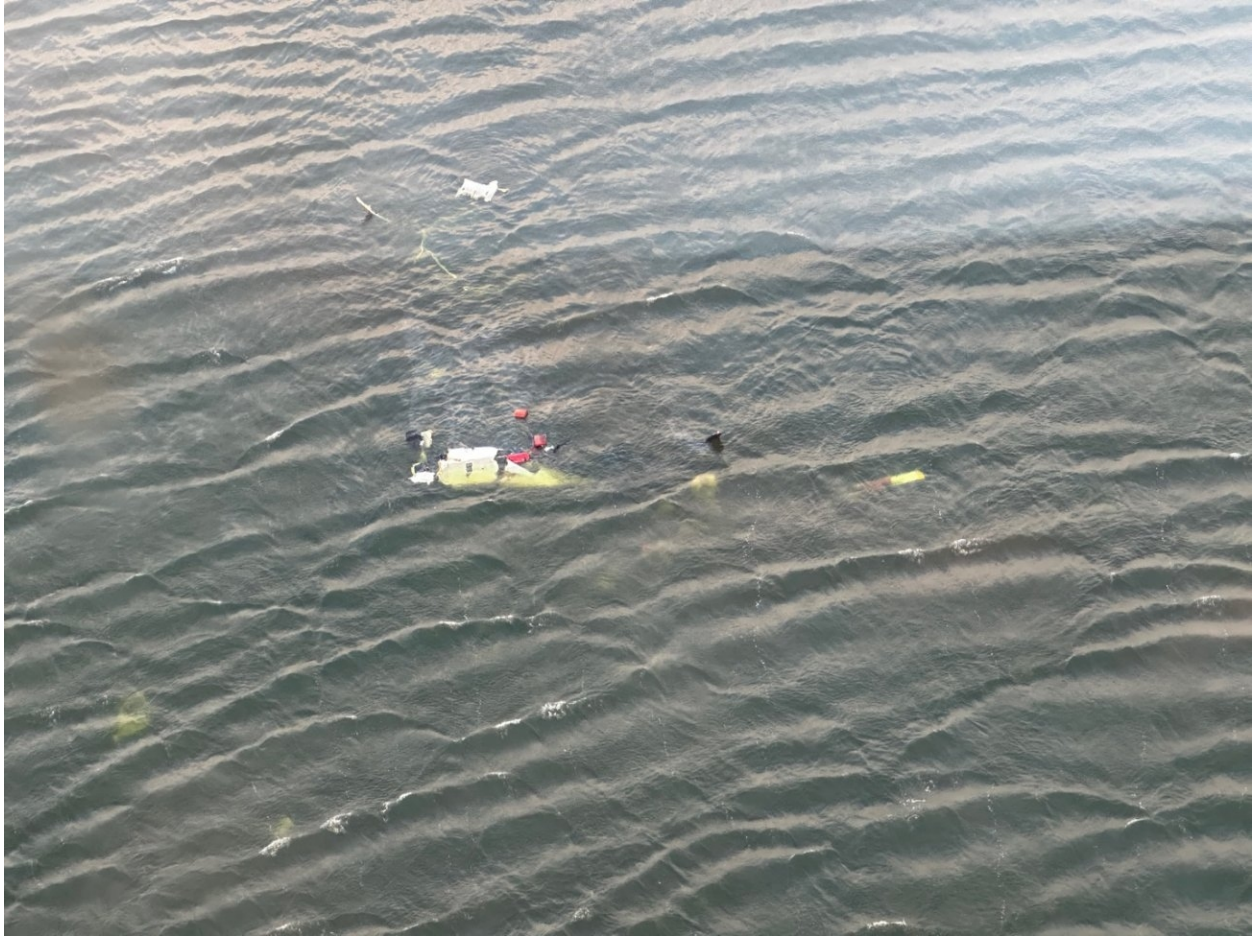
*Figure 2 Aerial view of fragmented wreckage, partially submerged in Lake Itinik (North Slope Borough Search and Rescue photo).*
