Aviation Investigation Preliminary Report

Location:	St. Marys, AK	Accident Number:	ANC23FA074
Date & Time:	September 12, 2023, 20:47 Local	Registration:	N109T
Aircraft:	Piper PA-18-150	Injuries:	1 Fatal
Flight Conducted Under:	Part 135: Air taxi & commuter - Non-scheduled

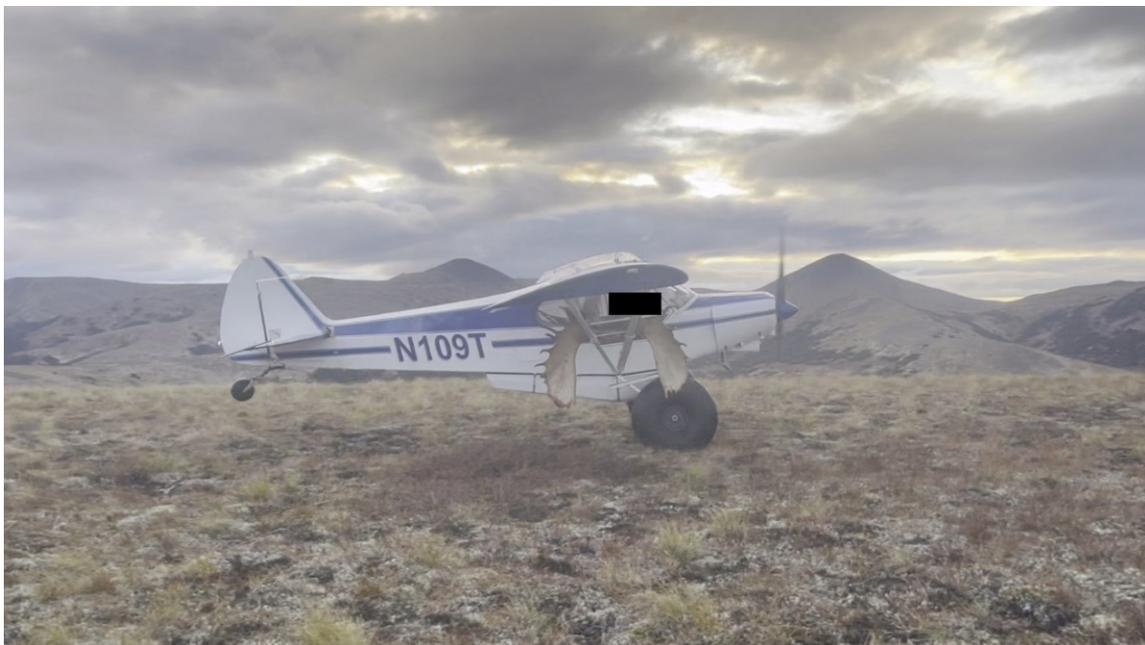
One of the hunters recorded a video of the accident takeoff. The video showed that the airplane began the ground roll at the southern end of the airstrip and departed to the north and uphill. The flaps were retracted, and the tail of the airplane came up as soon as the pilot applied engine power (see figure 1). The ground roll lasted about 530 ft, and, immediately after takeoff, the airplane pitched up and rolled about 20° right. The airplane then appeared to roll to a wings level attitude. The video ended a few seconds later and it did not capture the accident. The engine was heard operating during the recording, and the airplane was not trailing smoke or vapors.

Figure 1. Airplane during the takeoff roll (Source: Hunter video).

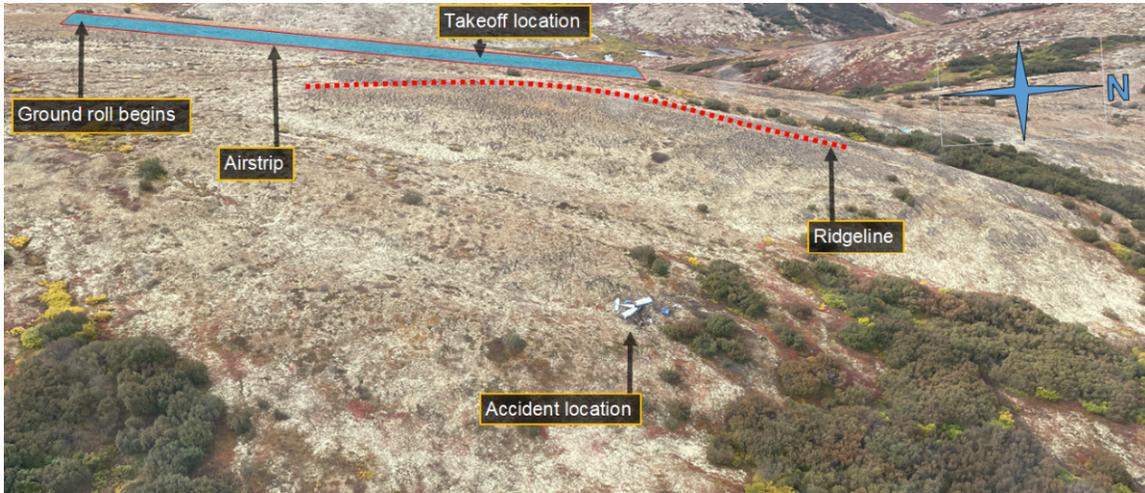
came to rest on a 30° downward slope on the other side of the adjoining ridgeline, at an elevation of 1,210 ft mean sea level, about 10 ft lower, and 600 ft east of the departure end of the airstrip (see figure 2). The surrounding area consisted of rolling hills covered in tundra, grass, and low-lying shrubs and bushes.

Figure 2. Accident site.

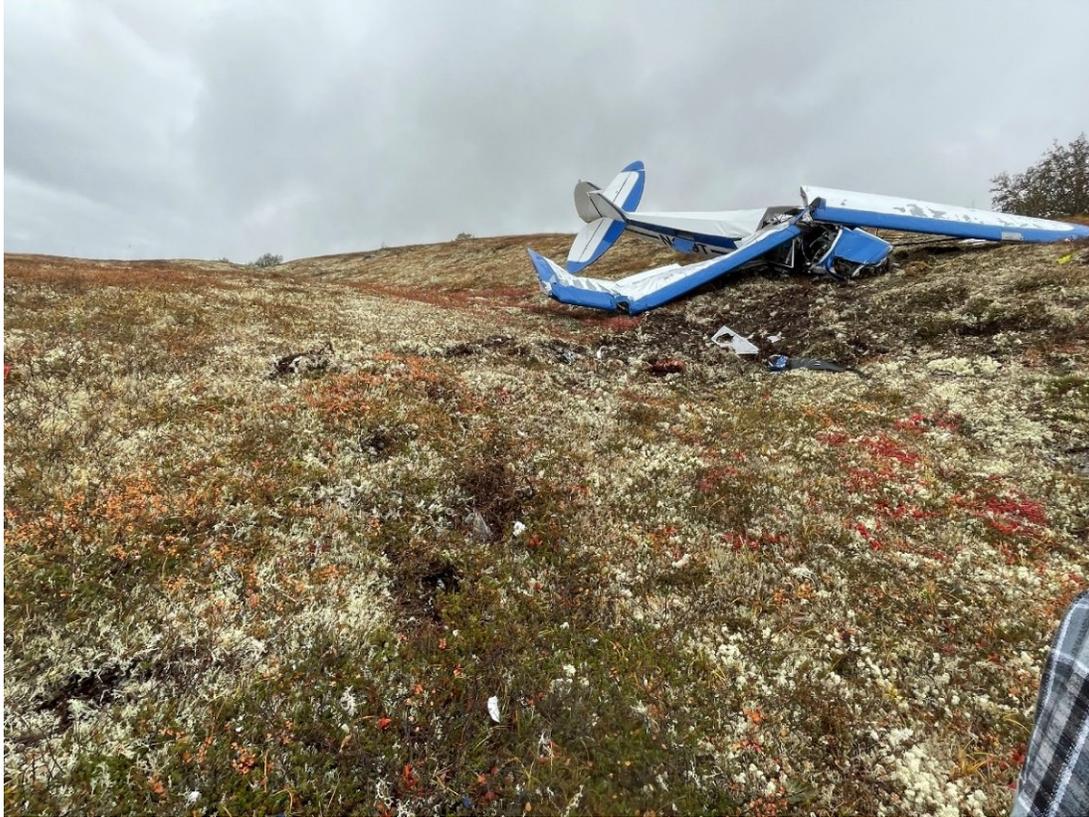
The fuselage was on a north heading, and both wings remained partially attached and generally in line with each other on a northwest-southeast orientation. The first identified point of impact, which was located about 20 ft below the main wreckage, consisted of a divot in the soil that contained blue and white fragments that matched the right wingtip (see figure 3). Next, the right wing landing light assembly and right window frame were located about 5 ft uphill in a west direction. A large divot in the soil, which was located 5 ft farther uphill, matched the general dimensions of a main landing gear tire. Adjacent to this hole was the propeller, which had separated from the crankshaft.

Figure 3. Accident site with the first point of impact in the foreground.
