Aviation Investigation Report AIR-23-01

Abrupt Loss of Pitch Control and Water Impact

West Isle Air dba Friday Harbor Seaplanes de Havilland DHC-3, N725TH

Mutiny Bay, Washington
September 4, 2022

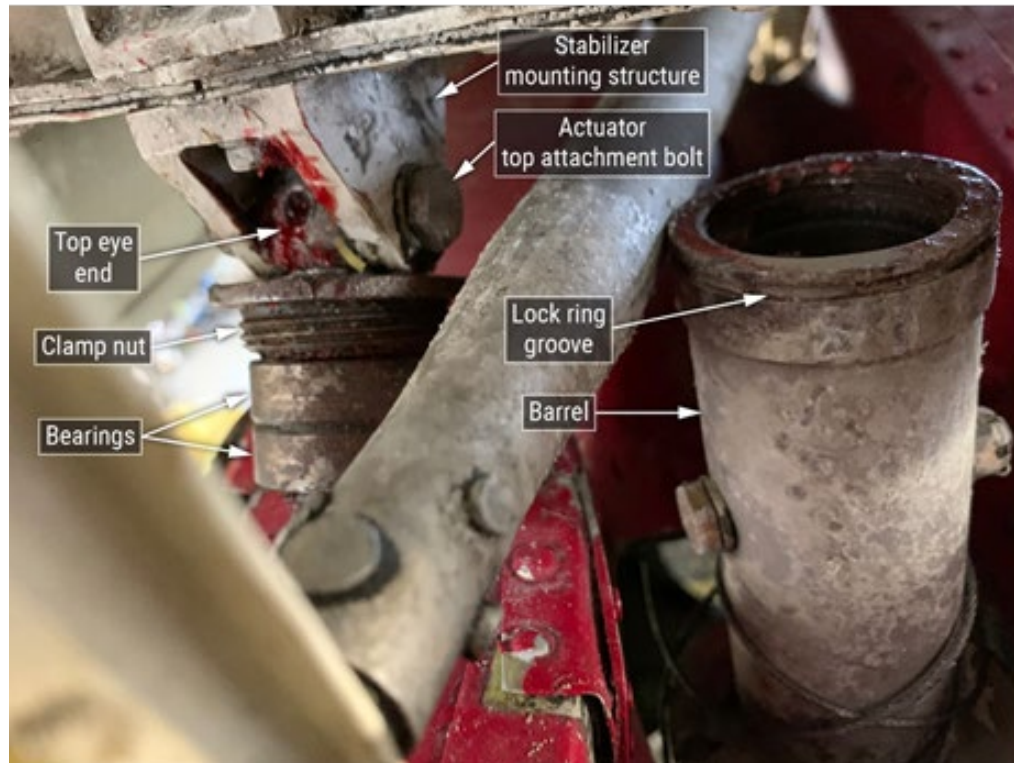
The horizontal stabilizer trim actuator's top eye end and bearing assembly clamp nut were found unscrewed from the actuator's upper housing with no obvious damage to the threads. The top eye end and bearing assembly remained connected to the horizontal stabilizer mounting bracket by the upper actuator attachment bolt (see figure 7) and could pivot freely about this bolt. The clamp nut could spin about

the top eye end. The lower actuator housing could rotate freely fore-aft about the lower attachment bolt.

Figure 7. Photograph of the clamp nut and barrel separation on the accident airplane.

When the barrel assembly was rotated full forward about the lower attachment bolt, the barrel contacted structure (which was bent inward and downward in this location). The lower center skin of the horizontal stabilizer was punched through at a 90° angle directly above the actuator when it was in the full-forward position. The punch-through was round and left a circular grease imprint on the contact surface that was consistent with the top of the actuator barrel assembly without the top eye end and bearing assembly present. The lock ring was not present in the lock ring groove of the upper barrel assembly. The through-hole in the lock ring groove was mostly clean, and light could be seen through it. The area below the actuator, as well as inside the horizontal stabilizer in the area of the punch-through, was searched for the lock ring both visually and with a magnet, but the lock ring was not found.¹⁹

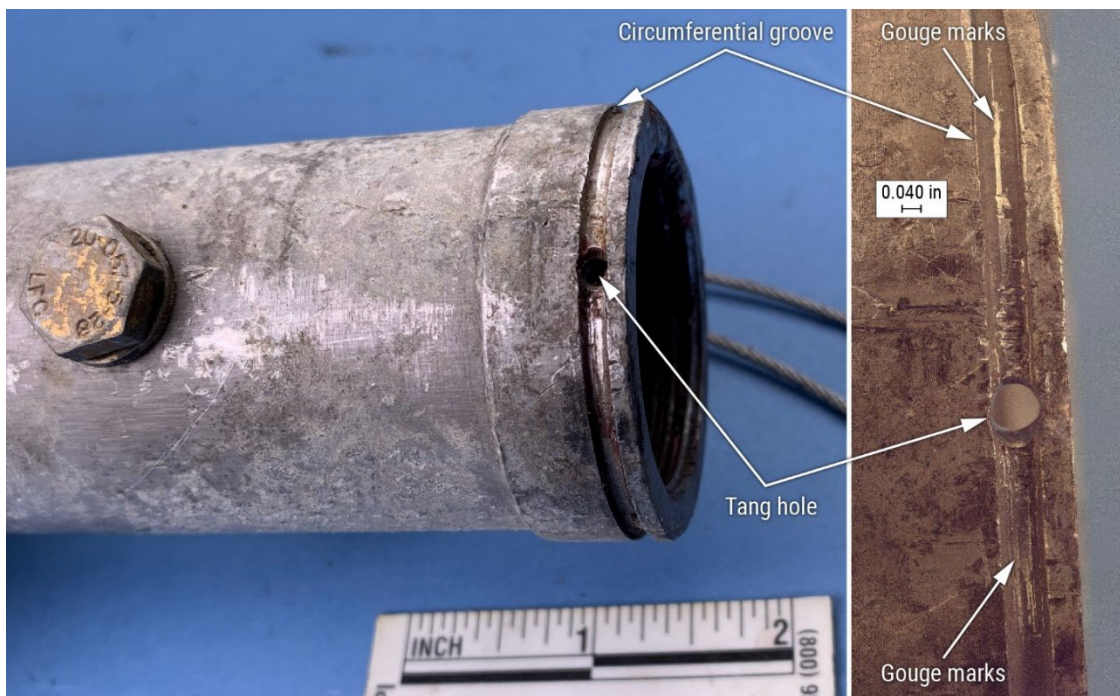
The horizontal stabilizer trim actuator assembly (with separated top eye end and bearing assembly) was sent to the NTSB Materials Laboratory for further examination. The top end of the actuator barrel at the outer surface contained a circumferential groove for a circular wire lock ring. The lock ring was not attached to the groove portion of the barrel and no fragment of the lock ring was found in the hole within the groove.

The manufacturer specification for the diameter of the tang hole in the barrel (intended for engaging the lock ring) was 0.098 inches; the specified diameter was confirmed by easily inserting the shank portion of a 0.098-inch nominal diameter drill bit into the tang hole. The tang hole at the outer surface exhibited evidence of elongation deformation on both lateral sides (perpendicular to the length of the barrel). The groove portion of the barrel contained circumferential gouge marks that extended about 0.9 inches to either side of the tang hole (see figure 8). The groove in areas outside of the gouge marks exhibited light contact (polished) marks consistent with the size of a lock ring.

Figure 8. Photographs of the top end of the horizontal stabilizer actuator barrel.

Note: The left image shows the circumferential groove and tang hole for the lock ring; the right image is a close-up view of gouge marks in the groove.

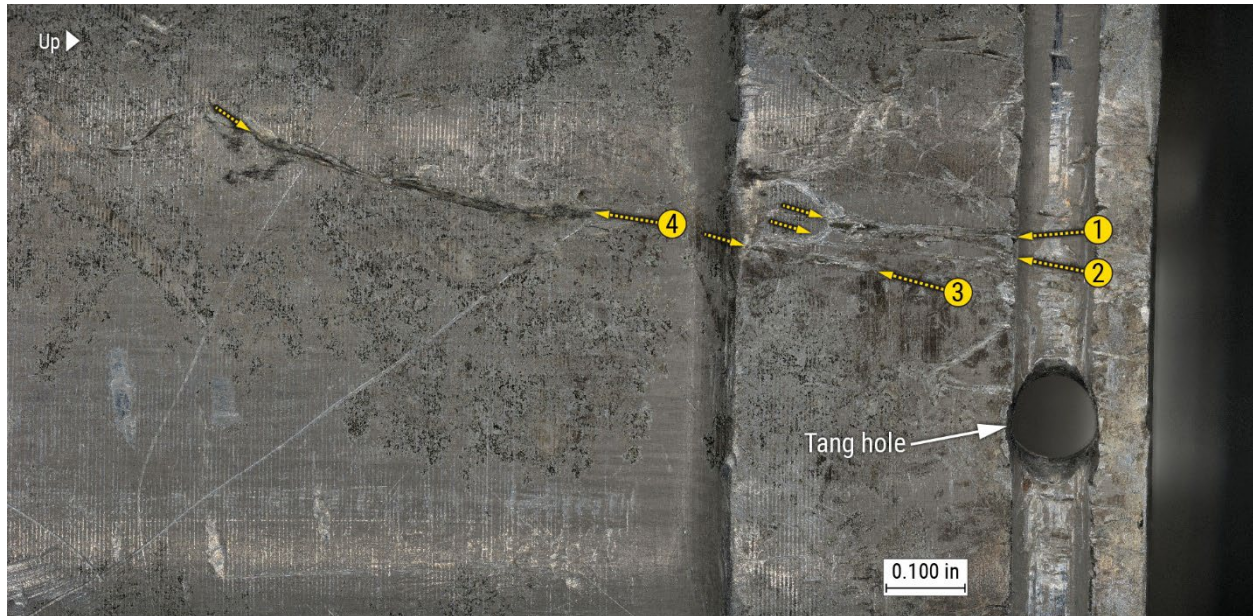
Several longitudinal gouge marks were noted in the general area of the tang hole (see figure 9).

Figure 9. Side view of the horizontal stabilizer actuator barrel.

Note: The image shows the longitudinal-like gouge marks that extended from the circumferential groove, in the areas between arrows "1" through "4".

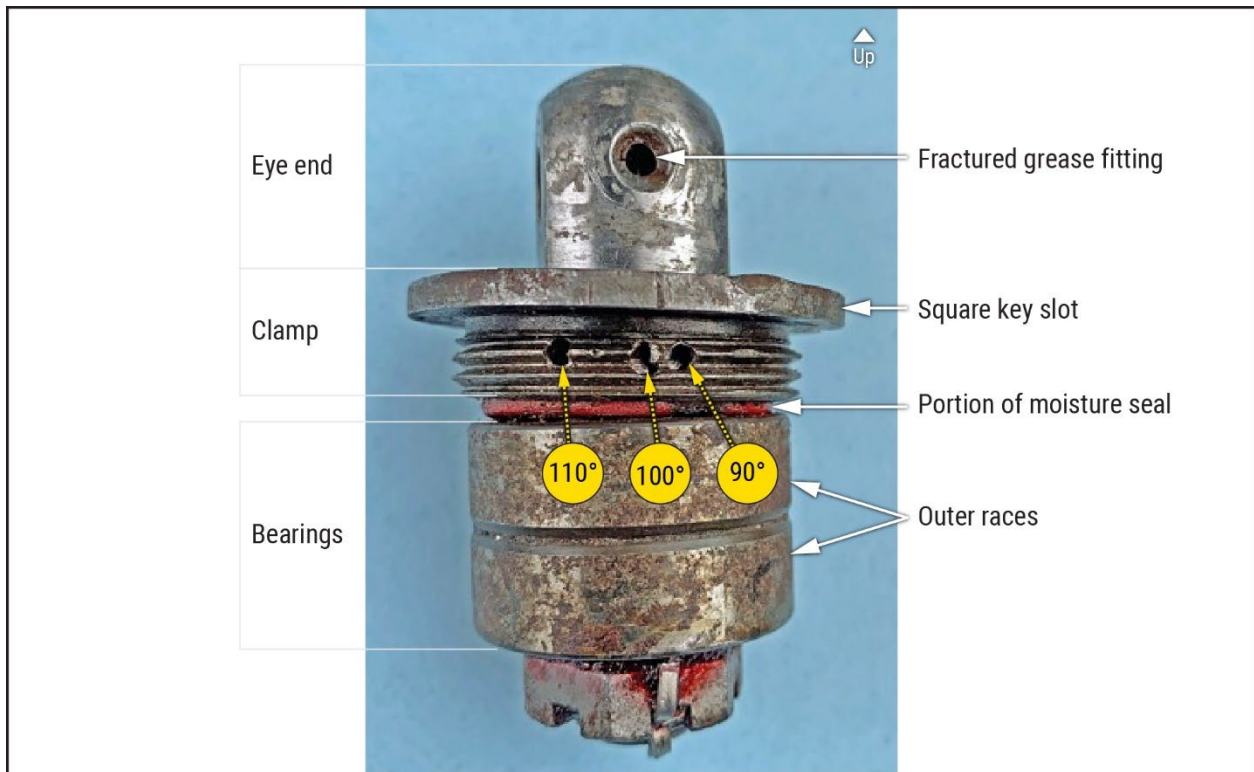
Figure 10. Photograph of the top eye end and bearing assembly showing three of five holes drilled into the clamp nut.

Five drilled through-holes were observed in the area of the clamp nut's external threads. None of the holes contained a fragment of the lock ring or foreign material. The positions of the drilled holes around the clamp nut were measured relative to the square key slot (which was arbitrarily assigned the 0° position). Two of the five drilled through-holes (located at 90° and 110°) were unobstructed, and the remaining through-holes (located at 100°, 230°, and 310°) were obstructed by wall deformation that reduced the diameter of the through-holes.²²

During interviews, the DOM and AMT both reported that they never drilled holes into the clamp nut. The DOM further stated the AMM contained no instructions for when the lock ring and hole do not line up.²³ A review of the AMM confirmed there was no information pertaining to multiple holes in the clamp nut (no authorization was given to drill additional holes or what to do if multiple holes were observed). Interviews with personnel from Viking Air indicated there should only be one hole drilled in the clamp nut.

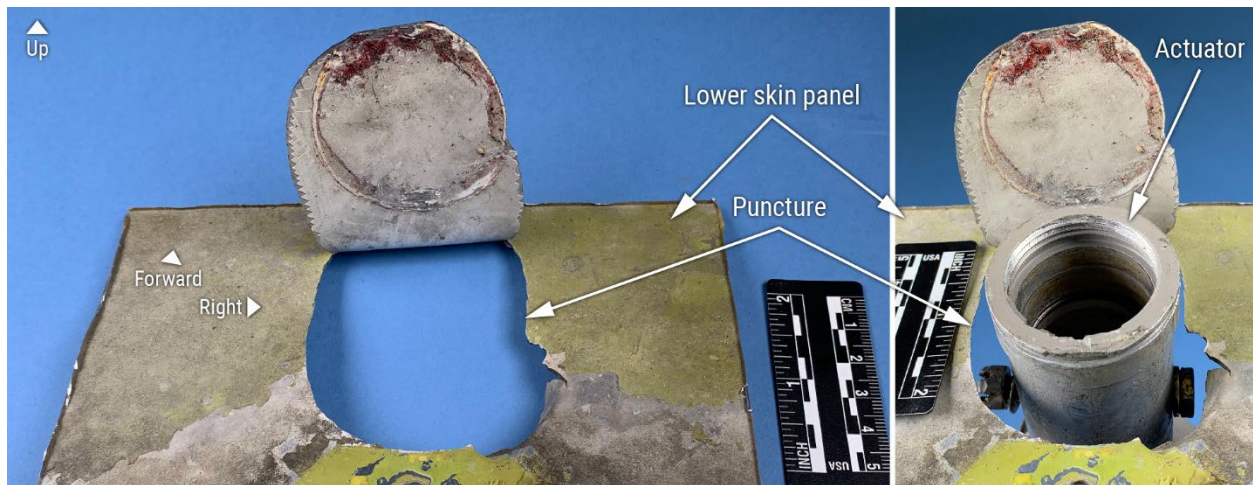
A lower skin panel from the horizontal stabilizer was examined at the NTSB Materials Laboratory. The panel contained a puncture with the ruptured flap portion that was deformed upward. The bottom face of the punctured skin exhibited a deformed curved pattern that was consistent with the shape and size of the horizontal actuator barrel outer diameter when the top eye end and bearing assembly was not present (see figure 11). The bottom surface of the flap was covered with translucent red grease (around and within the impression mark).

Figure 11. Photographs of the lower skin panel for the horizontal stabilizer.

Note: The left side of the image shows the puncture, and the right side of the image shows the barrel portion of the horizontal stabilizer trim actuator inserted into the open end of the puncture.

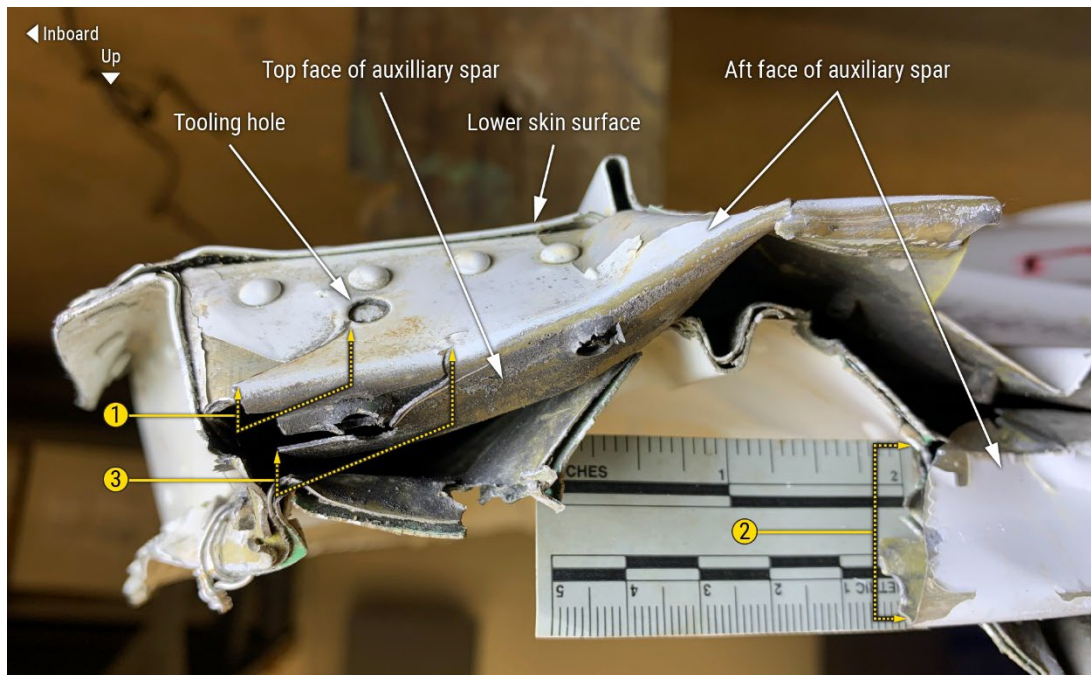
Examination of the left elevator assembly revealed the inboard end of the auxiliary spar contained three cracks (arbitrarily referred to as cracks "1", "2", and "3") (see figure 12). Cracks "1" and "3" were located in the same area that contained a

2-inch-long repair doubler (installed at the inboard end on the forward face of the auxiliary spar).³¹

Figure 12. Photograph of the auxiliary spar for the left elevator, after the tab was removed, showing cracks "1", "2" and "3" (view looking forward).

The cracks were examined by bench binocular microscope and scanning electron microscope. Cracks "1" and "3" revealed fracture features consistent with fatigue cracking, and crack "2" revealed evidence of overstress separation with no evidence of fatigue cracking. The repair doubler was intact, and no cracking was noted on it. The outboard end of the auxiliary spar was disassembled (de-riveted) from the left elevator to expose all surfaces of the auxiliary spar. The remaining portion of the auxiliary spar contained no evidence of cracks.
