Transport Accident  
Investigation  
Commission

# Final report

**Report of the Transport Accident Investigation Commission into  
two stevedoring accidents in April 2022**

***Maritime inquiry MO-2022-203  
Container vessel, Capitaine Tasman  
Stevedore fatality during container loading operations  
Port of Auckland  
19 April 2022***

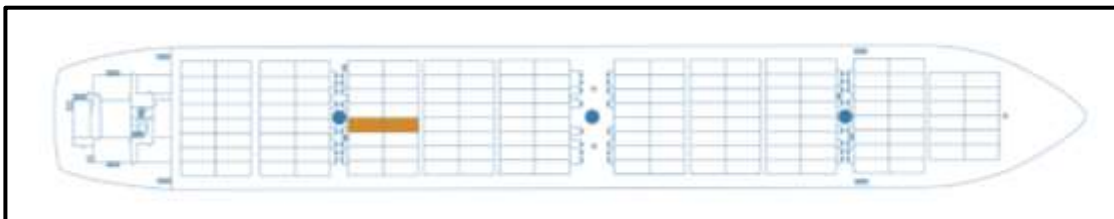
- A1.8. By about 0850, gang three had loaded twenty 20-foot containers onto the main deck of the vessel in bay<sup>43</sup> 32 (See Figure 7). The crane's spreader<sup>44</sup> was then changed to accommodate the loading of 40-foot containers, which were to be stacked on top of the previously loaded 20-foot containers.

**Figure 7: Plan view of Capitaine Tasman depicting container stowage in 20-foot units**  
**The blue circles indicate the position of the three cranes.**  
**The coloured box indicates position of the 40-foot container involved in the accident.**

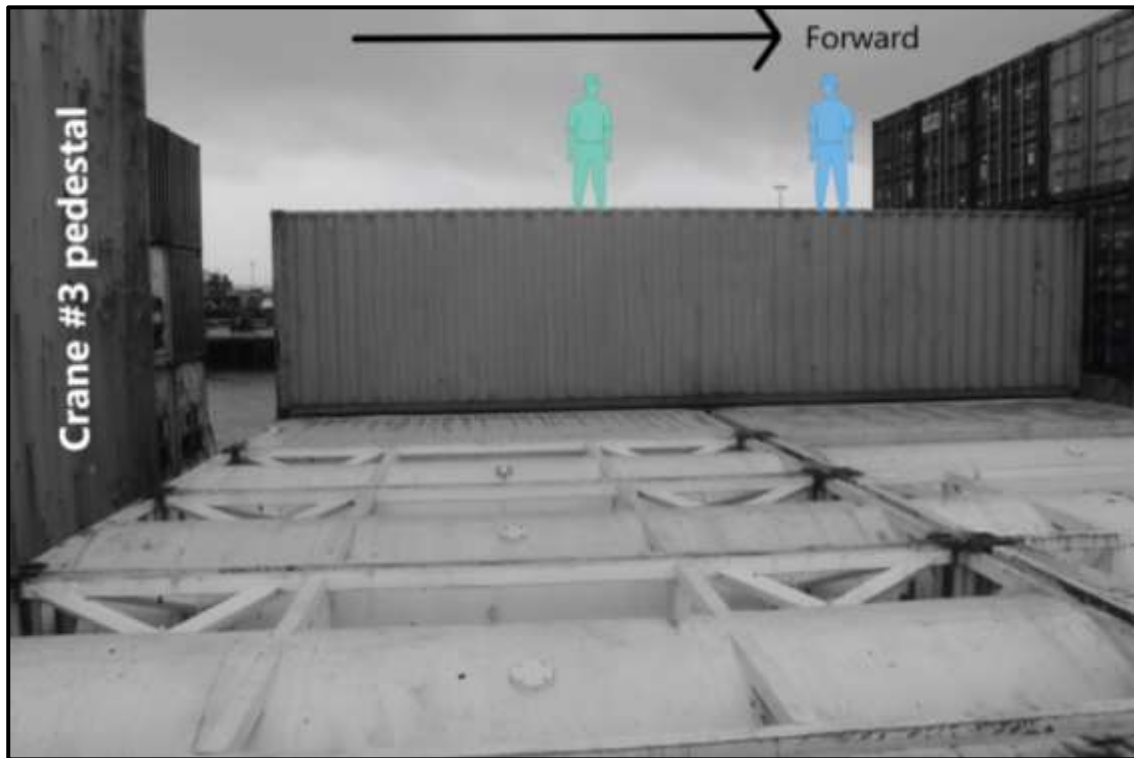
- A1.11. Two stevedores in gang three (hold operators A and B) were positioned on the second tier<sup>48</sup> of containers (see Figure 8). The hold operators' task was to guide the containers into the correct position as the crane lowered them. At the time the container was being lifted from the wharf, the hatchman had left the vessel to collect a rain jacket.

**Figure 8: Hold operators A (green) and B (blue) on the second container tier**

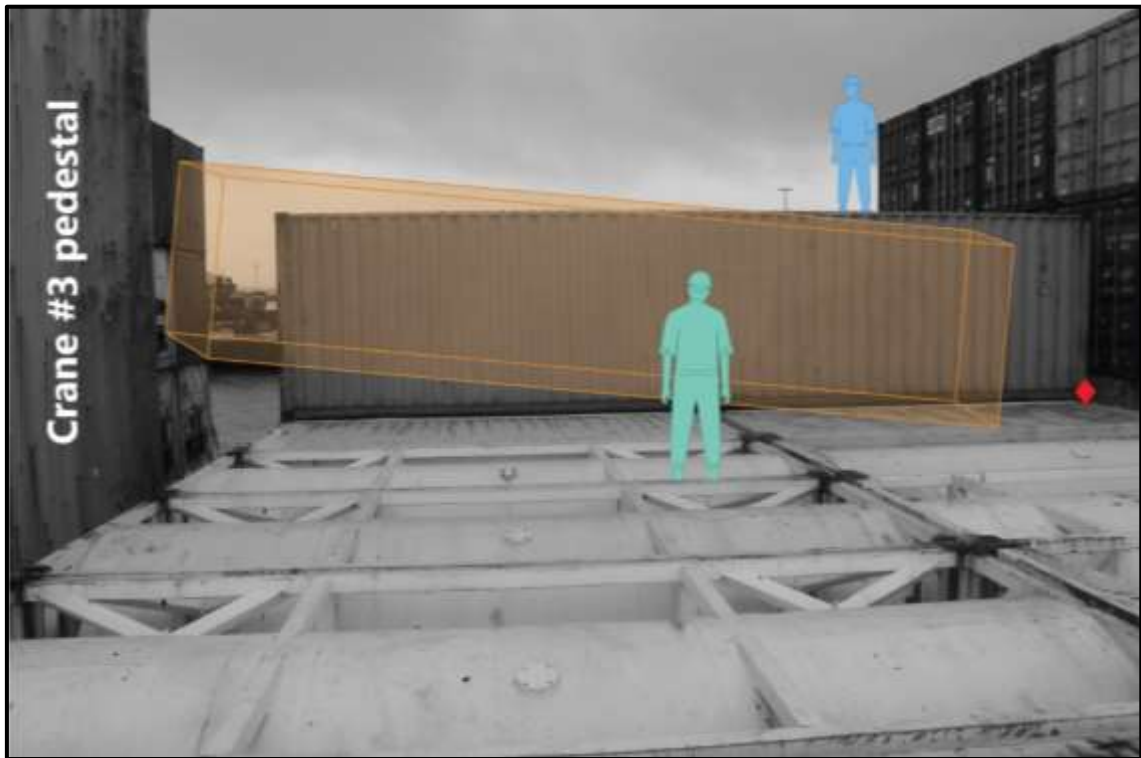
- A1.15. Once down on the first tier, hold operator A repositioned the displaced twist lock into the top corner casting of the 20-foot container.<sup>51</sup> Hold operator A remained on the first tier of containers and hand-signalled to the crane operator that the landing could be re-attempted (see Figure 9).

**Figure 9: Approximate position of hold operator A (green) after repositioning the forward port twist lock (red diamond)**

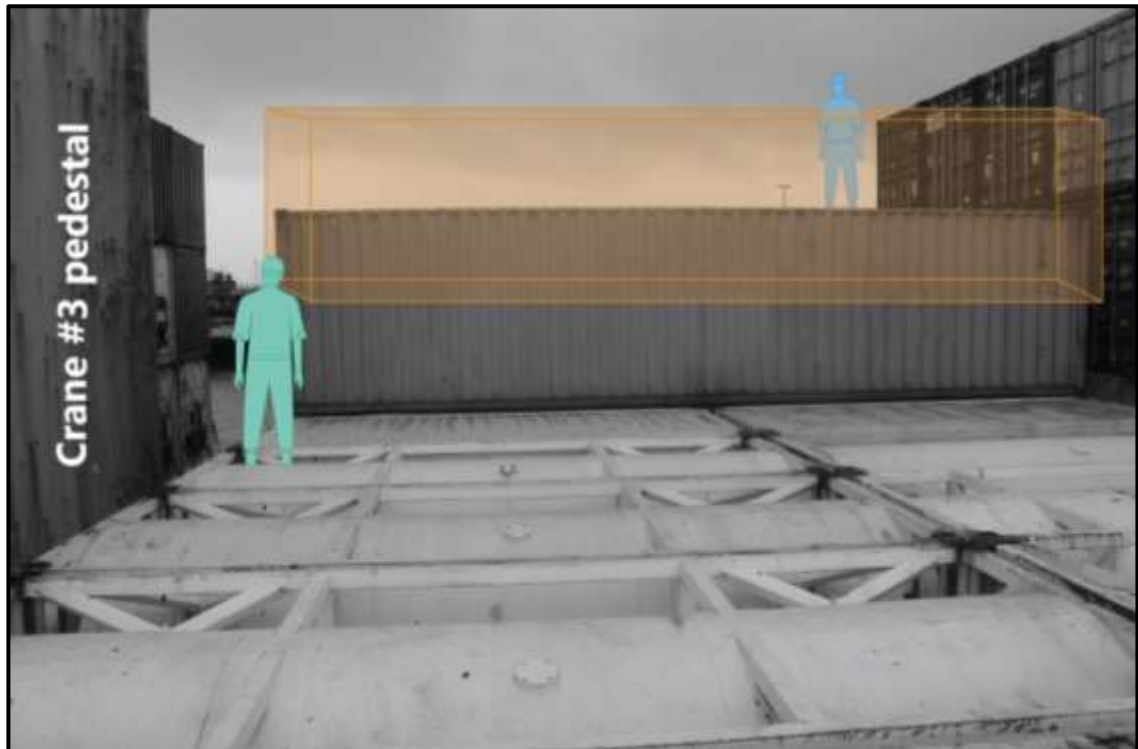
**Figure 10: Approximate position of hold operator A (green) on the edge of the first tier of containers immediately before accident**

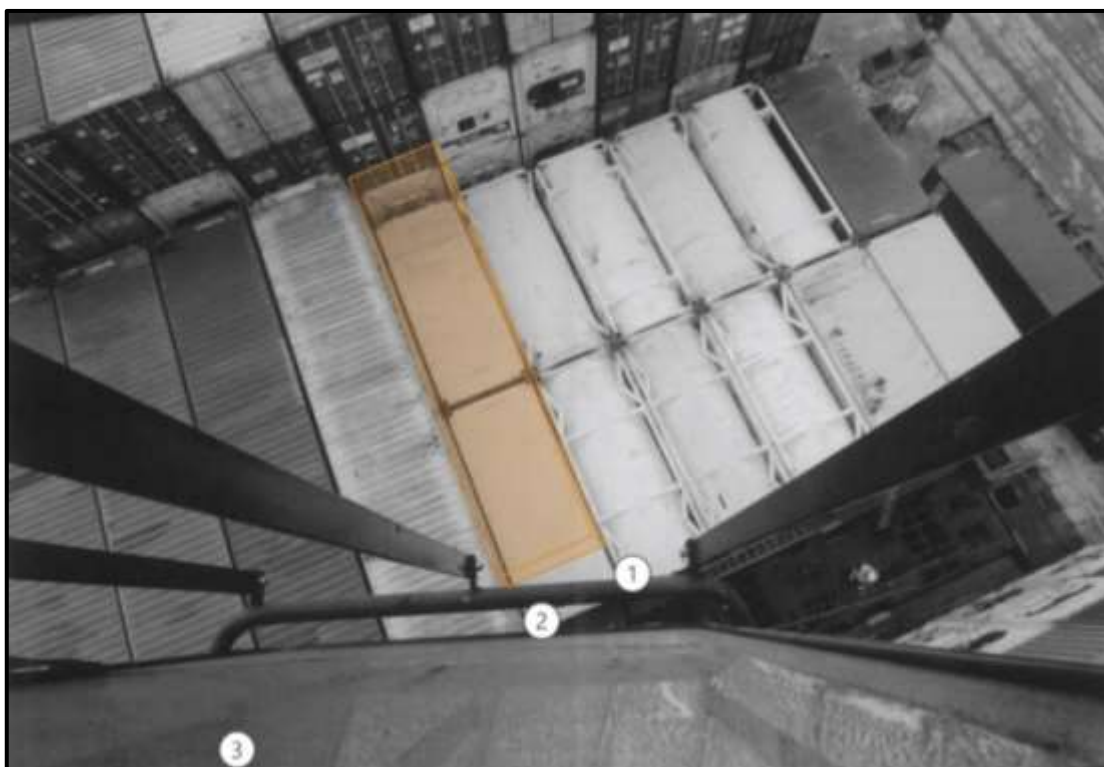
**Figure 12: View looking down from outside the number three crane cab window**

**Point 1 indicates where the eyewitness initially observed the victim;  
Point 2 indicates the victim's position when the container was lowered;  
Point 3 is the approximate location of the eyewitness  
who was standing below the containers on the main deck level.**

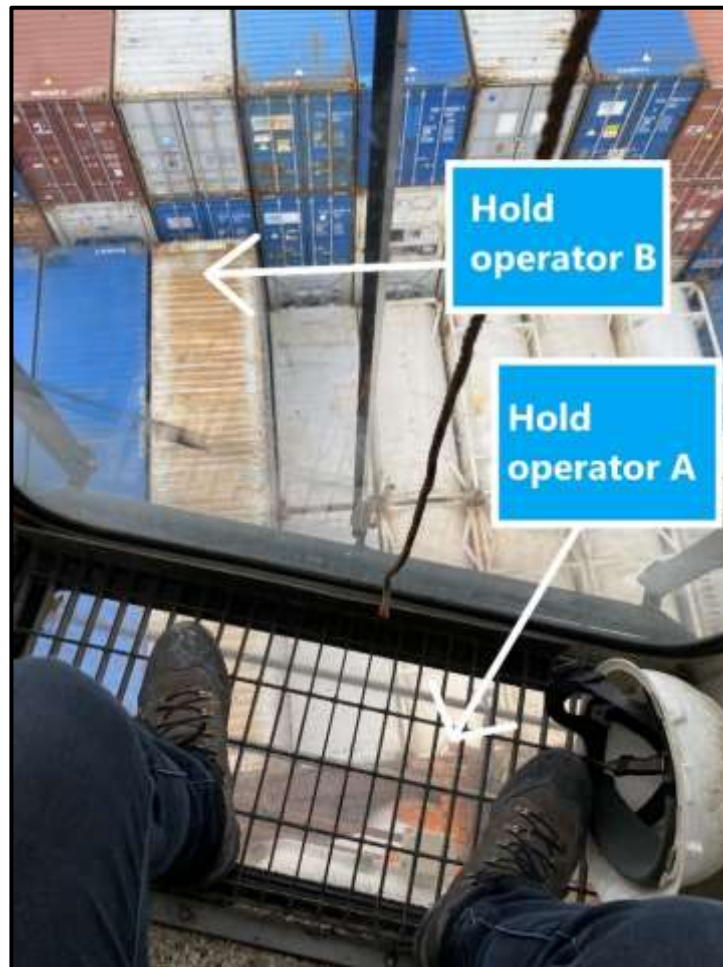
opportunity to observe hold operator A moving into an unsafe position. However, the Commission believes it is **unlikely** that the crane operator would have noticed the hold operator's movement even if they had unrestricted visibility.<sup>80</sup>

**Figure 15: View through crane floor grate**

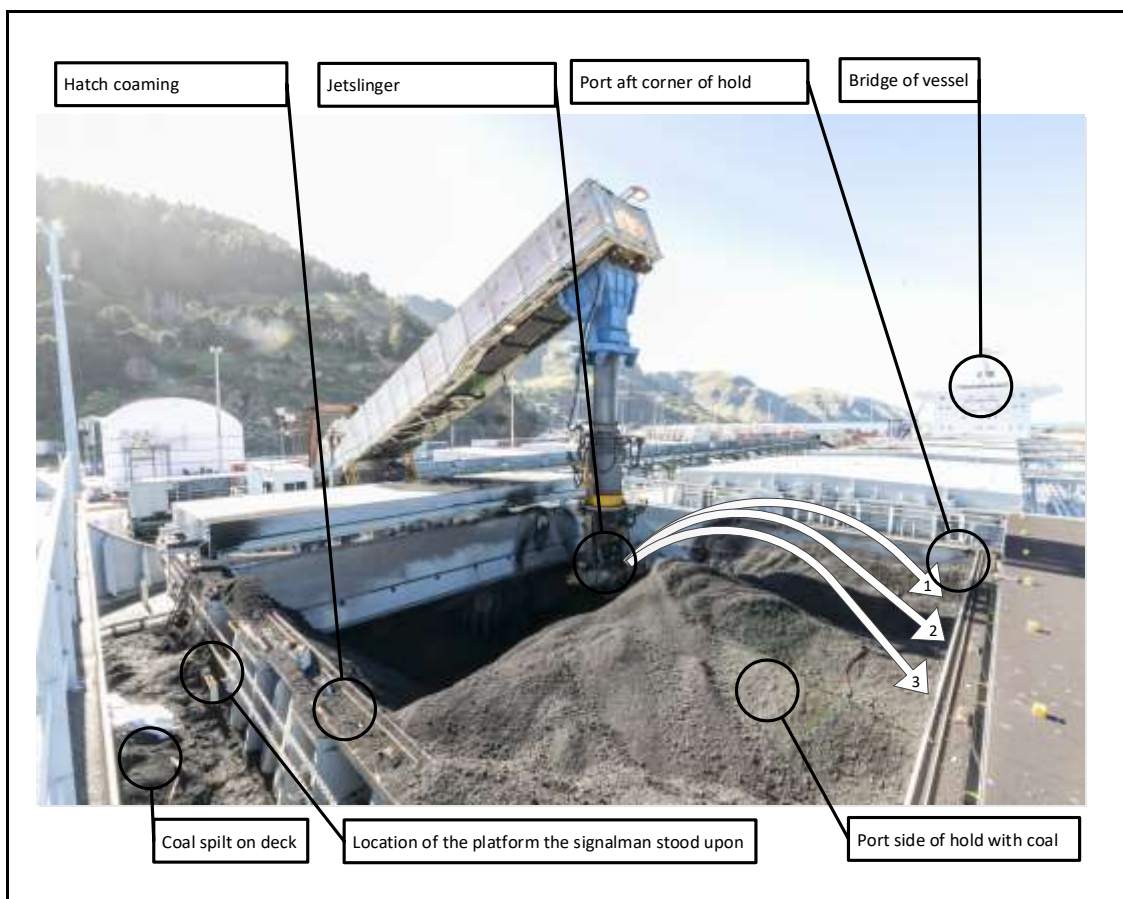
**Figure 18: Number one hold after the accident, showing the ship-loader and jetslinger<sup>95</sup>**  
(Credit: Maritime New Zealand)

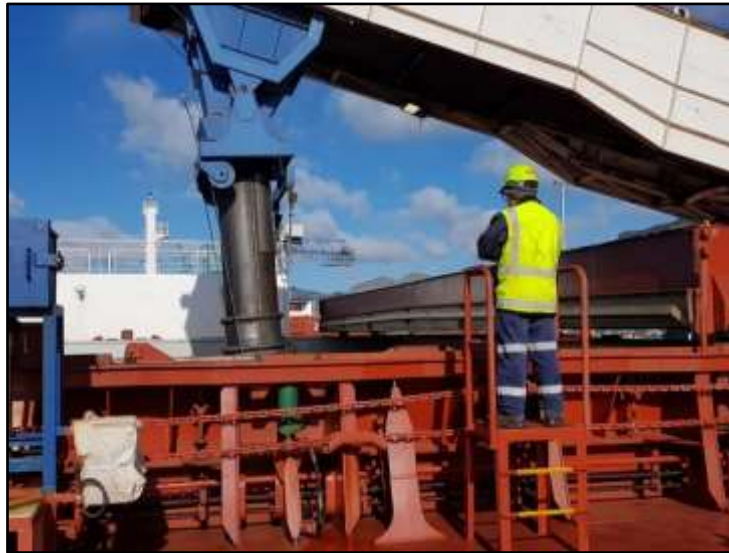
**Figure 20: Photo in SWMS showing the signalman standing on a pedestal looking over the hatch coaming into the hold**
