Aviation Investigation Preliminary Report

Location:	Anchor Point, AK	Accident Number:	ANC24FA008
Date & Time:	December 8, 2023, 13:15 Local	Registration :	N1880P
Aircraft:	Piper PA-18-150	Injuries:	1 Fatal, 1 Serious
Flight Conducted Under:	Part 91: General aviation - Personal

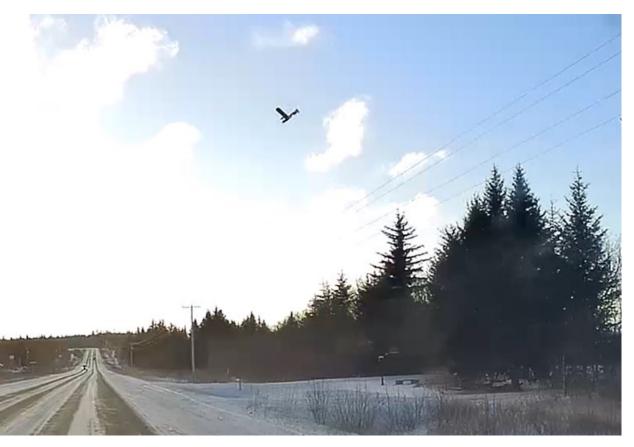
Review of a video from a vehicle dash-mounted camera showed the airplane in an inverted flat spin before disappearing behind trees (Figure 1). The video captures the spinning, inverted airplane as it descends vertically, but it does not record the initiating event. Additionally, the dash-mounted video revealed that as the airplane enters the top of the video screen, the airplane's left wing was folded against the fuselage as the descending wreckage entered an area of tree and brush-covered terrain.

Figure 1. Screenshot of dash camera video

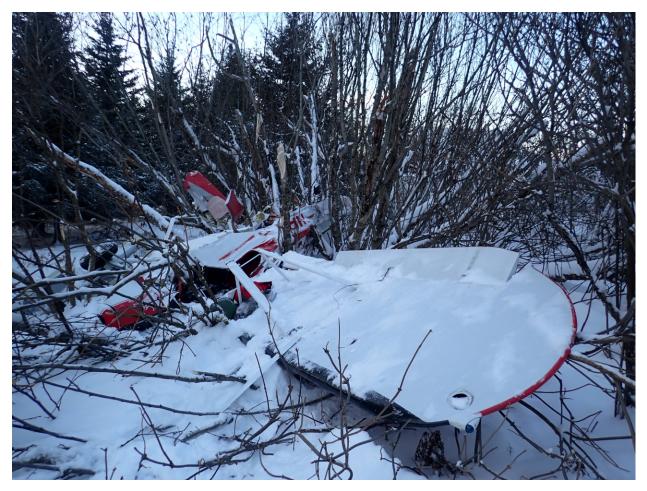
Figure 2. Airplane wreckage as found by NTSB investigators on December 9

The airplane came to rest inverted in an area of low brush. The left wing was partially attached to the fuselage; both lift struts were fractured. The right wing and right wing struts remained attached and were cut by first responders. The fuselage was twisted and sustained impact damage. Control continuity was established between the cockpit flight controls and their respective control surfaces. The engine remained attached to the airframe; one propeller blade was located next to the wreckage; the other blade tip was separated.
